Historic England

Conserving War Memorials

Inscriptions

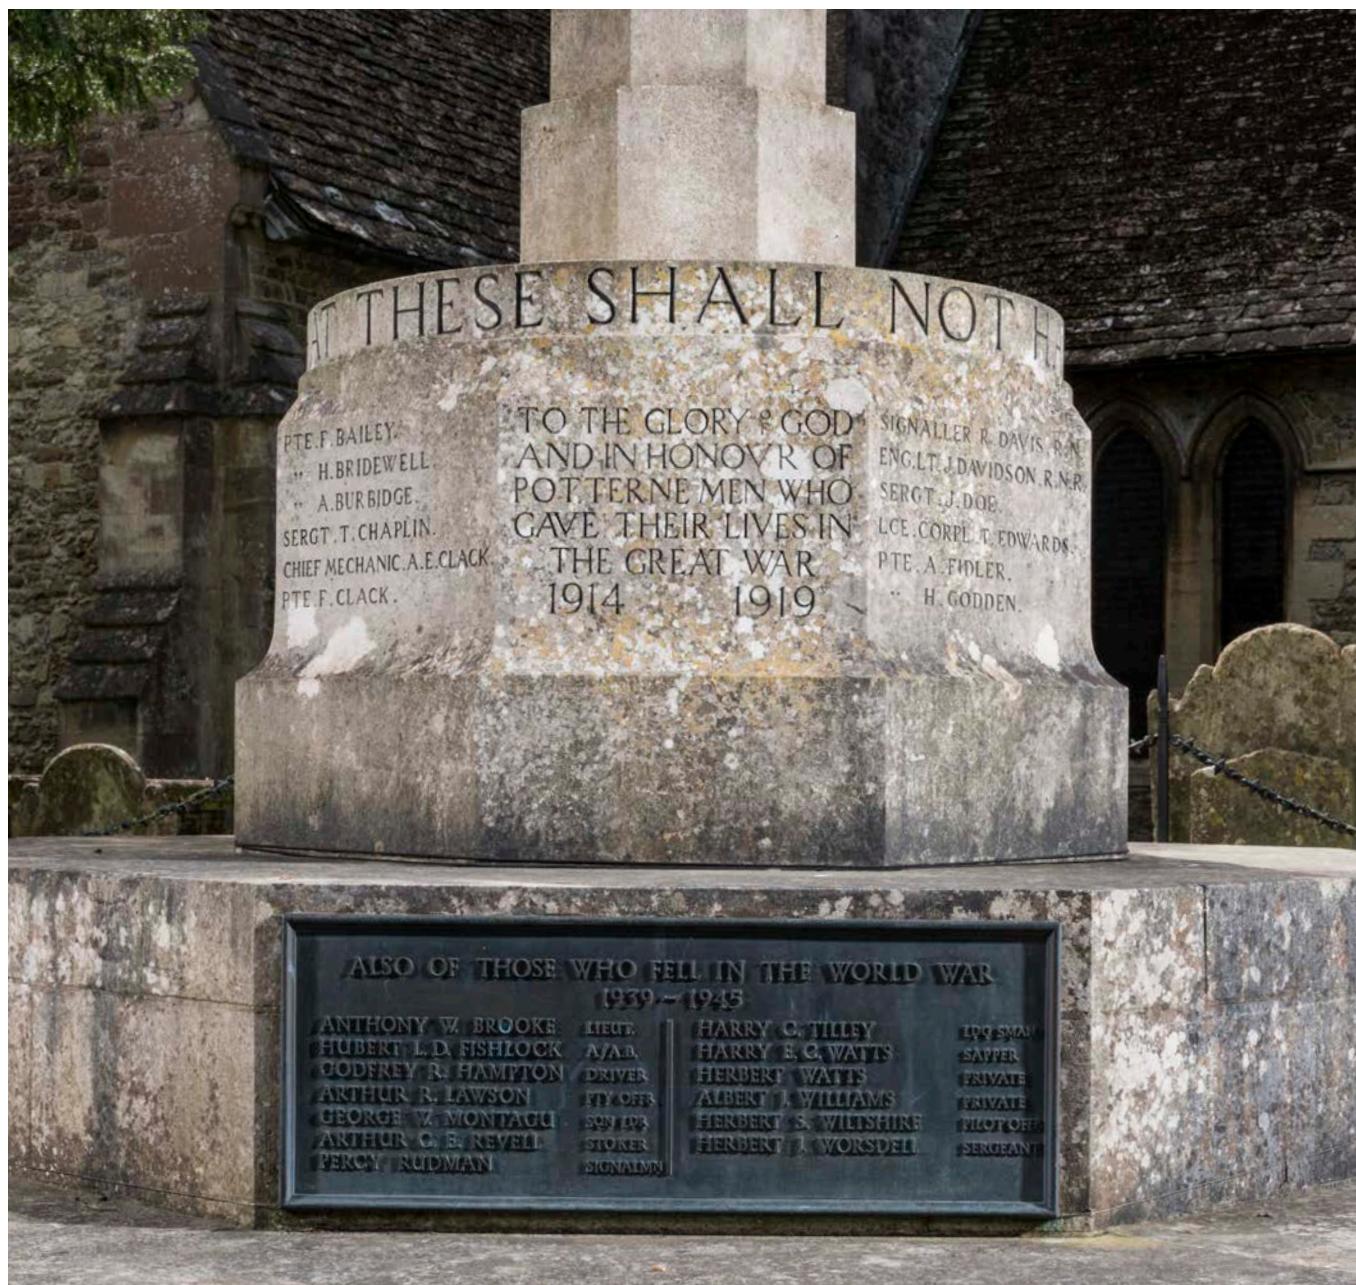
Front cover: An incised and painted inscription on a First World War stone memorial, updated to commemorate World War II.

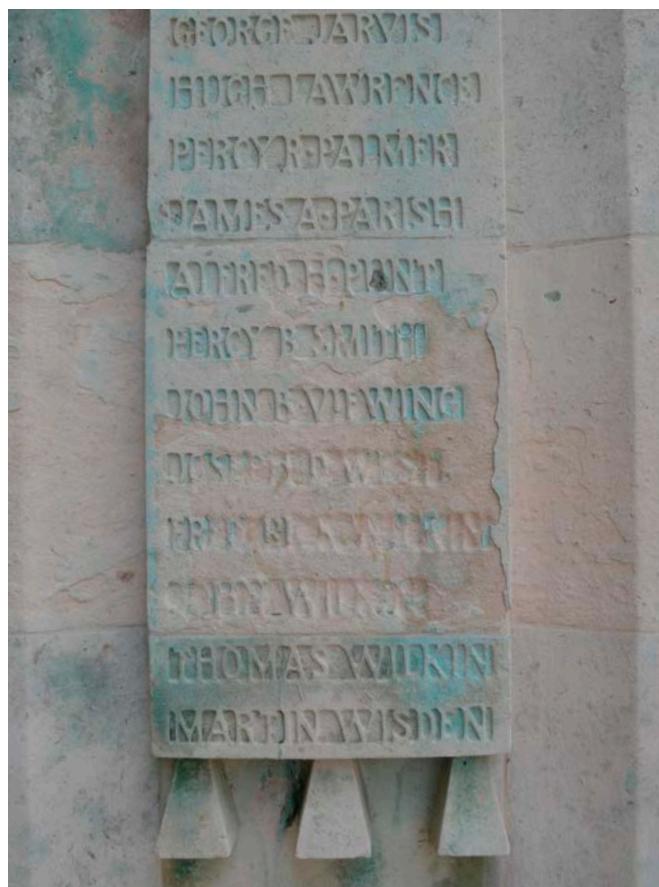
Figure 1: St John's Church, Waterloo, London. At the top of this memorial, the inscription is weathered but legible but towards the bottom, the inscription is illegible due to surface delamination.

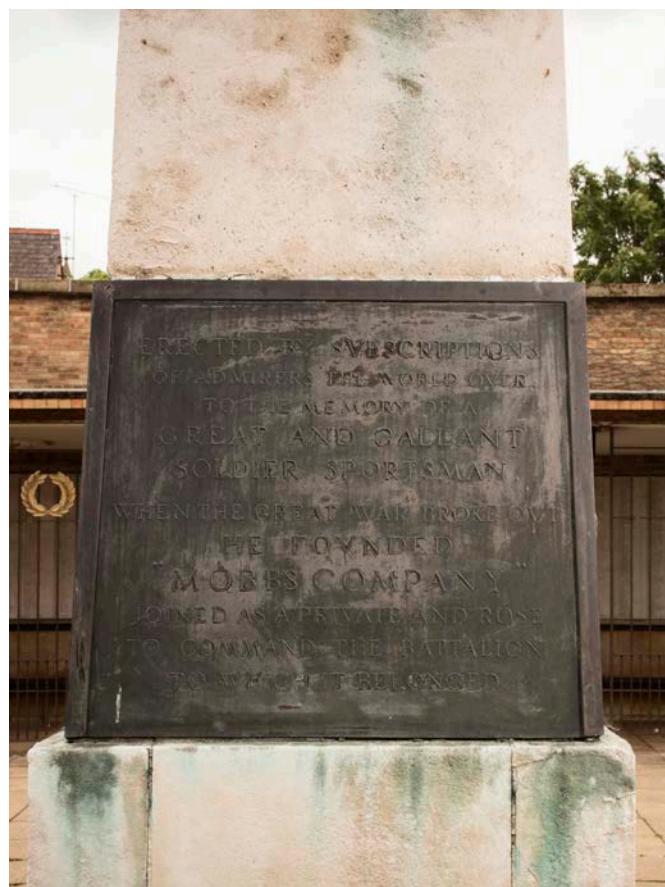
Figure 2: Memorial to Edgar Mobbs, Northampton. Surface discolouration has severely impaired legibility of this inscription.

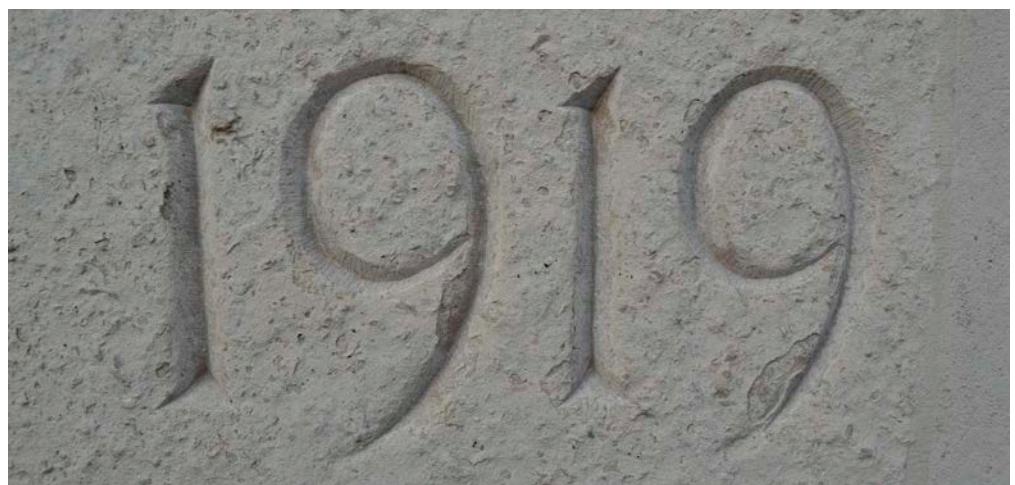
Figure 4: Stockwell war memorial, Lambeth Road, London. Incised lettering in Portland stone. The marks of the chisel are evident on each side of the 'V' cut of the letters.

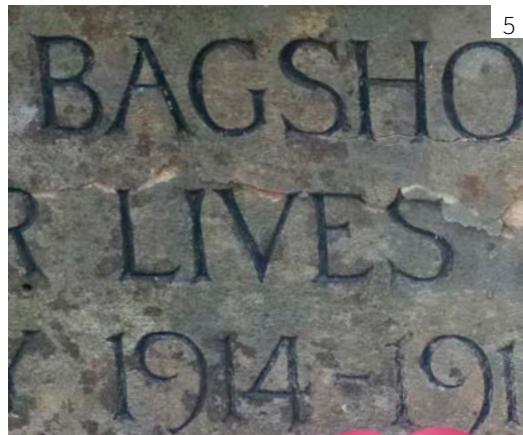
Figure 5: St Anne's Church, Bagshot, Surrey. Incised and painted lettering.

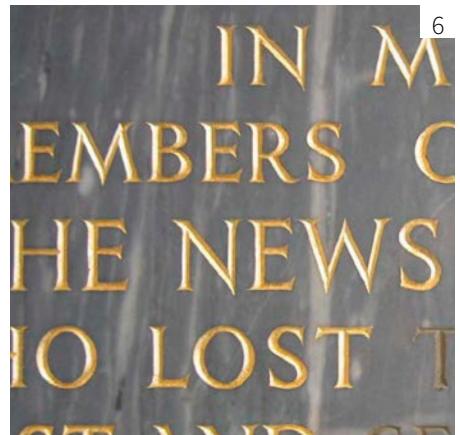
Figure 6: News of the World war memorial. Incised and gilded lettering.

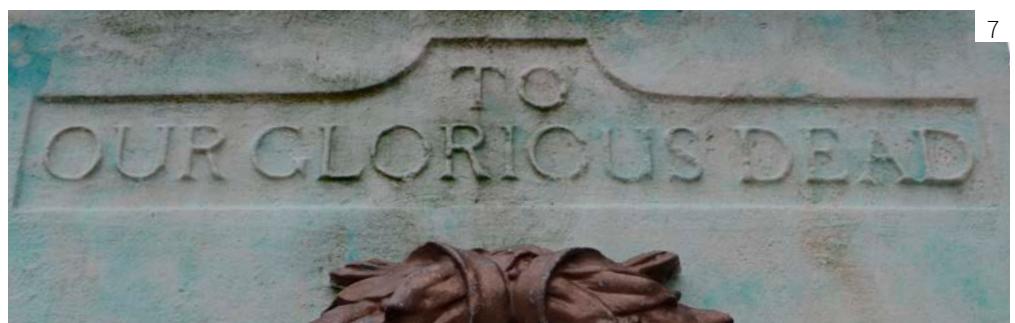
Figure 8: St Mark's Church, Kennington, London.
Lead lettering applied to granite. The drill holes used to anchor the letters can be seen where a 'T' has been lost, and the paint layer is damaged showing the lead underneath.

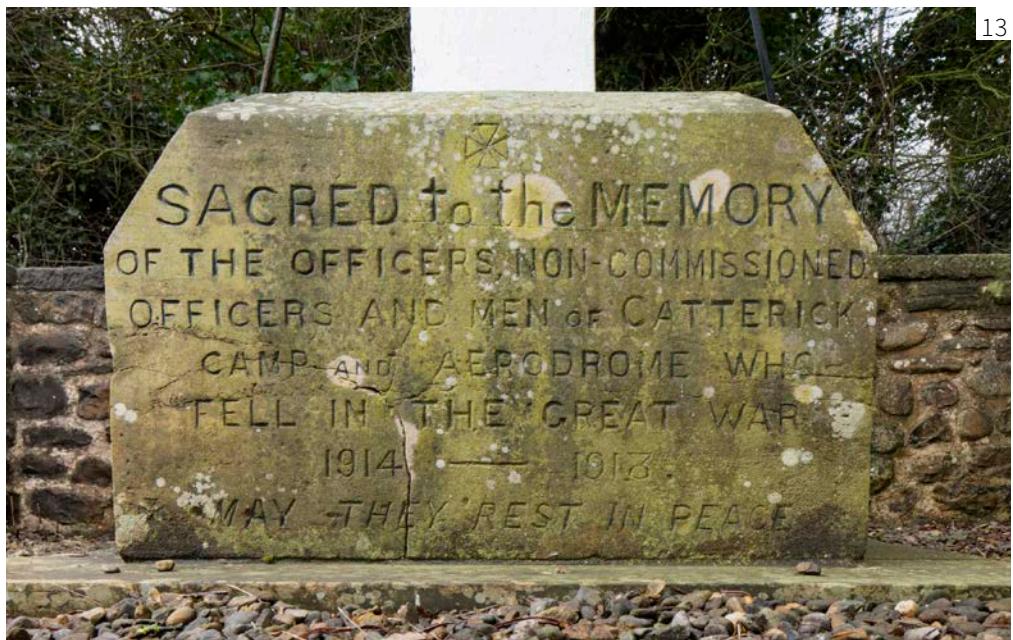
Figure 13: Memorial near Catterick, North Yorkshire. Legibility is impaired by the heavy algal growth.

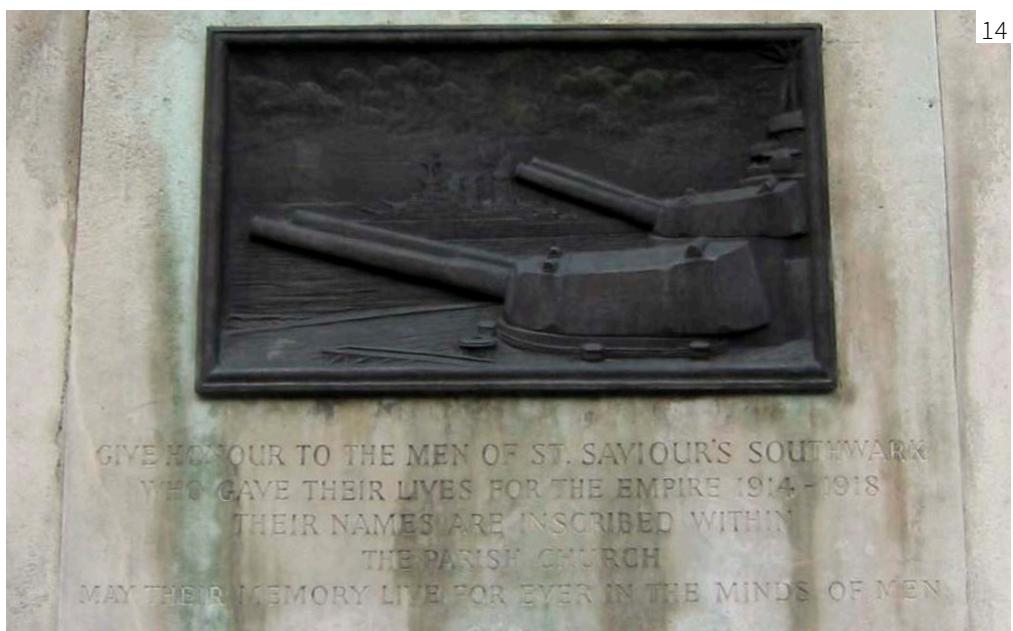
Figure 14: Southwark war memorial, Borough High Street, London. Copper staining on a Portland stone inscription underneath a bronze statue and plaque.

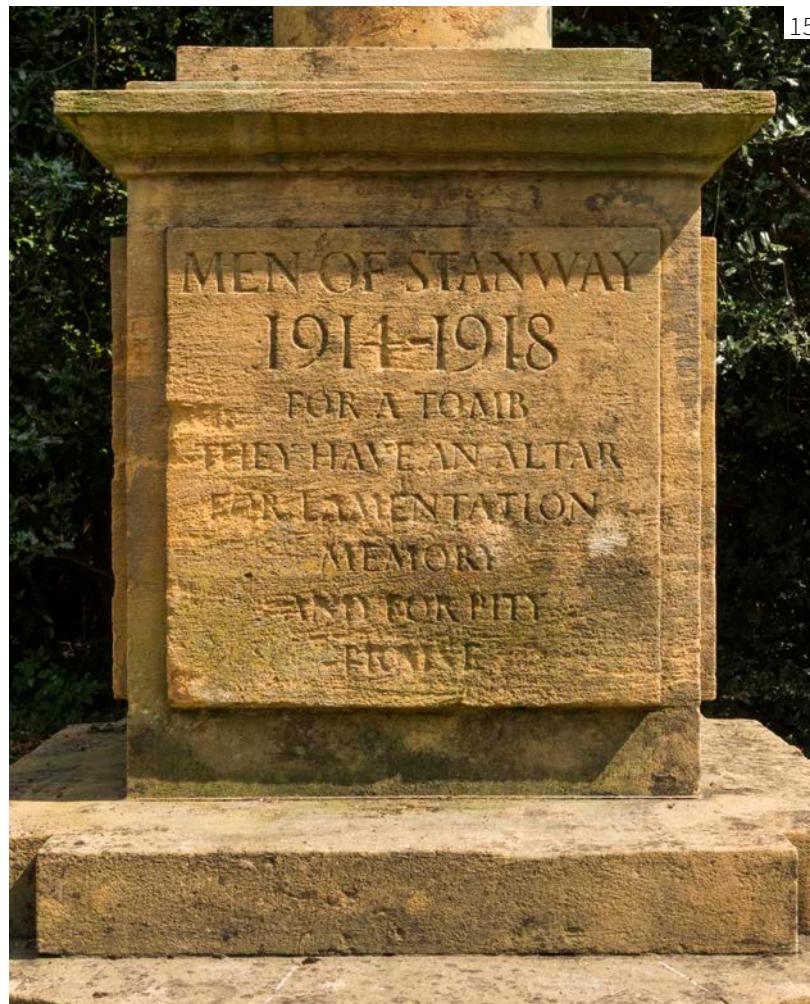
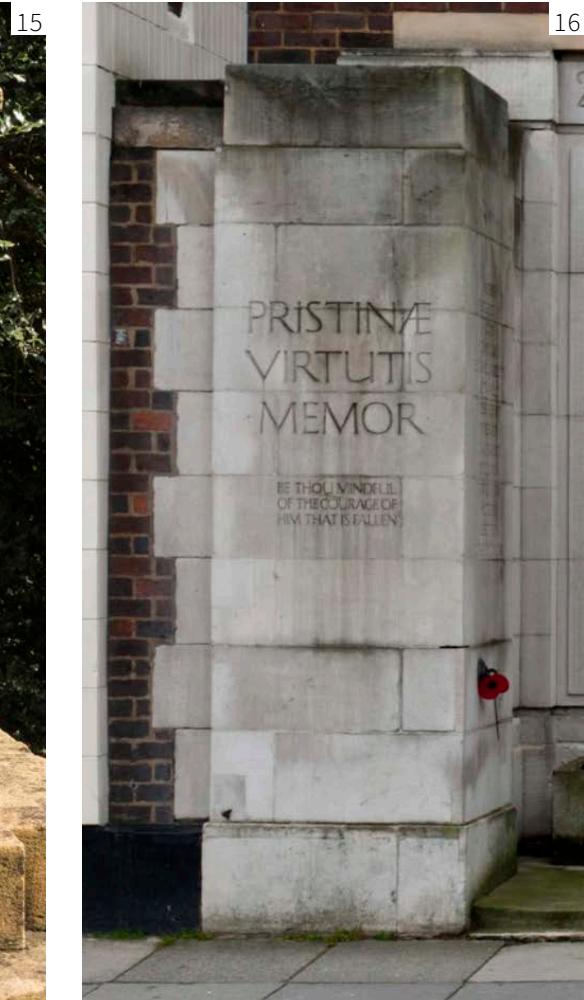
Flaws in the original design of the war memorial may only become apparent many years later. For example, elaborate architectural constructions may not shed rainwater effectively, instead channelling it down areas such as inscription panels, eventually resulting in differential weathering. Softer stones may be vulnerable to decay and vandalism, and if sedimentary stones with pronounced bedding planes are not correctly orientated, their edges can be exposed, leading to surface delamination and the consequent loss of inscriptions. Corrosion of ferrous fixings or dowels may result in panels working loose or even splitting as the rust expands.

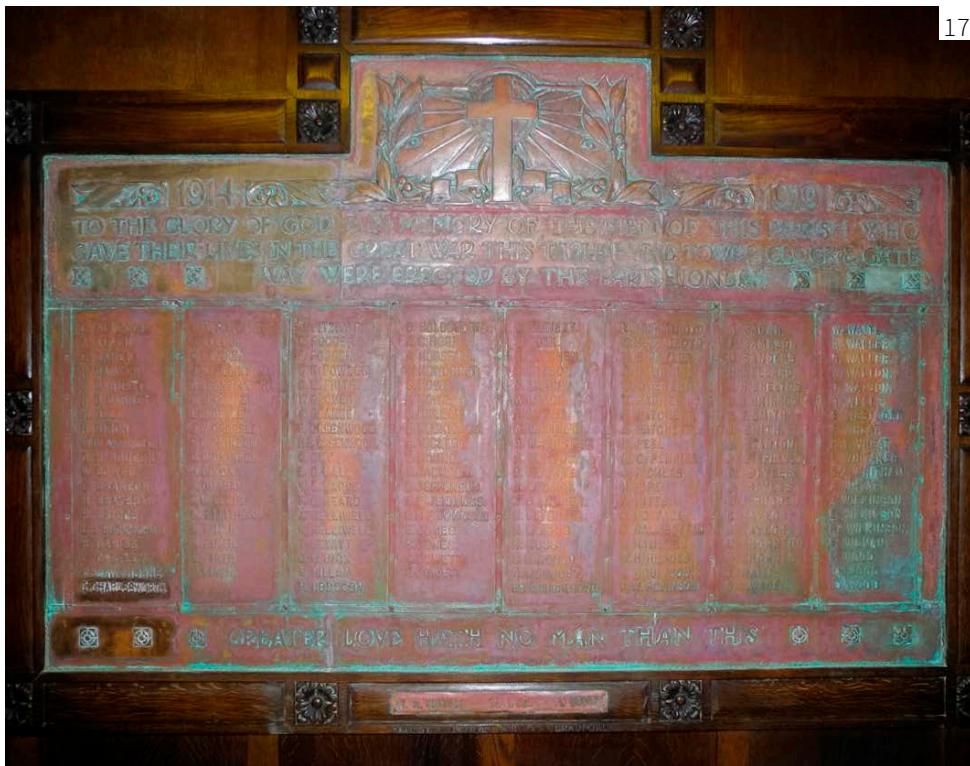
Figure 17: Inappropriate cleaning of this brass memorial has disfigured the surface making it harder to read the inscription.

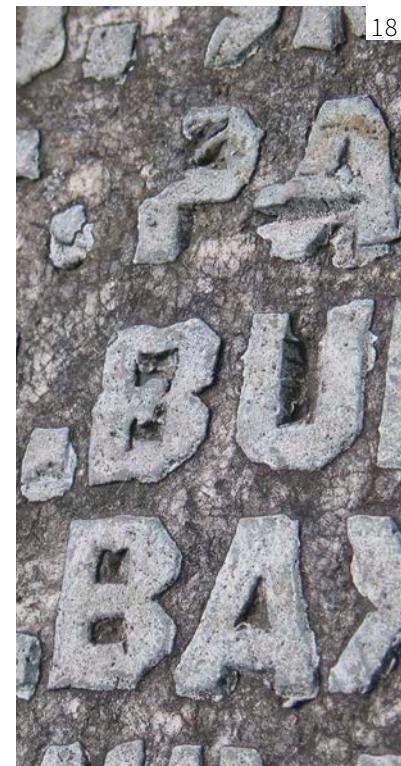
Figure 18: Lewisham Hospital war memorial, Lewisham, London. Raised lead lettering applied to granite. Lead is a relatively soft material and some letters have been damaged through impact. The surface is mottled as a result of oxidation.

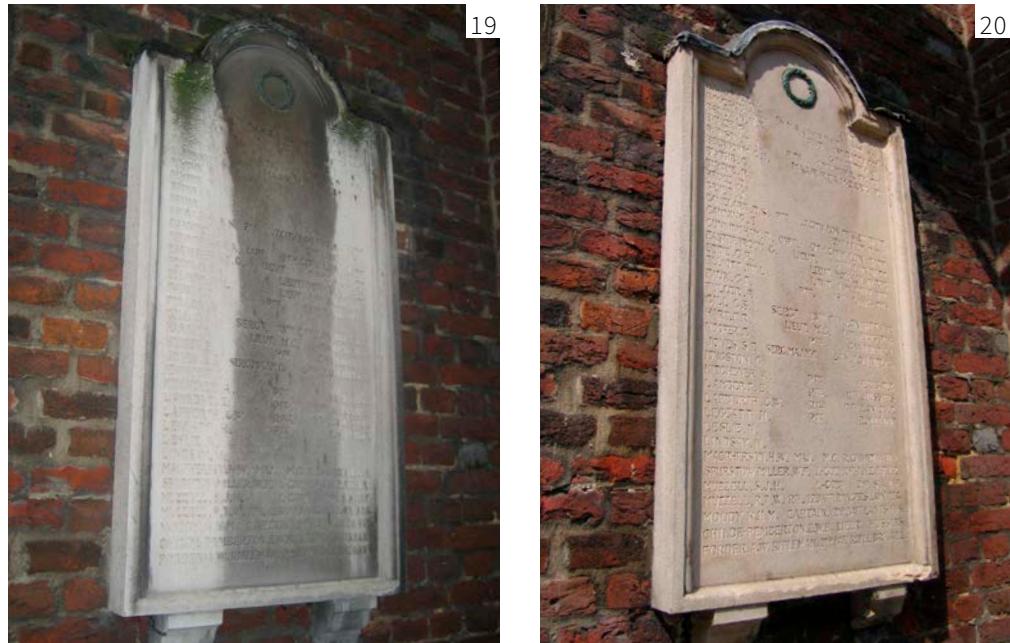
Figures 19, 20: Church of the Annunciation war memorial, Bryanston Street, London. Inscription obscured by calcium carbonate sulphation layer, caused by the area being sheltered by the moulding above and remaining unwashed (19). Inscription legible after cleaning (20).

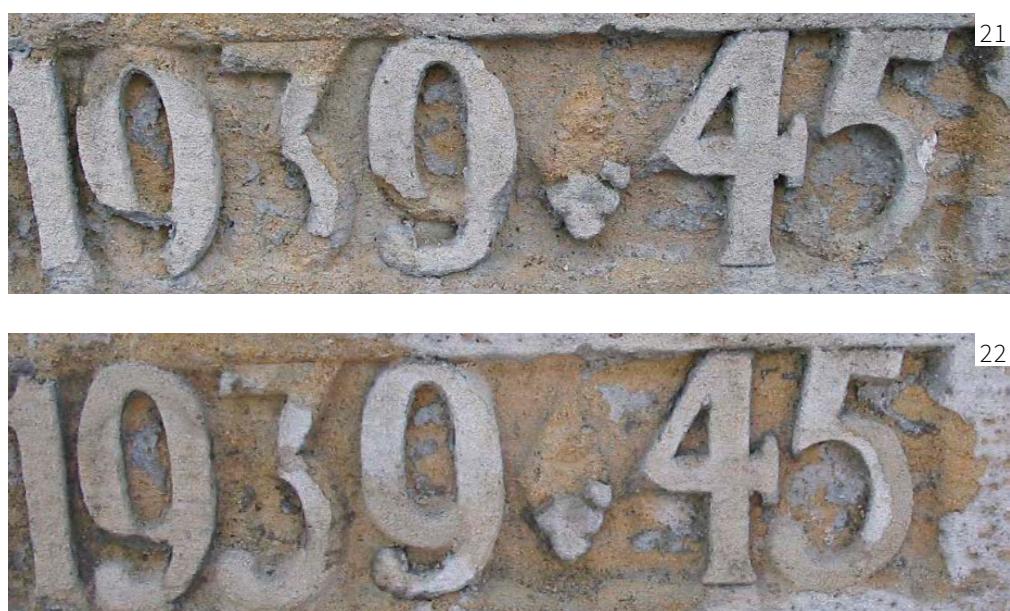
Figures 21, 22: St Mary's Church, Merton, London. Inscription before (21) and after (22) lime mortar repairs have been applied to the eroded areas to improve legibility and to protect vulnerable arises from further weathering.

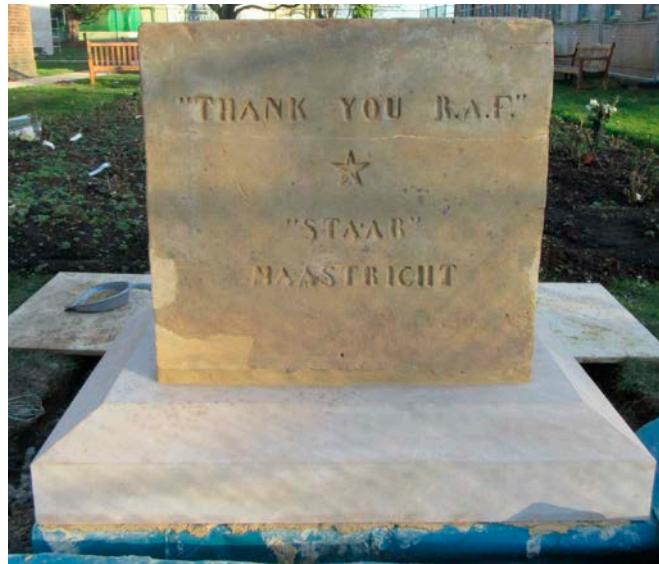
Figure 23: Biggin Hill Memorial Museum, Biggin Hill, London. A thin sheltercoat applied to a war memorial made of Maastricht limestone provides a sacrificial, breathable and protective coating to the stone.

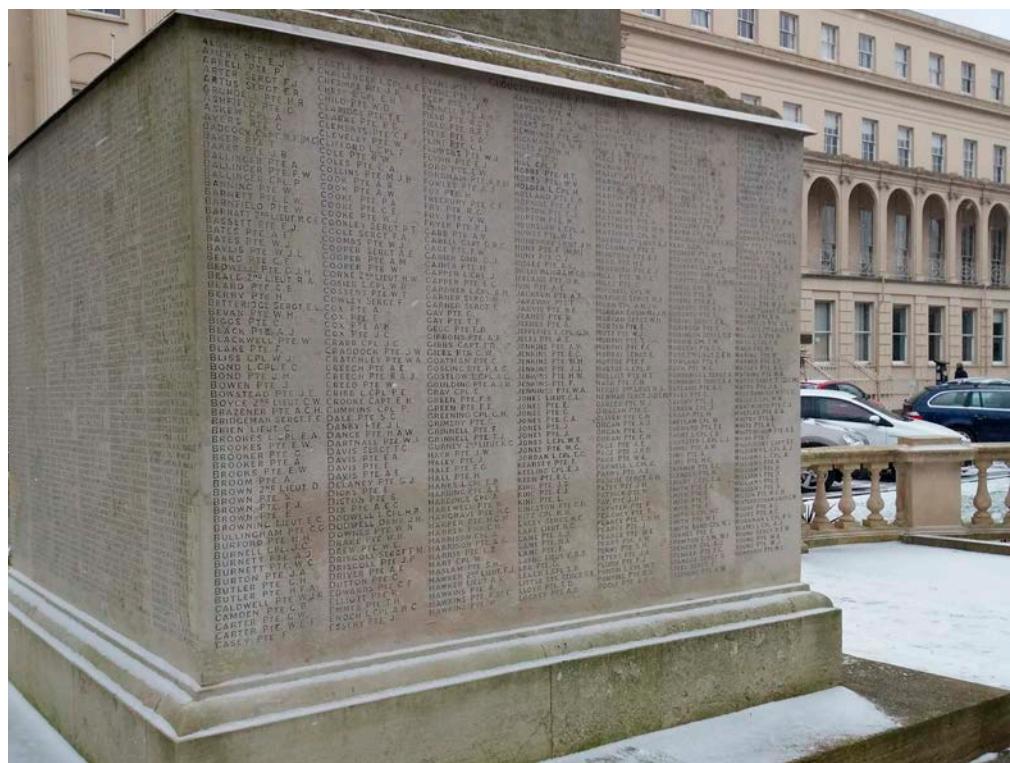
Figure 24: Cheltenham war memorial in Gloucestershire has more than 1,200 men commemorated on it. Each inscription name was originally carved and infilled with mortar. A discreet stainless steel flashing was installed, which seems to have minimised the run-off.

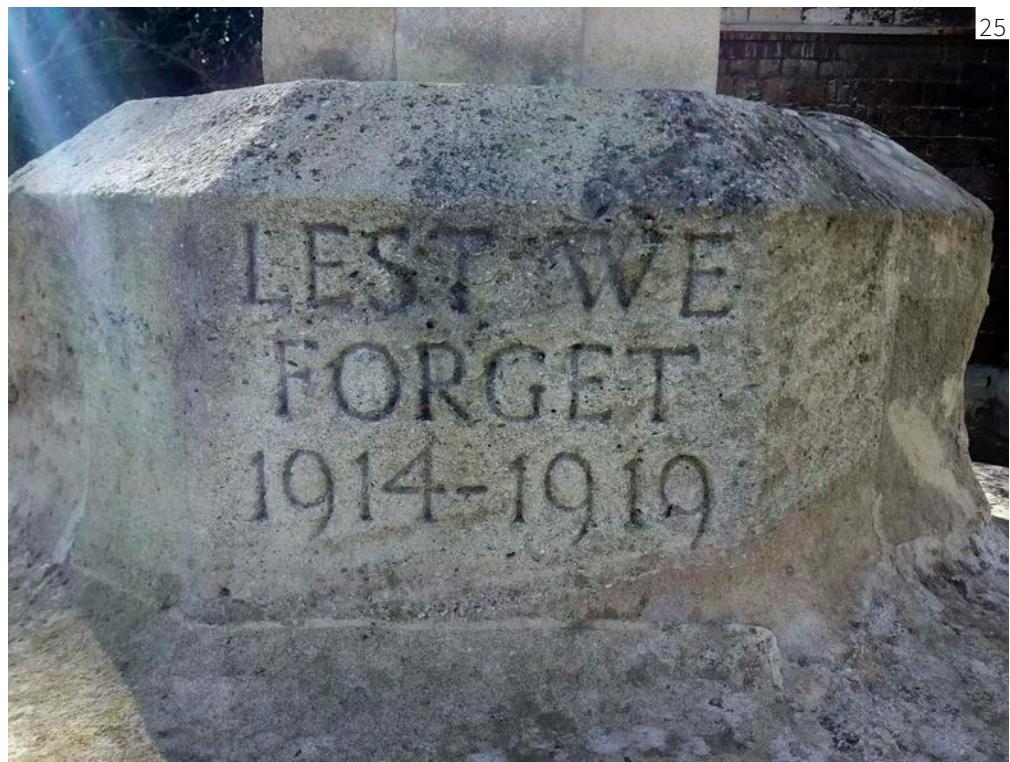
Figure 25: St Peter's Church, Cheltenham, Gloucestershire.
Tinted limewash applied to incised lettering improves legibility.

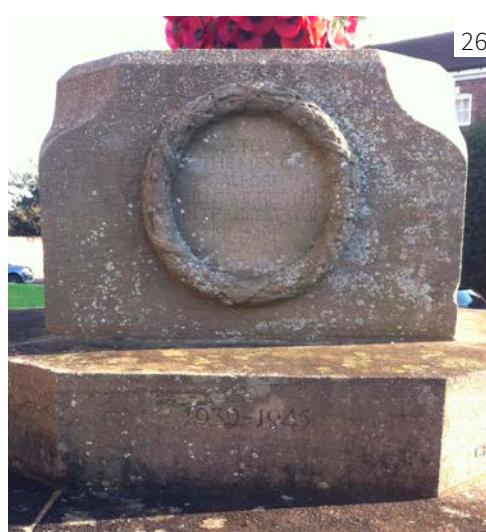
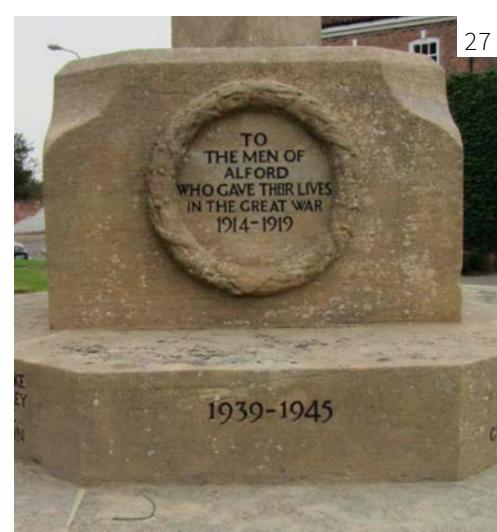
Figures 26, 27: Alford war memorial, Lincolnshire.
The inscription before and after inpainting.

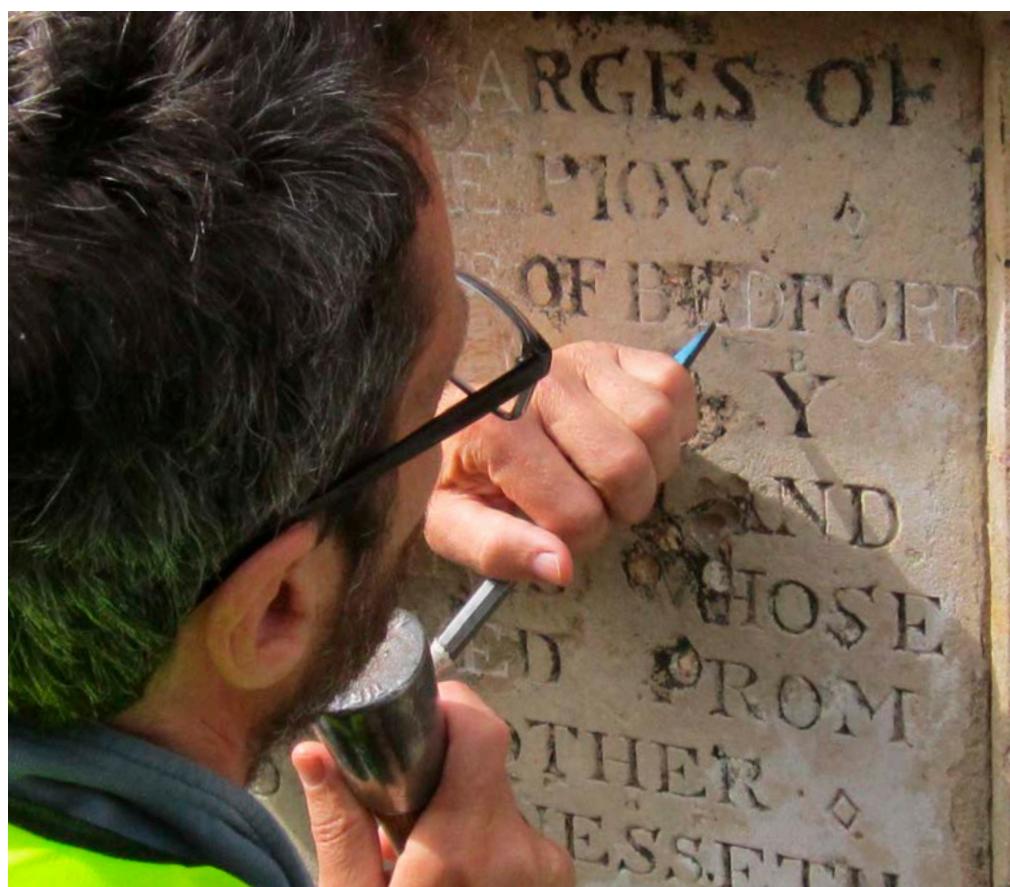
Figure 28: An experienced letter cutter can sharpen the inscription on a deteriorated stone panel to improve its legibility.

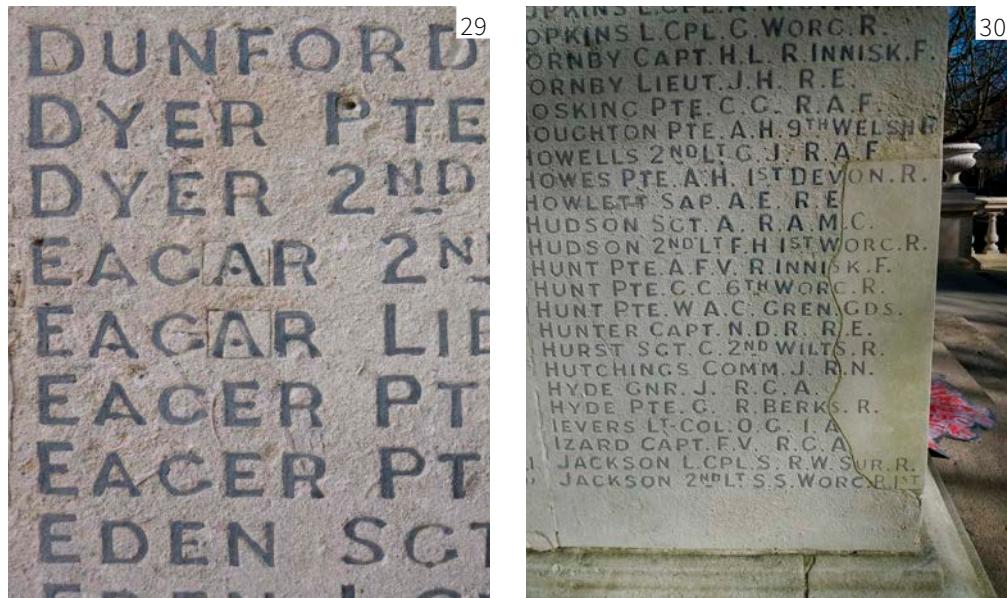
Figures 29, 30: Cheltenham war memorial. Portland limestone indents of approximately 10mm square have been precisely inserted into the original stonework. The letters have then been cut into these and filled with a coloured mortar. A larger Portland limestone indent has been cut to closely follow the area of loss. This has less visual impact than if the indent was cut as a rectangular insert.

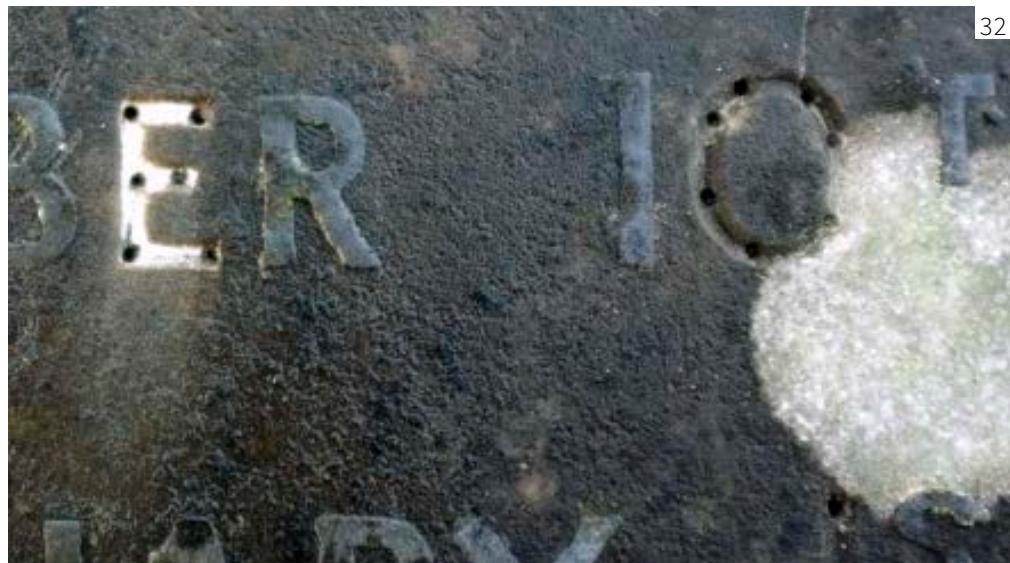
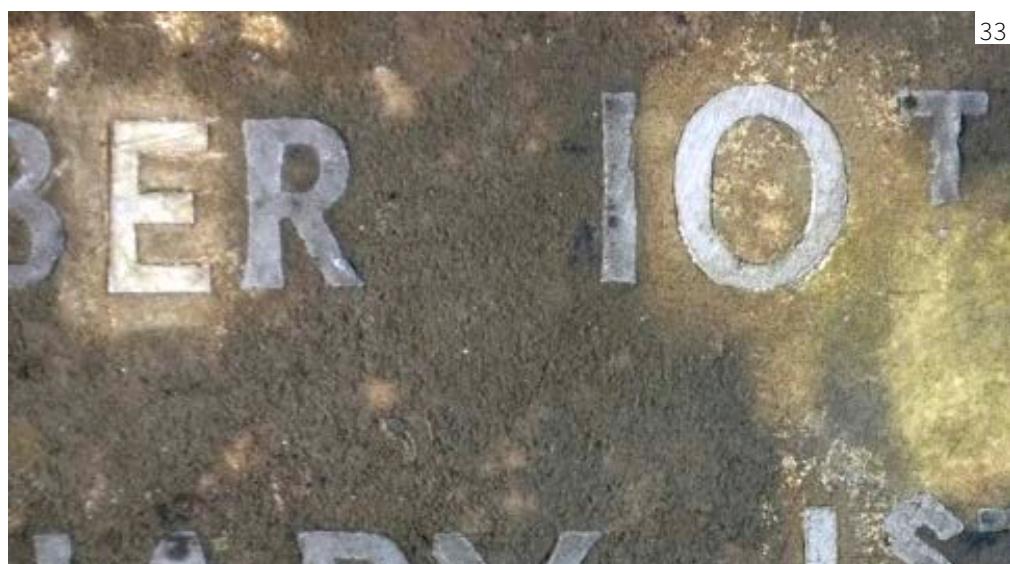
Figures 32, 33: St Mary Magdalene, Ickleton, Cambridgeshire.
Inscription with missing lead lettering (32). The fixing holes are evident as is the original colour of the stone beneath. The inscription after the lead lettering has been replaced (33). Great care needs to be taken to ensure that the font of the replacement lettering is the same as the original.

Damaged lead letters can be repaired by beating lead wool into any splits or damaged areas. Missing infilled letters can be refilled by tamping new lead into the incisions, with the original drilled holes providing the key. This requires a sharply defined incision at the edge of the letter. The finishing must be carefully carried out to avoid disturbing the original surface.

Raised surface letters are reproduced by cutting lead strips to size and beating them into the existing holes. The strip is then trimmed with a sharp chisel and rubbed smooth. Next, the letter is cut out using a variety of shaped chisels before finishing the surface with patination oil or black paint to match the surviving original letters.

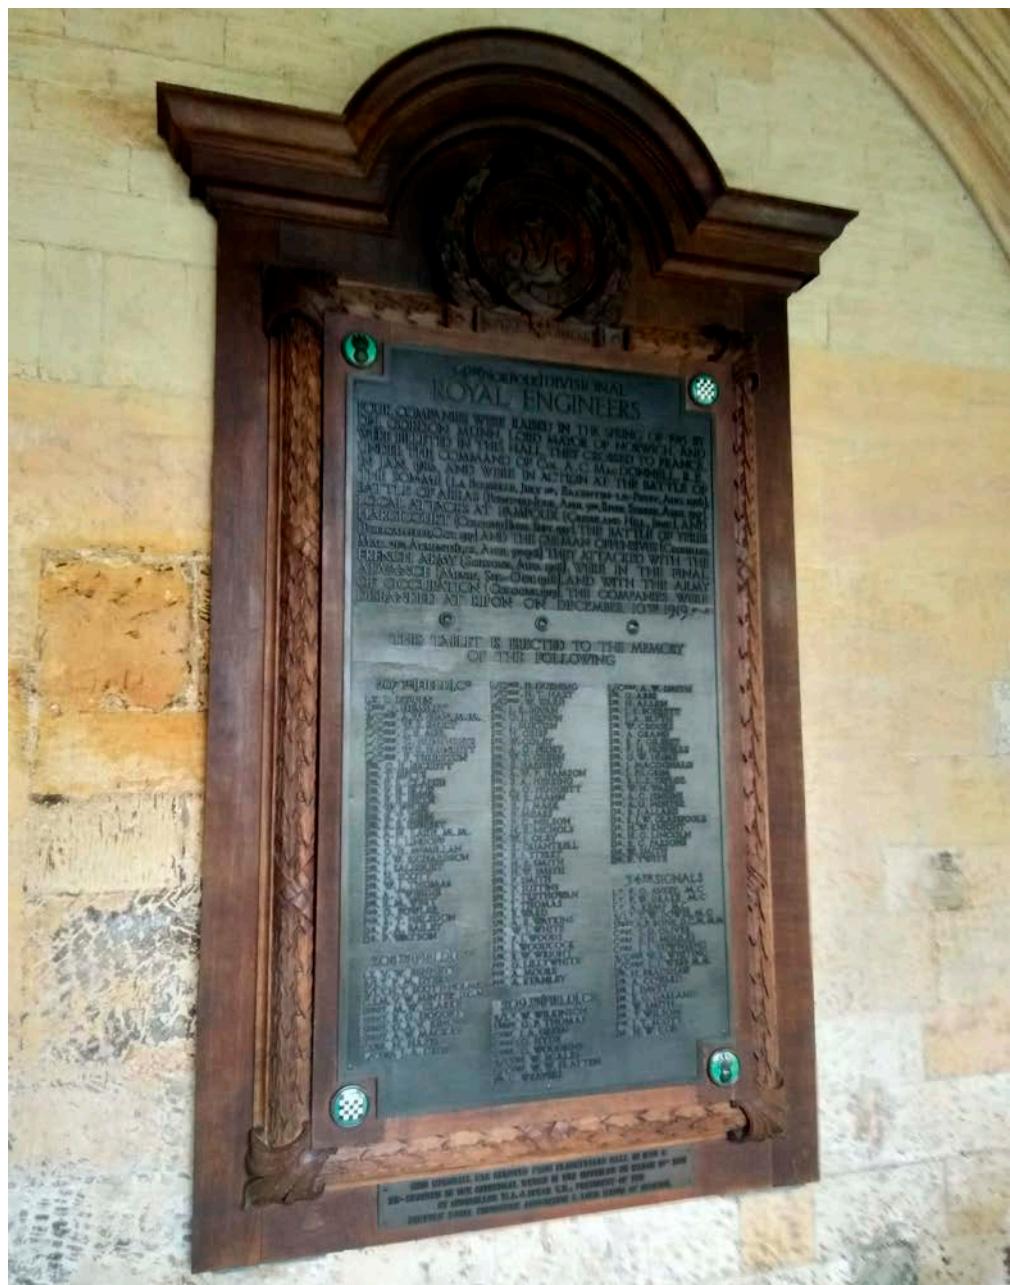
Figure 34: Norwich Cathedral cloisters, Norwich, Norfolk. The badges in the lower two corners have been cast in resin from moulds taken from the bronze ones at the top.
