A Visitors Guide to St. Nicholas' Church, Boarhunt

St. Nicholas' Church, Boarhunt

The purpose of this short guide is to tell you what we know about the history of the church and its surroundings and point out items of interest you will see as you walk round. The guide incorporates descriptions and a plan that were originally published by J.T. Irvine in 1877.

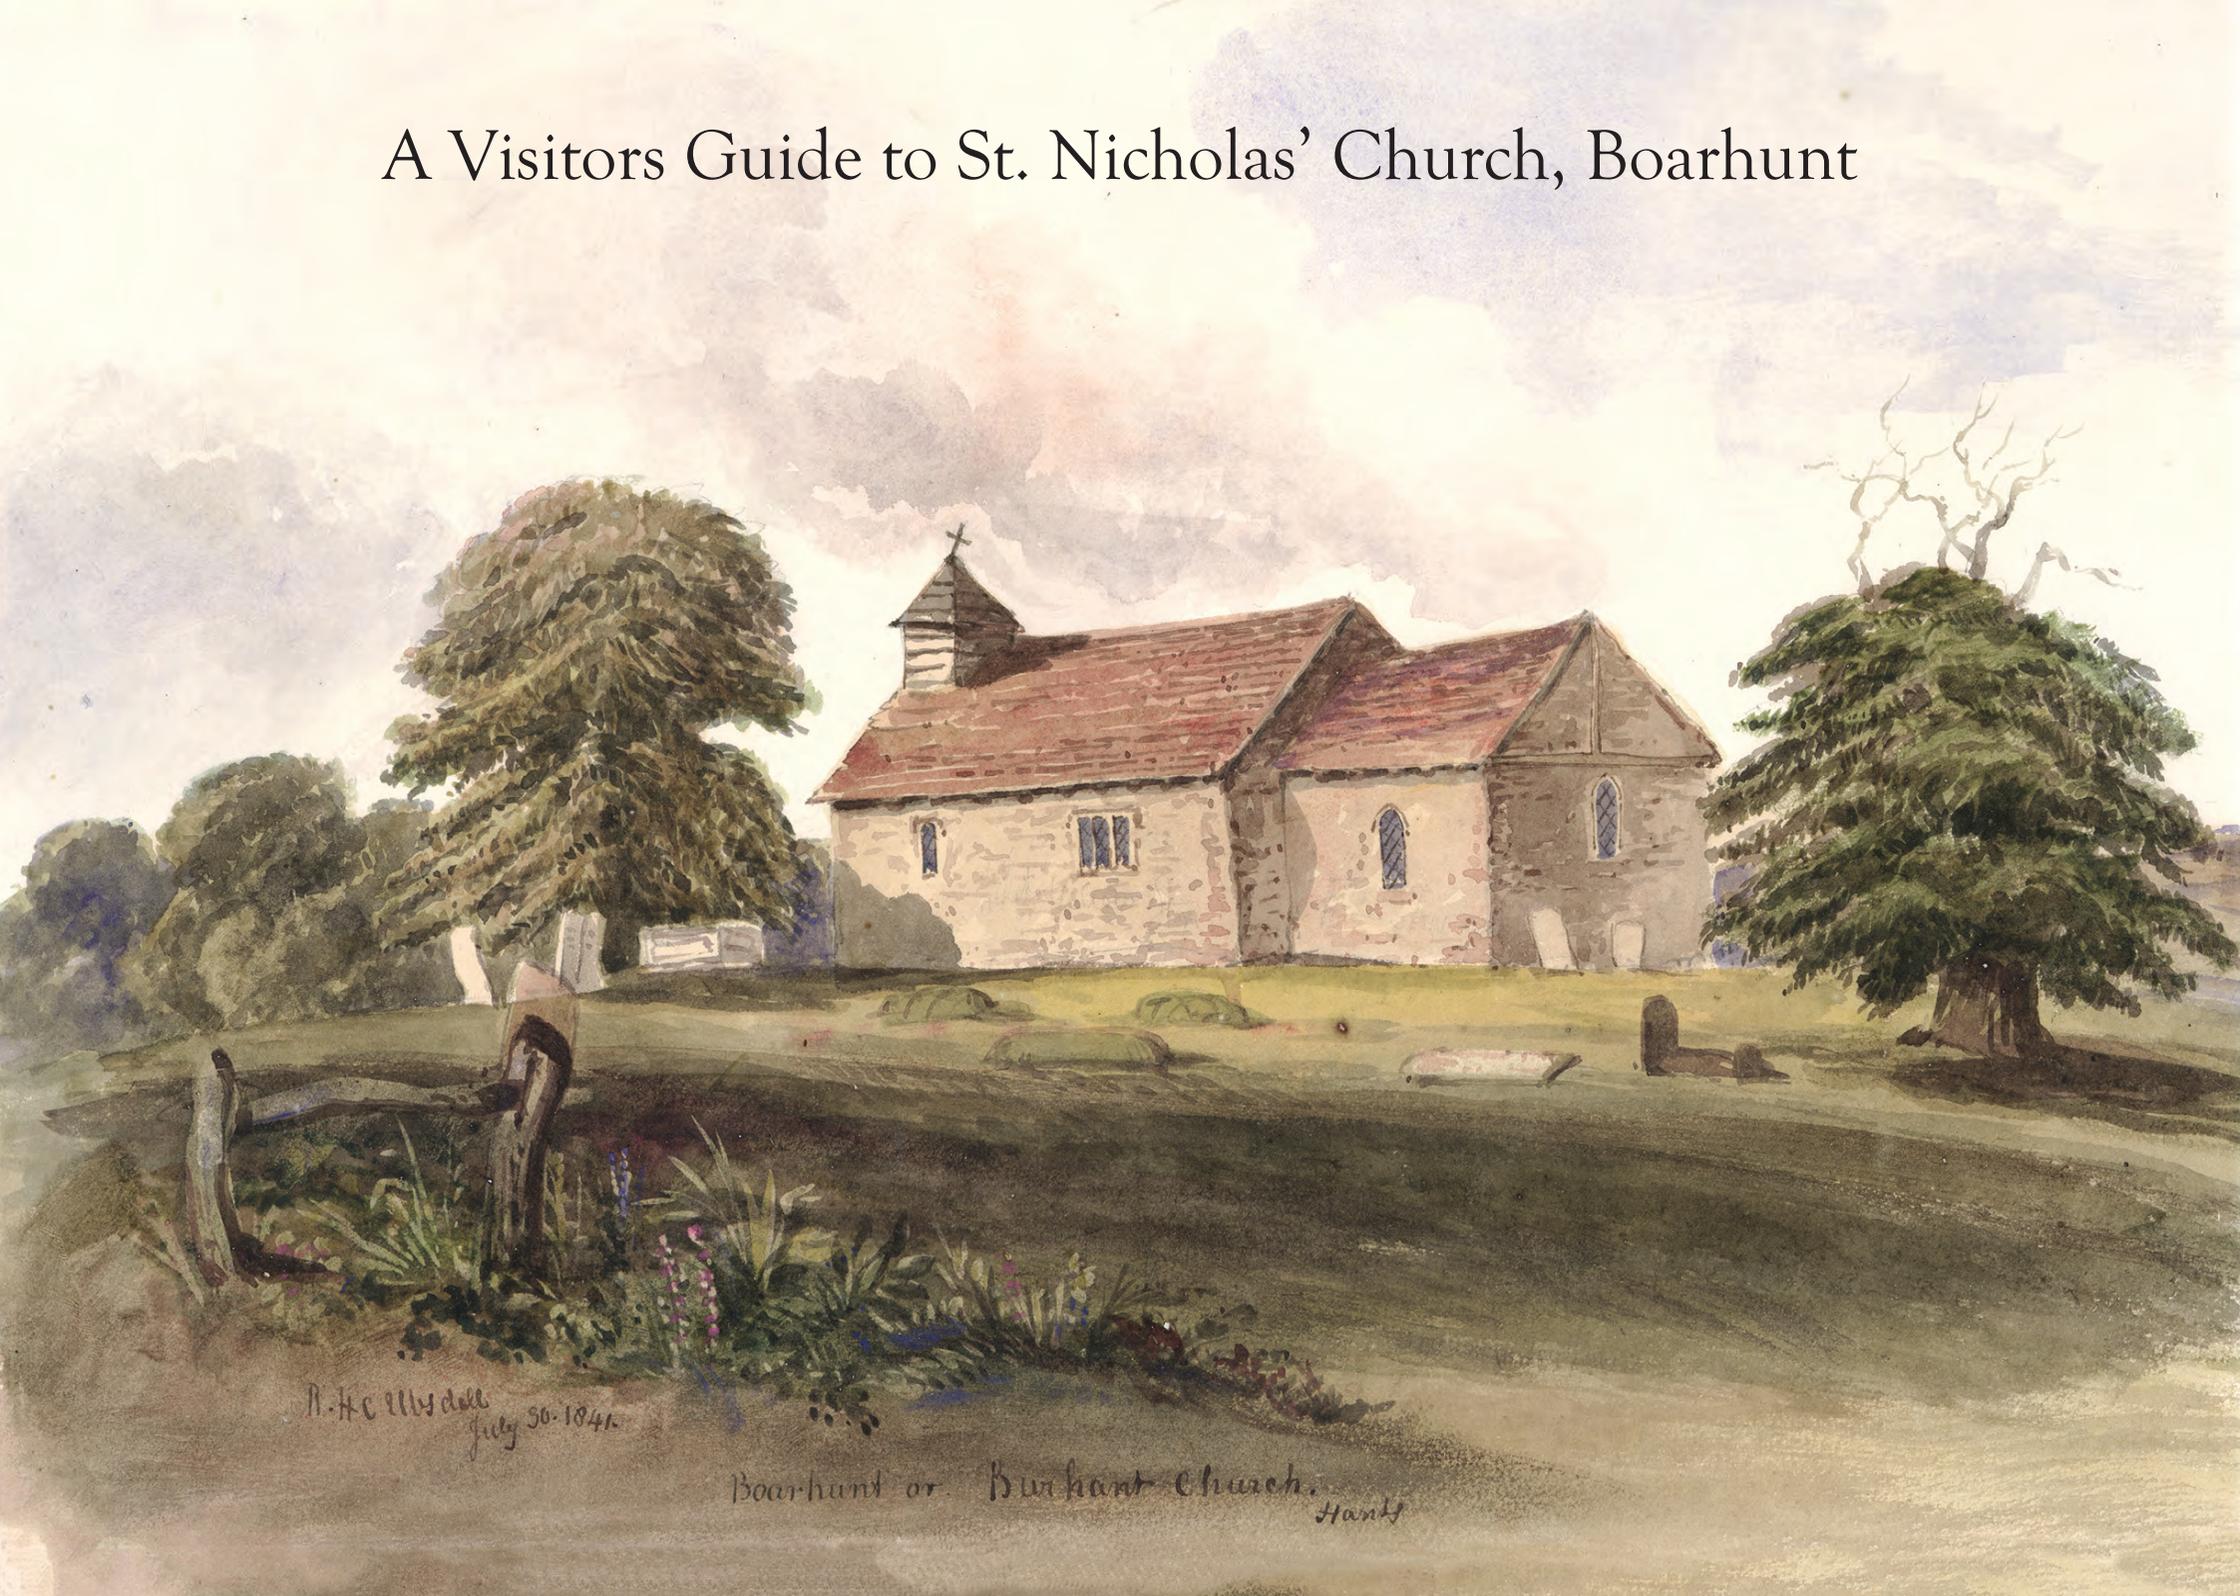
A. H. C. Myddell
July 30. 1841.

The painting on the front cover is reproduced by kind permission of Portsmouth Museum Service, Portsmouth City Council. It shows St. Nicholas Church at Boarhunt painted by the 19th Century Portsmouth artist and photographer Richard Henry Clement Ubsdell. The painting is dated July 30th 1841.

The beautiful painting by the 19th Century Portsmouth artist RHC Ubsdell, dated July 30th 1841, shown on the cover, clearly illustrates the previous wooden bell-tower mentioned in Birbeck’s letter.

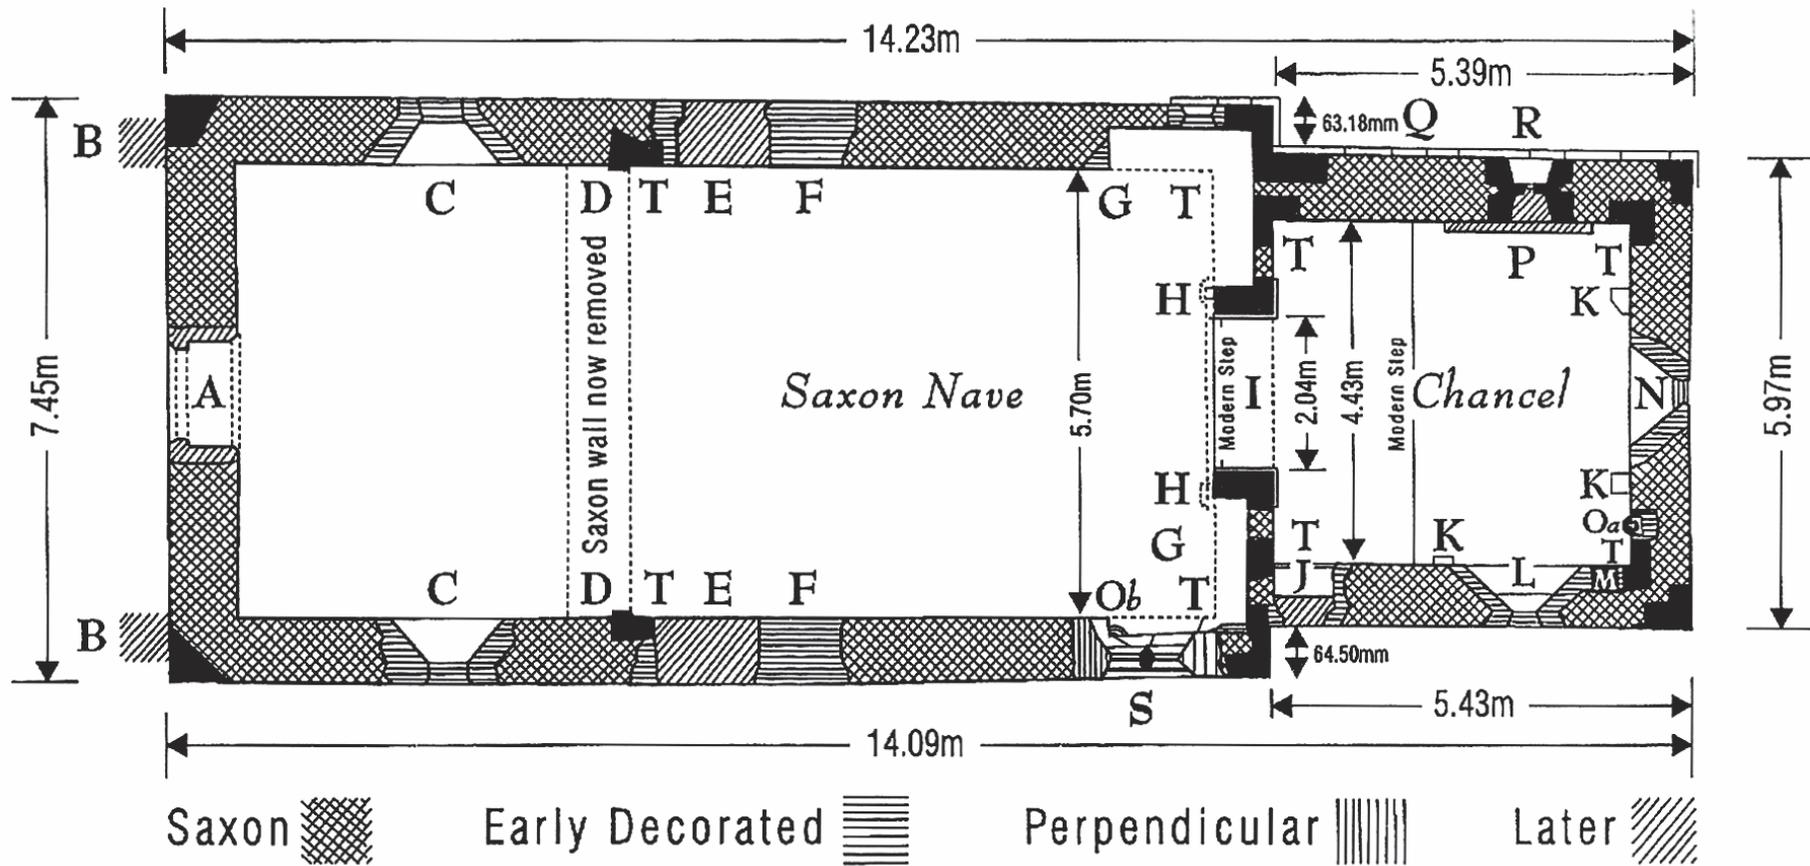
Original plan of the church by J.T. Irvine, 1877

A plan of the church is given on the inside cover. The bracketed letters below refer to the letters in the plan.

J.T. Irvine included in his plan of the church the position of 8 nook angles (T), possessing bonding quoins, as well as finished as the ordinary angle quoins.

Part of the external square plinth to the building is marked at (Q) on the plan but has since been hidden beneath concrete, necessary to improve the drainage at this part of the church.

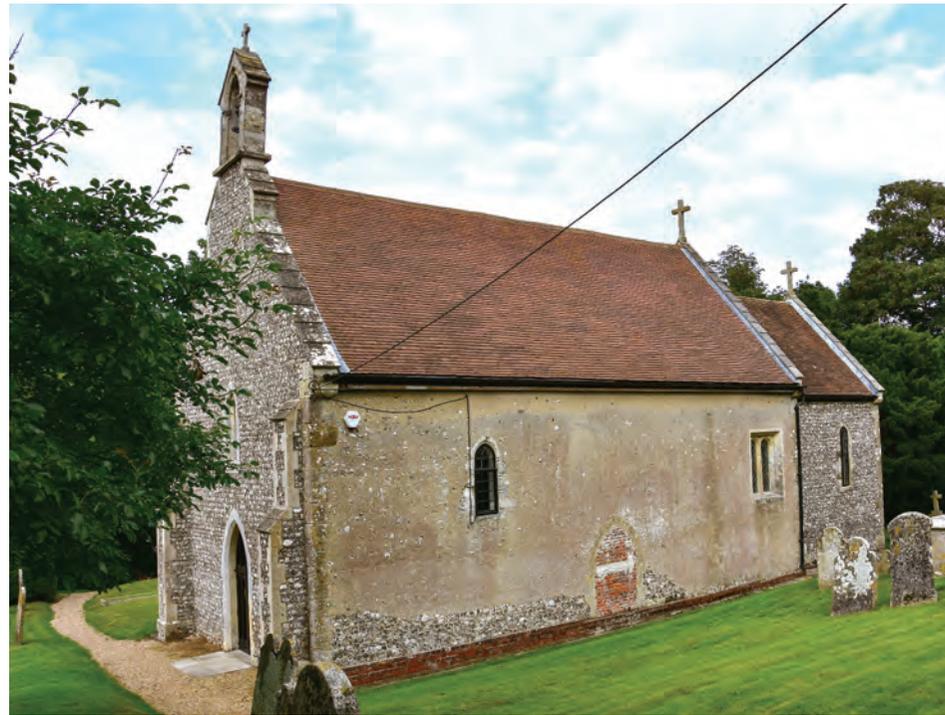
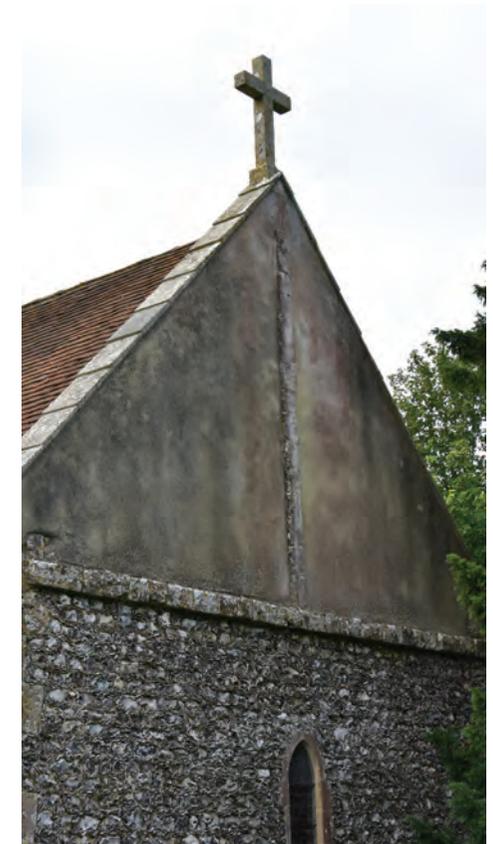
The walls of the church are rubble and flint and the west wall has been refaced with knapped flint and flint gallets. The two external buttresses (B) supporting the west wall were built using Bath stone probably at the time of the 1853 restoration.

The open bell turret, again dating from the 1853 restoration, has been formed as an archway, with delicately moulded pillars and is roofed with stone tiles.

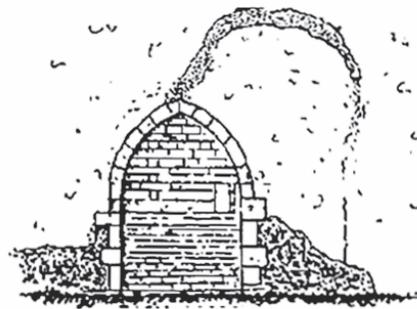
The window is the late Tudor two-light window which internally gives light to the pulpit.

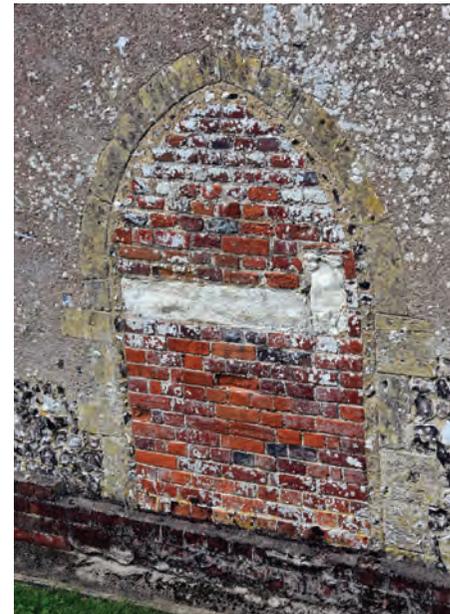
On the east gable a vertical pilaster strip rises from a stone string course, a feature of Saxon architecture.

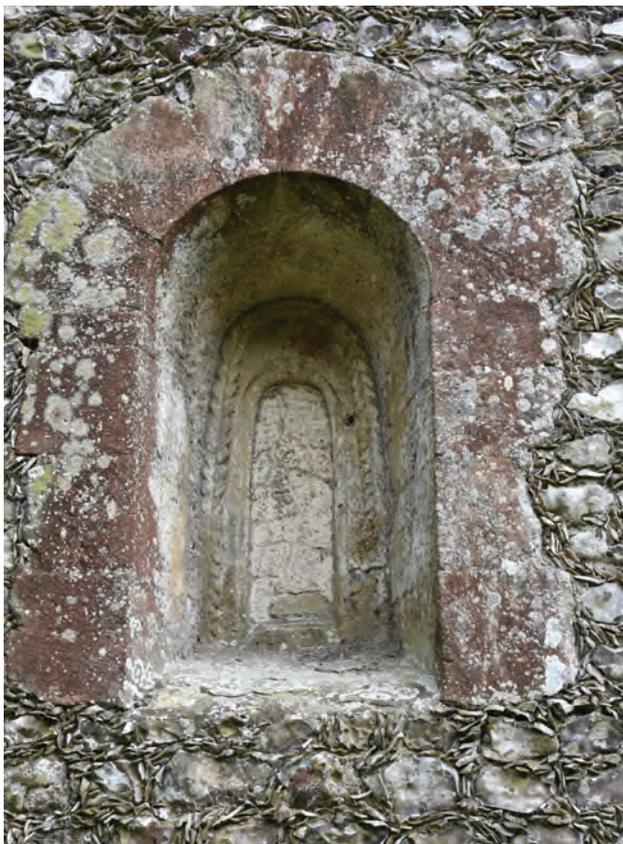
The window in the north wall of the chancel (R) is the one almost completely blocked inside the church by the Henslow monument. From outside, it can be seen to be an excellent example of a double-splayed Saxon window opening, decorated with a double line of cable-moulding. No trace of an early light opening, except this one, can be seen anywhere throughout the church. It therefore could have been the only window in Saxon times. There is some evidence that a wooden shutter was fitted at a later date.
