ST AIDAN'S CHURCH,
THOCKRINGTON
NORTHUMBERLAND
AN ARCHAEOLOGICAL ASSESSMENT
JUNE 2020

PETER F RYDER
B.A., M.Phil, F.S.A
HISTORIC BUILDINGS CONSULTANT

ST AIDAN, THOCKRINGTON

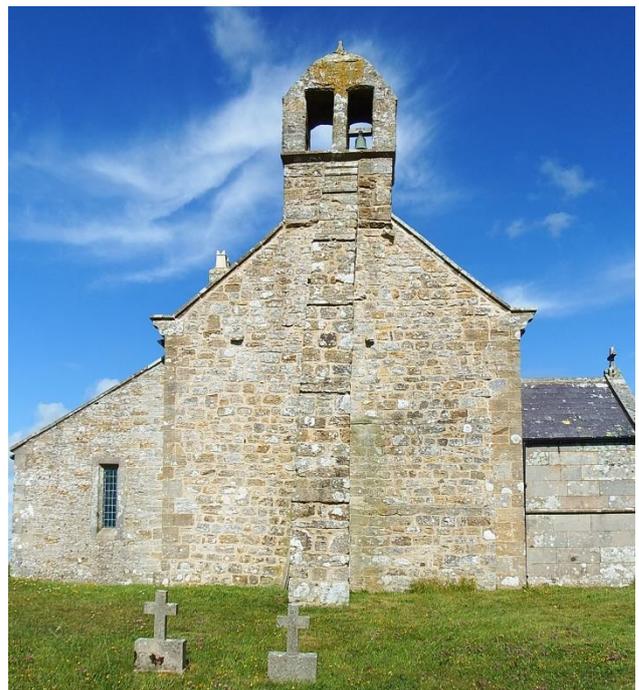
The west end of the **Nave** (right) is quite complex. A massive six-stepped central buttress rises (with a distinct lean to the south) to support the bellcote. To its north the wall is of coursed roughly-shaped stone, but the north-west quoins are quite regular and of 18th century character (except for the lowermost, which projects to the north and is

presumably an earlier survival). High up, against the buttress, is an area of disturbed stone, possibly a blocked opening. South of the buttress is a panel of thicker walling, which extends to c 0.60 m from the south-west quoin (which like the north-west looks 18th century). This panel is presumably surviving medieval work; it has a chamfered set-back/plinth at c 1.5 m above ground level, and a squared top at c 4 m. Above it there is clear evidence of an earlier roof-line, dropping to an eaves line c 1 m below the present one. On both side of the buttress are a few projecting through stones. The buttress rises to the picturesque bellcote, which is carried on a chamfered oversailing course and has two openings with narrow chamfered and shallow segmental-arched heads, and single much smaller square-headed ones to north and south; it has a truncated gable which merges into a pyramidal cap, with a worn finial.

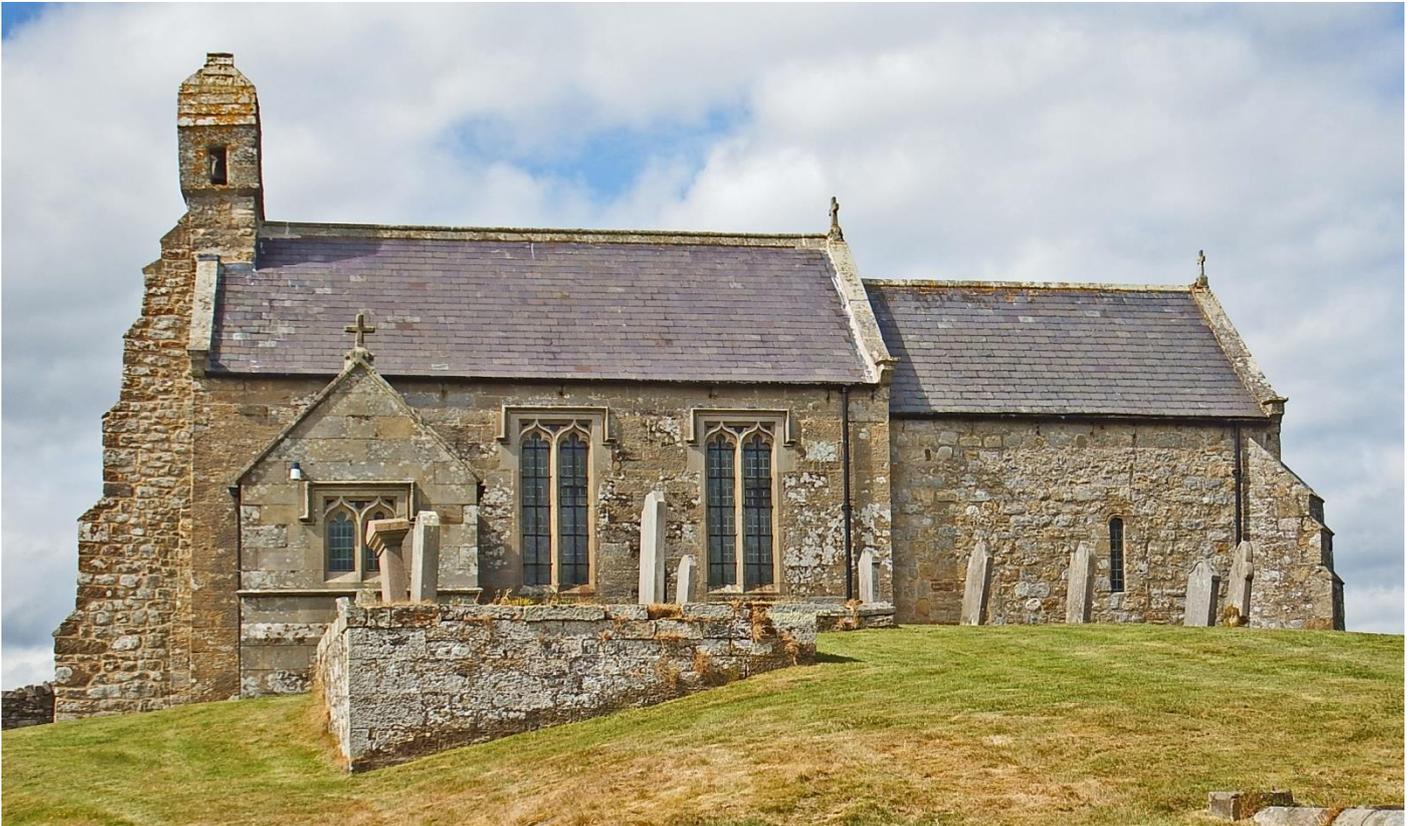
The south side of the nave (above) is of close-jointed and roughly-tooled stone, of 18th century character. East of the porch, which is set close to the west end of the wall, it has two tall windows, each of two trefoiled ogee-arched lights, under a casement-moulded hood with turned-back ends, with smooth ashlar dressings, of 1873. The north wall has roughly-tooled fabric, the courses varying in height perhaps older fabric re-used) except for, in the section east of the vestry, the lower 1m or so which is of rather smaller stone, and set at a slightly skew angle, flush with the wall above towards the east end, but by the time

it disappears behind the vestry, standing c 10 cm proud¹. The only window is a small square-headed one of the usual two trefoiled ogee-headed lights, but without a hoodmould.

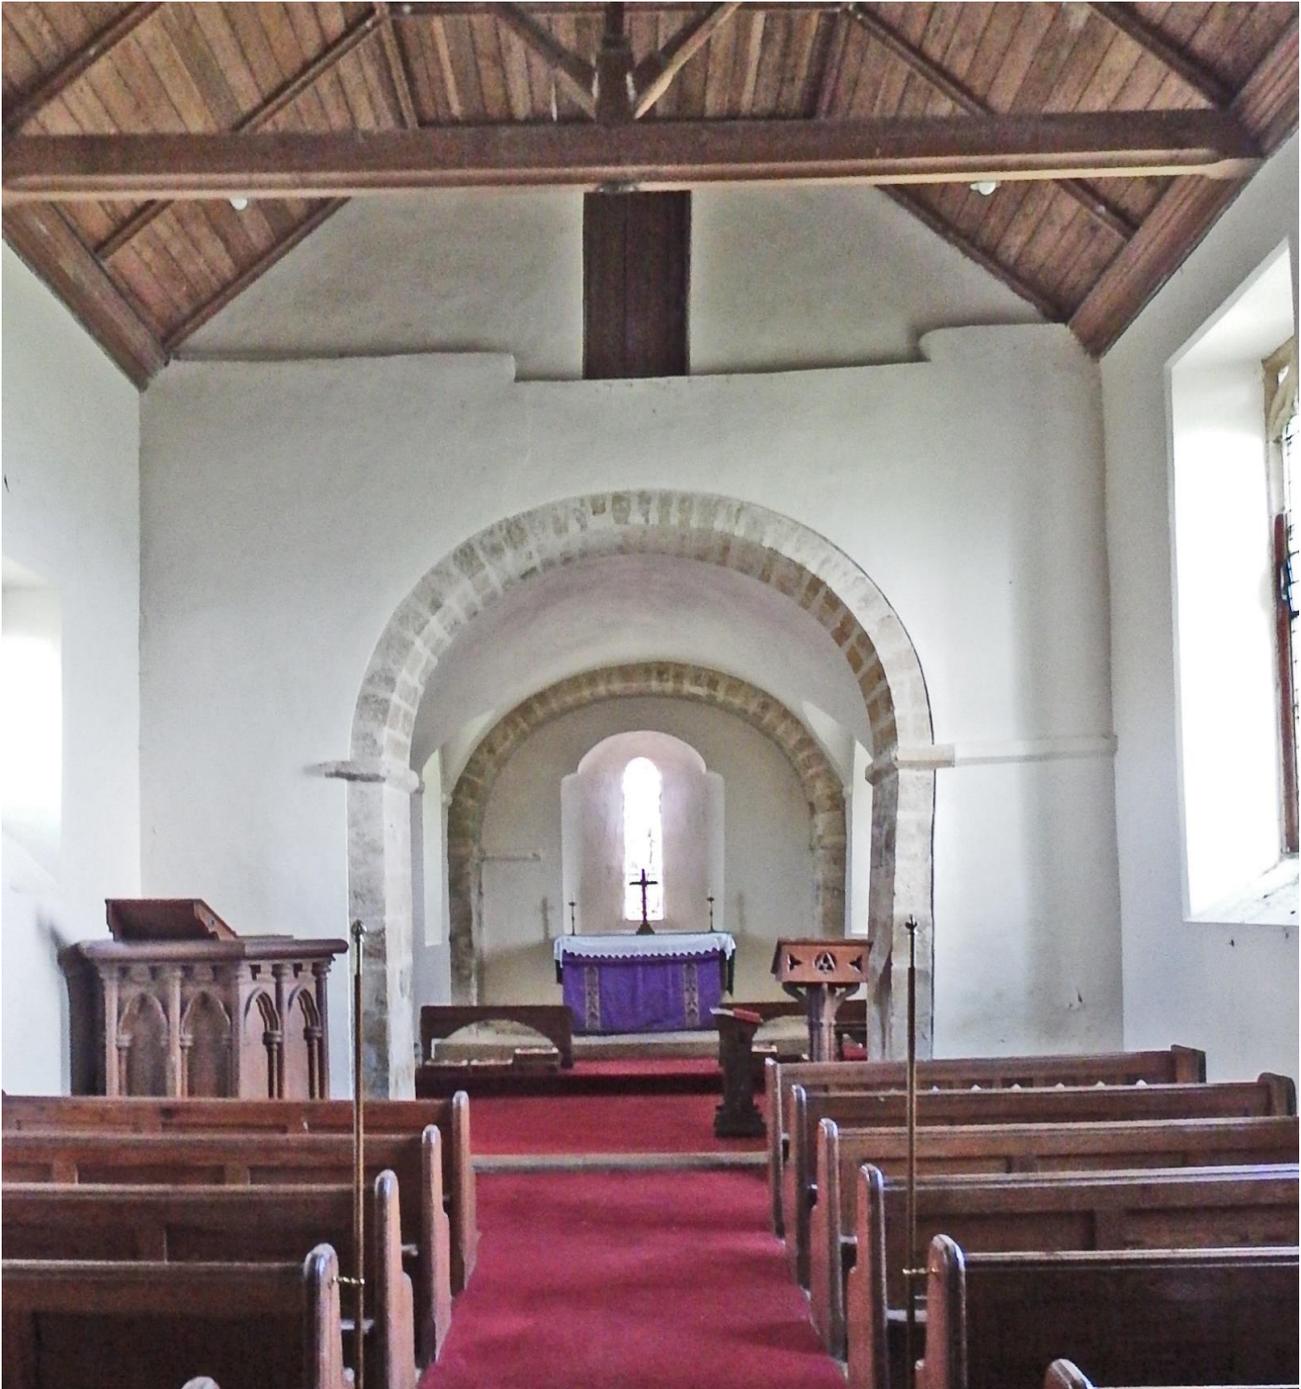
The chancel arch is of semicircular form (now a little distorted), of one square order, with some through stones being used; it springs from an impost band, square above and chamfered beneath, which is returned to the south wall of the nave, but not on the north. The jambs are of plain square section. Above the arch at the level of the nave eaves is a set-back, with a section making up about half its length, but set a little south-of-centre, stepped down by c 200mm . Set centrally in the all above is a plain doorway, without exposed dressings, with a slightly skewed lintel, giving access into the roof space above the chancel vault.

The chancel itself has a slightly-segmental vault (plastered over) springing from a string course, chamfered beneath, ie of the same section as the arch impost, but set c 300 mm

higher. The two windows have plain semicircular rear arches, which cut through this string, and into the haunch of the vault. At the east end of the chancel is a second arch identical to the chancel arch, with its northern impost being returned as a string for c 0.60 m along the east wall, ending a little short of the broad internal opening of the east window, which is of shouldered segmental-arched form. Cut into the northern jamb of the arch a little below the impost is a shallow and irregular socket of uncertain purpose; it is possible that there may have been a corresponding one opposite, in the south jamb, but this has been infilled with mortar.

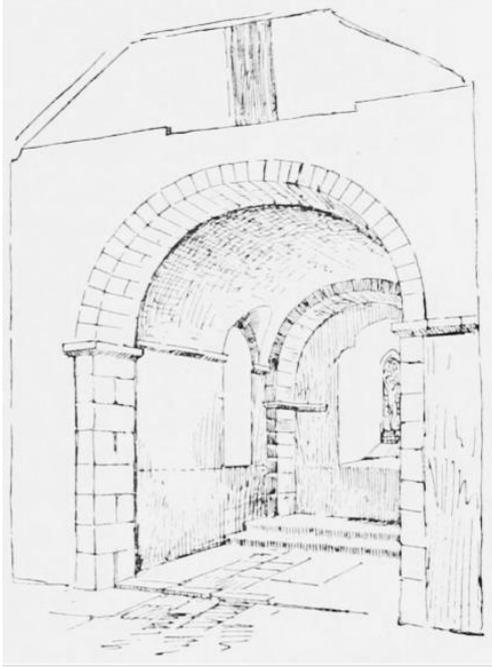
of any further structure³. The pair of huge diagonal buttresses look like an addition (they do not bond in with the masonry of the east end) and hint at a history of structural problems.

The high-level chamber above the chancel vault is interesting, being paralleled at Warkworth and Seaton Delaval, although it apparently retains no old features of any significance. It has been suggested⁴ that it might have formed a defensible retreat. The cut-out in the offset directly below its doorway is interesting, and might have been made for a wooden gallery or platform at the head of a ladder.

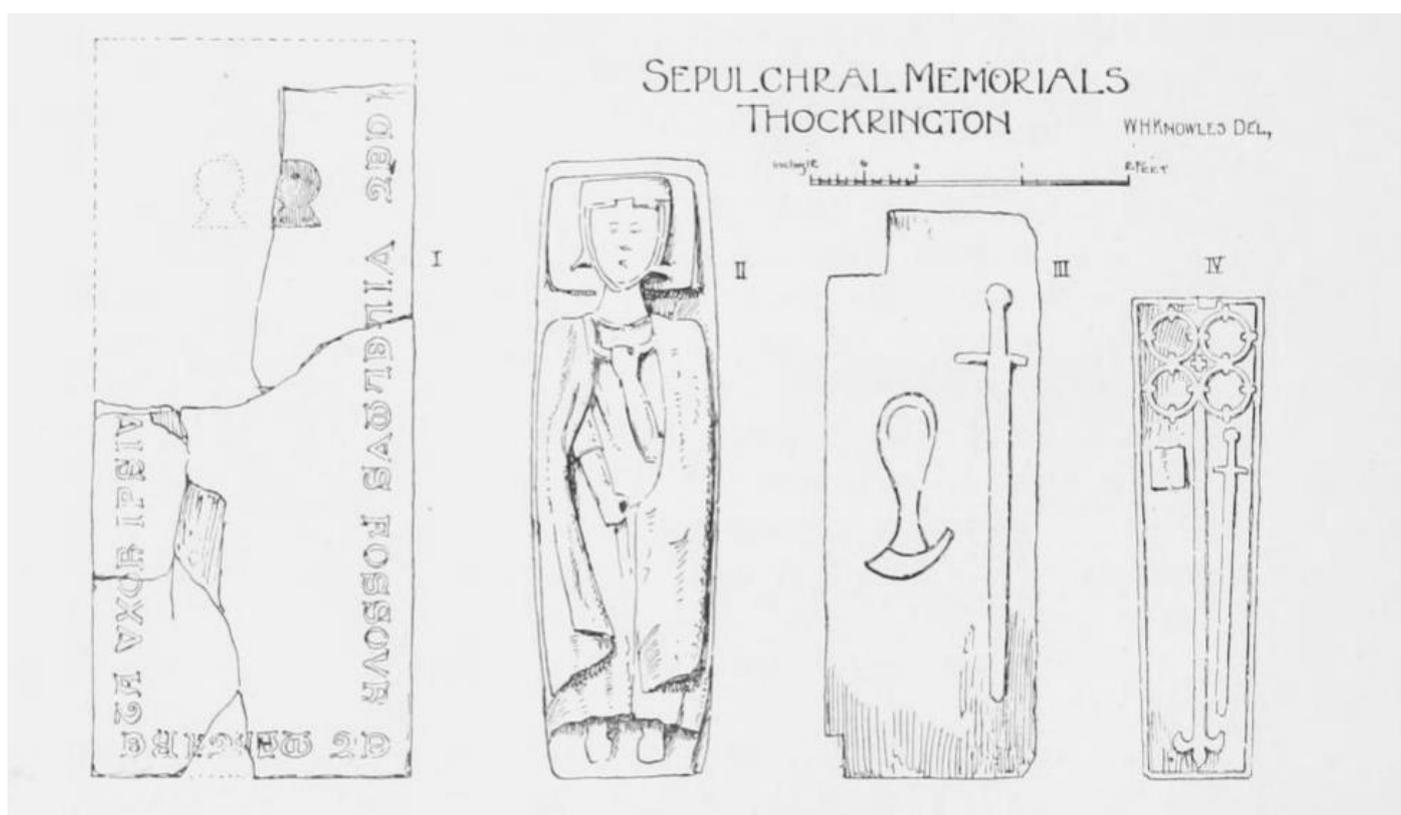
The churchyard has some fame as the burial place of Lord Beveridge, founder of the modern welfare state and Connie Leathart, one of the first woman aviator's. A worn cross base lies in the churchyard c 10 m south of the east end of the nave; what at first appears like a shaft fragment is an eroded carved stone with the bent leg of some sort of beast on each side; it may have been a simulated gargoyle (there is only a shallow cavity in the heads end). Outside the east end lie several mossed stones including a broken grave slab with the indents for two brass portraits and a Lombardic marginal inscription (Hic iacet) *Villelmus Fossour at Mar(gar)eta uxoir ipso(s) orate pro eis*⁵

(drawing by W.H.Knowles, from the Northumberland County History. Stones II and IV now lie in the church, at the west end of the nave.
