St Mary and St Michael, Doddington

An Archaeological Assessment

August 2017

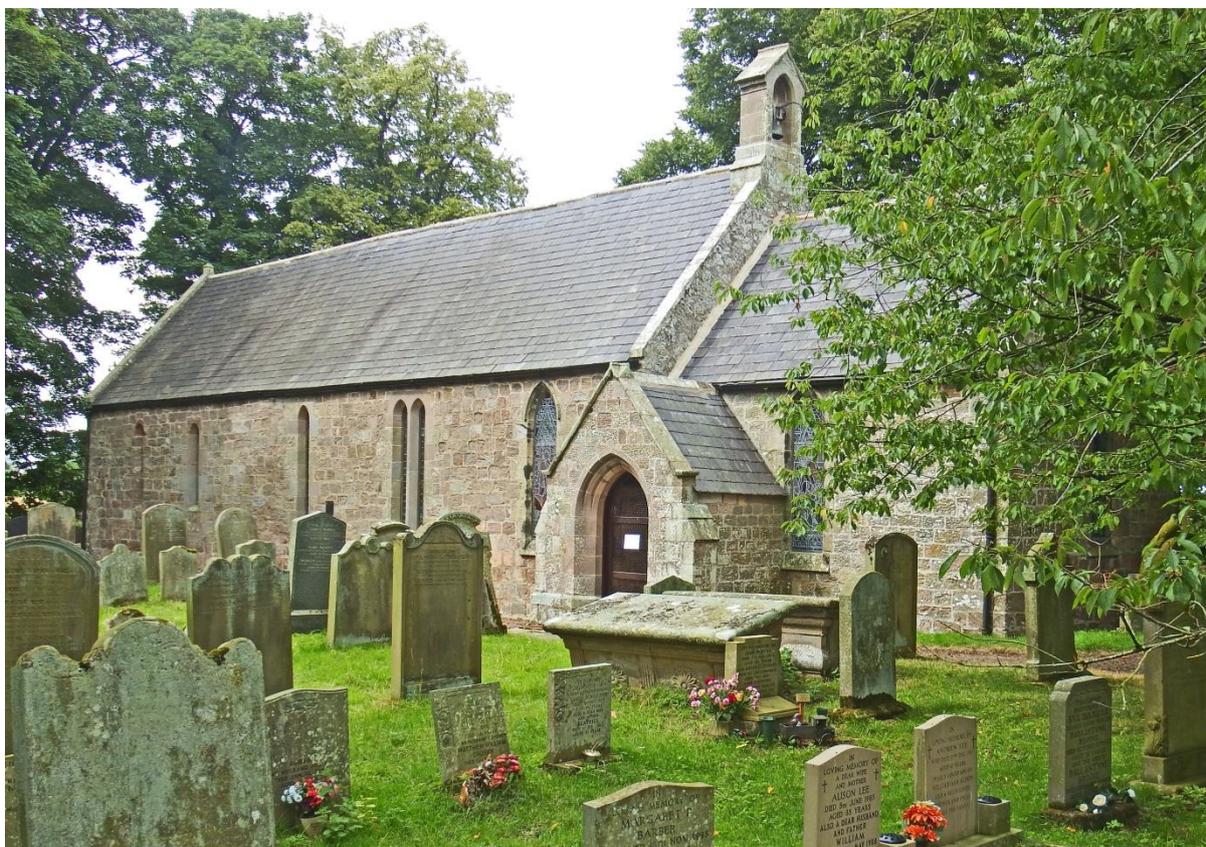
South-east view

The **Nave** (which has no external divisions from the chancel to the west) is built of squared and coursed sandstone. The south wall has three windows, from west to east a single lancet, then a double lancet, both with dressings of smooth late 19th-century ashlar, then a broader lancet of earlier 19th century date; it has a hoodmould chamfered above and below, and a steeply sloping sill that projects from the wall face. Below and slightly to the east of the western lancet the lower jambs of a doorway are visible, infilled with slightly more elongate blocks than those in the wall fabric; there are areas of pecked

stone around the western and central windows. A chamfered plinth appears on the western third of the wall.

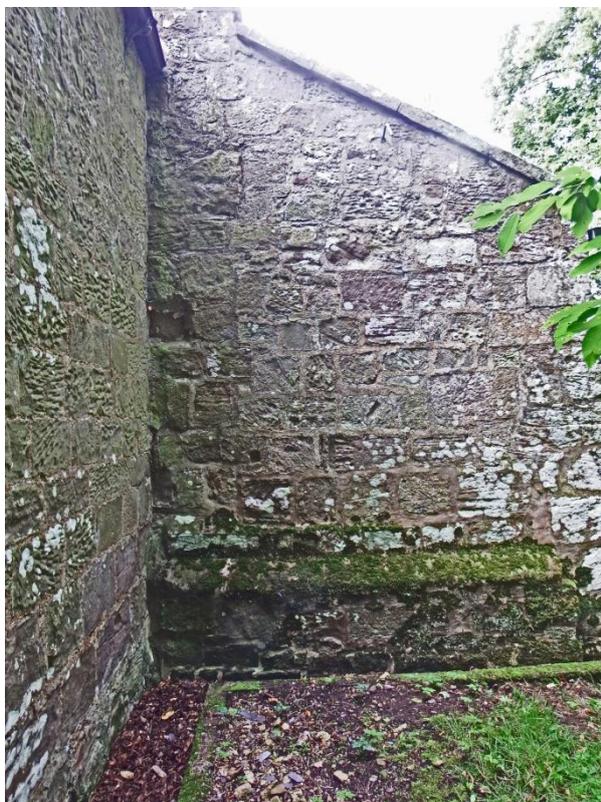
The east end of the aisle (right) is again structurally complex. It has a large chamfered plinth, ending in a ragged break a little short of the north-eastern corner, and further south the remains of an upper plinth, again chamfered. Both plinths

appear to overlap, rather than butt up against, the north-east quoins of the original nave. The wall above is of coursed roughly-tooled stone, with pecked 19th-century stone in its upper courses, with no real sign of the blocked window visible internally.

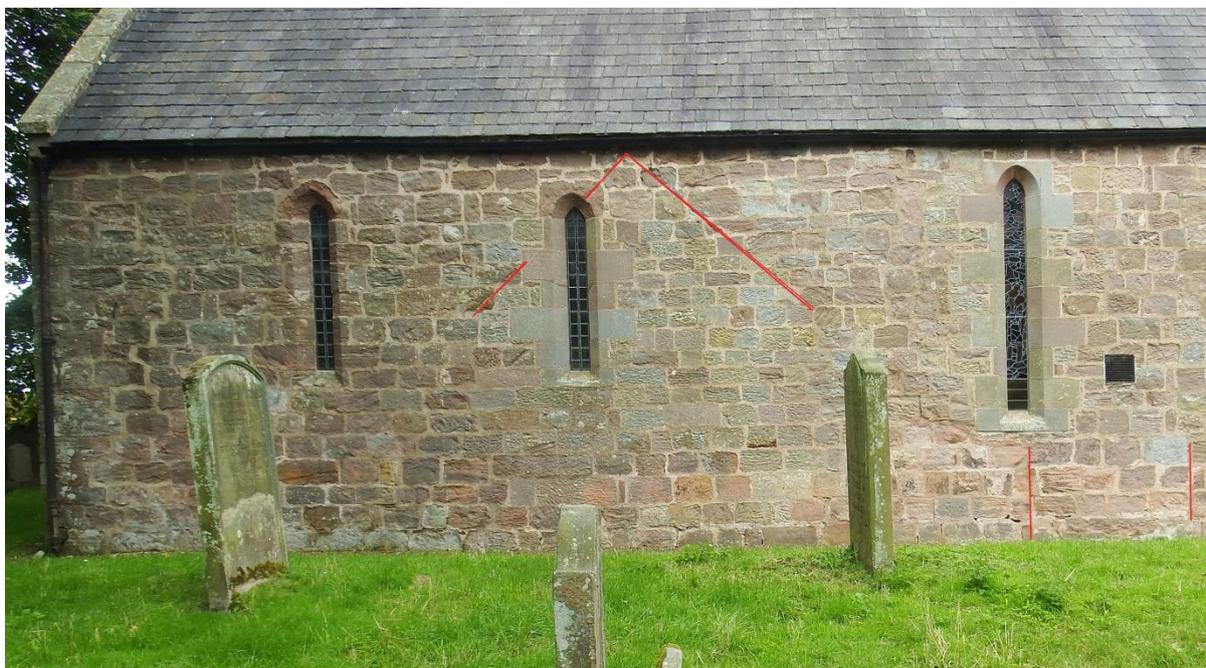
Chancel and west part of nave seen from the south. Highlighted in red the roof-line of the 1839-1893 south porch, and the jambs of the medieval south door

The south wall of the chancel has two lancet windows, with simple chamfered surrounds. The western seems thoroughly medieval, the eastern is of 19th-century stone bar its head, and is cut across by the roof-line of the vanished porch; the area occupied by the porch is infilled in coursed pecked stoned of 19th century character.

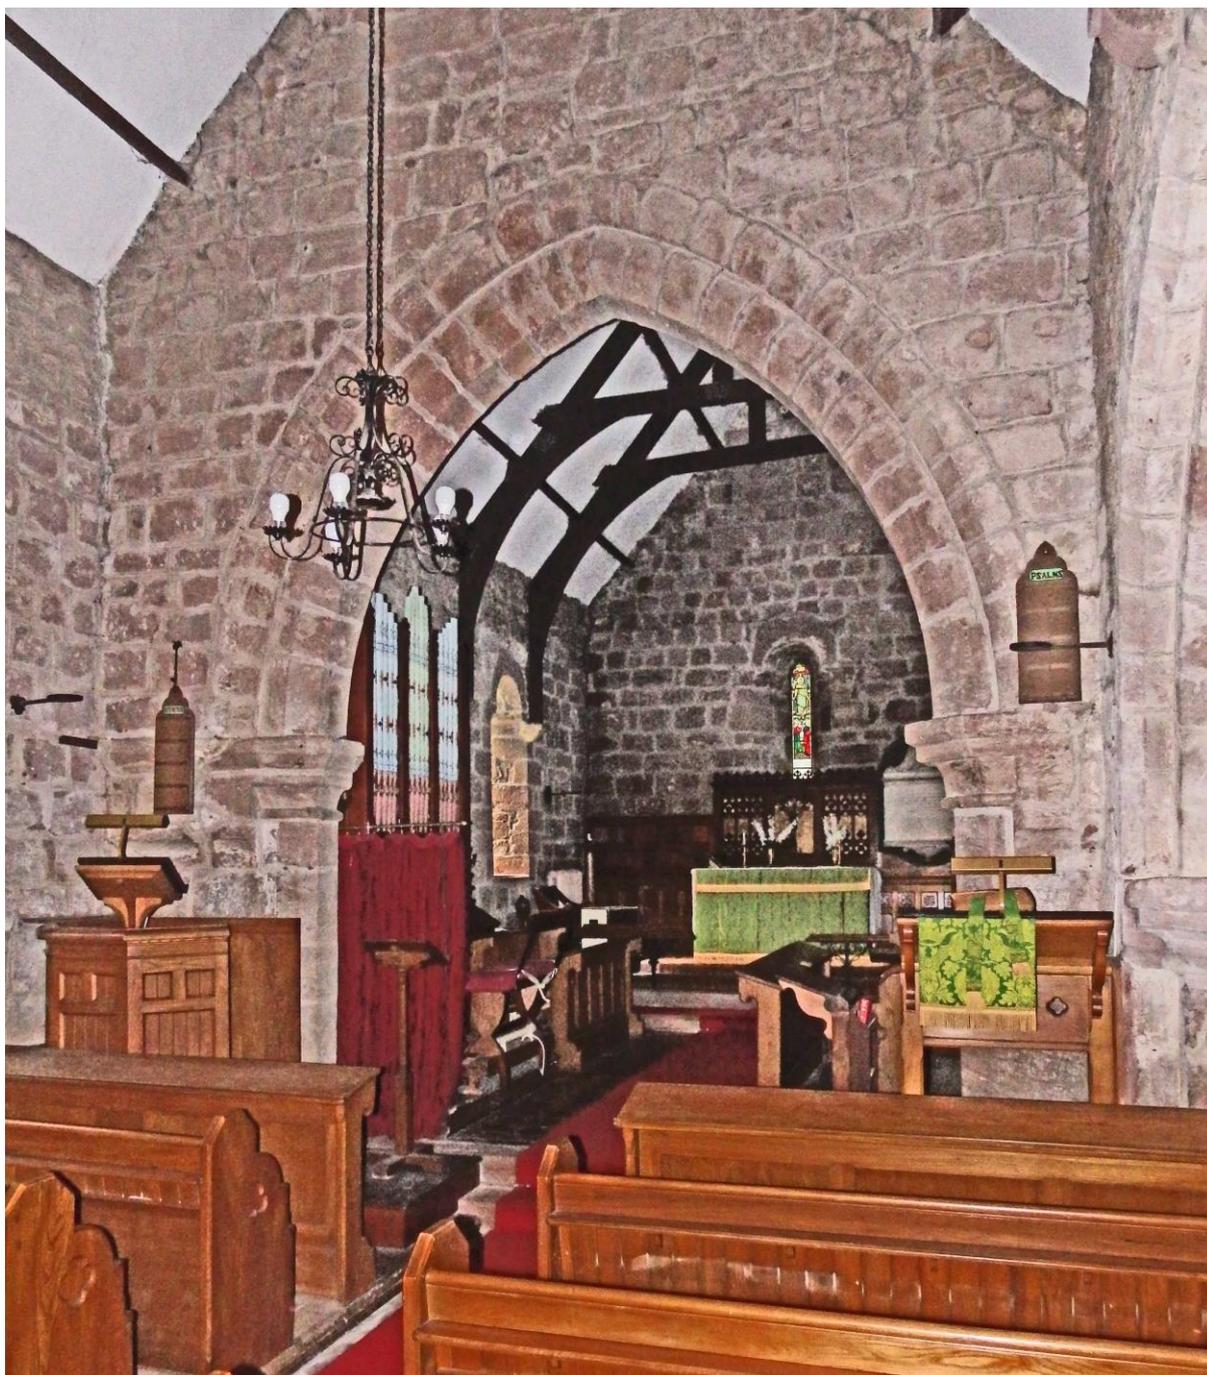
Looking east from the nave into the present chancel

The west wall of the nave contains the arch into what is now the chancel, a lofty opening of two-centred form, set noticeably north of centre. The arch is of two chamfered orders, without a hood, and springs from semi-octagonal responds with capitals of similar section to those of the arcade; no bases are exposed. On the south the impost, chamfered beneath, is carried back to the south-west corner of the nave, but on the north the impost block is thinner and the chamfer narrower, and stops short of the corner. The Northumberland County History account interprets the southern impost as being a 12th-century feature, a relic of an early tower arch, re-cut in the 13th century but this is perhaps questionable. Below the impost the wall thins back, on both faces of both responds, with a hollow-chamfered course, reducing the width of the respond from c 0.74 m to 0.52 m. The wall above the arch is of coursed stone, with a preponderance of squarish blocks, suggesting that 12th century fabric is extant, into which the arch has been inserted. A range of small sockets around 1m below the apex of the arch must relate to a post-medieval nave ceiling; higher up there is a cut for an older roofline a little below the present one.

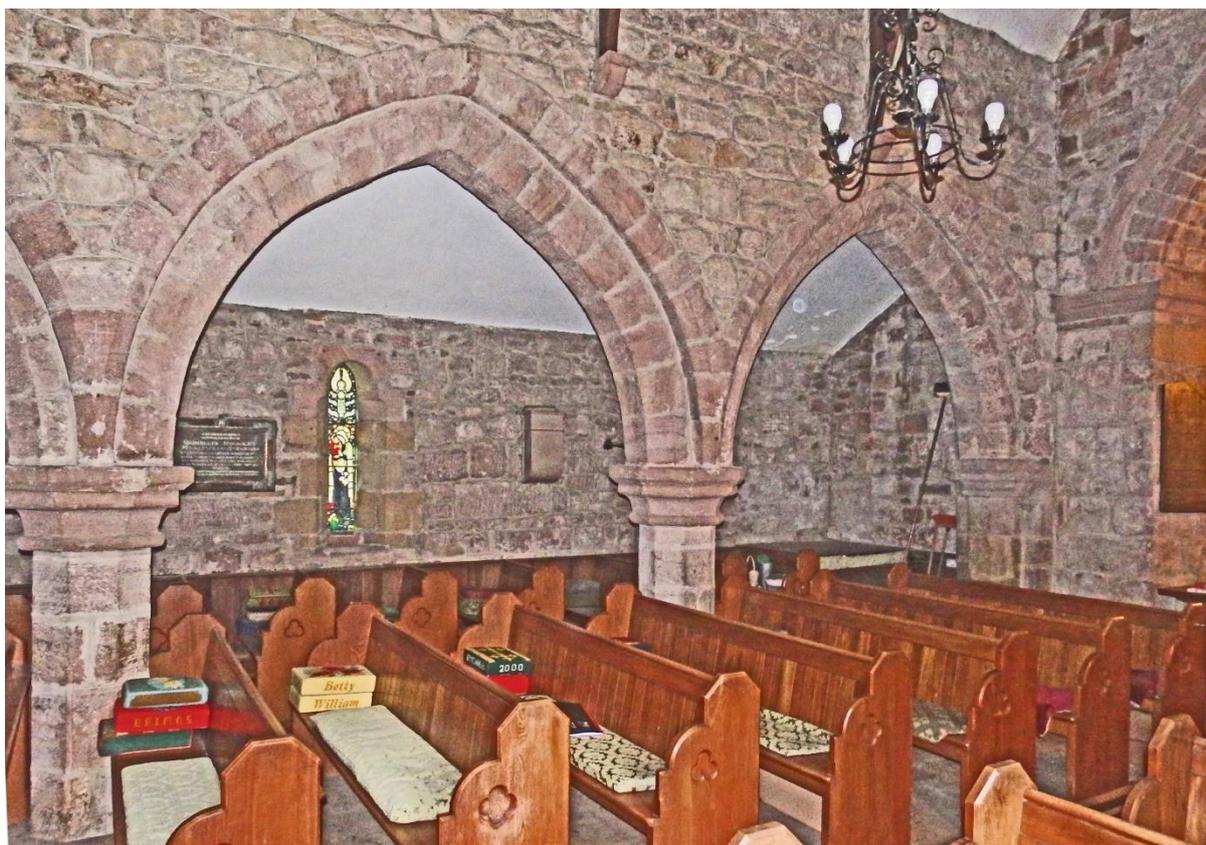
The south wall of the nave has areas of well squared and lightly-tooled blocks, characteristic of 12th-century work, with 19th-century pecked stonework around the windows. On the north is the three-bay arcade, of two-centred double-chamfered arches, carried on octagonal piers with moulded capitals,

and similar semi-octagonal responds. The eastern respond has a moulded base; little of the bases of the two piers or the western respond are exposed, which would appear to have been at a rather lower level, and to be badly decayed or else partly cut away. The wall fabric above the arcade is of roughly-coursed quite irregular stone, more like the internal north wall of the aisle than the other wall faces in the church.

The central and eastern arches of the north arcade

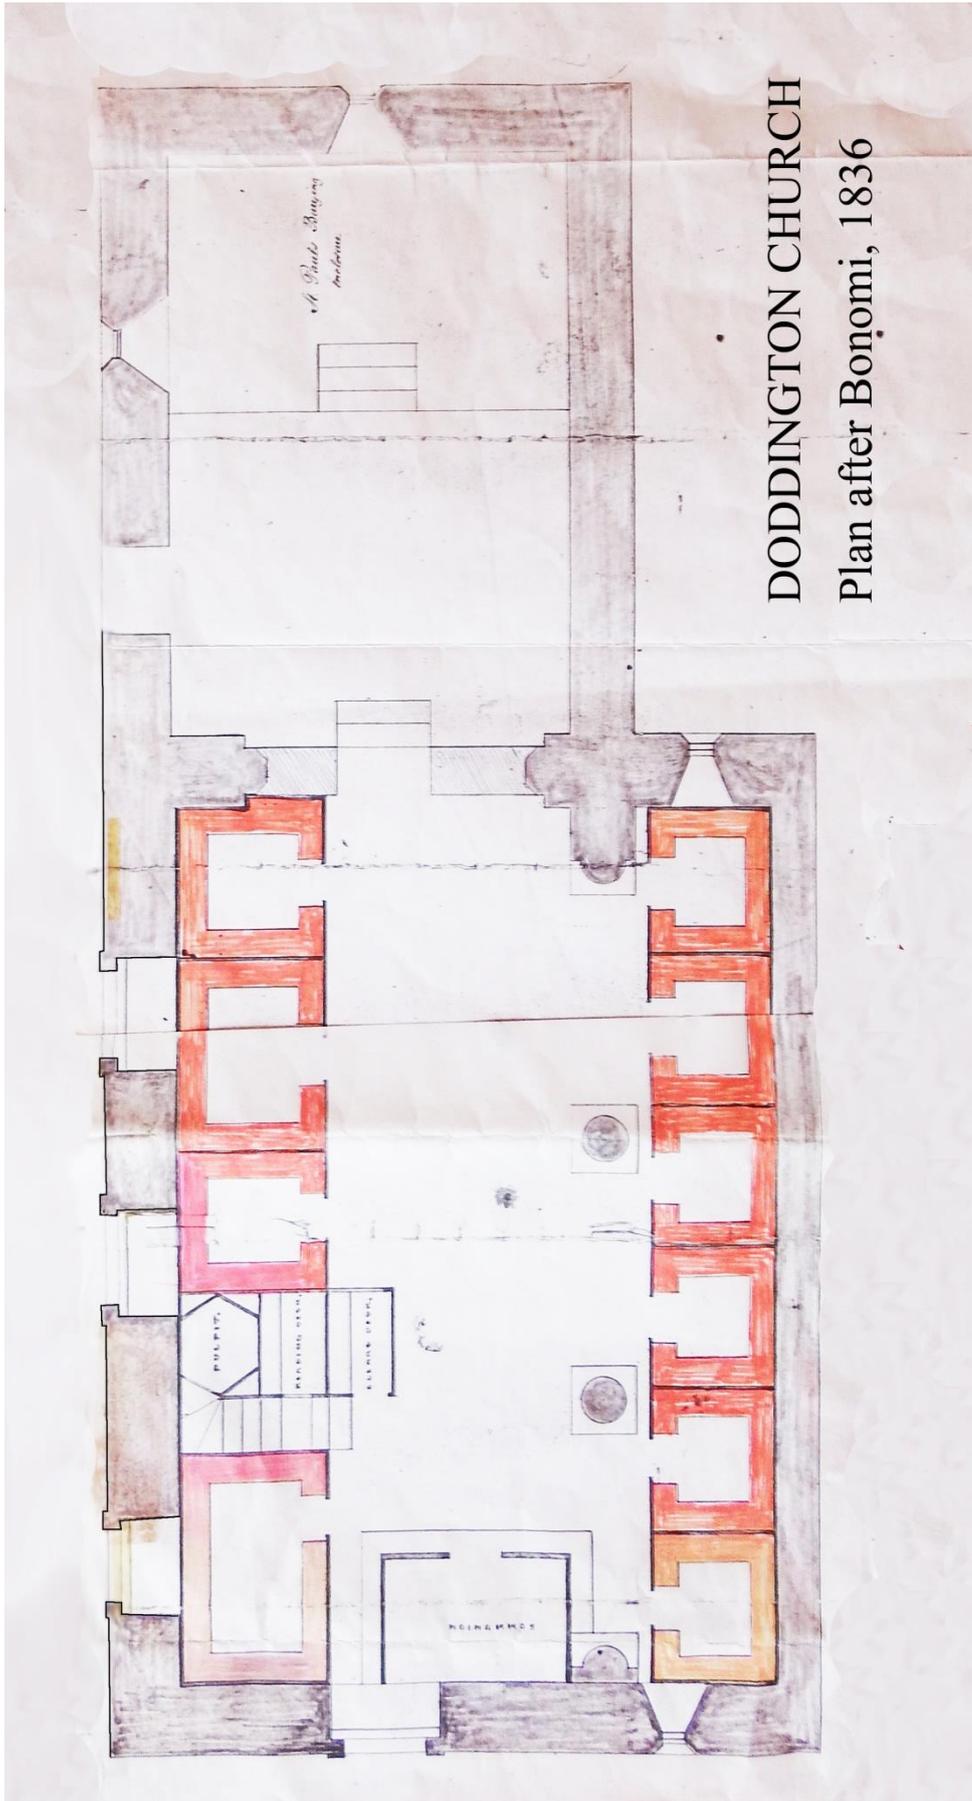
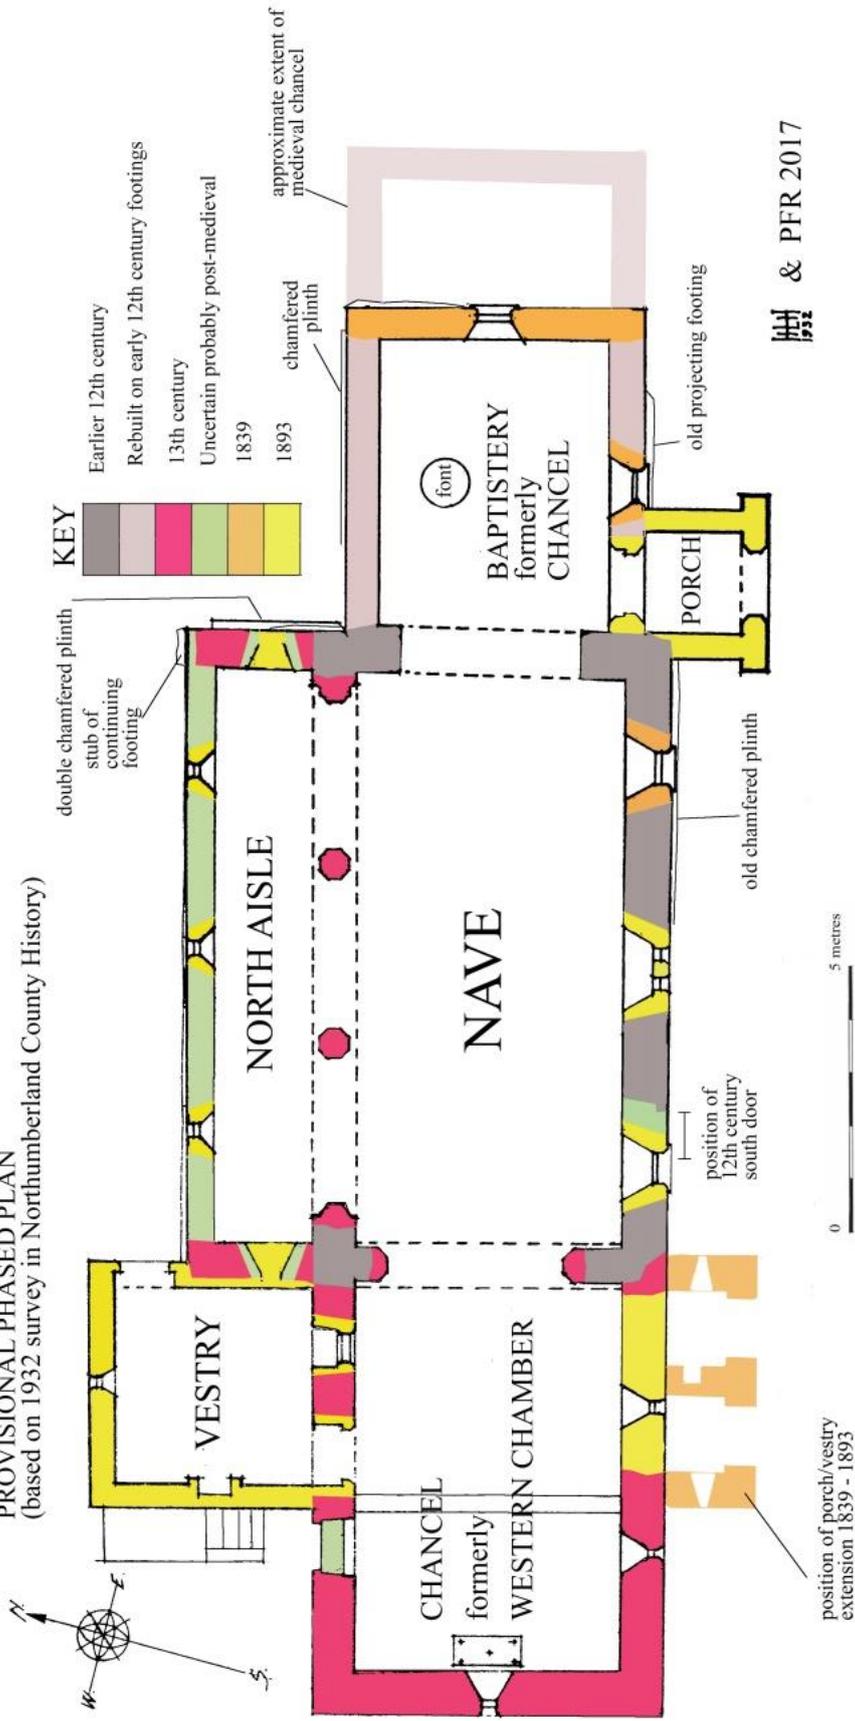
ST MARY AND ST MICHAEL, DODDINGTON

PROVISIONAL PHASED PLAN
(based on 1932 survey in Northumberland County History)

This is an intriguing building, and not one easy to make sense of. The earlier development of the building must be deduced from an examination of the fabric, from which it appears that the nave walls and lower portions of the side walls of the present baptistery represent a two-cell church perhaps of the early-12th century, with the baptistery representing a conventional eastern chancel. The lower jambs and at least some of the voussoirs of the arch survive, although this was reconstructed in 1839 as a taller opening with a pointed head, when it was almost certainly semicircular in its original form.

It appears as if this church was extended in the 13th century, by the addition of a north aisle and an unusual western chamber the full width of the nave, but separated from it by a transverse arch which seems to have been inserted in the old west wall. The function of the western chamber remains unknown; if it was simply an extension to the nave why was there an arch opening into it? The Northumberland County History account suggests that there was an earlier tower here, on the grounds that the southern impost was identified as 12th-century work, but this seems doubtful. Whilst the impost is a heavier block than that on the north, the treatment of the wall below it – with oversailing hollow-chamfered course on both faces – and would seem an unlikely modification if earlier fabric above were being retained in situ; in addition the wall seems too thin to have supported a 12th-century tower. It has also been suggested that the western chamber may have been intended to be defensible, but there is no evidence of this – unless the later walling-up of the arch recorded in an early-19th century account and shown on Bonomi's c1836 plan was prompted by a need for security. The western chamber, now divided from the nave, became the burial vault of the local St Paul family.

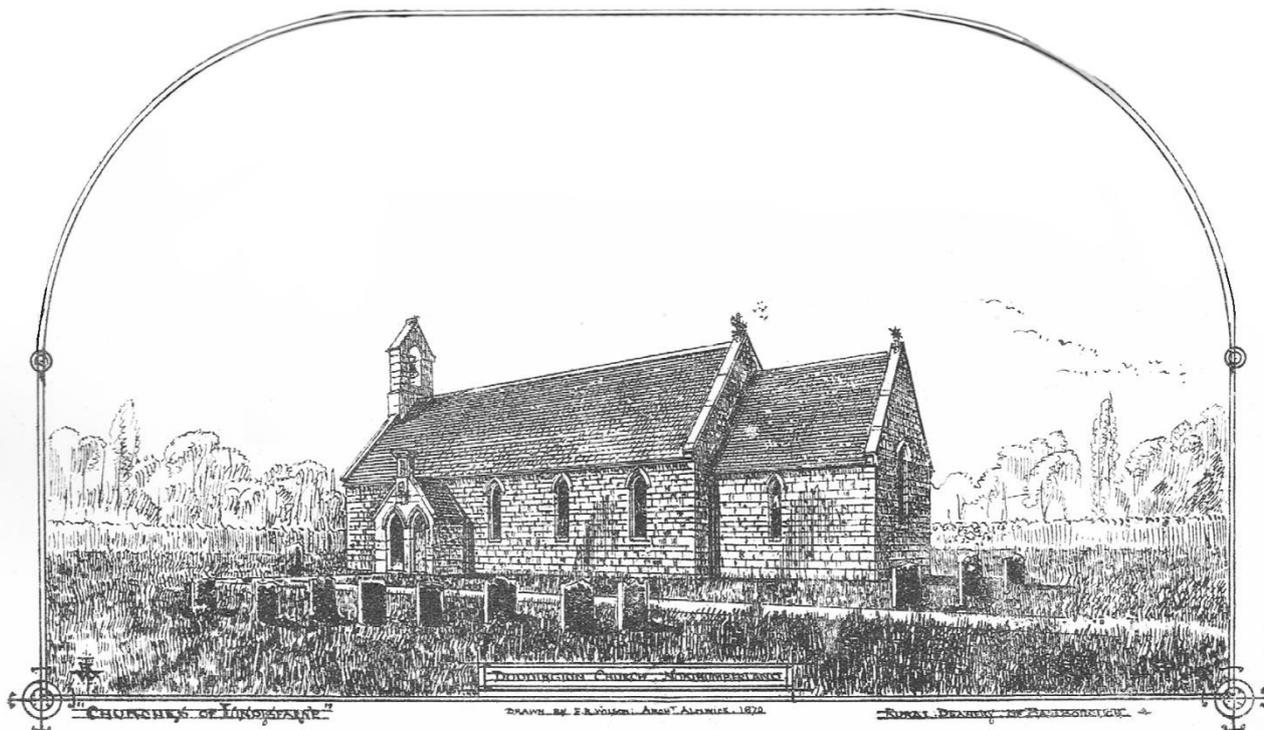
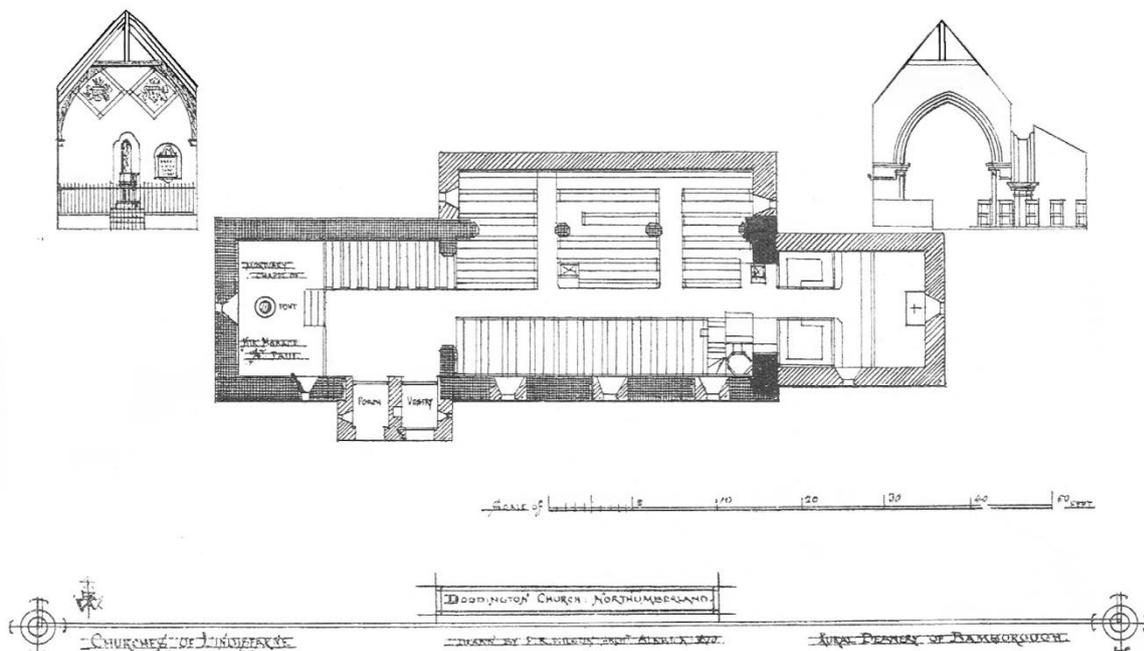
Drawing and Plan of the church as it stood in 1870, after F.R. Wilson

⁵ Wilson (1870) quotes the aisle as 16 feet wide, but this is clearly a misprint for 6 feet, as his plan shows the aisle as it is now. Is this error the source of the figure?

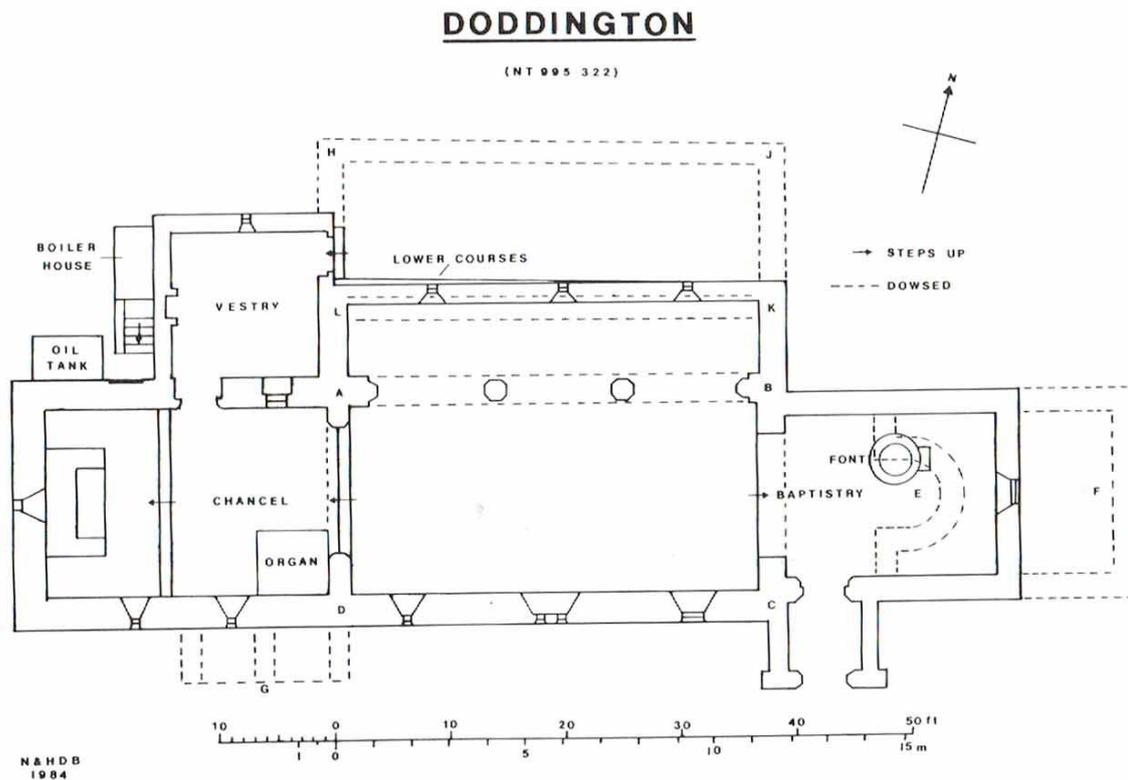
Dowsed Plan after Bailey, Cambridge and Briggs (1988)

The north aisle also poses problems. Whilst its present north wall is clearly of some age, at least in its lower courses, the 19th-century Proctor MS⁴ explicitly states that the church had had 'a double nave (mutilated, as it still is, in width of half its northern wing or aisle)'. The 16-foot (4.87 m) width quoted for the original aisle is another puzzle - this would make the aisle as wide as the present nave, which would be highly unusual in a medieval church, especially one of a remote village in 13th century Northumberland⁵. There is some evidence that the east wall of the aisle, with its plinths, might once have extended further north. A dowsed plan of the church⁶ does show what is either an even wider north aisle (5.8 m) feet or perhaps a separate rectangular

structure 3.6 m wide, the same length as and the present aisle and overlapped by its north wall⁷.

⁷ It also shows two earlier phases of the chancel, a short one with a narrower eastern apse, and one a third longer than at present, which tallies with 19th-century accounts of the foundations seen in 1839 – although the dowser may conceivably have known of this. The writer is not convinced by this technique.

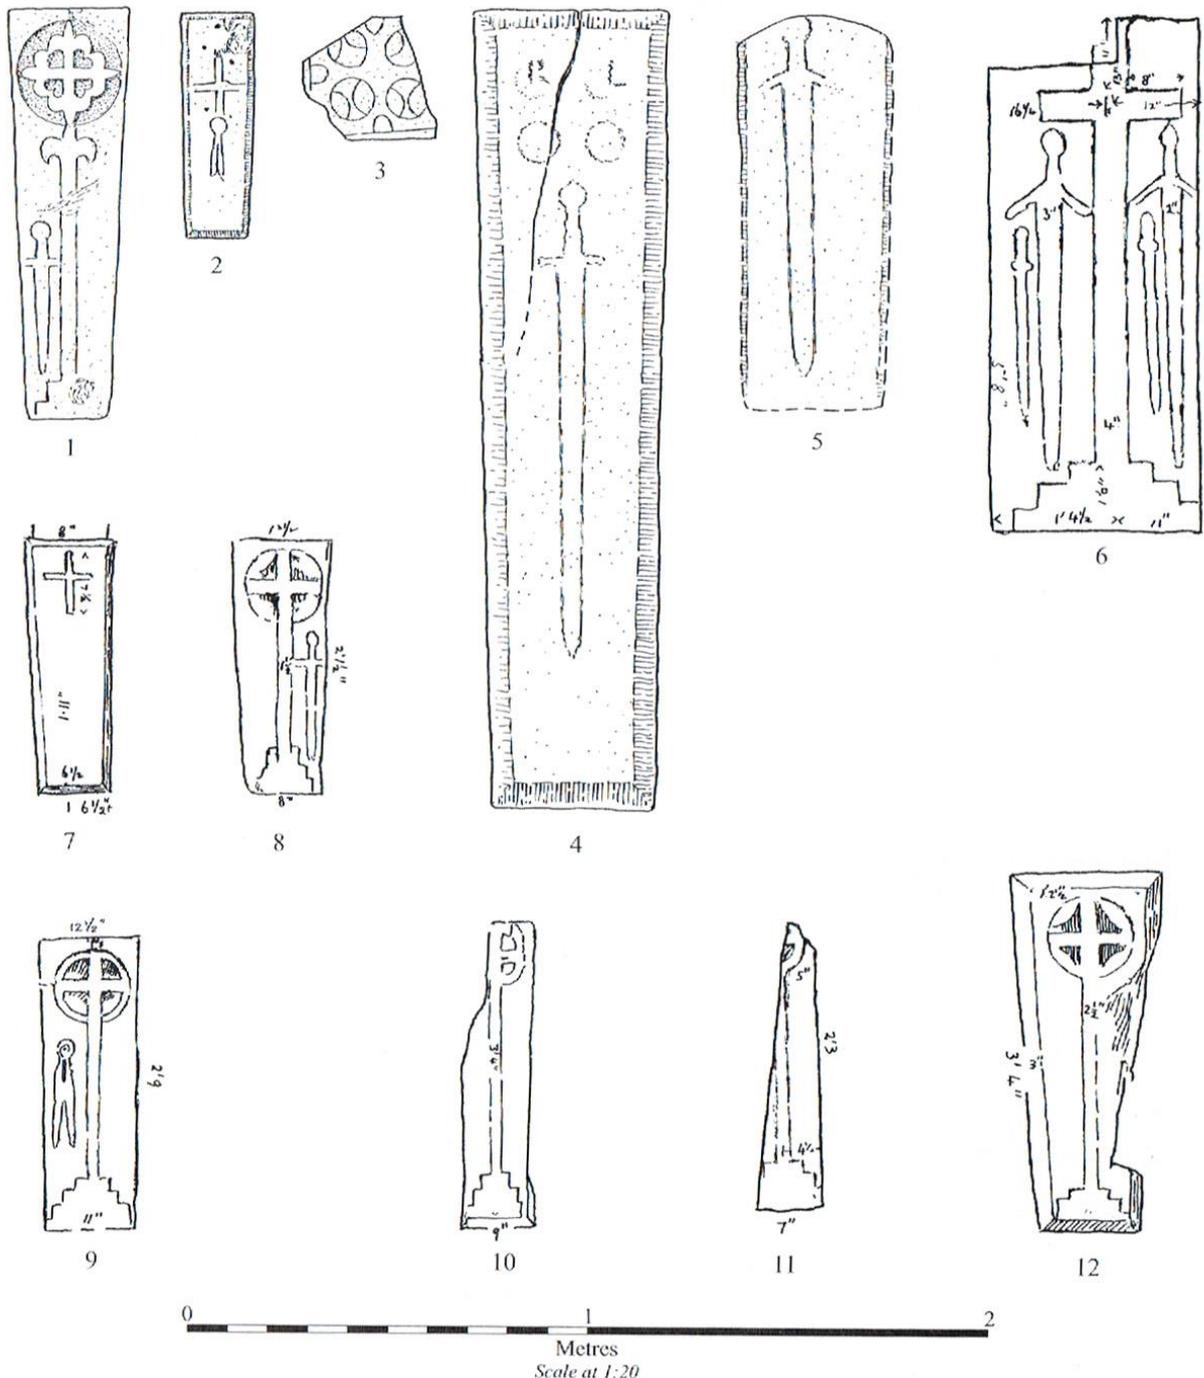
Fig. 13 North Northumberland cross slabs, cont.

Doddington (St Mary and St Michael) The scale-bar only applies to slabs 1-5.

- (1) Tapered slab of reddish sandstone built into internal face of west wall of porch. Cross head with fleur-de-lys terminals, the leaves linking to enclose heart-shaped 'bracelets', carved in relief in sunk circle. Remainder of design incised: cross shaft, with fleur-de-lys at top, rising from stepped base with sword on l. Thirteenth or fourteenth century.

- (2) Complete small tapered slab of purplish sandstone built into interior of east wall of porch. Very simple equal-armed cross with a pair of shears below. Date uncertain.

- (3) Fragment of incised sandstone slab built into upper part of internal face of west wall of porch. A series of circles with various curved lines apparently form part of a cross head. Early to mid-twelfth century?

- (4) Tapering recumbent slab of brown sandstone in the south-east part of the churchyard, c. 2 m south of a north-south row of three table tombs; incised design with a broad marginal chamfer. The cross head is represented only by four incised circles (*cf.* slab (3)), the upper two largely erased by the secondary initials 'R L', evidence of post-medieval re-use (*cf.* several slabs at Newbiggin). A sword is substituted for the cross shaft, as at Chillingham, North Gosforth and elsewhere. Probably twelfth century.

- (5) Slab built upright into the internal face of the south wall of the churchyard, just beyond the junction between the original yard and a more recent extension. The only motif is an incised sword, set l. of centre; the present arched top of the slab cuts the pommel of the sword, and must be secondary. Date uncertain.
