St Mary Magdalene, Whalton

An Archaeological Assessment

January 2007

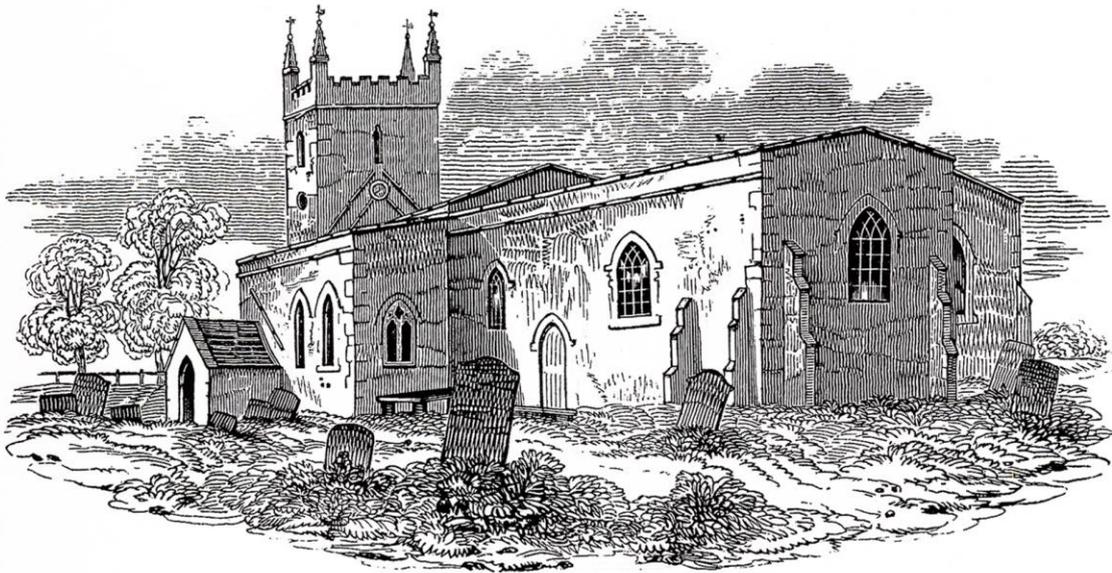
THE CHURCH OF WHALTON,

South east view, from Hodgson's History of Northumberland (1827)

Hodgson gives a print of the church, seen from the south-east, as it appeared after this restoration; he shows a south porch, clearly secondary, as the roof-line of a predecessor appears above it. Wilson's 1870 print (accompanied by a useful plan) shows that the sash in the east end had by then been replaced by a traceried window, but it was not until a major restoration in 1890, at the hands of the reputable Newcastle firm of Hicks and Charlewood, that the other sashes (except that in the tower) were replaced by good-quality Victorian gothic windows, in a free 14th century style; their 18th-century Gothick (or 'churchwarden', a perjorative term of the period) predecessors would have been thought quite inappropriate by this time; genuine medieval features were however respected and exposed.

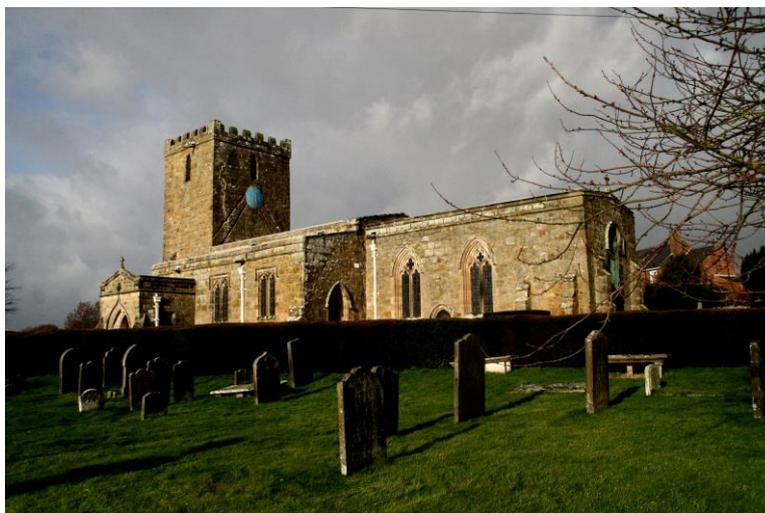
The church from the south east

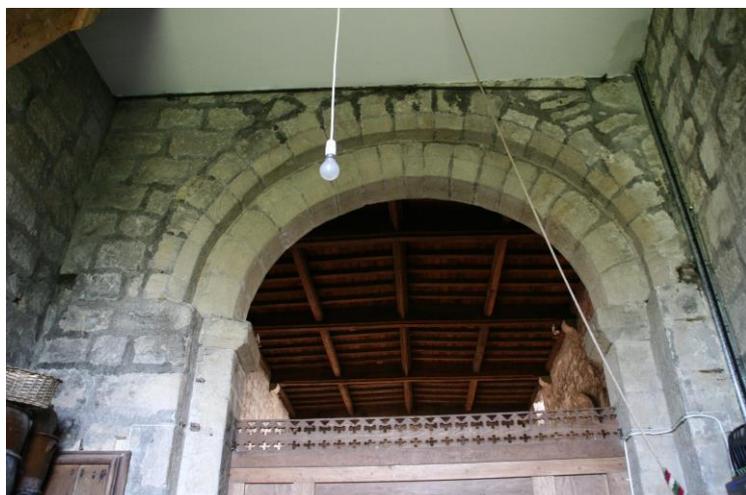
Inside the **Tower** the west face of the tower arch is similar to the east (see description of nave), and is set south-of-centre as regards the present tower. Above the extrados of the outer order on the south, and just below the underdrawn plaster ceiling, is an area of diagonally-set rubble; in the corresponding position to the north of the arch is conventional squared masonry. The lower 2.5m or so of the internal walls of the tower are concealed by a tall boarded dado.

tower arch

The west face of the

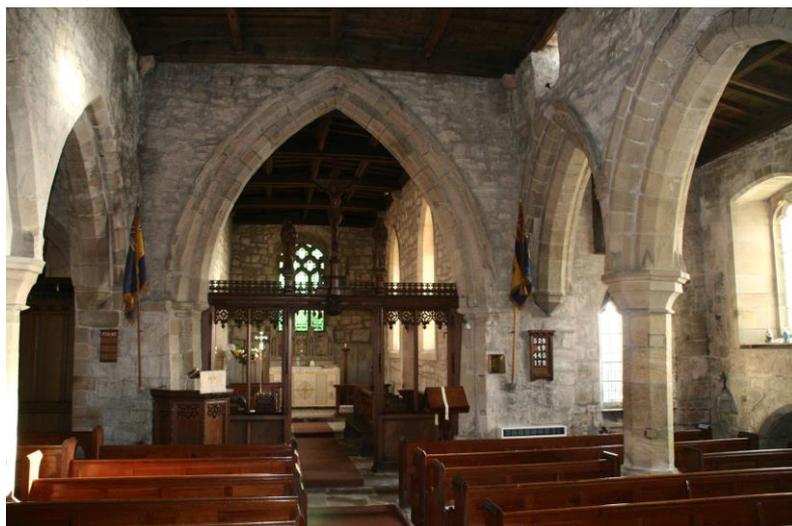
Interior looking east

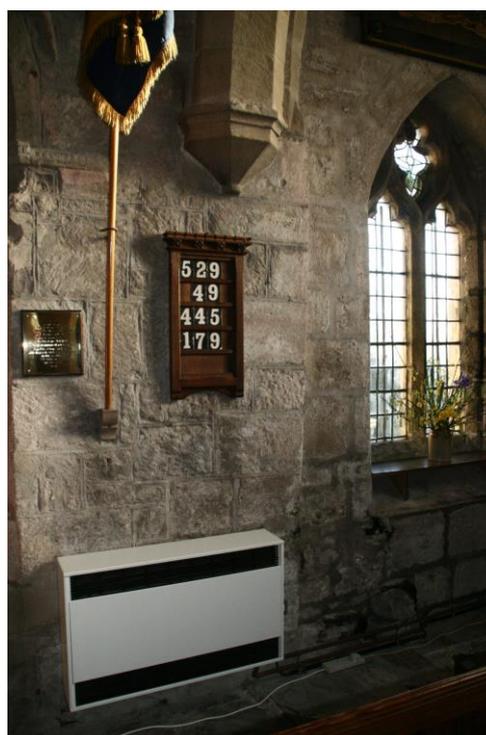
A particular puzzle is found at the east end of the arcade (right) ; the arch springs from a corbel of the usual type, but the corbel is set above a series of large blocks⁴ that have a straight joint in line with the external face of the arcade; the adjacent east end wall of the aisle is set-back a few cm to the east; these for all the world look like the south-western angle quoins of an earlier structure to the east. Couple this with the fact that the south-eastern angle quoins of the original aisleless nave do not appear externally where one would expect them to, and we have a structural enigma not easy to resolve (see Structural History section).

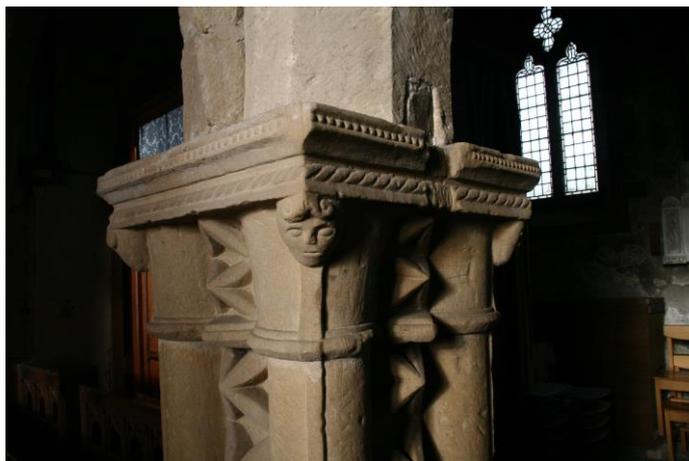
*The pier of the chancel arcade
from the south-east*

The chancel is seen by Briggs (2002, 6) as having been rebuilt at the very end of the 12th century, on the strength of the similarity of the ornament of the pier of its north arcade to work in the presbytery of Tynemouth Priory (1190-1195).
