St Mary's Church, Ponteland

Archaeological Assessment

January 2016

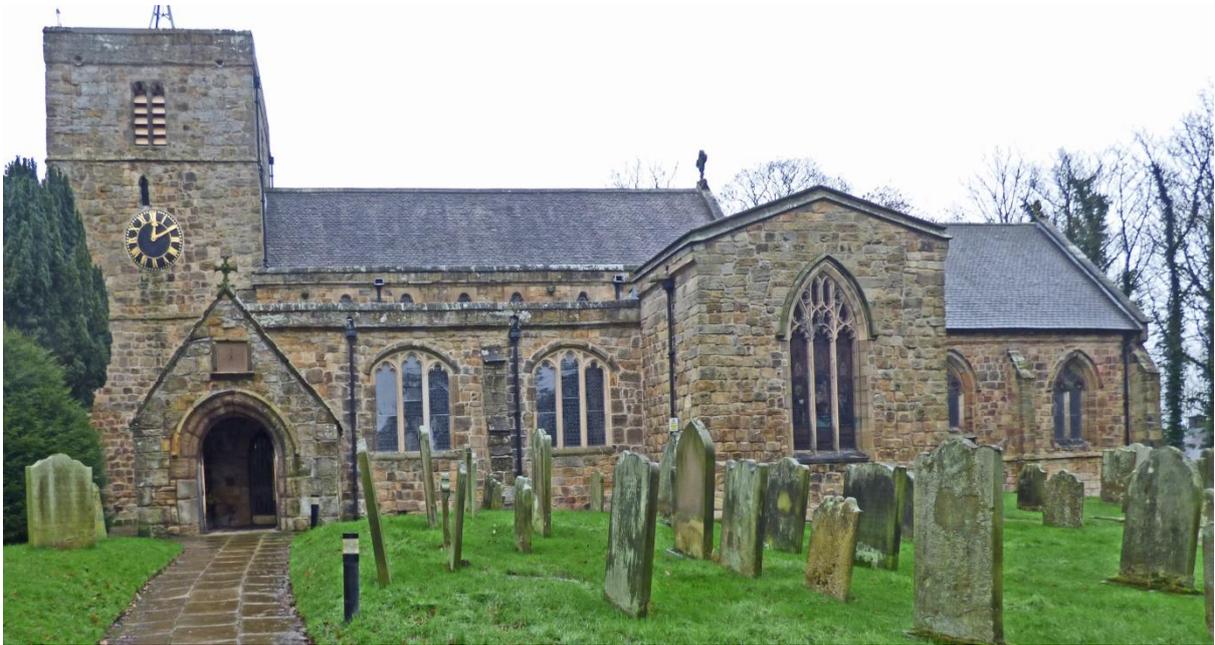
The church from the south

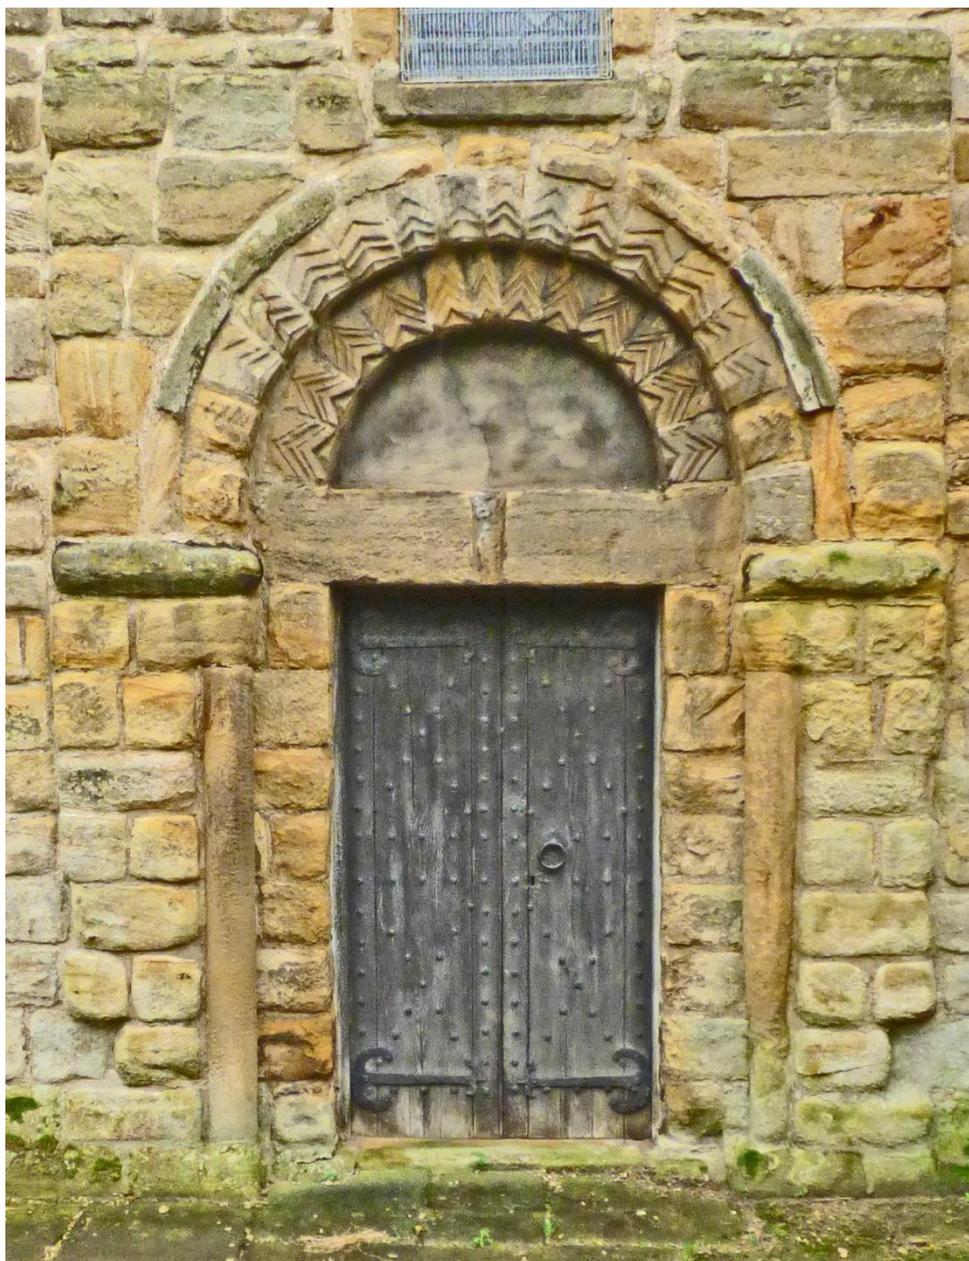
On the west of the lower stage is the 12th century west door, set in a slightly-raised panel of walling; it has a semicircular arch of two orders of chevron, enclosing a plain sunk tympanum above a plain lintel; the damaged intrados of the inner order suggests that an earlier tympanum has been cut away. The impostes are chamfered on the underside, and the outer order is carried on jamb shafts with capitals now so weathered that their original form is hard to determine; the shafts below have probably been renewed, although the southern is quite badly eroded. Directly above is a round-arched window, the sill of which cuts down into the chamfered top course of the raised panel of masonry in which the doorway is placed; it has the appearance of being an insertion, and its head and sill are relatively recent stone.

The West Doorway

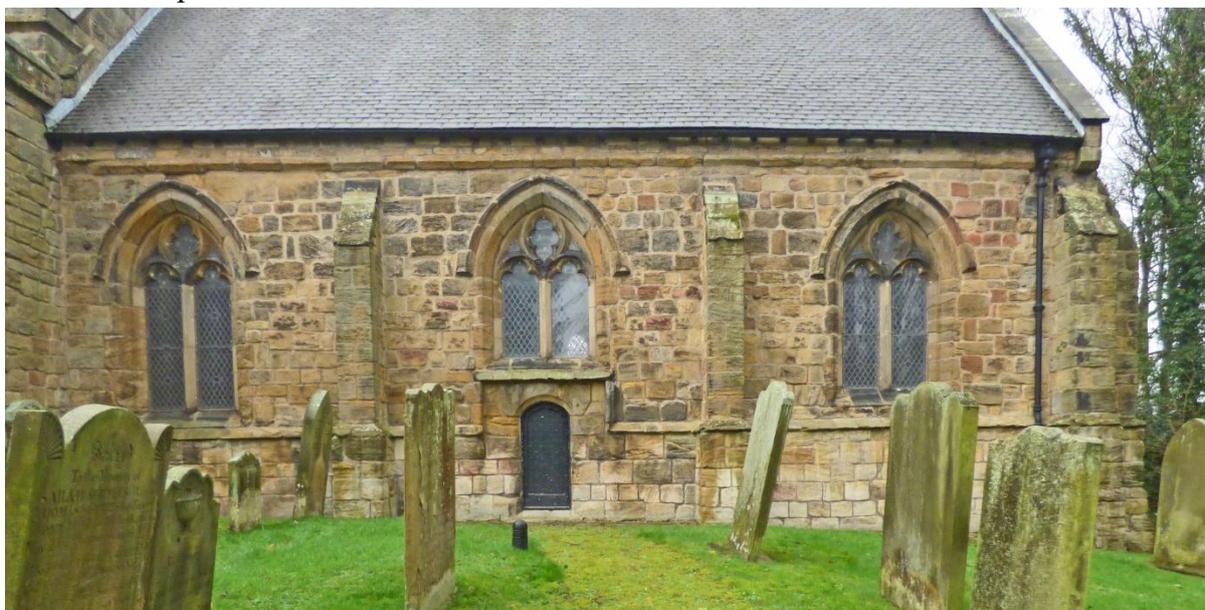
The three-bay **Chancel** is of good-quality squared stone, with some smaller squarish blocks, presumably re-used, in the lower courses, especially of the central and eastern bays on the south. The side walls are articulated by simple stepped buttresses, with a chamfered string

course which runs beneath the sills of the windows, and is stepped up to form a square hoodmould over the small priest's door in the central bay on the south, which is set in a slightly-recessed panel of walling and has a segmental head and chamfered surround. There is also a chamfered oversailing course a little below the eaves. On the south each bay has a 14th-century window of two trefoil-headed lights with a quatrefoil in the spandrel, under a pointed arch with a broad chamfered surround and a chamfered hood with turned-back ends; their jambs do not course in with the walling. The central one has its sill set at a higher level to allow for the priest's door beneath.

The chancel from the south

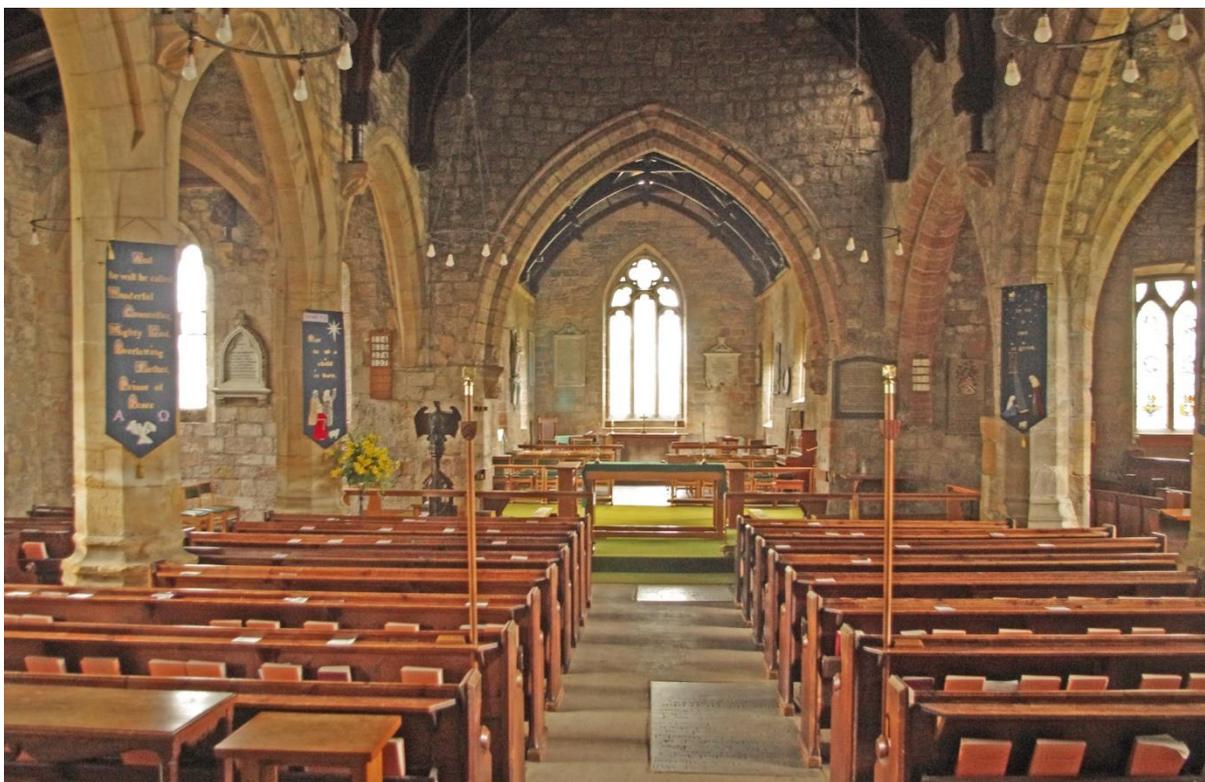
The **Nave** has four-bay arcades, the easternmost arches opening into the transepts. The north arcade is continuous but on the south there is a short rectangular block of walling in between the aisle arcade and transept arch.

The aisle arcade on the south has two-centred double-chamfered arches which simply die into the octagonal piers without any capitals; the piers have tall moulded bases of late 14th century

The nave looking east

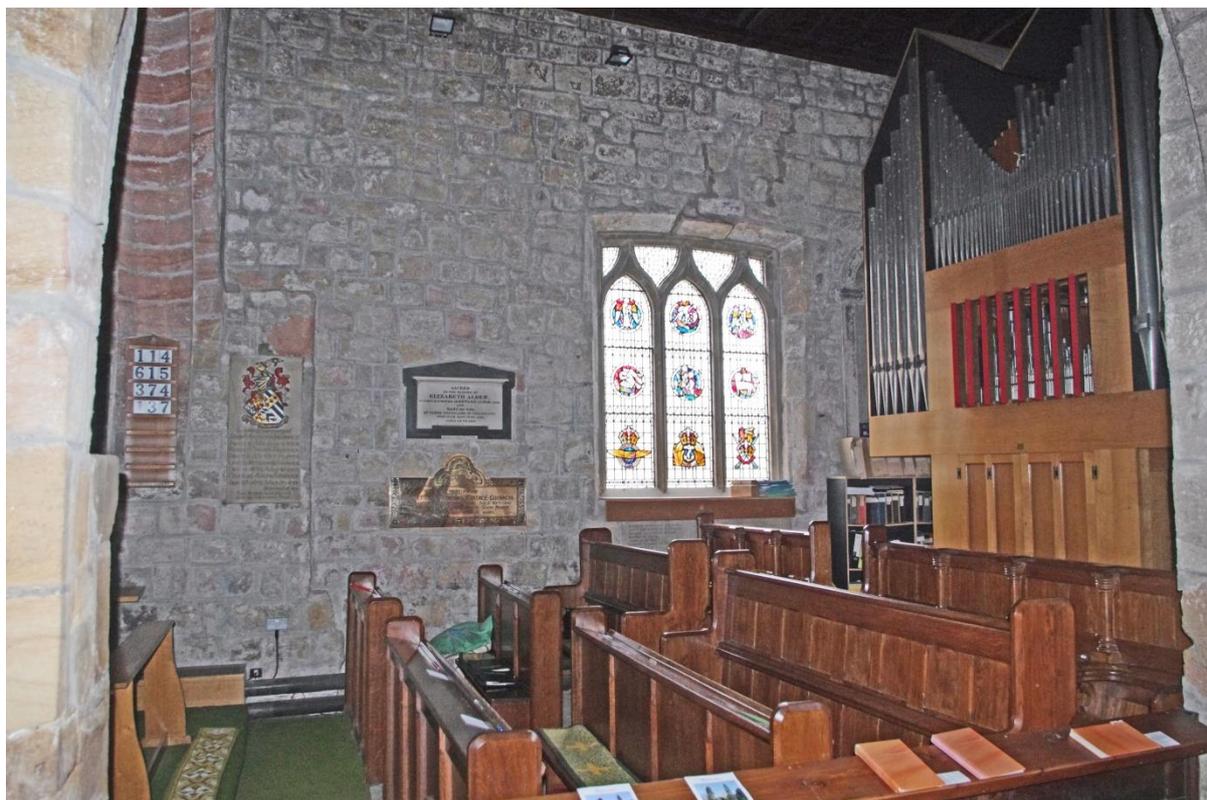
The South Transept looking east

The **South Transept** has some intriguing features in its east wall. There is a raised panel of masonry at the north end of its east wall, extending 0.86 m south of the corbel carrying the transept arch, rising to a height of c 3 m and set forward c 0.13 m from the main wall face. Its south edge, although interfered with by a 20th-century wall monument, has some large cut ashlar blocks, as if it has been the jamb of an opening. It does not extend all the way to the floor, 0.85 m above which more ragged masonry projects a further 0.40 m to the south. There is also a straight joint c 0.55 m north of the northern jamb of the rear arch of the three-light window, the shallow segmental-headed rear arch of which looks old. The siting of the organ, together with several 18th century wall monuments, makes it difficult to inspect the walls of the southern part of the transept. There is an old square-headed aumbry close to the south end of the west wall, rebated for a door.

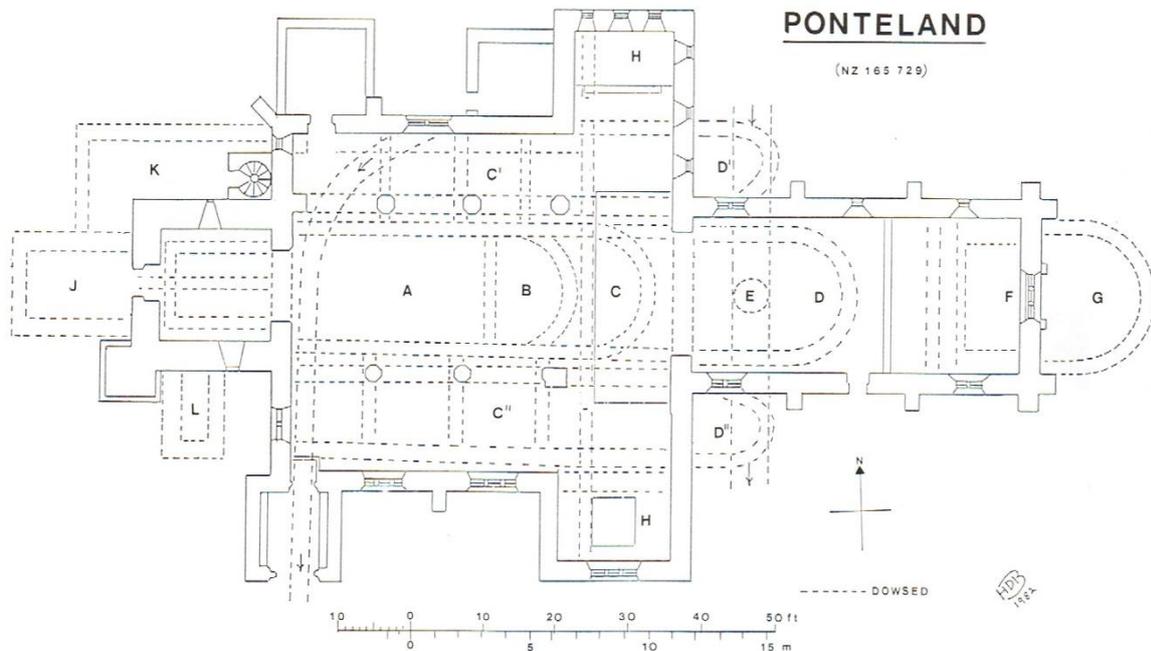
no less than four successive apsidal eastern terminations; there were also apses beyond the east end of the nave aisles, porticus flanking the early nave and a series of structures around and underlying the present western tower. In 1983 an excavation was carried out to test the validity of the dowsed evidence, in the angle between north transept and chancel, where the northern of the two subsidiary apses had been traced. The dowsing survey and excavation have been published (Briggs et al 1983 and 1985) and considered again against the wider background of similar surveys and investigation (Bailey et al 1988). To very briefly summarise the results of the excavation.. rubble footings were found beneath the western part of the chancel which clearly pre-dated the wall above, with irregularities in plan which would correlate with the removal of the dowsed apse to the north although this, if it existed, had been cleared away prior to the construction of the north transept. It was commented that the putative triple-apsed phase of the church would 'best fit into a Norman milieu' (Bailey et al 1988, 101). Early burials beneath the site of the putative removed aisle apse were set skew to the present axis of the building, but might have been aligned to an earlier Saxon apse further to the west.

Dowsed plan of the church (Bailey et al 1988, 163)

St Mary’s Church, with its Anglo-Saxon origins, is clearly a church of considerable archaeological importance. However much weight one gives to the dowsed plan, the complexity of the structural history of the visible structure means that evidence of earlier building phases almost certainly survives beneath the present floors, and in the churchyard adjacent to its walls, although as usual sub-surface deposits and structural remains will have been disturbed by the usual centuries of burial and perhaps the construction of an underfloor heating system- there is now no clear evidence of this, as the church has been re-floored.

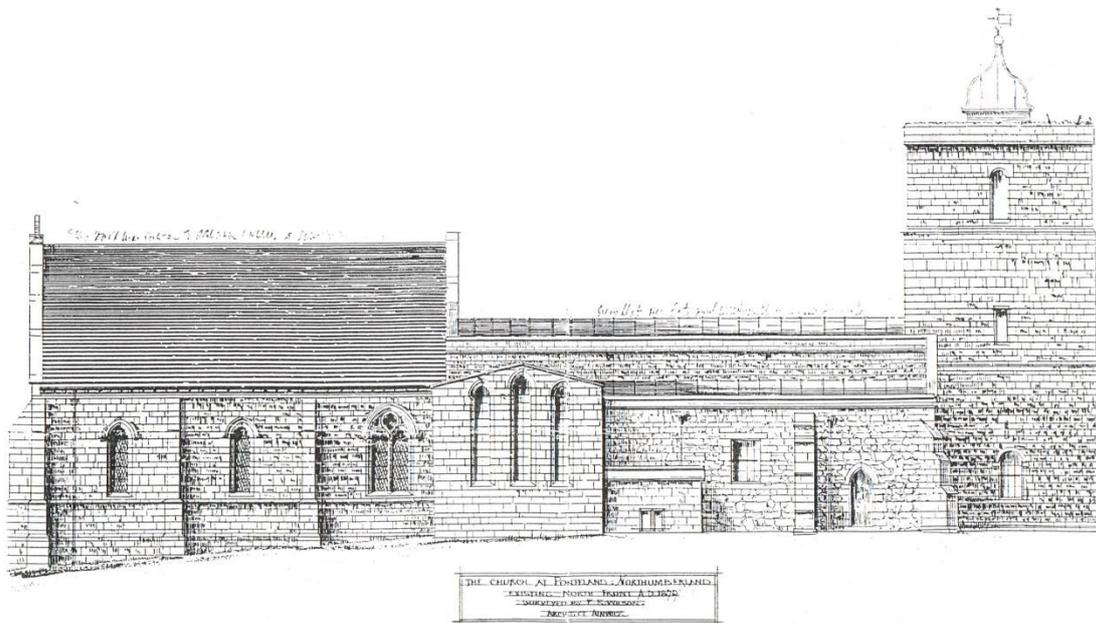
The north aisle is said to have been rebuilt in the 15th century, but it has suffered so many vicissitudes since that it is difficult to say anything conclusive about it, although parts of its walling and its two buttresses could well be late medieval. The high-pitched earlier medieval roof of the nave was probably replaced by a low-pitched leaded one later in the medieval period as well, which survived until c1880.

North elevation of the church prior to the c1880 restoration, after F.R.Wilson

In 1880-1882 came a major restoration carried out by the architect F.R. Wilson. The surviving papers⁸ include ‘as is’ and ‘proposed’ drawings for both the ground plan and the north elevation. Wilson added the present stair turret on the north of the tower; the drawings show he intended to rebuild the whole south-west corner of the tower, which was suffering structural failure, but instead he added the present large buttress; he also intended to add a full spire.. He also took down and rebuilt the north transept, which also had major structural problems, replacing the old features. In the north aisle he replaced a plain square-headed sash window in the north wall with the present two-light window, and made a new window at the north end of the east wall, replacing one further south now covered by the new turret. A new window was made at the west end of the south aisle. Inside the church he removed a western gallery in the western bay of the nave, which had been erected by a Mrs Barbara Coates and had panels painted by the ‘local poet Whittle’ in the style of ‘poker paintings’. The roofs of the nave and north transept were replaced, that of the nave being returned to its high-pitched earlier medieval form, which was evidenced by an old roof-line on the tower. An older leaded cupola on the top of the tower was replaced by a slated spirelet. The chancel was restored in 1885, its floor being raised, new organ, stalls and panelling being provided and a new roof constructed (Bailey 2005).
