St Bartholomew's Church, Newbiggin

An Archaeological Assessment

January 2013

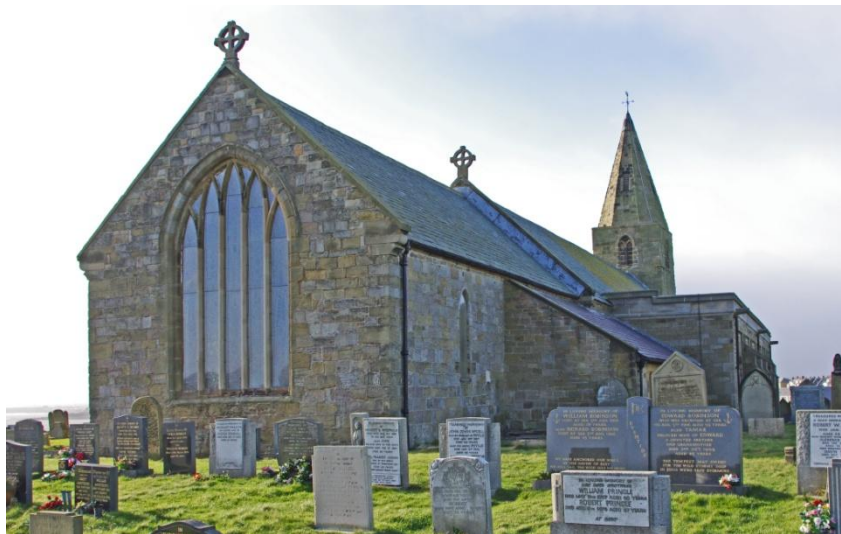
Newbiggin Church in 1832 (above) and today

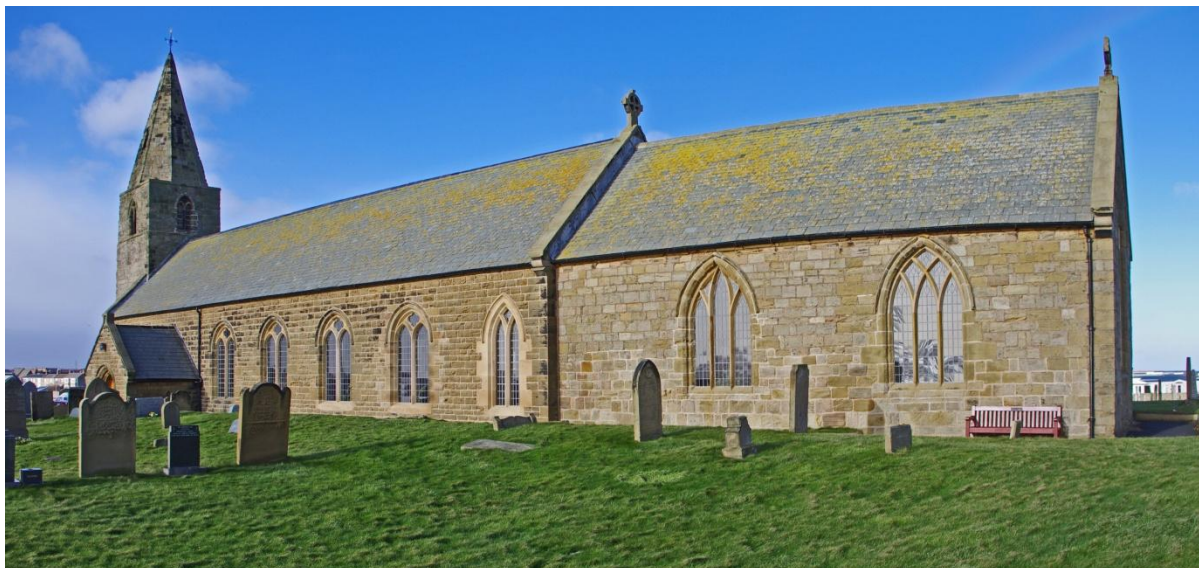
The external walls of the **Nave** are of mid-19th century coursed rough-faced stone, with alternating ashlar quoins; there is a chamfered plinth, only just exposed at the south-west corner and up to 0.50 m below the present ground level further east. There is a chamfered oversailing course to the eaves, and the gables have a square-edged coping carried on substantial kneelers with a concave lower and convex upper element; the eastern gable has a ring-cross finial.

The south wall is of seven bays, with the porch projecting from the second. The first and third to sixth bays have windows consisting of two broad lancet lights with a quatrefoil in the spandrel, under a segmental-pointed arch with double-chamfered jambs and a hoodmould, with shaped stops, chamfered on its underside; all are of mid-19th century date, although their stonework is quite weathered in parts, prompting some modern replacement, eg the sills of the windows in the fifth and sixth bays. The head of the sixth-bay window is quite recent as well³. The window in the easternmost bay is a very recent one, and has two lancet lights with a pierced spandrel, within a steep two-centred arch, under a similar hoodmould. Nave and chancel have roofs of green Lakeland slate.

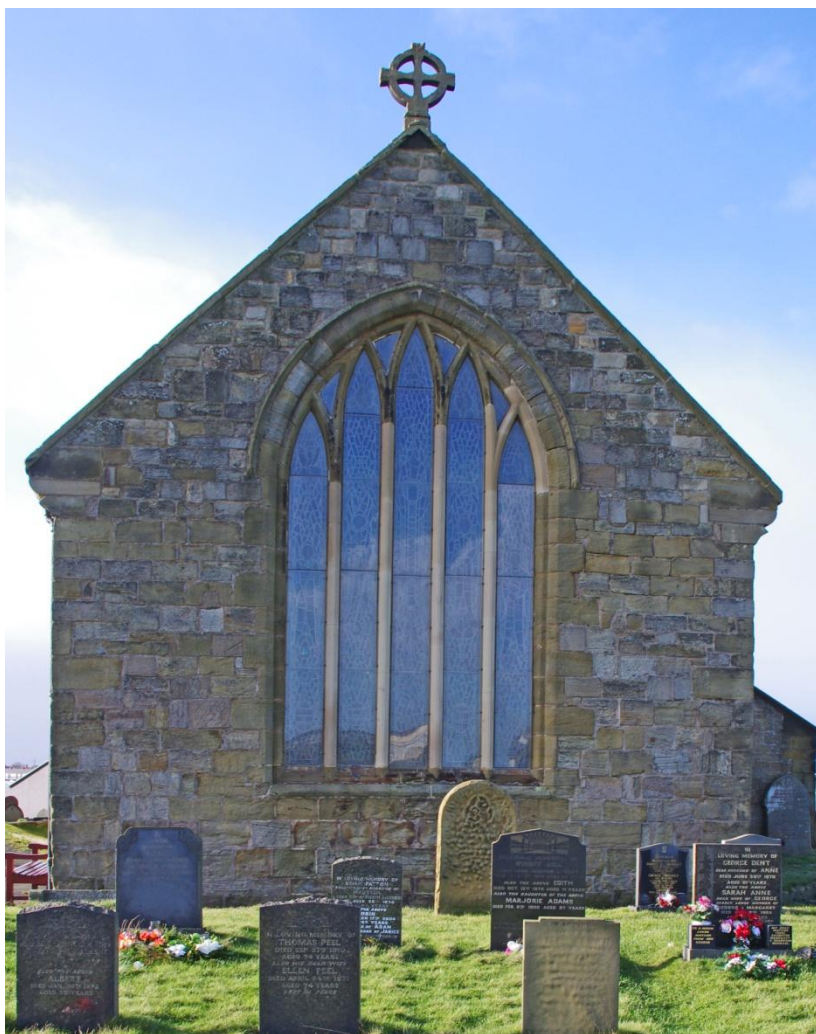
The **Chancel** is built of coursed squared stone, many of the blocks being almost square; there is a chamfered plinth but once again this is largely buried, only just appearing at the foot of the east end. There has clearly been extensive re-facing as the former priest's door, clearly visible internally, shows very little external evidence. There are two windows in the south wall; the western is of three lancet lights, with open spandrels, and the eastern, again of three lights, has simple intersecting tracery; both have hoodmoulds chamfered below, with simple shaped stops like those of the nave windows. The east end (left) has a large window of five stepped lancets, again with

the spandrels open, with similar detail; about 0.50 m out from the head of each of its jambs is a small blocked opening with an eroded sill, perhaps a drain⁴. The east gable has a 19th century coping and kneelers like those of the nave, and another ring-cross finial.

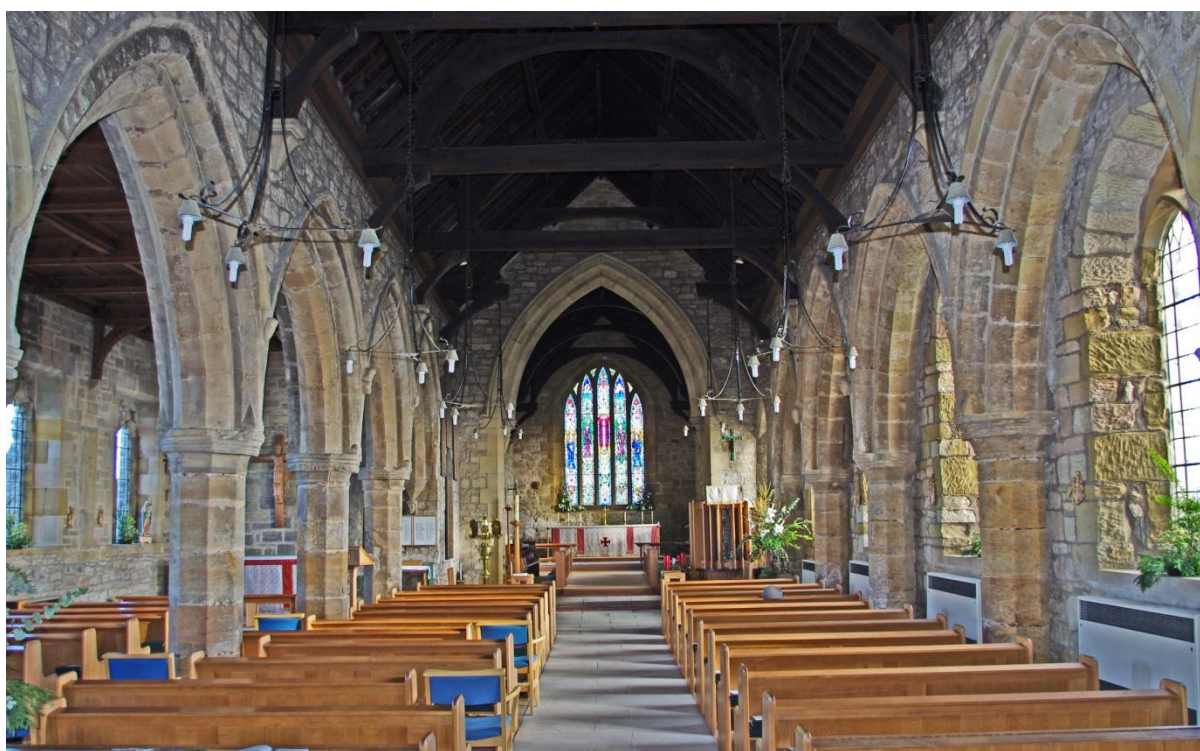
Interior looking east

Inside the main body of the church the walls are all of exposed stonework; the internal dressings of the doorways and windows in the nave and chancel are roughly-tooled, as if to take plaster. Inside the **Nave** the west wall is built of coursed squared stone; the tower arch, now blocked, has been of segmental-pointed form, apparently with a chamfer to the head only, stopped on the lowermost voussoir on each side. The lower stones have the jambs have been removed and re-set to form the jambs of a narrower doorway, set within the blocked close to the north jamb, which has a square head and quite a broad chamfered to its surround. Its opening is bricked up on the line of the west face of the wall, but the recess is infilled with

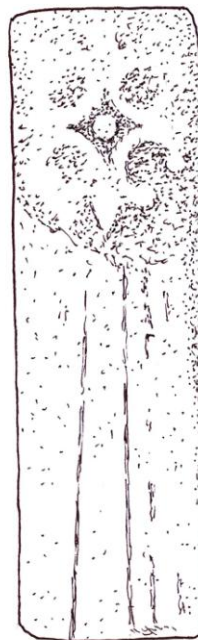
Slabs 28 and 29 do not appear to have been recorded prior to the 2013 Assessment.
