THE CHURCH OF ST MARY MAGDALENE MITFORD

NORTHUMBERLAND

AN ARCHAEOLOGICAL ASSESSMENT

MARCH 2011

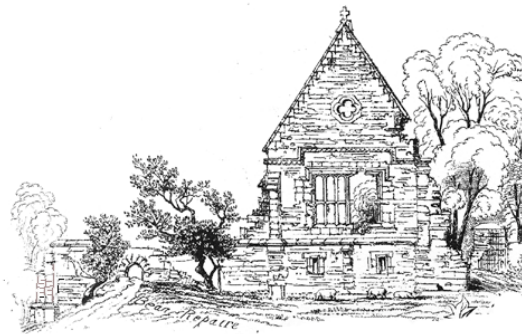
St Mary Magdalene, Mitford

The parish church of Mitford, although locally prominent in the landscape through its lofty spire, lies low on the south bank of the Wansbeck, and is overlooked on the south east by the prominent knoll that carries the ruins of Mitford Castle. The church consists of a nave with a four-bay south aisle, small transepts or transeptal chapels, a south porch and a west tower; the aisleless chancel has a small north-west organ chamber. The parts of the church dating from the 1874-5 restoration (tower, south aisle, porch and nave clerestory) are of close-jointed brown/olive sandstone of near-ashlar quality, with ashlar dressings; the medieval parts are of coursed squared or roughly-squared stone, and the roofs of red tiles.

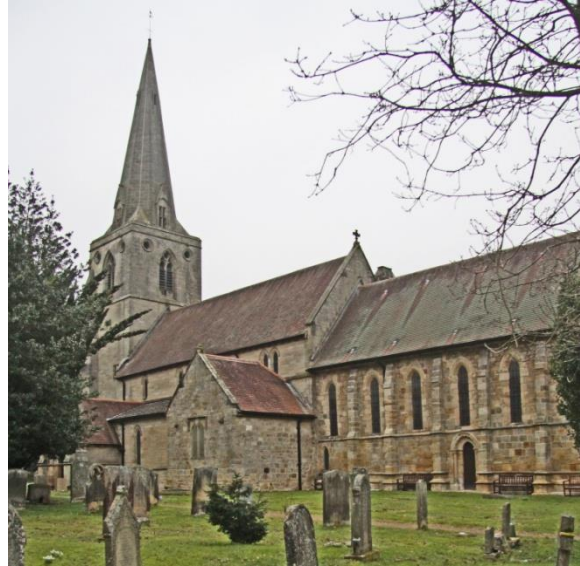
South-east view

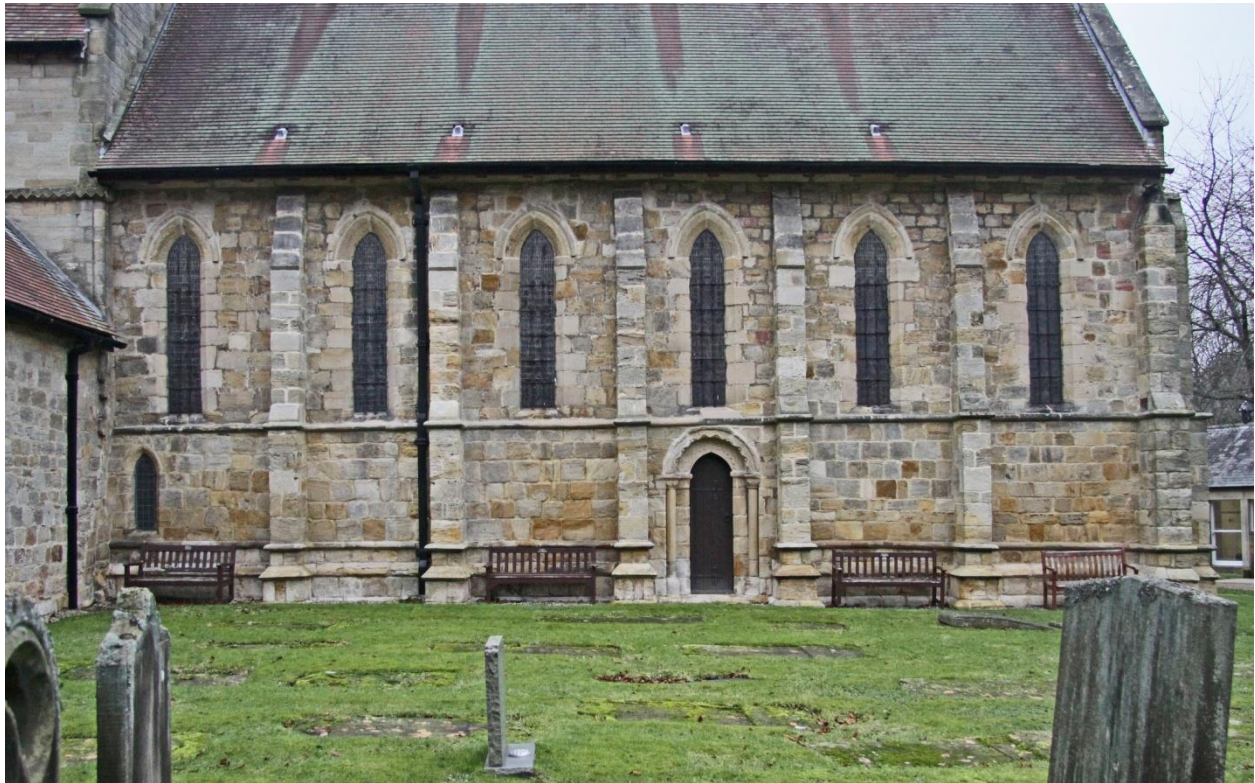
The south elevation of the **Chancel** is constructed of coursed squared blocks, and presents an impressive elevation of six rather irregular bays, articulated by stepped buttresses. There is a three-part plinth (a chamfer at ground level, a bold chamfer at mid height and a moulded string at the top) and a moulded string at the level of the sills of the six lancet windows, as well as an oversailing chamfered course to the eaves. Below the string, set left-of-centre in the westernmost bay, is a low-side window, another lancet, and in the fourth bay a priest's door. This is of two

orders; the inner has a narrow two-centred arch with high-relief chevron, now very worn, and the outer a near-semicircular arch (formed from three stones) with chevron in its angle and leaf motifs; there is also a hoodmould, flush with the wall on one side and projecting on the other – one of several features that make this door look like a re-set piece. The outer order is carried on (renewed) shafts with old scalloped capitals; one block in the east jamb has sharpening grooves that clearly pre-date the reinstatement of the shafts. Above the string the lancets windows have chamfered hoods, all now somewhat eroded.

The chancel from the south

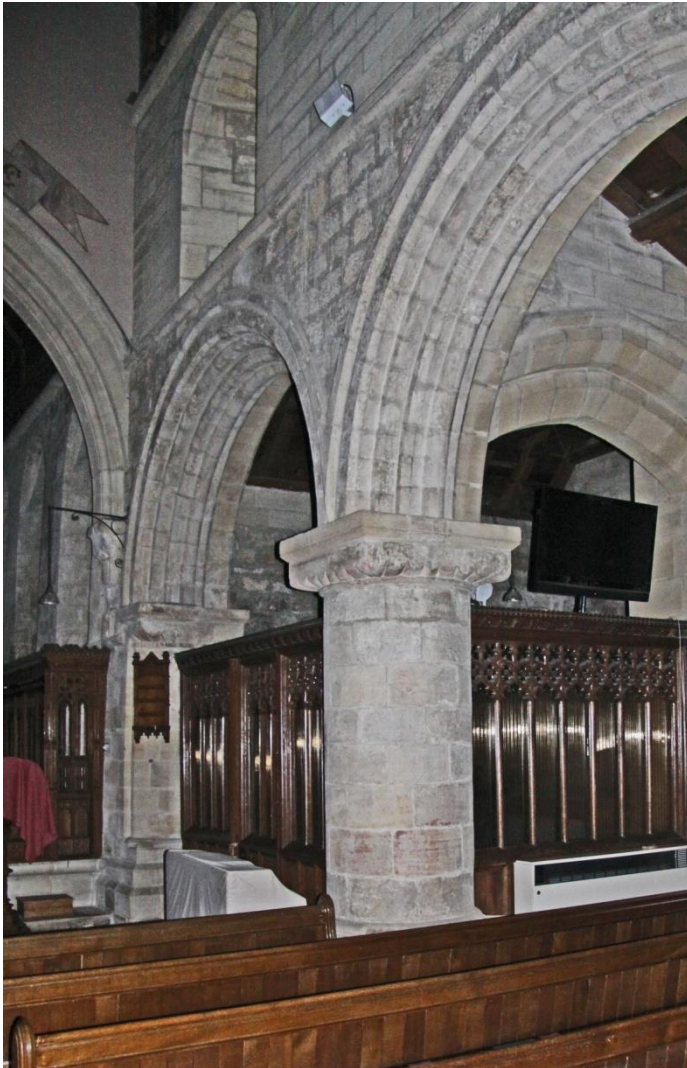
Inside the **Nave** three bays of the south arcade (left) are of 12th century date, and the fourth, westernmost, a copy of 1874-5. They are semicircular in form, and spring from massive circular piers with scalloped capitals, with moulded bases – each with a large leaf set diagonally at each corner – set on stepped and grooved square plinths. The arches are of two orders; the inner has a soffit roll between two chamfers, the outer is moulded towards the nave but simply chamfered towards the aisle. The eastern respond is semi-octagonal, with a billet moulding to the abacus ring; the western respond is copy. Piers and arches show considerably patching, and the regularly-coursed stonework in the spandrels of the arches seems all of 1874-5³. On the north side of the nave the arch into the north transept is of similar form, but looks all restoration, as does its eastern respond, which puzzlingly takes the form of a three-quarter pier, with a scalloped capital. The western respond however is ancient, and has clearly been a full pier,

with a capital that has both scallops and carved foliage on the vertical faces. Nothing remains of any arch springing westwards, which must have been replaced by the present nave wall with its three lancet windows (the rear arches of all three, of the usual type, appear ancient) and the blocked north door, which has a segmental rear arch. 3.6 m west of the respond is the straight joint in the lower part of the wall (also seen externally); this is in approximately the right place to represent the western respond of a second arch to the former north arcade.
