The Church of St Peter and St Paul, Longhoughton

An Archaeological Assessment

February 2014

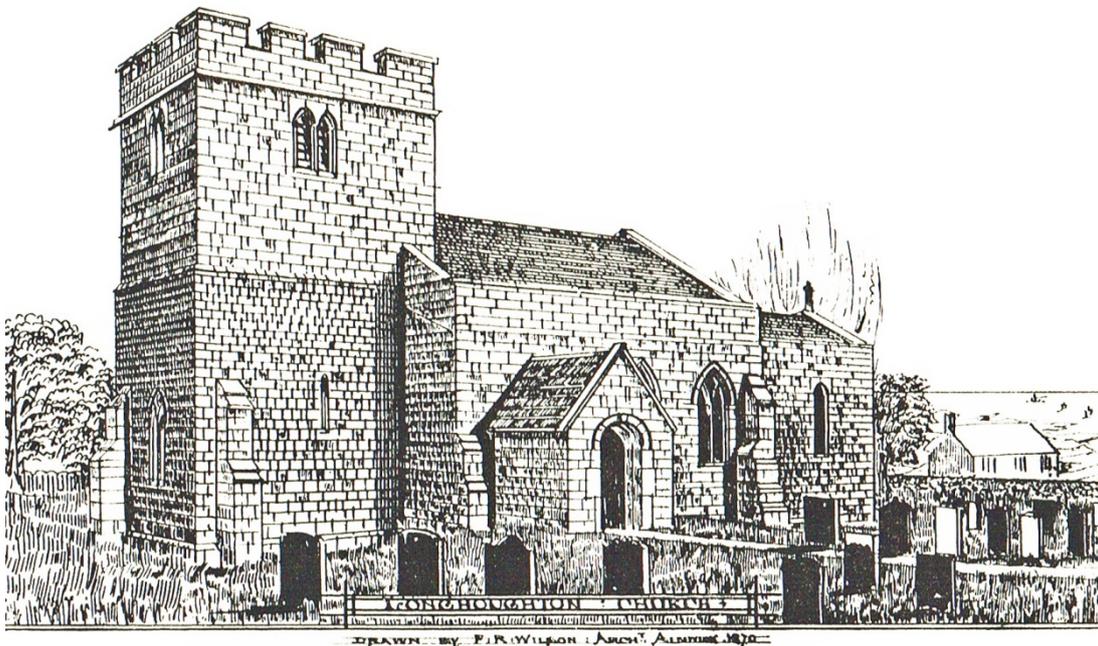
South-west view after F.R. Wilson (1870)

Further changes seem to have taken place around 1840, when in addition to the documented gallery works (p.1) it would seem the building was Gothicised. Wilson's 1870 drawing (see cover) and plan show the result; the drawing (a south-west view) shows that the heightened south aisle remains, but the two windows east of the porch are now Gothic-arched ones of two lights, and there is a similar Gothic window in the west wall of the tower. The plan shows the aisle with its east but no west window, two two-light windows on the north of the nave, a two-light windows in the east and at the west end of the south wall of the chancel wall; the shading implies that all of these were of recent date. A narrow window at the east end of the south wall of the chancel, and a doorway at the west end of the north wall, were shown as medieval features. No gallery or gallery access is shown.

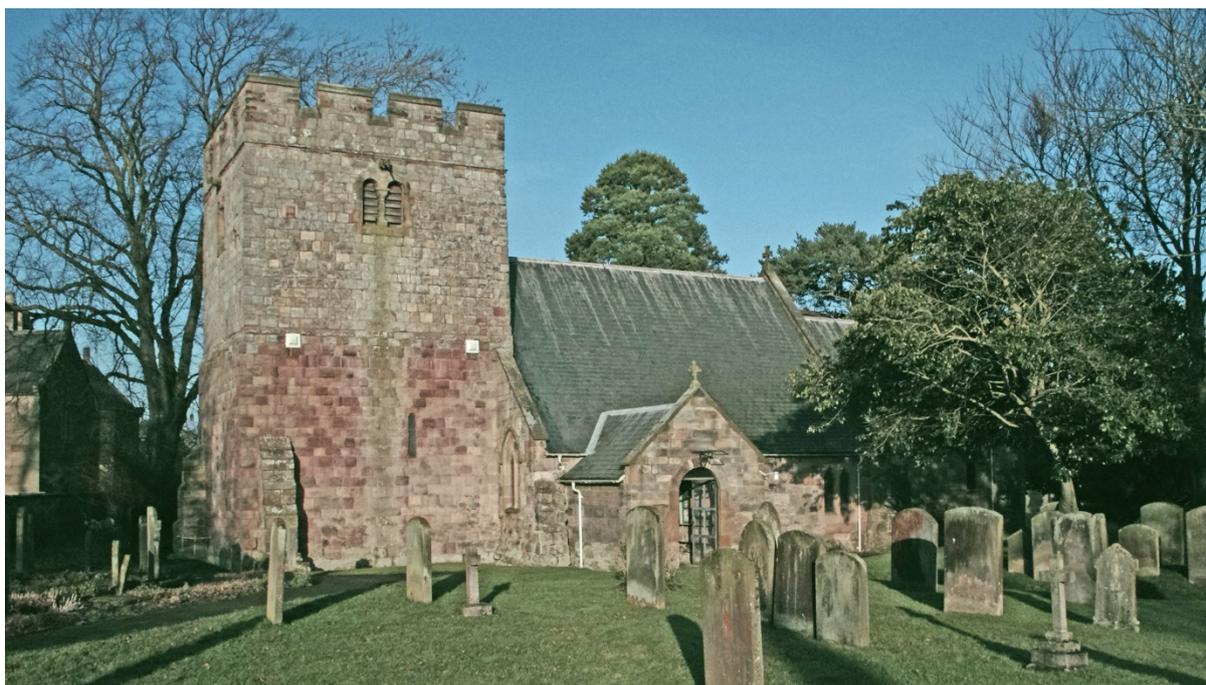
The **West Tower** is relatively massive and squat, and rises in two approximately equal stages, divided by a set-back. The lower stage is of coursed quite square blocks of sandstone, a fabric type characteristic of the 12th century. Most are red in colour (cf Lindisfarne Priory) but there is some variation, perhaps due to different beds in the same quarry. The upper stage is of slightly less regular squared stone, and quite different – more of a grey/fawn in – colour; in addition it has occasional larger blocks used as quoins, although most are simple the height of a single course.

The lower stage has a narrow chamfered plinth, only exposed on the west, again characteristic of 12th century work. Two stepped buttresses of grey stone are clearly secondary, rising only to a height of c 3.5 m. Both have weathered stepped plinths that appear ancient, although their upper parts may have been rebuilt. The west wall has had a window, apparently with an arched head, infilled in grey stone, with its sill c 2m above the ground, although there appears to be a slightly wider disturbed area below, all in red sandstone that may indicate an early door position. Within the infill of the window (which is shown as two-light one on Wilson's 1870 drawing) a narrow single-light one with a round-arched head has been formed³. There are similar single-light windows in both north and south walls at the same level, but these both appear ancient. At the east end of the south wall there is also an odd patch of rubble, low down, and higher in all three walls are infilled putlog holes in both stages of the tower. All three walls also show plates marking the ends of more recent tie-bars, two just below the set-back and two at belfry level.

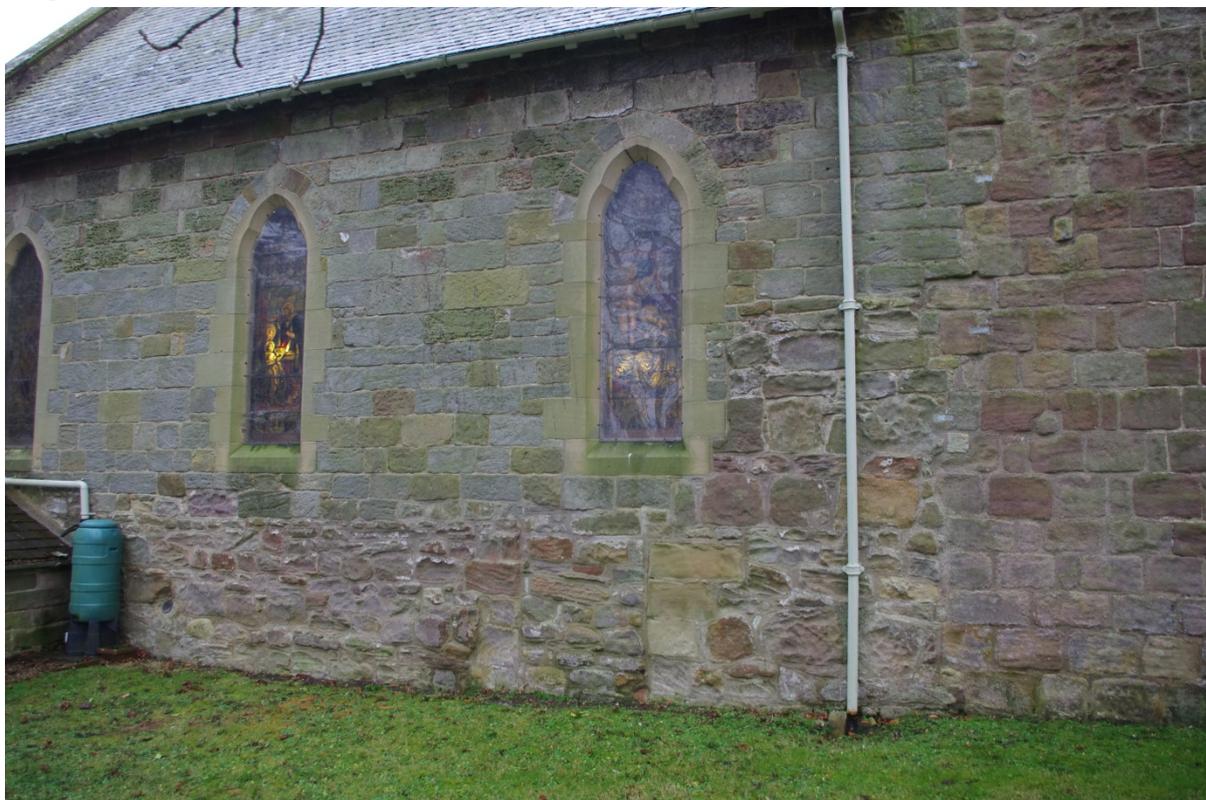
Only the north wall of the **Nave** (above) is exposed externally (along with a little masonry at its south-east corner). The north wall has a variety of fabric types, and its development is difficult to read. The lower c1.5 m of the wall is of coursed rubble, ending to the west in an

irregular straight joint in line with the external east face of the tower. About 2m above ground level is one possible large quoin, then above that an area of coursed close-jointed masonry that continues a little further west; then, c 1m below the nave eaves, comes a straight joint rising c2m, set about 0.30 m west of the external east face of the tower, with an L-shaped block at its bottom. The set-back at the top of the first stage of the tower ends at this joint, and is not continued around the north-east angle.

About 2m from the west end of the nave are the lower jambs of a blocked doorway, made up of quite large but irregular blocks, with nothing to give a clue to its date; it is not clear whether it is an insertion. The upper wall is largely of well-squared blue/brown stone, the courses varying in height; this all seems to be fabric of 1873 and the three windows appear to be contemporary with it. They are trefoiled lancets, with surrounds of diagonally-tooled yellow sandstone ashlar, with relieving arches of roughly-shaped voussoirs to their heads. At the east end of the wall, above the boiler room, is an upstanding area of older less regular masonry.

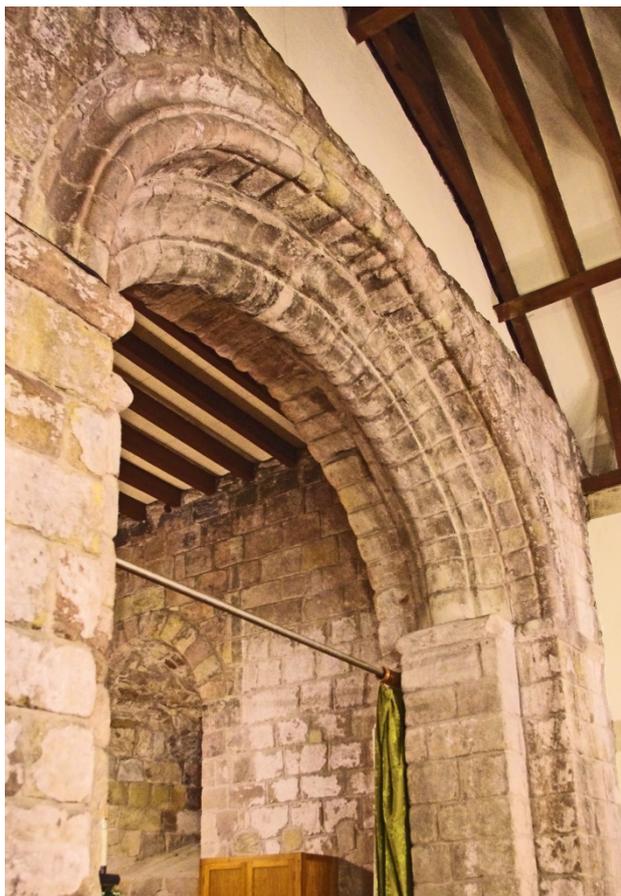
The large and impressive arch into the **Tower** (right) is set on jambs of simple stepped plan⁵ below an impost band, which is chamfered on its lower edge, and extends the full width of the west end of the nave (its northern section having been somewhat hacked back). The semicircular arch is of two orders, the inner with a big half-roll to its soffit, between broad hollow chamfers, the outer square towards the tower but towards the nave, having an angle roll and a deep hollow. c30cm above the top of the arch is a deep off-set, with the gable wall above that being plastered⁶. Towards the nave the dressings of the arch show remnants of plaster, and also of possible wall paintings –see the yellow colouration on the upper parts of the south jamb.

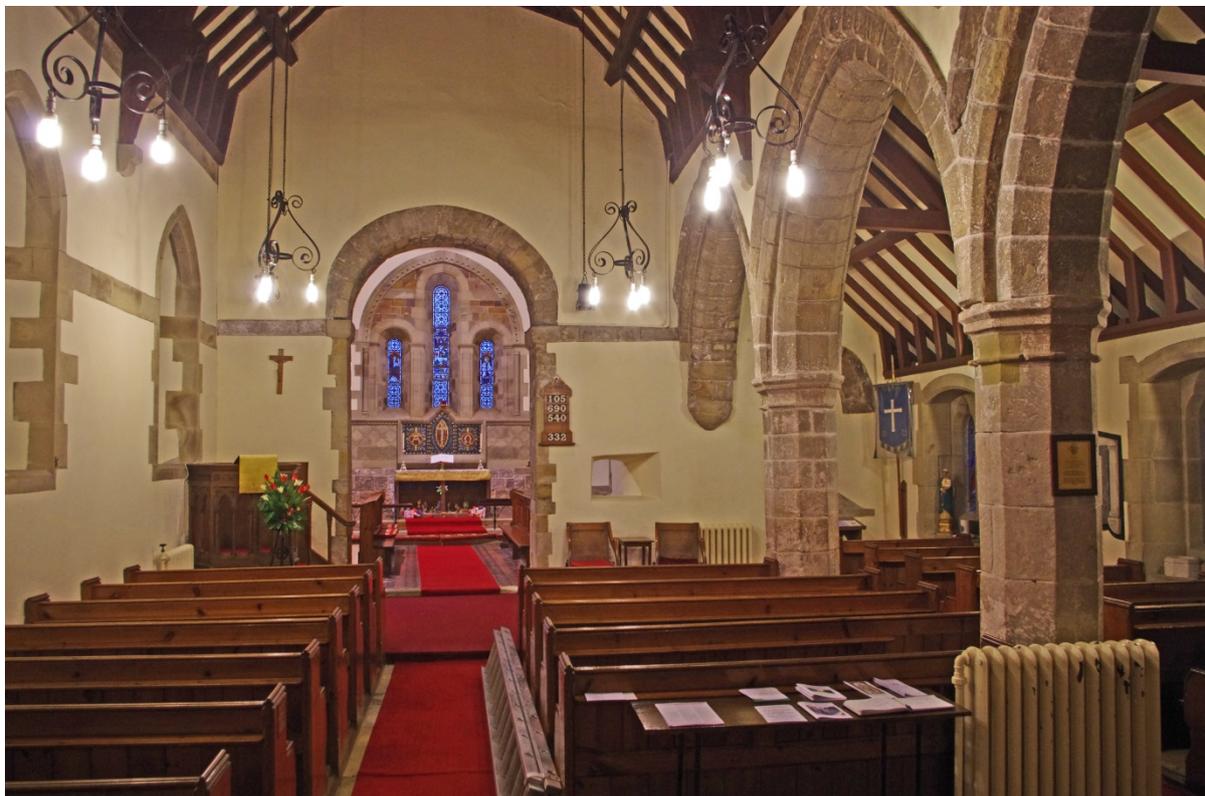
Interior looking east

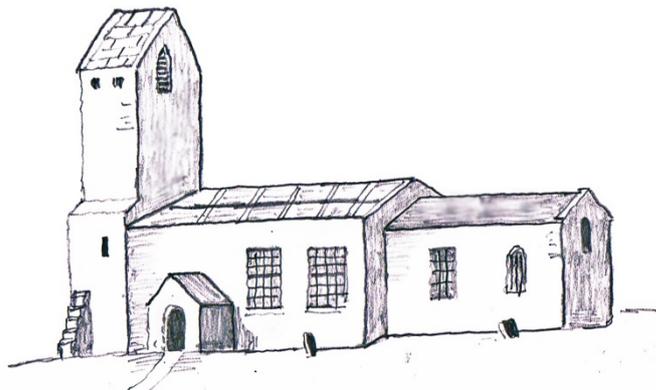
Unfortunately the upper stage of the tower seems to retain no datable features. The only evidence we have of its medieval or early post-medieval form is Davison's print of 1825¹⁰, which shows quite an extraordinary structure, a tower considerably higher than at present, topped by an east-west gabled roof of stone flags, with a pair of low square-headed openings below the eaves on the south, and a larger one in the eastward-facing gable. The 1567 reference (see p.1) makes it clear that the church tower at this date was seen as a defensible refuge, which goes some way to explaining the stranger appearance of the

Sketch after Davison's 1825 print

This brings us to the Davison's 1825 print which shows this new roof (apparently leaded) and two big square-headed sash windows in the south wall of the aisle. A smaller sash is set near the west end of the south wall of the chancel and an arched window further east, whilst the east window seems to be a small one set high in the wall, but it is not clear if the illustration can be relied on as regards detail – for instance the ancient stepped buttress near the south-west corner of the tower is shown, but those supporting the aisle are omitted.

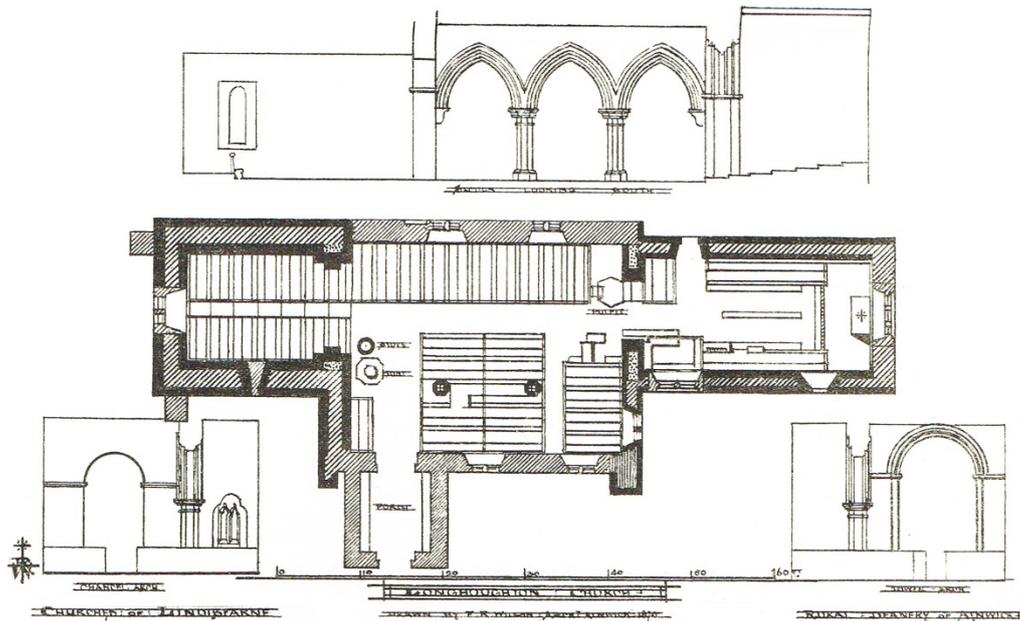
Plan after Wilson (1870)
