St Andrew's Church, Hartburn

Analysis of the Fabric and Archaeological Assessment

March 2001

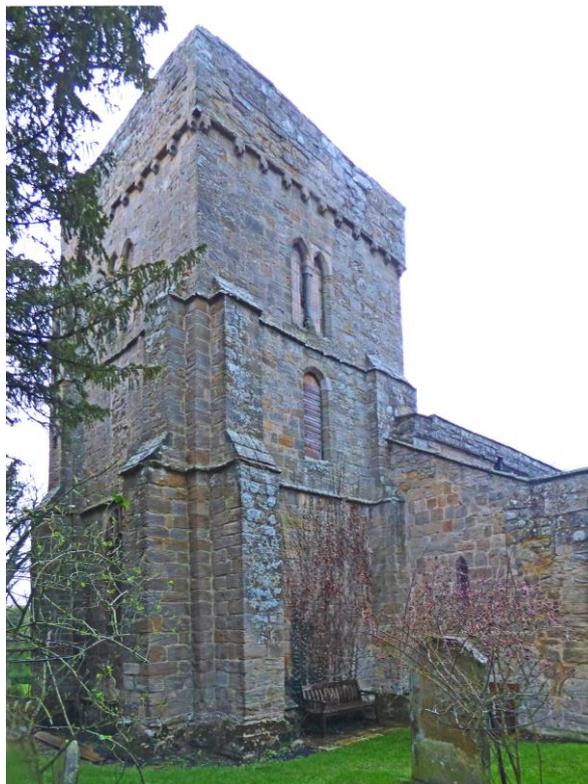
The only external opening to the lower stage of the tower is the west window, which is clearly an insertion. This is of three trefoil-headed lights with trefoiled sub-lights above, within a four-centred arch, the whole head being cut in a single rectangular block of gritstone, a good example of the Northumberland tradition of monolithic traceried window heads (eg Felton, east end of south aisle). The second stage has a single-light openings with distorted semi-circular heads, those on the north and west are now blocked. The belfry has pairs of lancets to north, south and west with chamfered surrounds, divide by octagonal shafts with worn square moulded capitals; it is recorded that the heads of these were renewed in 1843 (Donnelly 24). On the east the tabling of the 13th-century (?) steep-pitched nave roof extends up to the base of the parapet.

The tall parapet has a plain square-edged coping, without any embrasures.

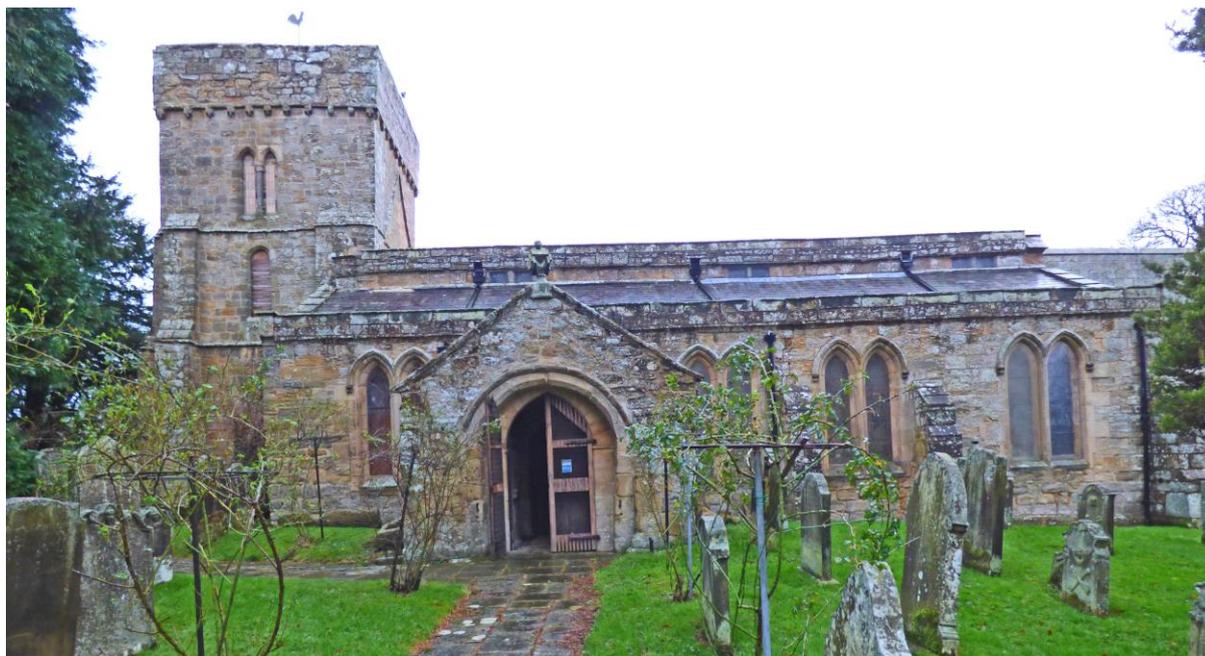
The **South Aisle** (below, seen from south) is constructed of coursed squared stone including some quite large blocks. At the west end of the aisle is quite a small chamfered lancet, with two earlier roof-lines clearly visible above it. The south-west angle of the aisle may have been rebuilt, and includes some elongate blocks that could be re-used grave covers.

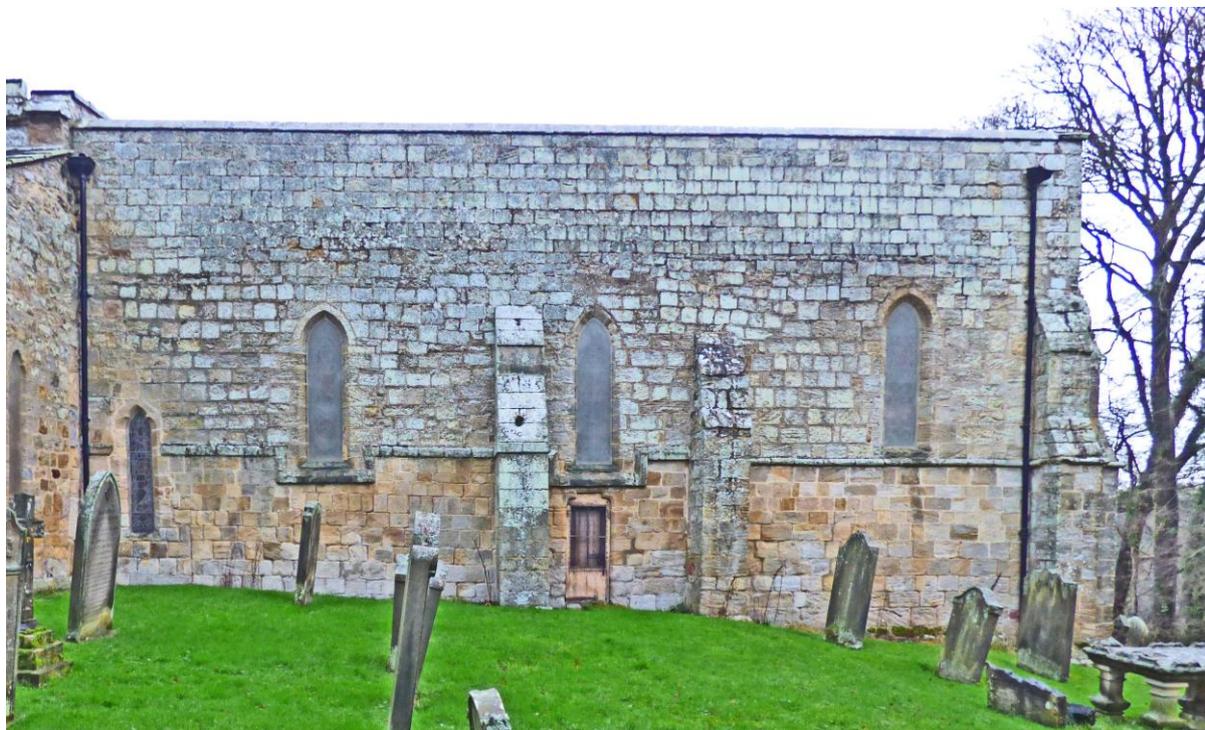
The south wall of the **Chancel** (below) is of squared coursed stone, and is divided by buttresses into three very irregular bays, the short central bay containing the priest's door. The masonry of the long western bay, and perhaps of the central bay as well, includes many almost square or even 'upright' stones, but the east bay has more elongate blocks. Above the heads of the buttresses the whole upper section of the wall is of more-regular masonry (perhaps in two phases), and is topped by a plain square-edged parapet.

At the west end of the western bay is a low-side window with a rather unusual trefoiled head. This is obviously an insertion, set within the blocking of an earlier priest's door; the lower part of the east jamb of which remains visible as an obvious straight joint. The low-side window cuts through quite a heavy string course, which is stepped down beneath the sill of a lancet window further east; in parts the string is chamfered on its lower angle, but in the dropped section below the lancet this angle is left square. The lancet has a chamfered surround; its head is clearly of 19th-century date; Hodgson's 1828 print shows the opening as then having a plain square head.

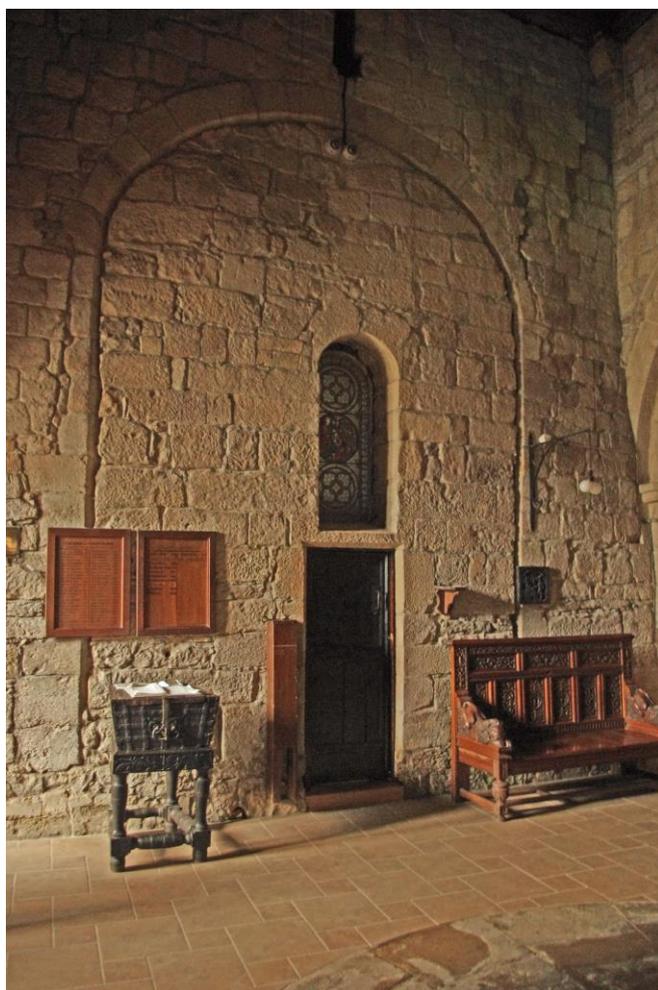
At the west end of the nave the **Tower arch** (left) is roughly semicircular, and appears to be of a single chamfered order, without any imposts; its dressings, in particular those of the jambs, looks very much to be insertions in an earlier wall. From measuring the distance between the jambs on the east face of the wall, and that between the side walls of the basement on the west face, it would appear that an inner order may be concealed in the blocking. At its apex the arch appears to cut through the lower part of a blocked doorway²; the slightly-pointed head of this is clear, but its jambs less so; in the blocking is a rough square-headed loop. The tower arch itself is blocked by walling comprising quite large blocks, coursed in a slightly irregular manner; set slightly north of centre is a square-headed doorway with a chamfered surround (holding an 18th-century two-panel door), with directly above it, with its sill cutting into the doorway lintel, a window with a round-arched head of plain square section, cut into two blocks.

A row of infilled sockets runs across the blocking of the arch, at the level of the springing of the head of the window; these must relate to a former western gallery.

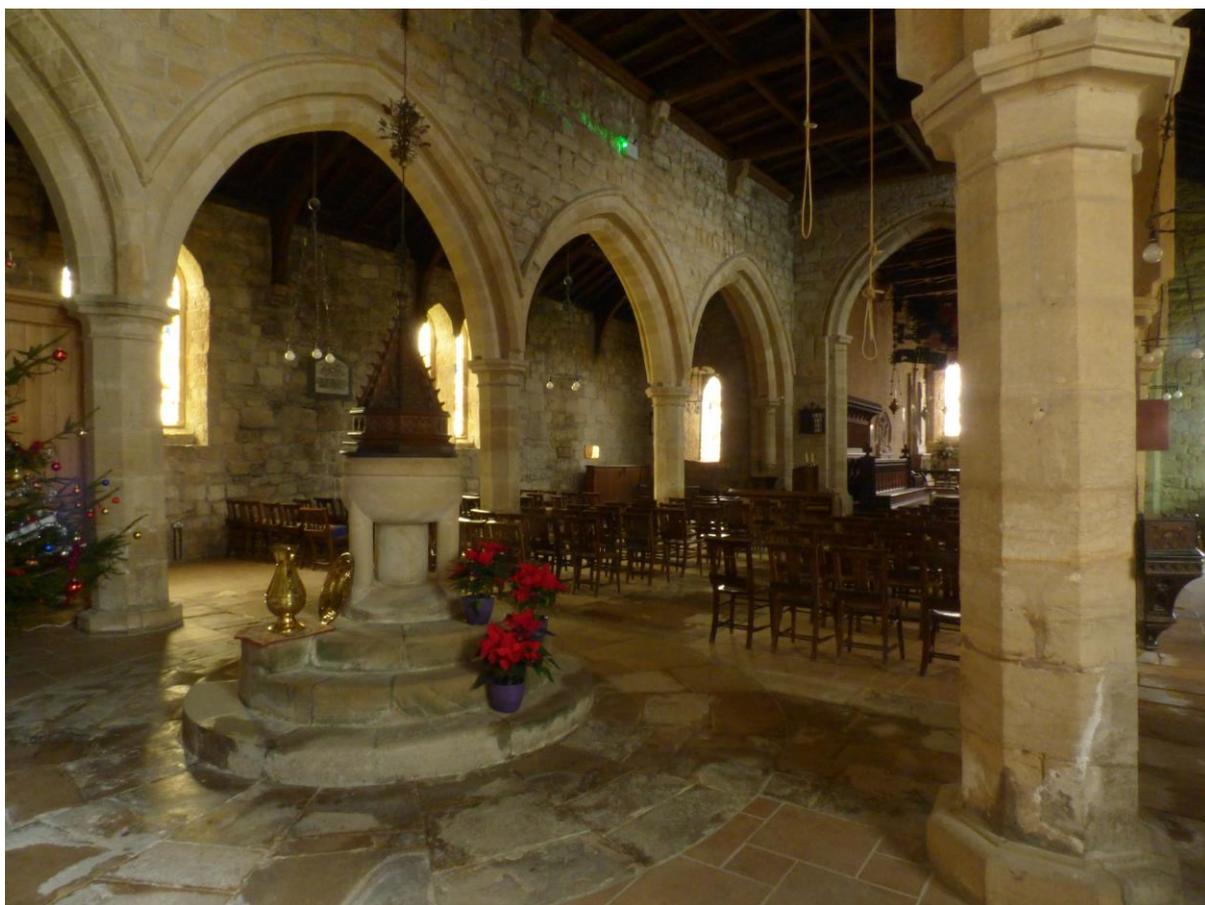
The nave, looking north-east

The side walls of the **Nave**, above the arcades, are of coursed squared stone. The relationship between the walls and the arcades is curious, and several points need to be described before any consideration of the architectural detail of the latter.

The arcades are each of four two-centred arches, each of two chamfered orders with a hoodmould chamfered above and below, with stops above the piers in the forms of varying Romanesque-style animal masks, some damaged; all the piers (some of which now lean in a rather disturbing manner) are octagonal and all the responds semicircular shafts carried on moulded corbels, carrying the inner orders only. Piers and responds have fairly simple octagonal and semi-octagonal moulded capitals and the piers moulded octagonal bases; some variation in section may be the result of re-cutting and repair.

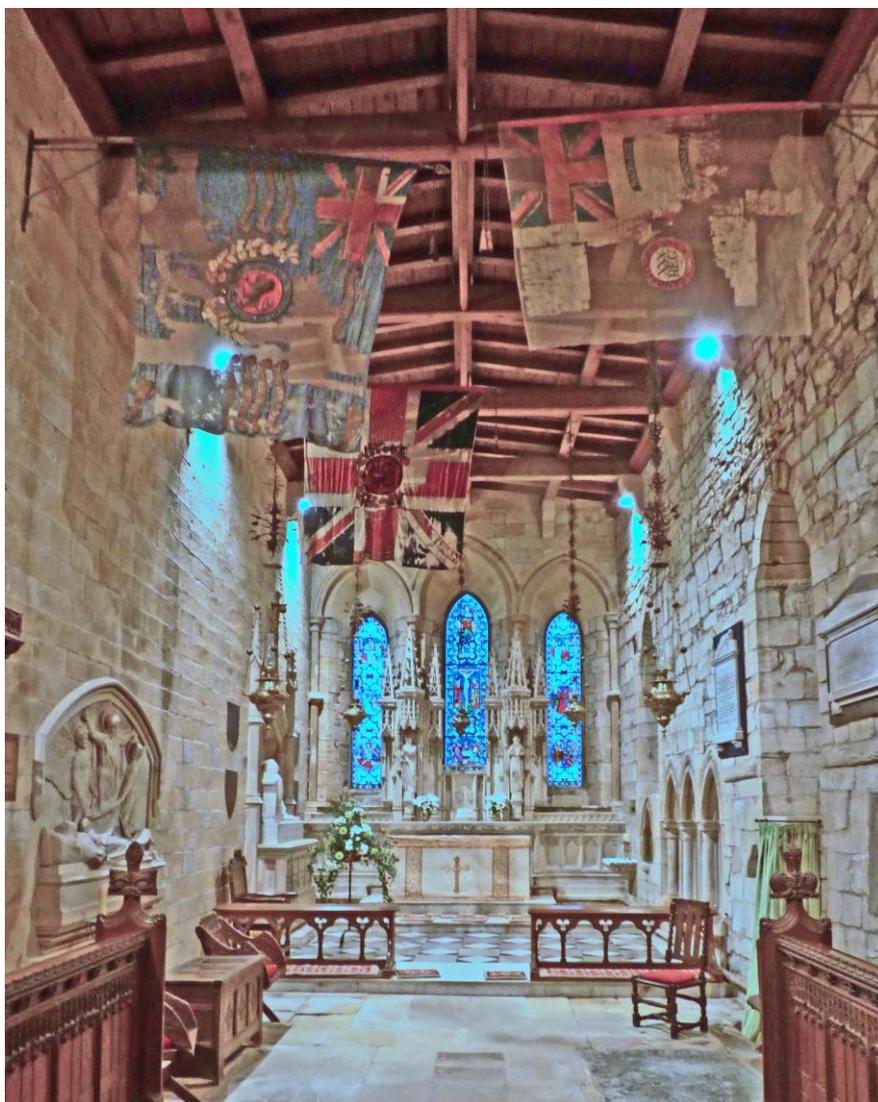
The **Chancel** (right) is entered under a broad two-centred arch; the wall above shows some areas of disturbance, and possible traces of a steeply-pitched roof with its eaves at around the level of the tops of the arcade arches. The chamfered inner order of the arch is carried of semi-octagonal responds with moulded capitals quite like those of the arcades; the outer, with a big keeled roll moulding between hollows, has been carried on jamb shafts, all now missing. Towards the nave the whole angle of the southern respond has been hacked back, whilst the northern only retains the base of its shaft; towards the chancel the bases and capitals of the shafts remain, at least in part. On the east face of the wall there is marked set-back in the wall at the level of the respond capitals; the walling

above the arch is of quite rough small masonry, with the lines of two low-pitched roofs, one just trimming the apex of the arch and the second a little below the present roof.

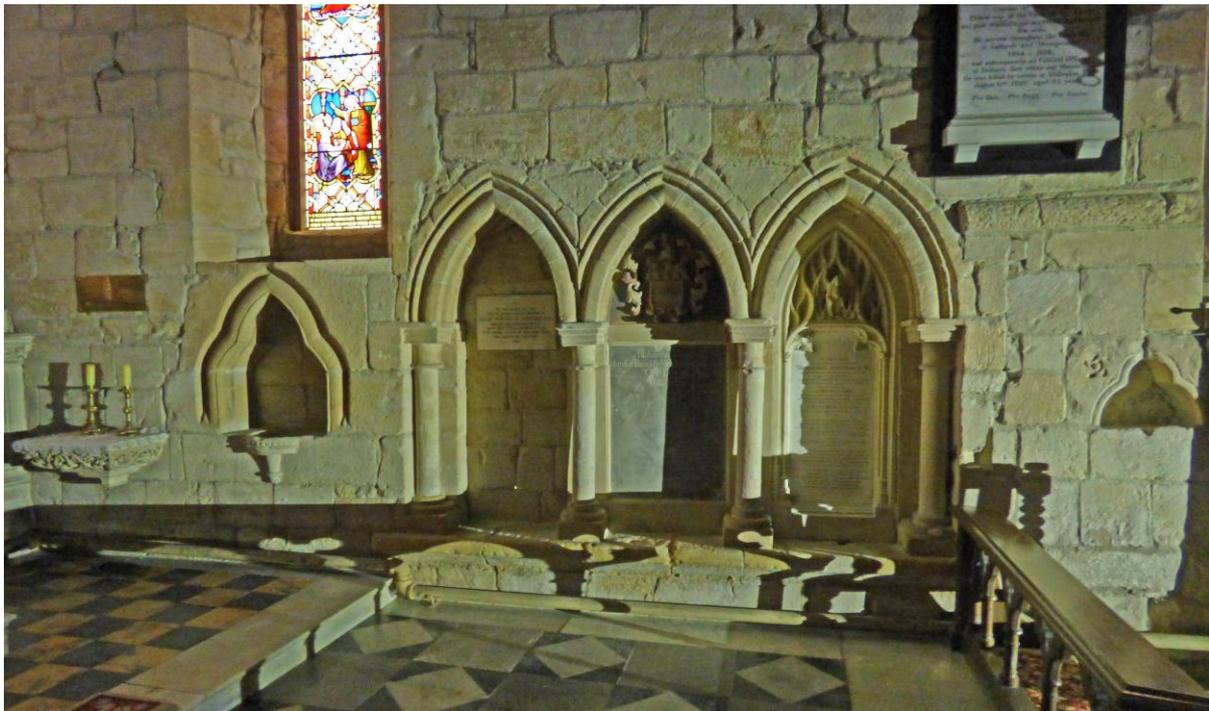
Piscinae and sedilia on south of chancel

The south wall of the chancel contains a variety of features and changes in fabric type. Over its whole length there are three clear vertical divisions, the medieval masonry, quite large coursed squared stone, up to the level of the heads of the lancet windows, then a series of thinner courses, and finally a metre or so of larger better-squared stone again, below the eaves. The chancel stalls and various wall monuments combine to obscure quite large areas of the wall. At the west end is the low side window, with a segmental rear arch largely cut from one slab; the upper sections of its jambs (and head) are roughly tooled, and are probably later than the smoother lower jambs. The sill is level. The walling above is of coursed almost square blocks, of 12th-century character. A metre or so above the rear arch of the low side are a series of infilled sockets, which continue beyond the first of the full-height lancets. This has a trefoiled rear arch, but the ashlar dressings of its head are clearly of 19th-century date. Its sill cuts down through a string-course (also interrupted by the low-side) which is of roughly semicircular profile, but is much damaged. The sill continues eastward until similarly interrupted by the second full-height lancet, which has the priest's door directly below it. Both jambs of the doorway appear to be insertions; c 15 cm to the west are two chamfered blocks that may indicate an earlier splayed jamb. The internal head of the doorway, which is chamfered, is formed by an ashlar block that looks to be of 19th-century date. The dressings and shouldered rear arch of the lancet above look wholly medieval, although there is a slight change in the angle of the splayed jambs, suggesting that a window with a slightly narrower external openings has been modified at some time. Immediately to the east of the doorway is a piscina with a roll-moulded trefoiled arch; the sill simply has a narrow drain crossing it, at right angles to the wall, suggesting that a projecting bowl must have been cut away, although no other sign of this is visible. The large block forming the head of the piscina seems to have been truncated at its west end when the doorway was inserted; at its east end is a carved roundel surrounded by spiral panels, now badly weathered.

Immediately east of the piscina is a ragged vertical break in the fabric, which corresponds with the end of the final short length of string course above. Beyond this are the rather fine triple sedilia, with two-centred arches moulded with a big keeled roll flanked by hollows, with detached circular shafts with square capitals and moulded bases; the projecting sill is chamfered on its lower edge. Above the sedilia is an area of walling of large rectangular blocks that may be some sort of patch or infill; there is a ragged joint between it and the dressings of the western jamb of the easternmost lancet (again with a trefoiled rear arch), which seems contemporary with the easternmost section of wall, which is of well-squared coursed blocks, mostly quite elongate in shape in contrast to the squarer stones of the western section of wall. To the east of the lancet is a piscina with a trefoiled arch moulded with a filleted roll, and a projecting moulded bowl ornamented with a line of nail-head.

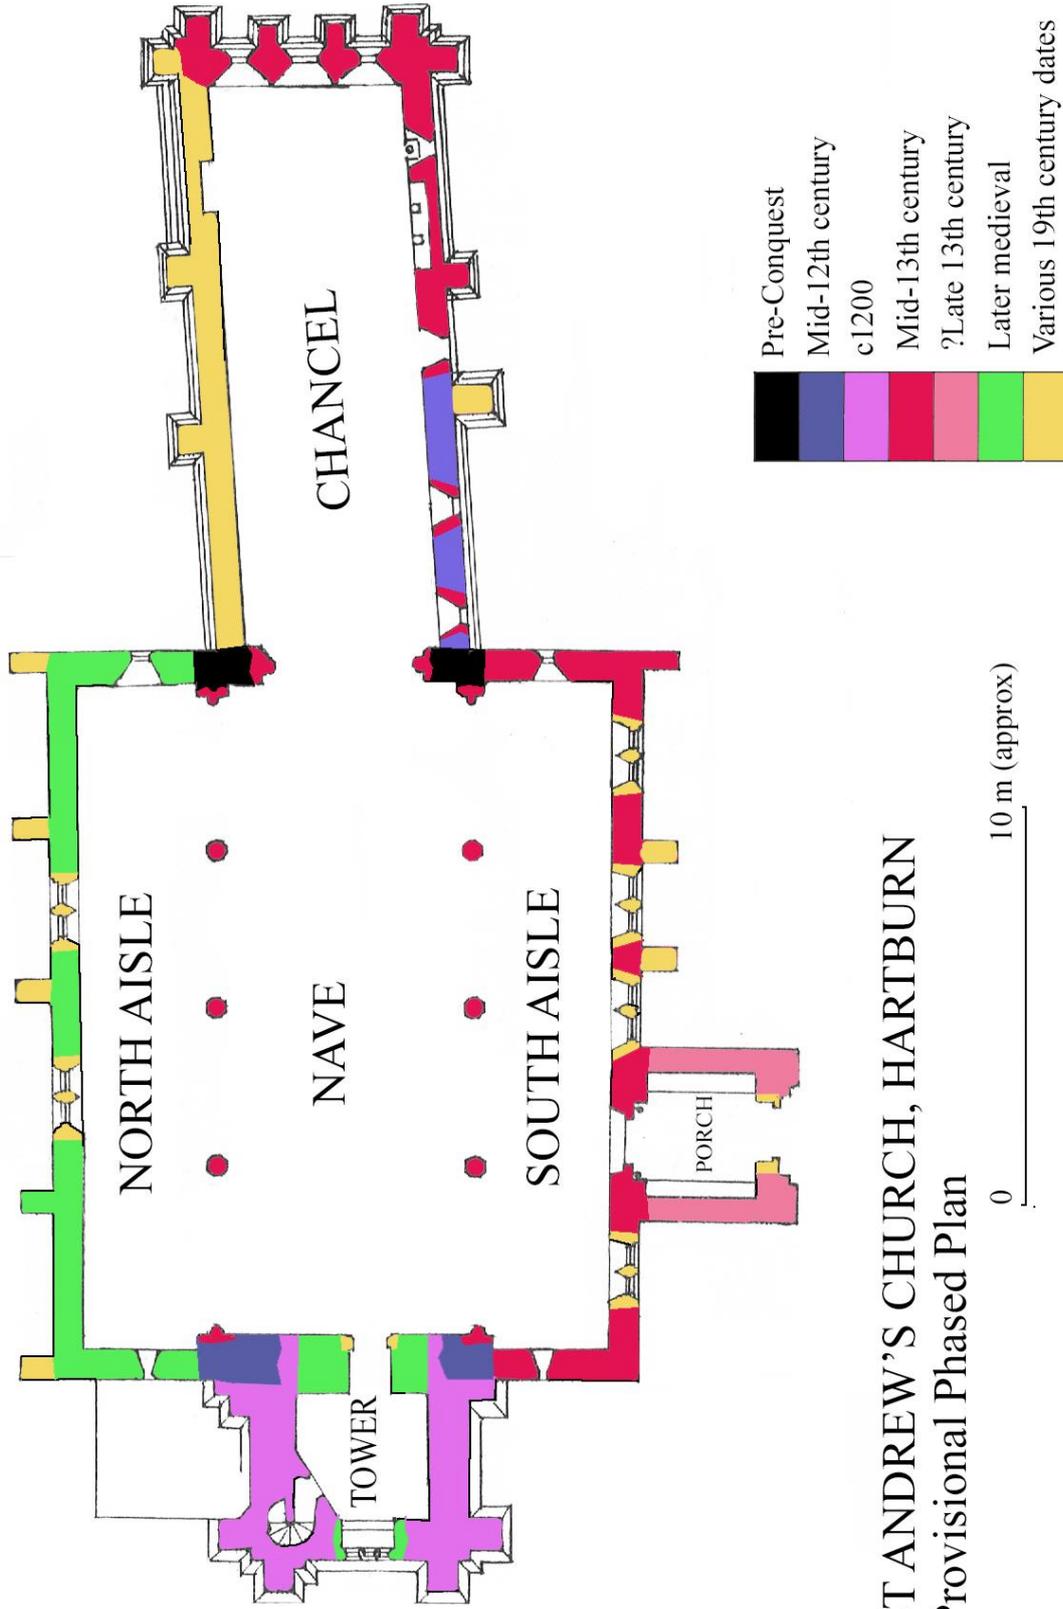
ST ANDREW'S CHURCH, HARTBURN
 Provisional Phased Plan

From a plan by F R Wilson (1870) amended PFR
