St Peter's Church Bywell Northumberland

An Archaeological Assessment

March 2007

Peter F Ryder
Historic Buildings Consultant

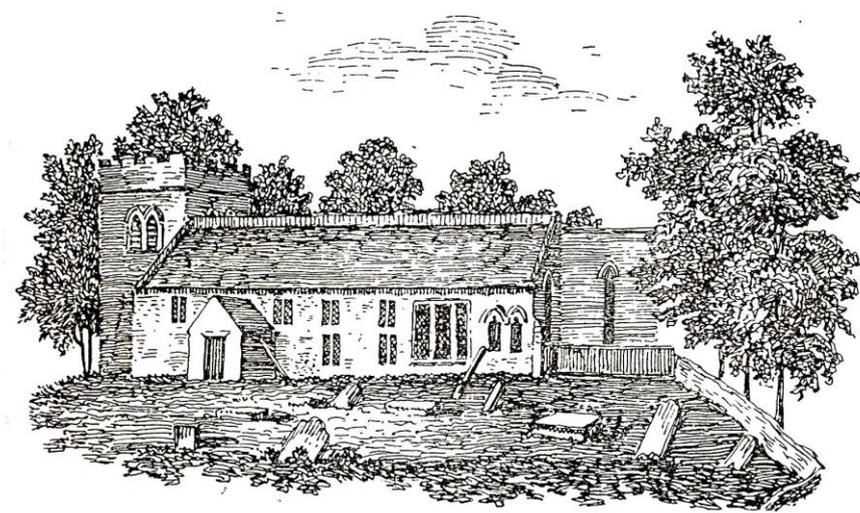
BYWELL ST. PETER'S CHURCH IN 1824.

Other later medieval and post-medieval changes were clearly erased by the rather brutal restoration which the church underwent in 1849. An 1824 print (NCH) shows the aisle before this; its western part has a series of two-light mullioned windows at two levels, presumably lighting a gallery that could be readily be accommodated beneath the tall arcade, but further east was a tall three-light window and then one of two trefoil-headed lights, mentioned by Glynne (who dismisses the other windows in the wall as 'modern'); he also mentions a 'small window, perhaps Decorated, of two lights' at the east end of the aisle, of which the outer jambs still remain. At some time the North-East Chapel had become the village school, with the arch by which it opened to the nave being walled off.

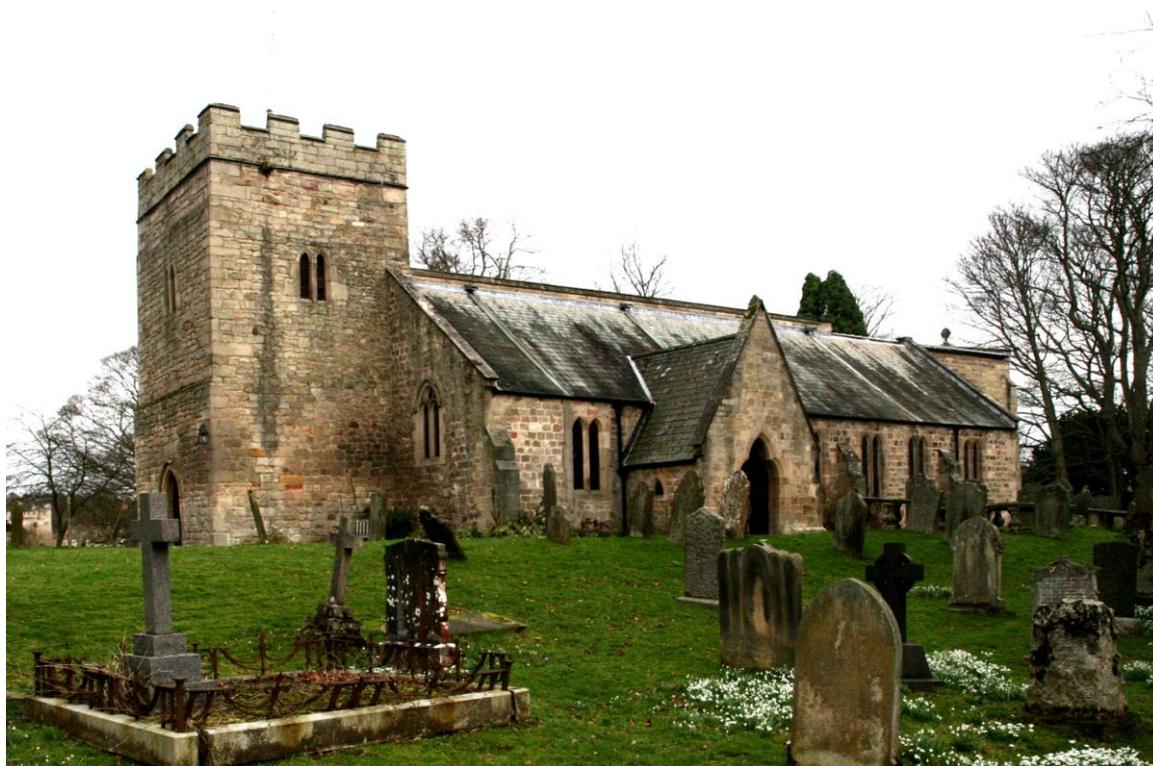
The church from the south-west

The West Tower is built of coursed roughly-squared stone, the stones varying in height, with fairly well squared but irregular quoins at the western angles. There are two chamfered offsets on the west side of the tower, one at about half height and the second a metre or so below the embattled parapet, carried on a hollow-chamfered string course, which has a moulded coping. The southern part of the west wall has what appears to be a projecting footing c 1.5 m long at its south end.; this is in fact the lowermost course of an earlier wall, and has, now concealed beneath gravel, a chamfered plinth. The earlier wall is set on a slightly different alignment to the present one, so that at the north end the present wall face overhangs the plinth.

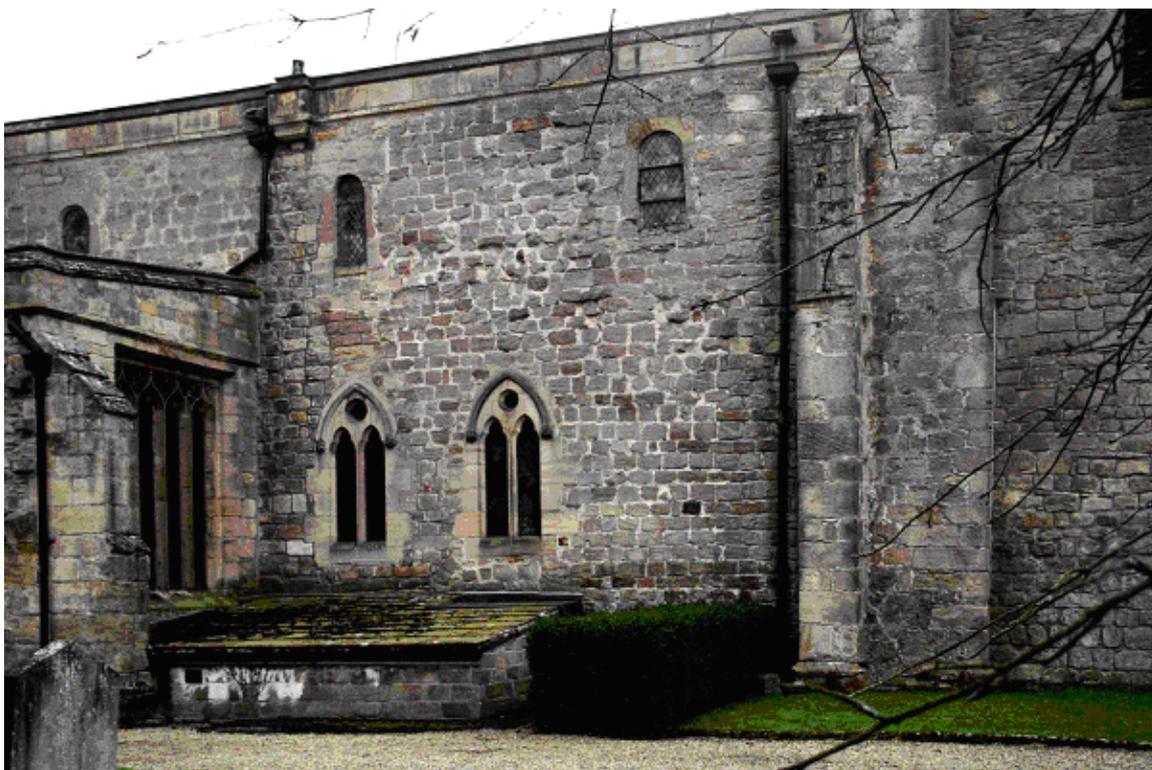
The North Wall of the Nave (West Part) showing early windows at high level

hood with foliate stops. In the upper section of the wall are a range of four round-headed single-light windows, two above the North East Chapel and two further west. The westernmost is the broadest of the four, and its head looks relatively freshly cut; there is one big upright gritstone block that seems old in the west jamb (although this does not relate well to the adjacent masonry) and the sill again looks patched up and untrustworthy. The next window has its head cut into the soffit of a very large gritstone block (perhaps a re-used Roman slab; it has what looks like the remains of a lewis hole?); each jamb has a big upright block of red sandstone, curving in at the top to join the head. Below these the lower jambs and sill look more recent. Above and to the east of this window the 19th-century parapet is corbelled out into what looks like a chimney stack. The third round-headed window again has its head cut into a big block, which this time extends some distance further east; the jambs again have large upright blocks, and this time the whole opening looks convincingly ancient, as does the easternmost window. Close to the east end of the wall and just below the parapet is a block c 2 m in length, difficult to make sense of unless it was the lintel of a further opening, although there is no other visible evidence of this.

The surviving Saxon parts of the fabric comprise the north wall of the nave with its high-level round-headed windows (although the westernmost seems to have been altered), the eastern angles of the nave and the side walls of the western part of the chancel. The blocked door on the north of the chancel opened into a porticus, the roof-line of which survives, indicating that it was lapped around the north-east corner of the nave. The roof-line of a corresponding porticus is also clear on the south wall of the chancel (now inside the organ chamber)⁶ and it seems likely that the ‘low-side’ window is a modification of an earlier doorway corresponding to that opposite.

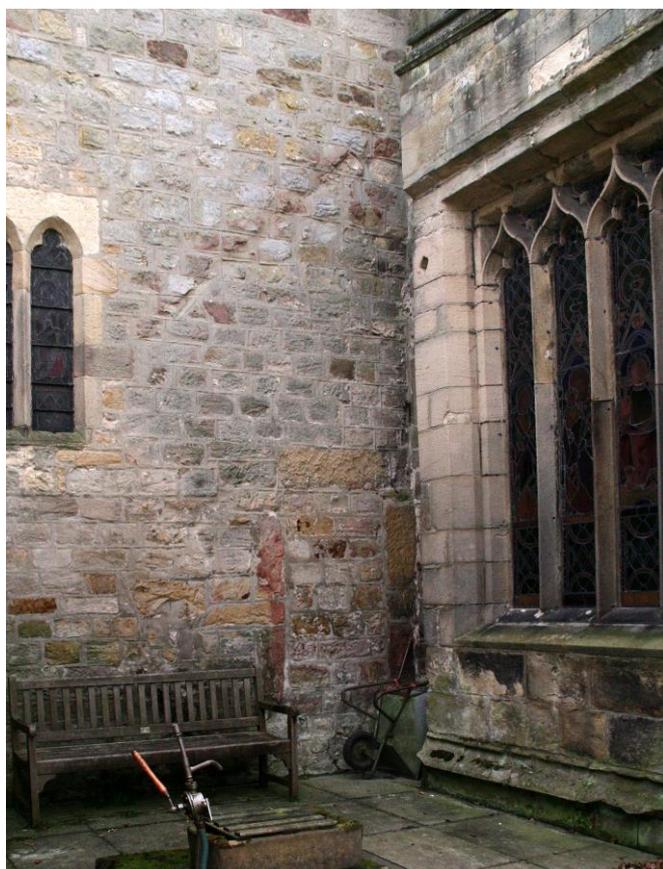
The western part of the north wall of the chancel, to the west of the vestry, (left) is one of the most interesting parts of the church, being largely of Saxon date. It has no above-ground plinth³ and is constructed of coursed fairly well squared stone. At its west end is a blocked square-headed doorway, with its sill apparently c 0.3 m above the present ground level. Each jamb is made up of two big uprights with a horizontal block between, the dressings being roughly-tooled yellow gritstone. There is a second horizontal block at the head of east jamb, carrying a lintel that barely overlaps jambs. The jambs show considerable evidence of burning. A disturbed area of masonry c 1 m east of the doorway and extending up to c 1.5 m above the ground may indicate the position of the east wall of the porticus into which the doorway opened; its gabled roof line is very clear, cut into the walling stones and emphasised by

reddening, as if the roof was burned. Further east and set quite high is a medieval window of two trefoil-headed lights, their heads cut into a re-used medieval cross slab grave cover of whitish stone (Ryder 2000, 59, 10).

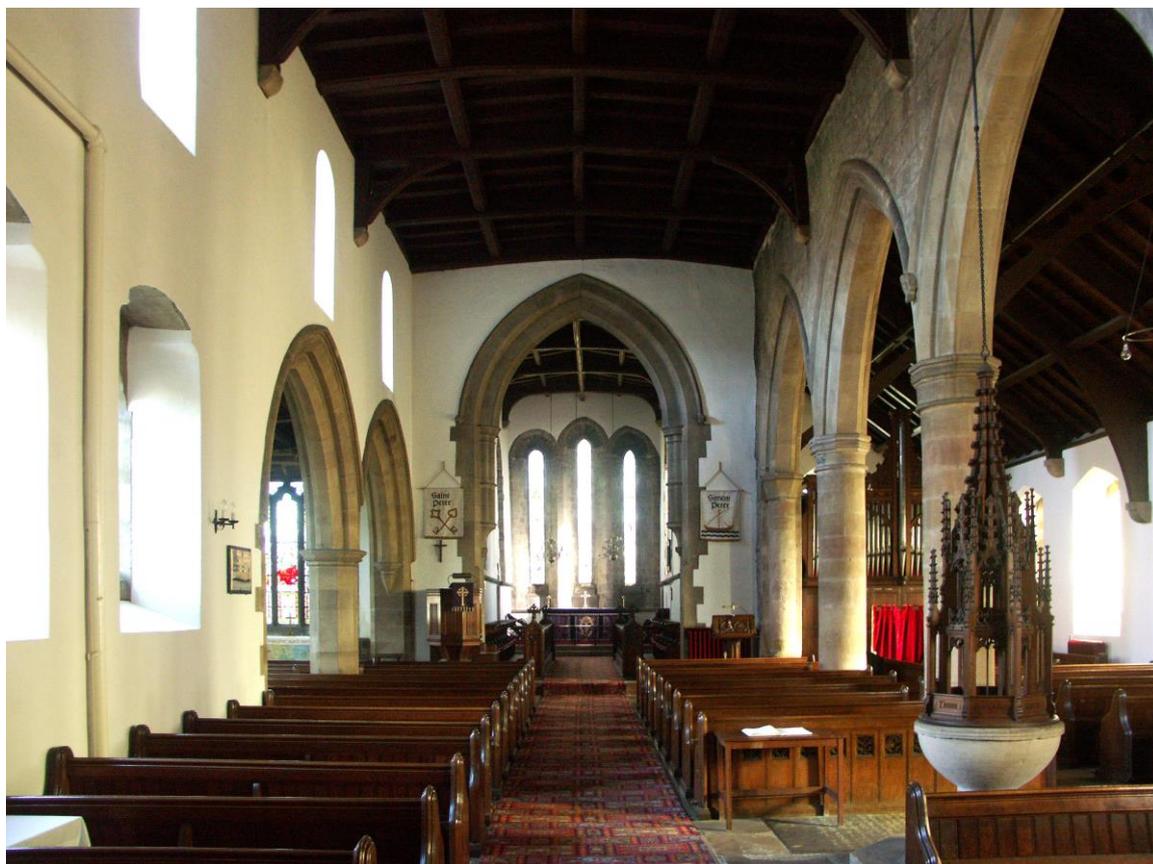
Interior looking east

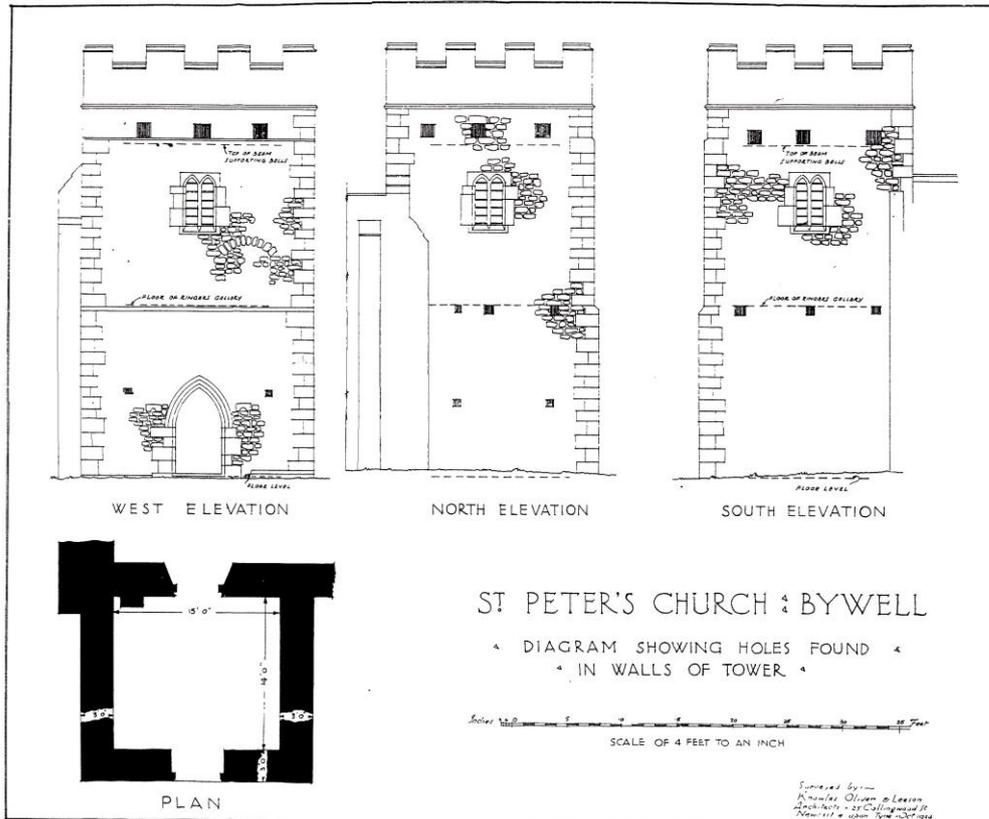
1924 drawings of tower showing features revealed during repair work

^{1 1} These were discovered during repairs in 1924, and are shown in 'diagram showing holes found in walls of the tower' drawn by Knowles, Oliver & Leeson, architects (Woodhorn Northumberland Museum Archives ref EP 45/83) where a suggested function was 'defence or observation'.

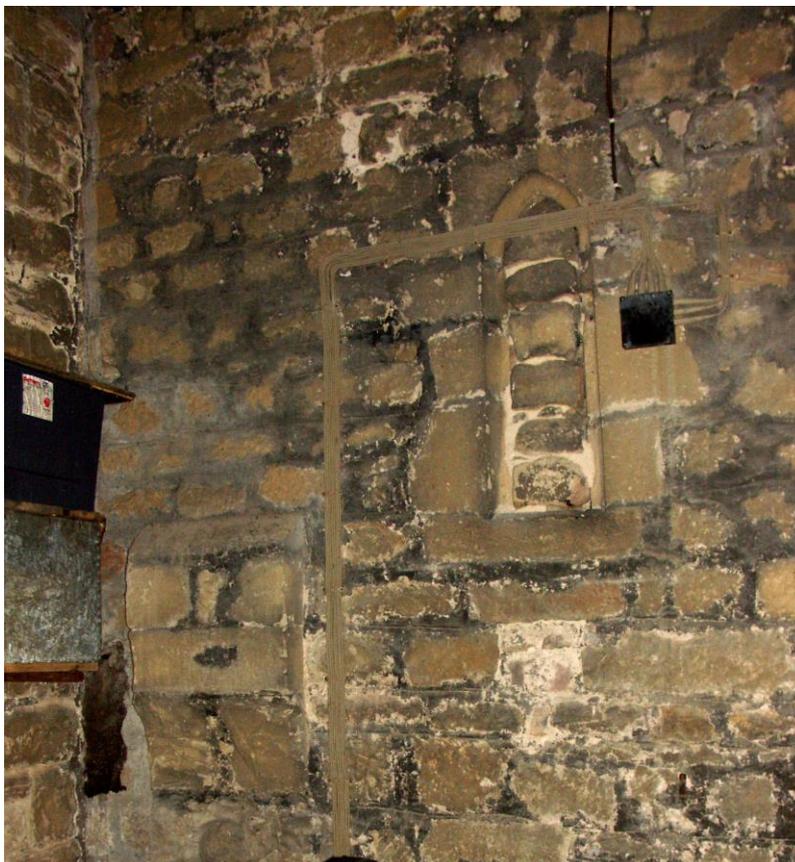
Upper stage of tower, east wall, previously west end of church as remodelled c1285) showing lancet window with ? 'quenching hole' beneath and, to left, remains of upper section of buttress

On the east at this level is a blocked lancet window in the earlier west end of the nave, with a hollow-chamfered surround, with what looks like a small infilled rectangular opening directly below it⁴. To the north is the upper part of the buttress seen below, its sloping top, c 2 m above the floor, intact, but the section below heavily cut back. Just short of the south-east corner disturbed masonry marks the position of a second buttress (of the same height), with a socket cut into it c 1 m above the floor.

The Lanercost Chronicle records that the church suffered a serious accidental fire in 1285, which several writers have correlated with the truncation of the west end of the nave¹⁰. Although the NCH account seems to date the present south aisle to the earlier 13th century, its arcade fits so well with the present shortened nave that it is easier to see it as part of the same scheme of works. Several writers (eg Briggs 2002, 30) have pointed out the similarity between the arcade and those at nearby Ovingham. The new west end constructed is something of a puzzle in its asymmetrical arrangement of buttresses, only its doorway being central. The small size of the west window, and the apparent provision of an opening below –

possibly a ‘quenching hole’¹¹ - suggest that the threat of Scots raiding was already in mind. The eastern bay of the aisle continued alongside the chancel; it is not clear whether this was part of the 13th-century work or a later addition; it is thought that

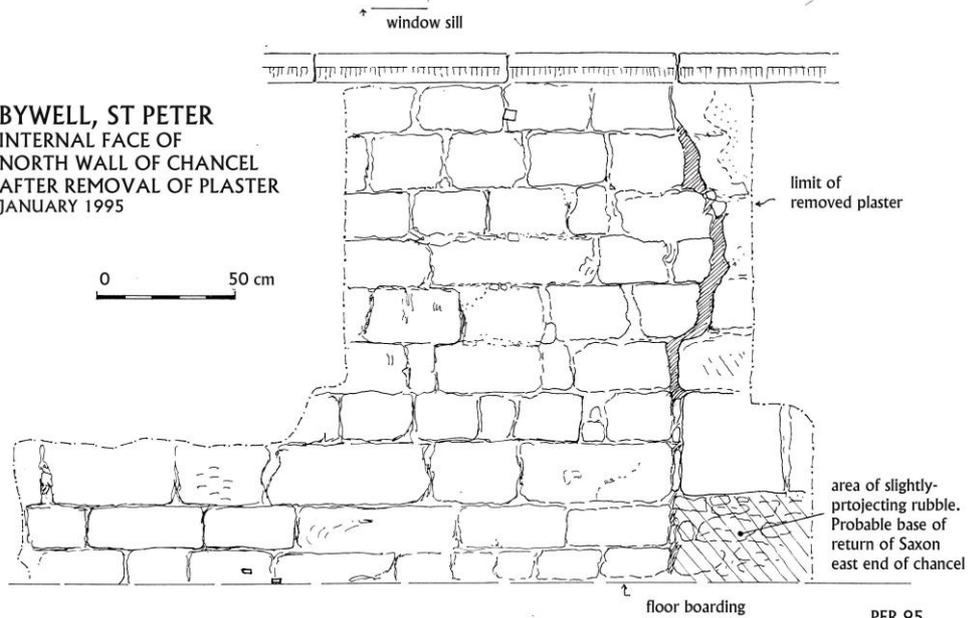
PFR 95

BYWELL, ST PETER
INTERNAL FACE OF
NORTH WALL OF CHANCEL
AFTER REMOVAL OF PLASTER
JANUARY 1995

When plaster was stripped from the internal face of the north wall of the chancel in 1995 (Ryder 1995) a discontinuous straight joint and other features were removed which almost certainly indicate the position of the north-east corner of the Saxon structure, which would make the early chancel 4.8 m long and 4.2 m wide internally

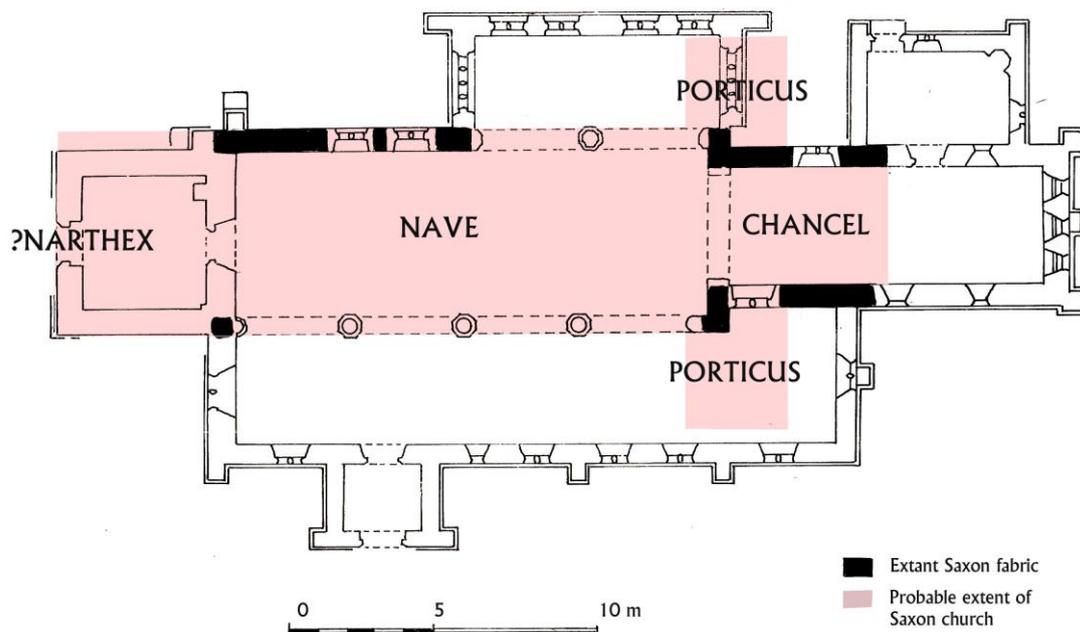
ST PETER'S CHURCH, BYWELL THE SAXON BUILDING

- Extant Saxon fabric
- Probable extent of Saxon church

Note: it is possible that there were also ranges of porticus flanking the nave

Thus the early church at Bywell seems to have been a surprisingly large one, and it is possible that it also had ranges of porticus flanking the nave, as suggested by the windows I the north wall being set so high, and perhaps also by disturbed and reddened masonry beneath the two western ones which could relate to the burning of roof timbers. It is possible that this church was monastic, and accompanied by other stone buildings⁷. Until a few years ago a massive stone slab, such as seen in the footings of the church, was exposed in the pathway a
