St Cuthbert's Church
Bedlington
An Archaeological Assessment
January 2015

St Cuthbert's Church, Bedlington

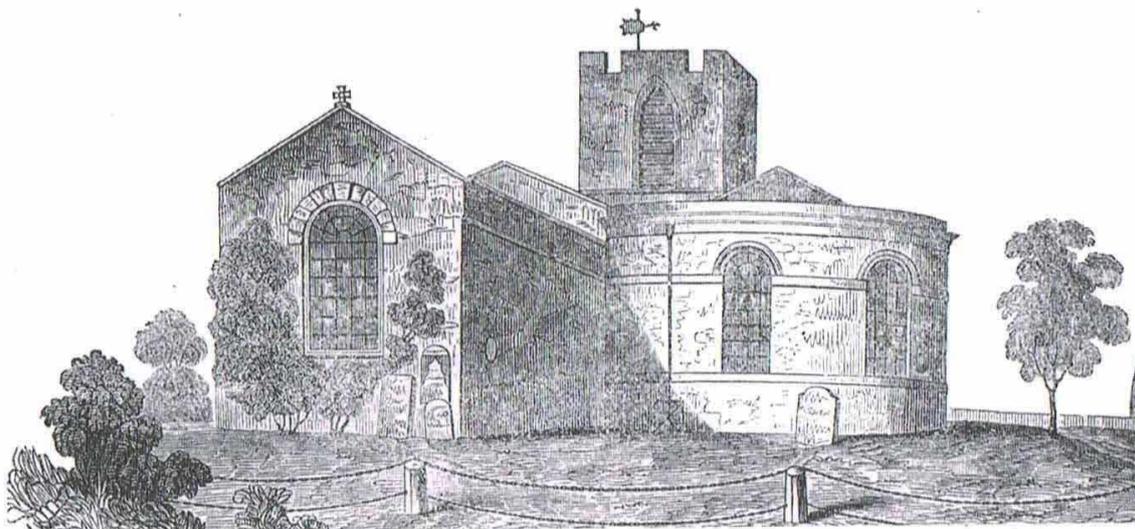
The church as illustrated by Hodgson in 1832;

Note the 1736 chancel, and the apsidal 1817 extension

on the north of the nave

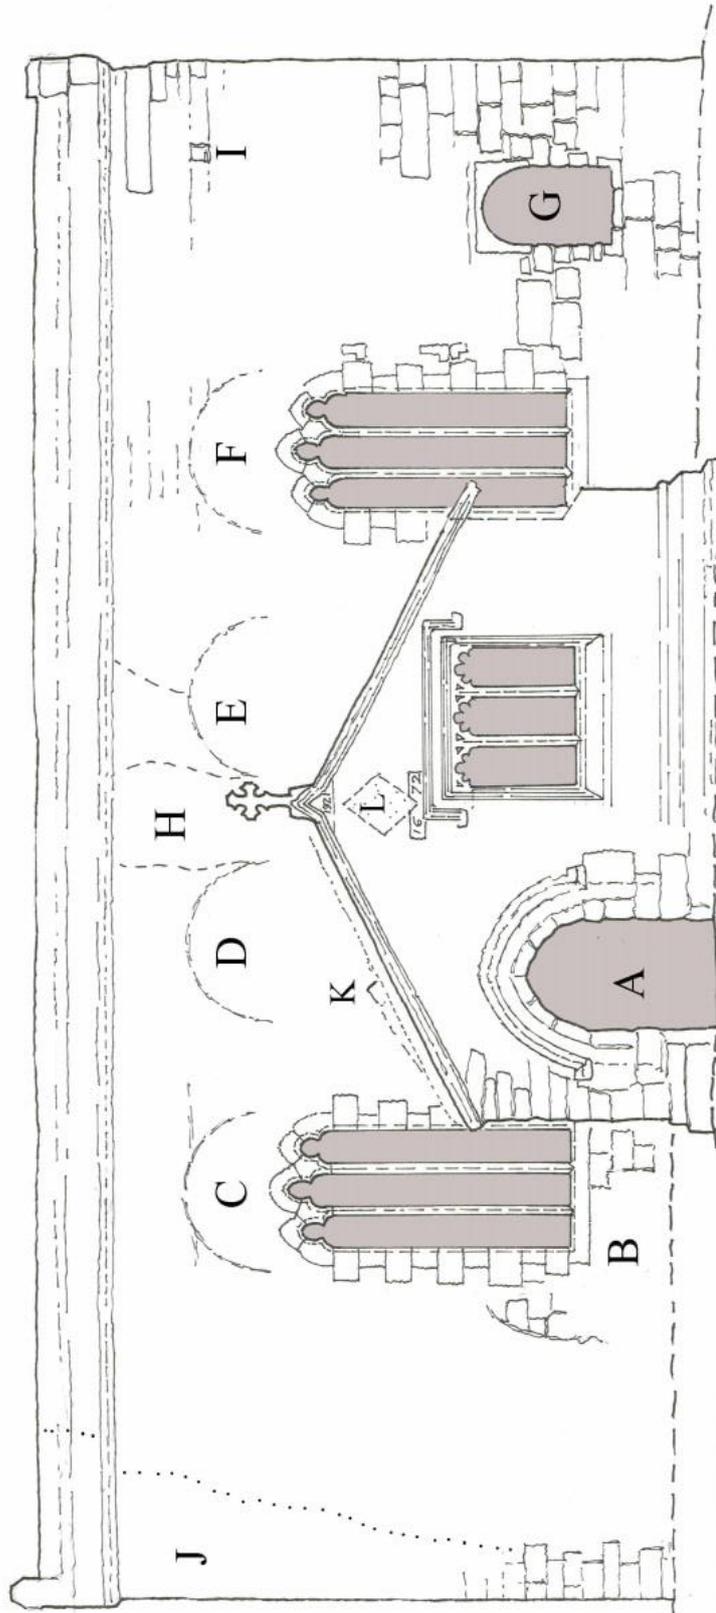
ST CUTHBERT, BEDLINGTON
 SKETCH ELEVATION OF EXTERNAL FACE OF SOUTH WALL OF NAVE P F Ryder January 2015

Only the south and the upper parts of the east wall of the **Nave** are readily visible – the upper part of the north wall (which is entirely of 1911-12; the original wall had been completely removed in 1817) is concealed from most viewpoints by the pitched roof of the aisle. The bulk of the stonework is in coursed almost square blocks, very much of 12th century character, apart from the south-west angle which has been rebuilt in tooled-and-margined ashlar clearly of the same build as the tower. The coursed masonry continues round the south-east angle, without any larger quoins; the upper parts of the east wall (above the chancel roof) may have been rebuilt; there are four areas of red tile patching here. The lower part of the central section of the wall is concealed by the South Chapel; on either side of this has been a large round-headed window, with two more, their sills at a higher level, above its roof; these appear to date to 1746 and are all now blocked; within the openings of the two outer ones, but with their heads a metre or so lower, are 1911-12 windows of three stepped trefoil-headed lights, with diagonally-tooled ashlar dressings. Close to the east end of the wall there is a smaller window, set quite low (a 'low side'?) with a round-arched head cut into a single large

- A: South doorway (13th/14th century?)
- B: Possible original position of South Doorway
- C, D, E, F: positions of 1746 windows
- G: Low-side window, medieval, enlarged in C18? blocked then re-opened 1911-2
- H: possible buttress position??
- I: Block corbel
- J: Rebuilt quoins and walling, 1868
- K: Roof-line of porch pre-dating South Chapel
- L: Eroded sundial

block – in fact very little of the block survives, suggesting that the window was originally smaller and has been enlarged. There are vestiges of earlier features in the wall; c 1 m to the west of the western window is a ragged break which might result from the dressings of an arched doorway being removed¹ and there is a straight joint under the window which might represent its eastern jamb. Above the chapel roof are some inclined stones which might indicate the roof-line of a former porch relating to the doorway that now opens from the nave into the chapel, and between the two central blocked windows is a vertical feature that may indicate an early buttress. High up near the east end of the wall is a projecting corbel-like block, and there are one or two elongate blocks in this area, whilst lower down, around the east jamb of the eastern three-light window are a number of L-shaped blocks which similarly must have some significance, which at present remains elusive². The top of the wall is an oversailing chamfered course carrying a low parapet with a moulded coping.

As already outlined, the surviving medieval east and south walls of the nave retain a complex series of structural features which as yet are not fully understood. Measured sketch plans have been prepared in the course of this assessment, but there are of a very provisional nature and in no way a substitute for what is really needed, proper stone-for-stone drawings which should properly depict changes in coursing ,remains of early architectural features, tooling and mason's marks. Only by this rather painstaking means will further light be shed on the structure, and the long and complex development of the building. The fabric of St Cuthbert's Church undoubtedly has more to tell us, but the coaxing-forth of this information will take time and effort.

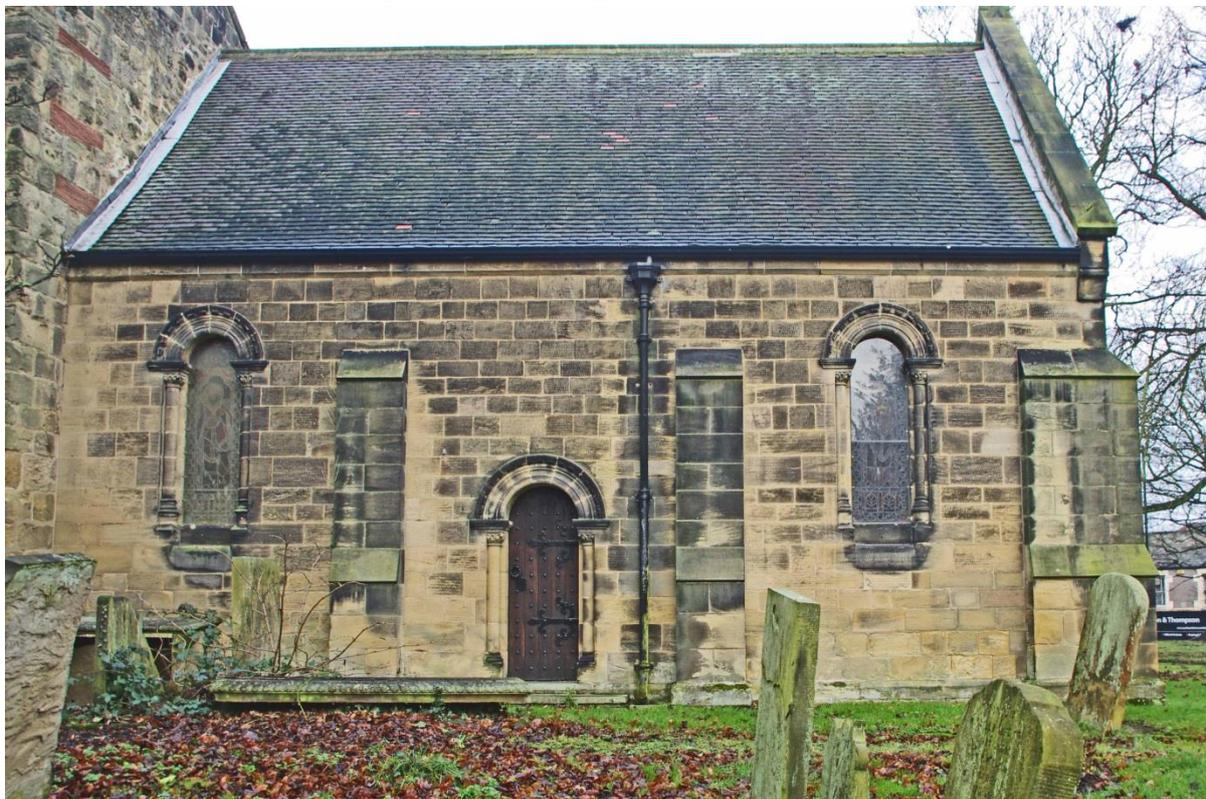
The **Chancel** (above, seen from south) is built of tooled ashlar, in a neo-Romanesque style, with a steep-pitched roof of Welsh slate; it has a chamfered plinth, and shallow stepped buttresses articulating the three-bay south elevation and clasping the eastern angles; there is a chamfered oversailing course to the eaves. On the south there is a priest's door that has attached shafts to its jambs, with carved capitals, and a moulded arch with a billet hoodmould. The windows – one in each end bay on the south, an equal-height triplet in the east end and one at the east end of the north wall – all have similar detail; the central section of their sills is stepped down as a blind panel below the bases of their jamb shafts. The east gable has moulded kneelers and a coping chamfered on its underside, and is topped by the base of a missing finial.

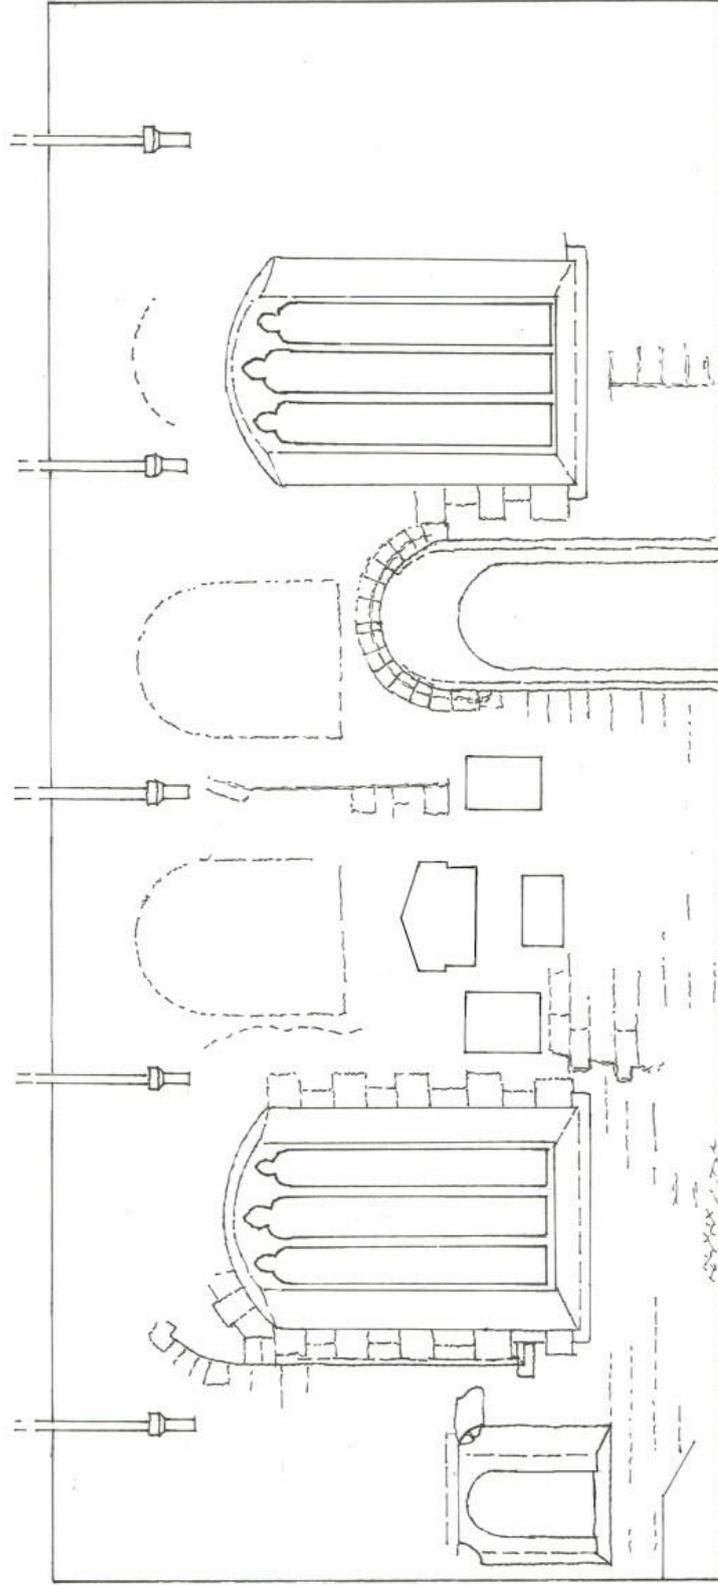
SKETCH ELEVATION OF INTERNAL FACE OF SOUTH WALL OF NAVE

Inside the **Nave** the medieval south and east walls are of exposed stonework. At the west end, the inner face of the tower arch is now largely concealed by the modern west gallery. Much of the internal face of the south wall is of regular squared stone of 12th-century character, and many blocks bear mason's marks, often a simple incised cross. The masonry is worth a detailed study³ and shows some irregularities including a strange ragged break a little to the west of the eastern three-light window, to the east of which the lower courses are eroded and damaged. On the south the doorway into the South Chapel has a semicircular rear arch with an angle-roll to its head. The two 1911-12 three-light windows segmental rear arches with ashlar alternating-block surrounds, and the small window set low towards the east end of the wall has a shouldered rear arch, with a recent lintel carried on the east by a simple corbel and on the west by one in the form of a large nail-head motif. There are also evidences of earlier openings; the outlines of the central two of the four round-headed windows of 1746 are very clear, but the outer two only show as areas of general disturbance. A little to the east of the eastern three-light window is a tall jamb, and turn of the chamfered sill, of a window which was presumably of 12th century date as its jamb stones course in with the walling to the east. The curve of its rear arch survives, although it ends in a stone shaped like an inverted 'V' which presumably is out of place, as if this was really the apex of the opening it would make this a very narrow lancet which, with the observable splay of the jamb, would be too narrow to pierce the thickness of the wall. Further west, in between the central two 1746 openings, is another straight joint which again seems to be the east jamb of an early window, with just the beginnings of a possible arched head visible. Of the possible blocked doorway towards the west end of the wall, the eastern jamb is visible beneath the western here-light window, but

the lower wall west of this is hidden by monuments now set upright against it, a post-medieval slab and two cross slabs.

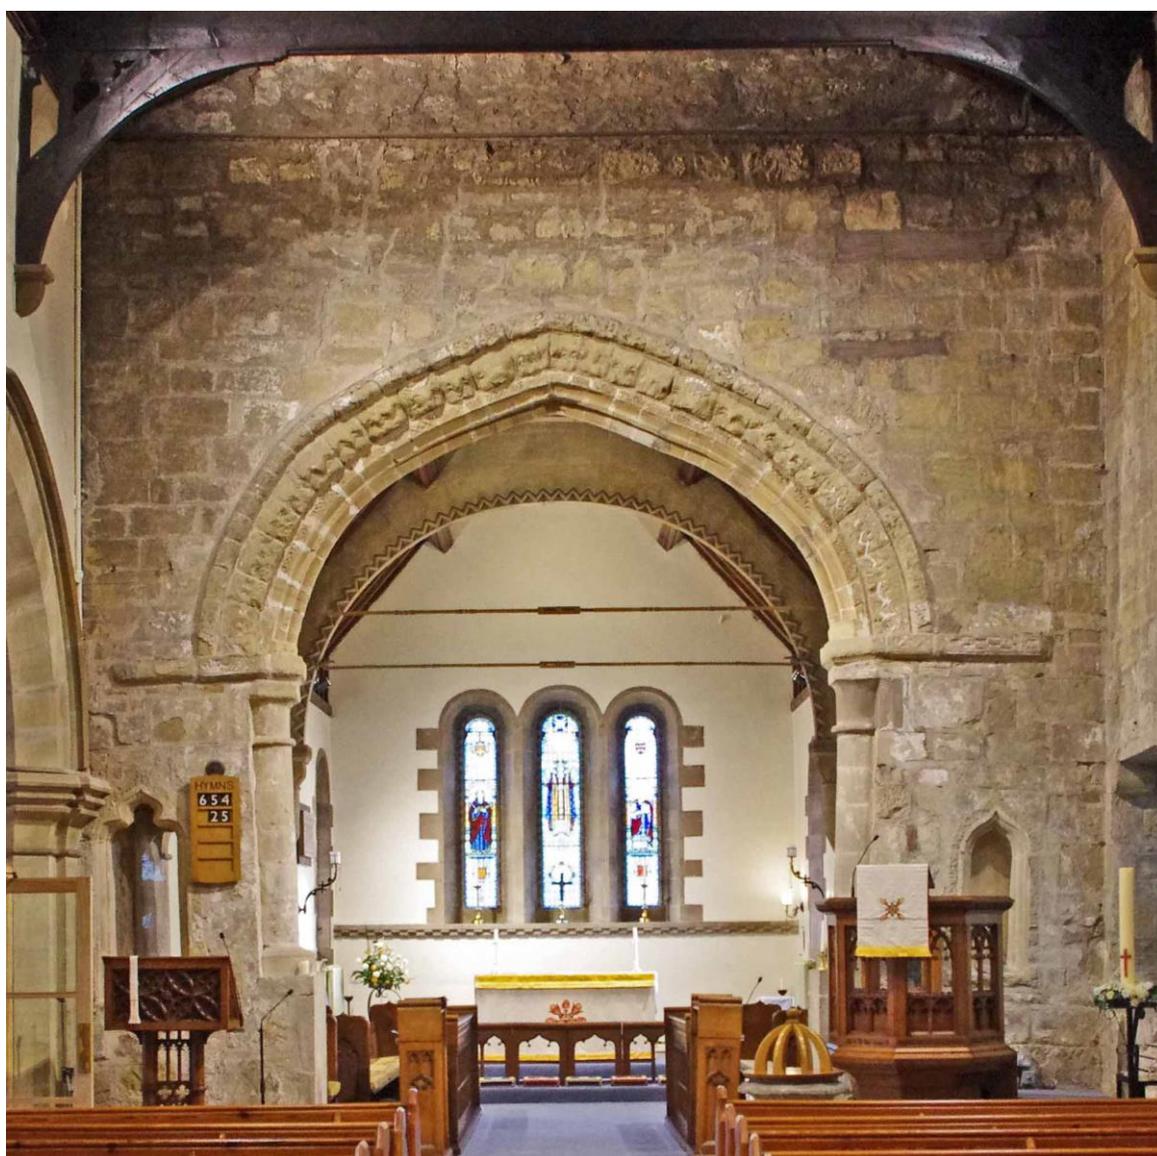
The east wall of the nave (below) contains the chancel arch which is now of four-centred form, which must be the result of some reconstruction; in its original form it would have been semicircular. It has jambs with bold half-shafts that have renewed moulded bases set on plinths c 1.5 m above the floor; the plinths are of tooled stone of late 18th or early 19th century character. The simple capitals have abaci, chamfered beneath, which may have been cut to their present semi-octagonal form, and are carried back as a string course for some distance on either side of the arch, with some worn carved decoration. The arch itself is of two orders. The inner has a soffit roll between two hollow chamfers, the vertical face towards the nave having varying incised decoration including interlace and four-petalled flowers. The outer order has deeply-carved chevron but is very badly eroded; there is also a hoodmould, carried on the impost band, which also has remains of carved ornament.

On either side of the arch are ogee-arched openings, perhaps of 14th century date, with their sills c 1.5 m above the floor. The larger northern one is a squint, cut obliquely through the wall to give a view of the altar, and has a trefoil-cusped head. The southern is a shallow recess which unlike the northern has the moulding continued round its sill. Both have their heads cut into single blocks, and both have had an outer moulding that has been trimmed back flush with the wall.

Higher up the wall there appears to be a disturbed area towards the south end, with two elongate blocks with a close horizontal tooling, and then there is a set-back at the level of the eaves of the side walls.

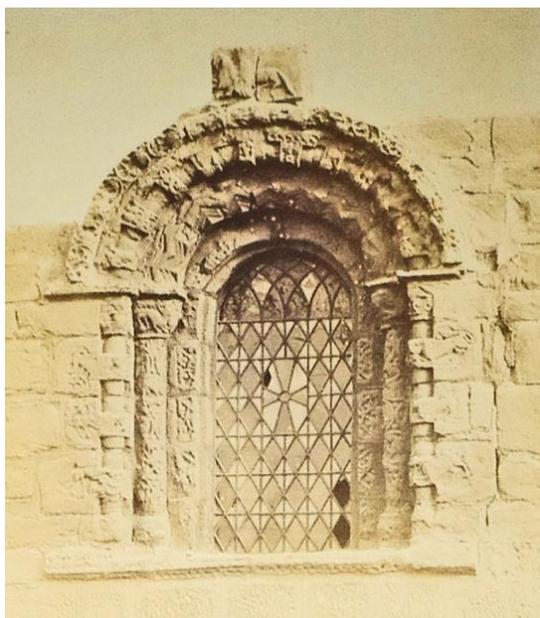
This tower, demolished in 1868 would appear to have been contemporary with the nave, to judge from descriptions and a surviving photograph⁷ of its west window (left), which Hodgson describes as ‘beautifully moulded and fretted’ although its ‘enrichments’ had ‘certainly suffered much by the mouldering hand of Time’. Perhaps as a justification for its rebuilding an inscribed tablet in the present tower specifies that its predecessor was both ‘decaying’ and of ‘unknown date’; the large and plain Gothic-arched belfry openings shown on old illustrations suggest that its upper parts may have been a post-medieval reconstruction. The 1st edition Ordnance Survey 25”:1 mile map of c1860 shows the old tower as

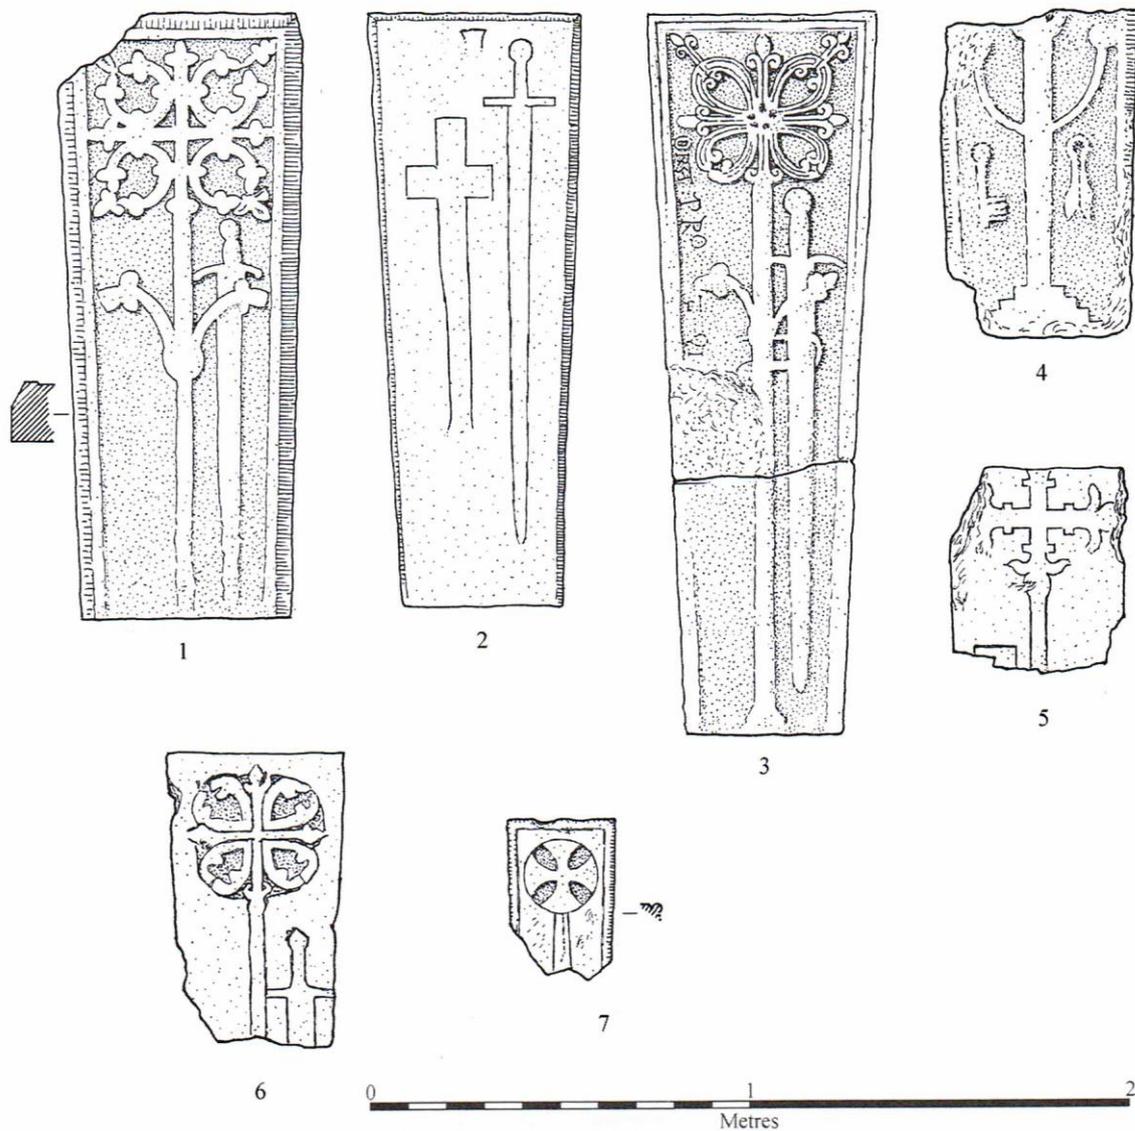
Bedlington (St. Cuthbert)

(1) Relief design on brown sandstone within raised border. Bracelet cross with trefoil terminals, fleur-de-lys springing from shaft and sword on r. Base missing. Probably early thirteenth century.

(2) Incised slab of brown sandstone. Simple Latin cross with longer sword on r. A trace of design at the top of the slab looks like the upper terminal of a splay-armed cross, mostly tooled away when the slab was re-cut with its present design. A very simple slab difficult to date; perhaps twelfth century. Ryal (12) is a close parallel.

(3) Relief design on dark grey sandstone, within raised border. Elaborate cross head with the outer leaves of each terminal uniting to enclose heart-shaped 'bracelets' from which further diagonal fleur-de-lys spring towards the upper corners of the slab. As with further fleur-de-lys spring from the cross shaft and there is a sword on the r; in addition there appears to have been a belt wound round the sword, but this part of the stone is badly damaged. On the l. side of the slab is the beginning of an inscription in Lombardic capitals:

A high-status slab of the late twelfth or early thirteenth century.

(4) Lower half of a yellow sandstone slab now built into the west wall of the nave to the north of the tower arch. Relief design. Broad cross shaft with stepped base, with paired flowers or leaves on long curved stems, as on several slabs at Newbiggin. Key on l. of shaft and shears on r., indicative of a woman's grave. Probably fifteenth century.

(5) Incised design on grey sandstone. Greek cross with cross bars and late-form fleur-de-lys terminals; a rectangular emblem, perhaps a book or work-box, on the left of the shaft. Fourteenth or fifteenth century.

(6) Slab of buff sandstone with cross head carved in relief in sunk panel and remainder of design incised. Design a cruder and simpler variant of 3. Sword on r. of shaft. Thirteenth century?(7) The upper part of a small slab of coarse grey sandstone now built into the internal sill of the small window at the east end of the south wall of the nave. Incised design except for sunken panels between arms of cross head. Cross pate in circle, tapering shaft. Roll-moulded edge. Good-quality workmanship, perhaps later twelfth century.

(7) The upper part of a small slab of coarse grey sandstone now built into the internal sill of the small window at the east end of the south wall of the nave. Incised design except for sunken panels between arms of cross head. Cross pate in circle, tapering shaft. Roll-moulded edge. Good-quality workmanship, perhaps later twelfth century.
