The Parish Church of St Aidan, Bamburgh

Analysis of the Fabric and Archaeological Assessment

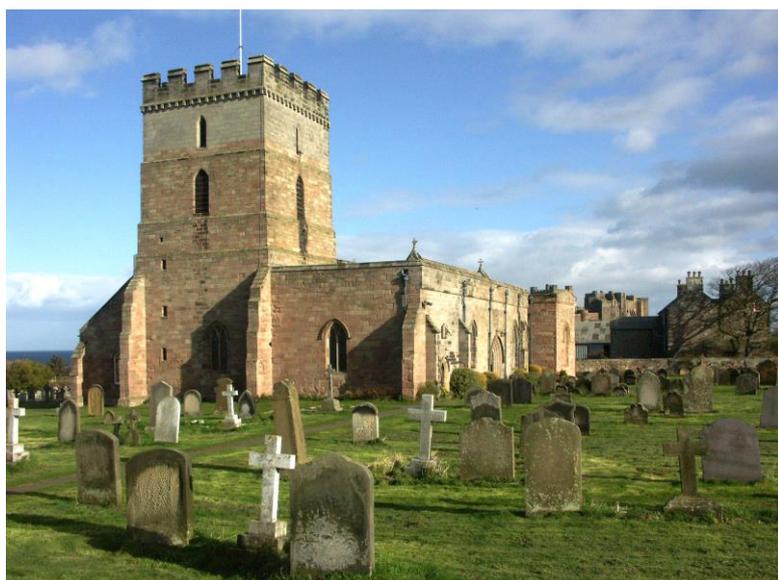
The **West Tower** is built of squared and coursed stone, mostly pinkish in colour except for the top stage (above its two lowest courses) which is in white sandstone. Virtually all this stonework is 19th-century re-facing, whilst the top stage is a mid-19th century addition. The tower has a chamfered plinth, and rises in four stages of varying height, divided by chamfered set backs. The first and tallest stage rises above the aisles, which engage the side walls of the tower. On the west of it are a pair of stepped buttresses, and between them, set to the south of centre to clear the stair, the west window has Y-tracery with trefoiled cusping beneath a two-centred arch, and a moulded hood with turned-back ends; all its dressings are of parallel-tooled ashlar, and of 19th century date, except for the sill, which seems to survive from an older window c. 0.20 m wider. To the north is a vertical series of three small chamfered square-headed windows lighting the stair; in the second stage is a smaller rectangular opening without any chamfer, which is probably a secondary insertion. This stage has a chamfered square-headed window on the south, looking out above the south aisle roof, and a similar opening above the low-pitched nave roof on the east. On each face of the third stage of the tower, which is in fact the belfry, there is an almost door-like segmental-pointed opening, with a chamfered surround. The added top stage has narrow trefoil-cusped lancets in broad chamfered surrounds. The parapet, set forward on a series of plain block corbels, has a crenellated parapet with moulded copings only to the merlons.

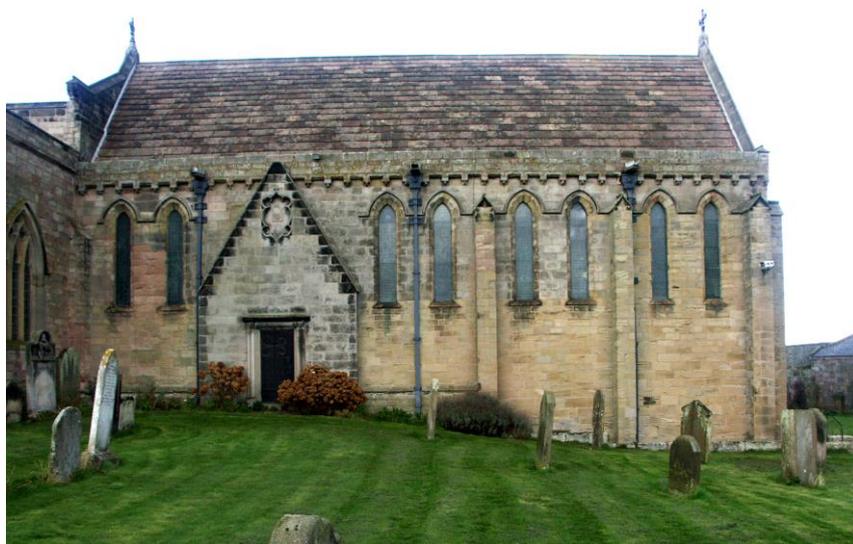
The **Chancel** is constructed of yellowish coursed squared stone; there has been extensive restoration and re-facing. It is five bays long, and has a large plinth with a bold roll at the top and two chamfered steps below. The second bay from the west was remodelled in the early 19th century, and has a priest's door set in a shallow gabled projection, of grey

diagonally-tooled ashlar. The studded door is set in a square-headed opening flanked by pilasters, with a moulded cornice broken forward round the pilasters; the gable above has a ogee-cusped octofoil panel. The other bays each have a pair of lancet windows with linked hoodmoulds, and there are gable-topped buttresses between the third, fourth and fifth, their

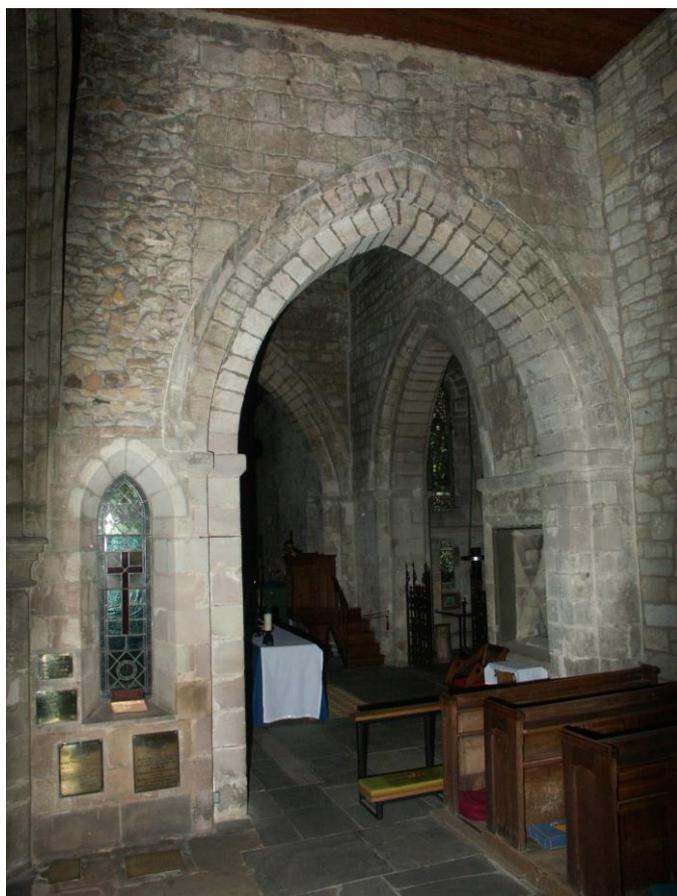
On the south face of the wall (left) there is a vertical column of rough rubble immediately to the west of the arch, generally interpreted as the cut-away west wall of a narrower transept; to the east of it the walling is of large blocks, some more upright than square, of 'early' character. The line of the western slope of an earlier and lower transept roof cuts across both the squared masonry and the rubble column. The relationship between the rubble column and the crossing arch is not quite clear; the western jamb of the arch and the west end of its hoodmould impinge on the boundary, but not to a sufficient degree for one to insist that the arch must be later than the removal of the old west wall, although the sag of the courses above it seems to point in the direction of the arch being an insertion. Below the rubble column, the section of wall adjacent to the western respond of the arch has been re-faced

(on both sides) in the 19th century, and contains a strange lancet window, equally splayed from each face of the wall. The north face of the wall shows a less clear and more irregular vertical break between the heavy squared fabric and walling with more elongate blocks, c 1.5 m from its west end, which might tally with the western wall of a former crossing being cut away at this point.

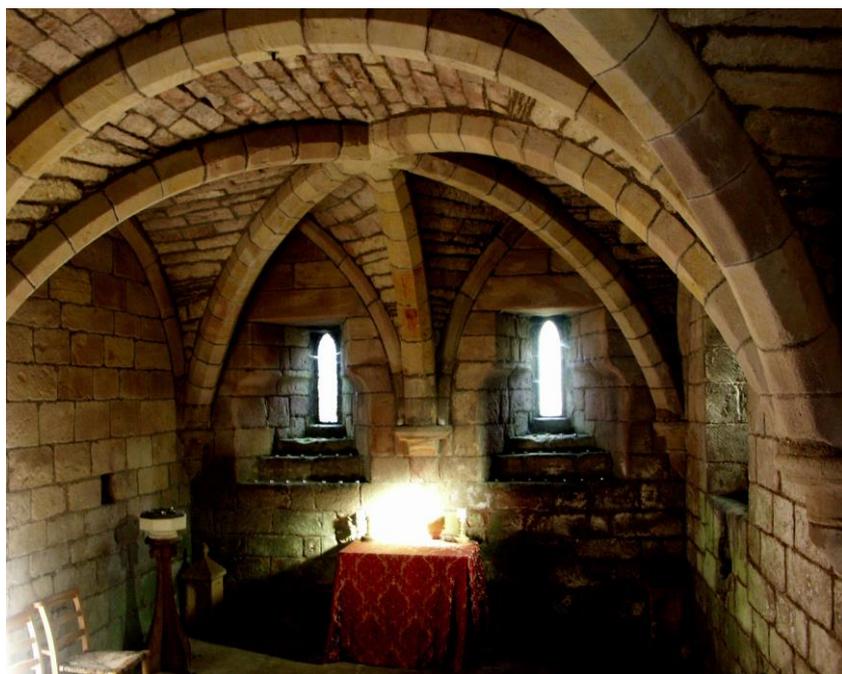
19th-century date, with a steep little stair at the south-east angle. The crypt itself consists of two parallel chambers, one under the southern two-thirds of the eastern two bays, and a narrower passage-like compartment to the north.

Five steps lead down from the south door to the slabbed floor of the main crypt chamber, which has a groined vault in two bays; the NCH (107) describes it as being ‘a peculiar combination of the quadripartite and sexpartite forms, the outer halves of each bay being of the latter, which the inner, where they conjoin, is of the former construction. The transverse rib is semi-circular’. The vault ribs are all chamfered on their lower angles. Three lancets that light the crypt -

two on the east and one on the south - have triple-stepped internal sills, and the two eastern ones have a peculiar form of shouldered rear arch. Beneath the lancet on the south is a piscina with a trefoiled arch and a projecting bowl, now broken away. In the east wall are two small sockets, perhaps for brackets to support an altar, whilst on the north are a range of three rough sockets, c 1.5 m above the floor, which may relate to post-medieval use as a burial vault. Towards the west end of the north wall is a low square-headed opening into the northern chamber; it seems to have had chamfered jambs and head, but these have been hacked back to allow slightly easier access. The chamber beyond has walls of neatly-tooled ashlar, and its sides a string, chamfered on its lower angle, below the rubble barrel vault. The small lancet on the east has a triple-stepped sill. At the west end a crude staircase descends from the chancel above (now covered over by slabs) to break through the end wall of the chamber 1.5 m above the floor; it is clearly a secondary insertion, and must have been continued by a wooden section within the chamber. The floor of the chamber is of earth, and on it lie the dismembered remains of a 14th-century three-light window; perhaps this is the old stonework from the north window of the north transept, the restoration of which was regretted by the NCH account (106, footnote 1).
