ROTHBURY

ALL SAINTS' CHURCH

AN ARCHAEOLOGICAL ASSESSMENT

OCTOBER 2020

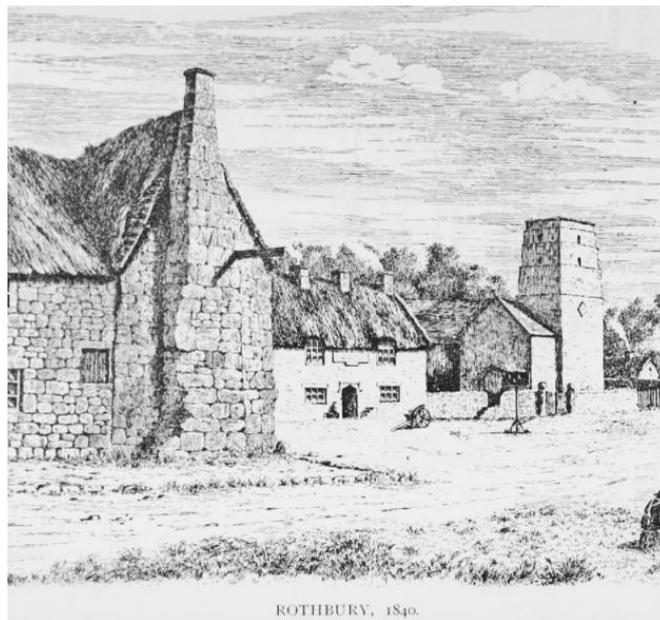
North-west view after Dixon, 1840

⁷ Shown on An 1840 drawing of a north-west view of the church (Dixon, D.D (1903). *Upper Coquetdale*. Robert Redpath, f.p.374), as being as tall as the nave, and with a large round-arched (Romanesque?) doorway in its north end. . Honeyman suggests that it was remodelled as a vestry in 1611, the date on a doorhead in the

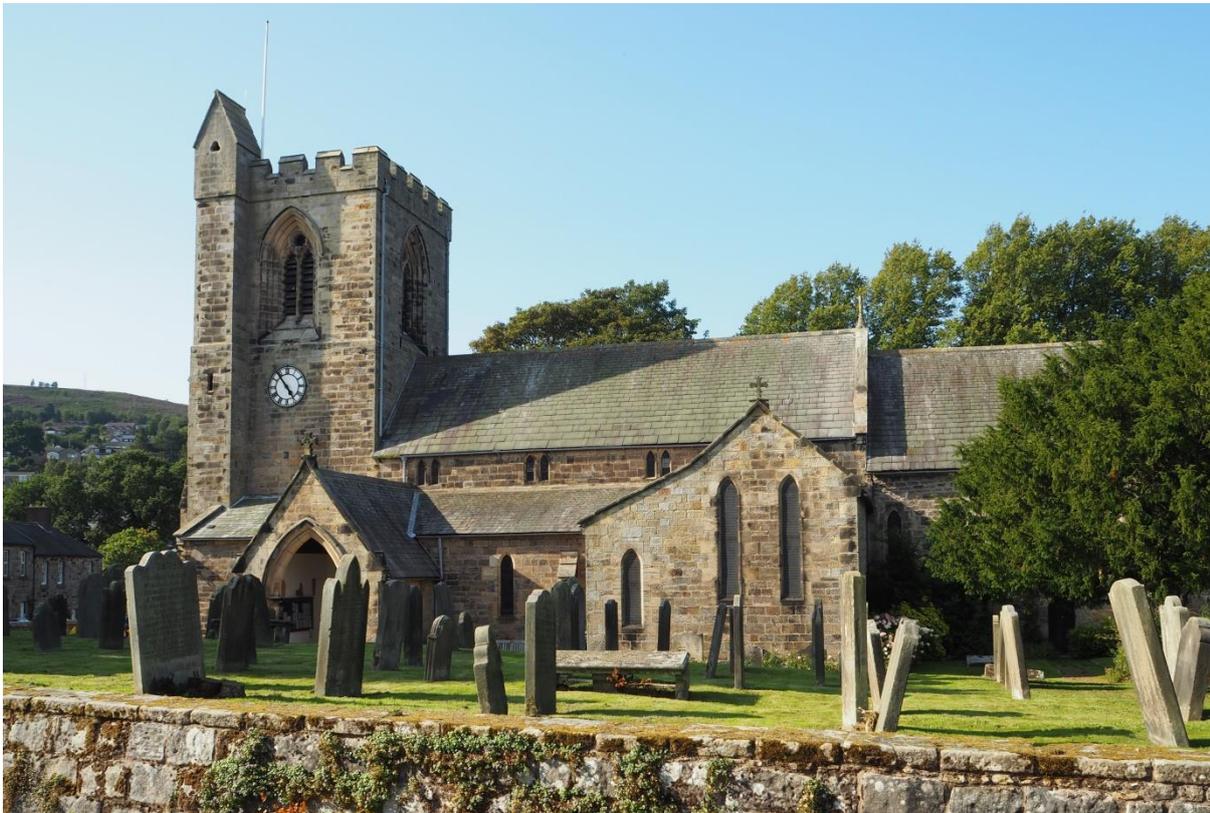
South view

The **Nave** has a clerestory of three pairs of chamfered lancets on each side and a coped eastern gable with a ring-cross finial. The aisles are each of three and a half bays, the half-bay being at the east end, and their side walls are articulated by stepped buttresses, except on the south where the porch serves this function and there is only one buttress between the third and fourth bays; each bay has a chamfered lancet window.

The **South Porch** has a large outer arch of two chamfered orders, with jambs of the same section that have moulded bases and capitals; the steep gable has a coping that is chamfered on its under side, and carries a bracelet cross finial. The internal walls of the porch are plastered; three carved stones are built into the west wall. The inner doorway has a sharply two-centred arch of two continuous orders, a moulded inner and a chamfered outer. In the east wall of the porch is a window of two lancet lights, with a segmental rear arch.

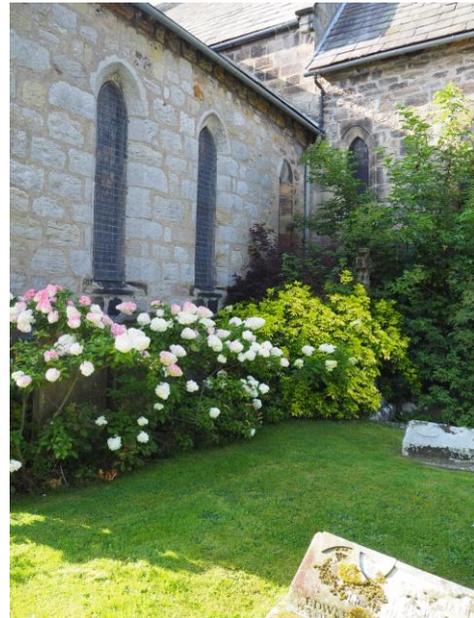
aisle; the coped gable has a foliate cross finial. The east wall of the transept (right) is of medieval date, of roughly-shaped and roughly-coursed stone, generally blue-grey in colour; it has three lancets, the southern two, wider and with broader splays are in blue-grey stone, whilst the dressings of the northern lancet in brown sandstone. The northern bay is difficult to see due to trees.

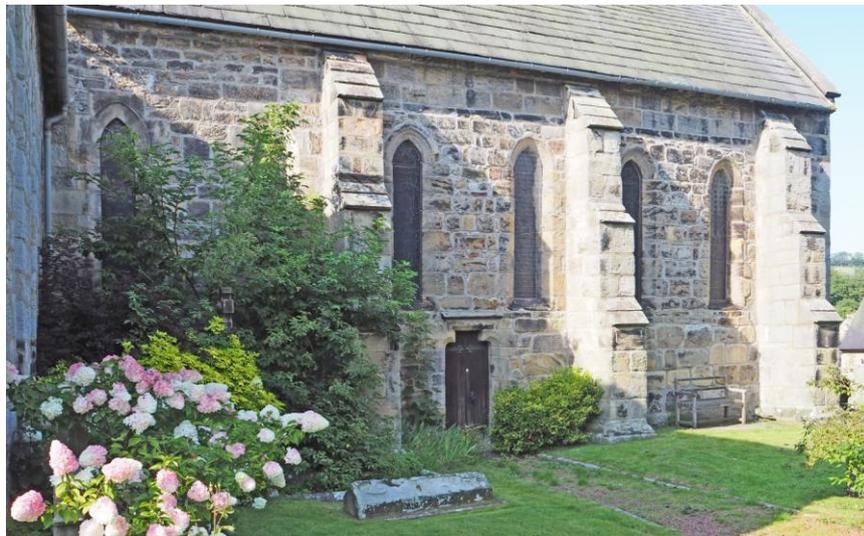
The south wall of the **Chancel** (left) is of three bays, articulated by big stepped buttresses; the western is clearly 19th century but the other two, between the central and eastern bays and around a metre short

of the east end, are older. The easternmost buttress has an old incised sundial c 1.5 m above the ground, a circle with a central socket and 16 regular divisions; there is a second smaller and simpler sundial in the eastern bay, beneath the cut-back string. The walls are of roughly coursed and roughly-squared stone, usually brownish in colour, with some very large blocks in the lower courses, and also more regular (and presumably 19th century) masonry in the uppermost courses. In the central bay is a priest's door with a chamfered shouldered arch, with some of its dressings renewed, and a label which is actually a section of a string course, otherwise cut back flush with the wall face. Higher up each bay has a pair of chamfered lancets, the two in the western bay in 19th century stone, the others ancient.

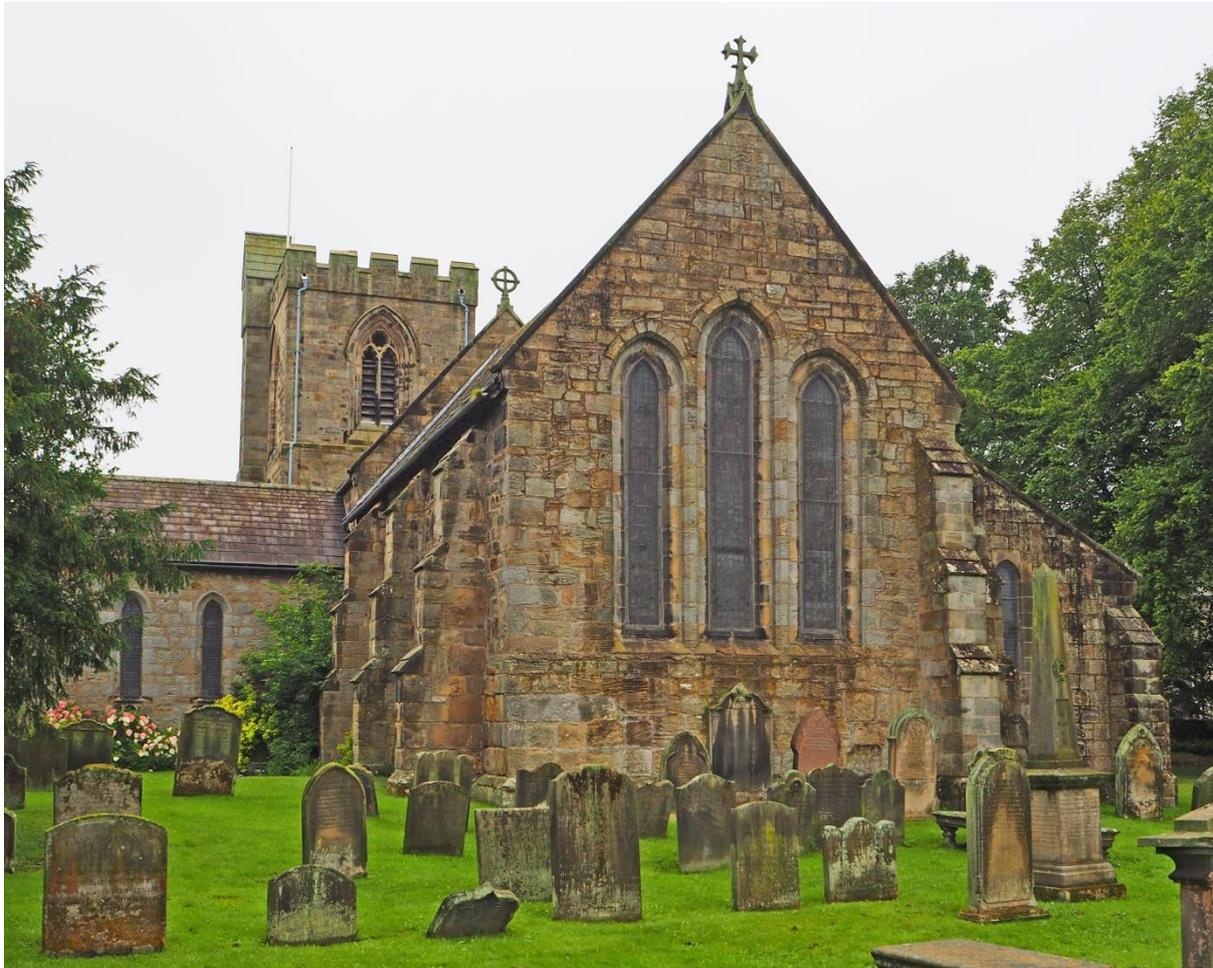
The east wall of the chancel has some very large blocks low down, including two elongate tapered ones in the lower south-east quoin which are probably medieval grave slabs. Above the cut-back string course are a triplet of lancet windows with double-chamfered surrounds, the glass-line being, unusually, central to the wall. At the north-east corner are a pair of 19th century stepped buttresses. The short length exposed of the north wall, to the east of the late-19th century vestry, is of medieval masonry, with remains of the string course.

East view

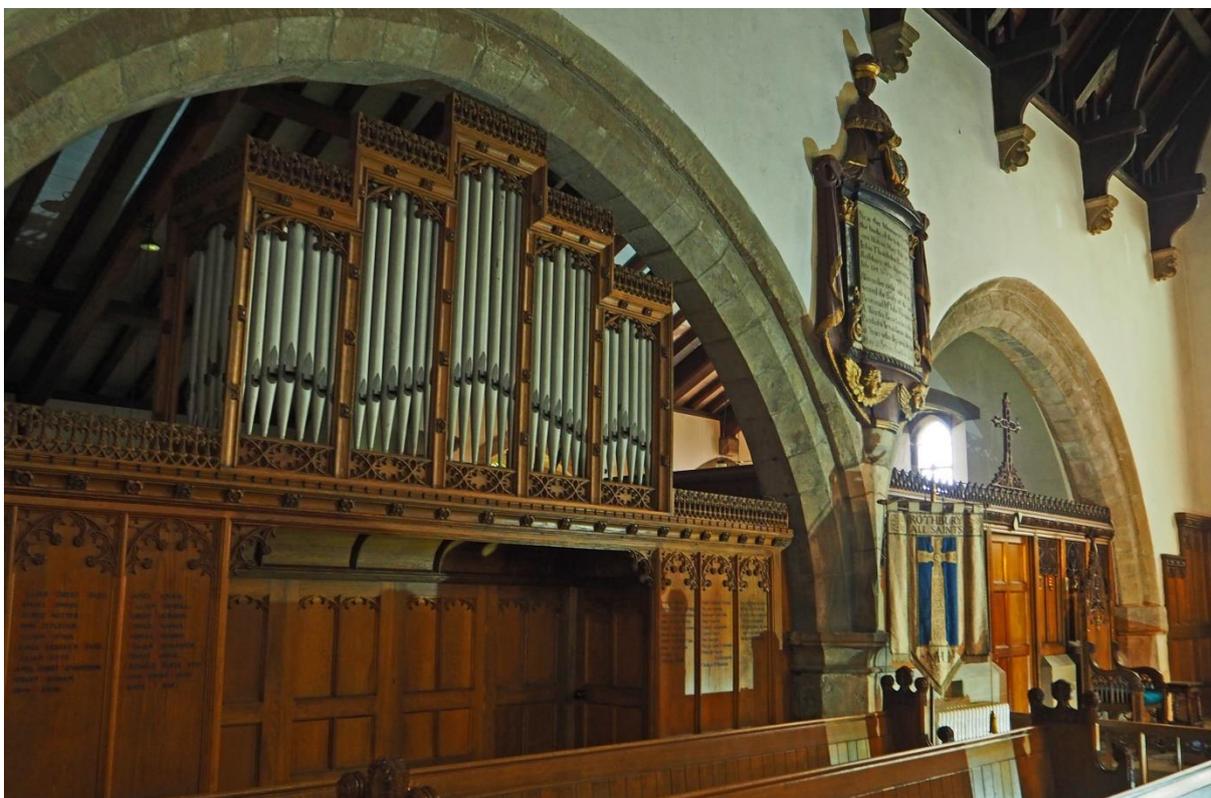
On the south of the chancel the six lancet windows all have plain segmental rear arches, plastered over. Underneath the easternmost is a recess that has a trefoiled head with a broad chamfer, and a sill formed by a square-edged slab with below it the semicircular moulded bowl of a piscina, springing from a corbel. The eastern triplet of lancets have double-chamfered surrounds, as to the exterior. On the north of the chancel are a pair of wide arches, of near-semicircular form and of two chamfered orders, resting on an octagonal pier. The western respond is of plain square plan, but the eastern semi-octagonal; the pier and responds have simple moulded capitals, but their bases are not exposed.

North chancel arcade, formerly opening into Cartington Chapel

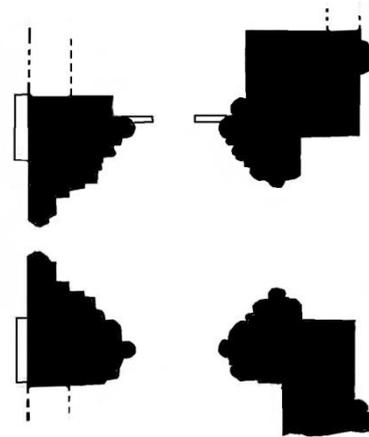
ROTHBURY THE MEDIEVAL TOWER

Accompanying the report is a very interesting plan³. It is not dated, and has a note saying ‘the red portions of the plan denote the new stone work’ – yet it is all in black! It does however tally with the recommendations in Salvin’s text, with the west bay of the south aisle and west aisle of the south transept shown, as well as two shallow buttresses he proposed for the west side of the tower. It is the tower that is the most interesting feature, as the plan clearly depicts the medieval structure. It seems to have had arches in all four side walls, all reduced in size, are shown as having elaborate moulded jambs. The four arches show that this was a crossing, which may or may not originally have been carried up as a tower; what is unclear is its date. If it were Anglo-Saxon, then the elaborate moulded responds would indicate a high-status structure, and have no parallel in the North of England. If it were Norman Romanesque, then the only real parallel is Kelso Abbey, with its surviving western crossing.

redrawn from plan of proposed restoration by Salvin c1845

There remains however the evidence of Salvin's notes and plan (and Mackenzie's earlier comment), showing that there once was a western crossing. Old illustrations show that its northern arch appeared to open into a sizeable transept-like structure, later used as a vestry⁷; Salvin's proposed plan shows this rebuilt to match the south aisle.

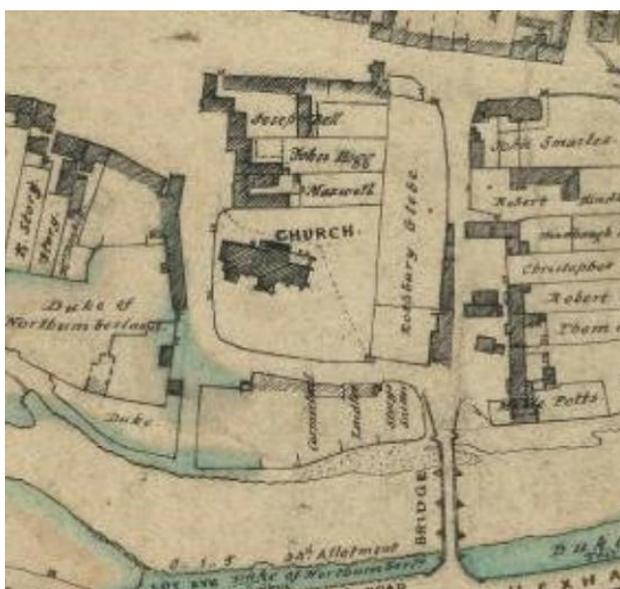
c1800 Bell plan showing outline of pre-restoration church. There is a discrepancy with the c1840 Dixon in that the projecting NW vestry is not shown

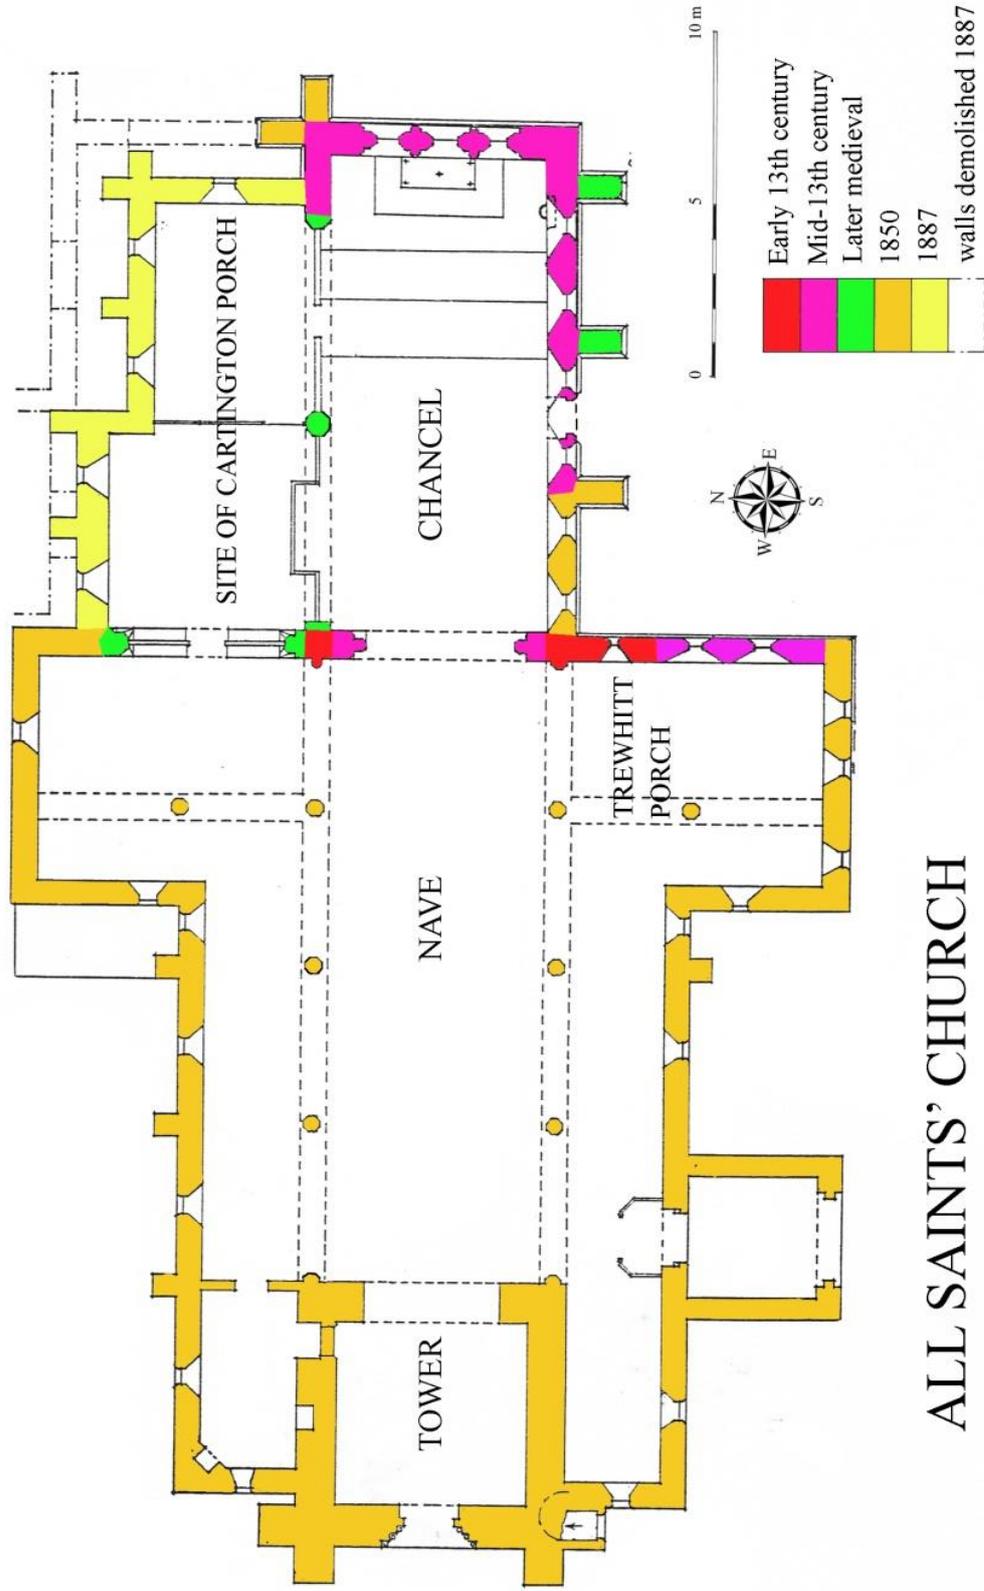
ALL SAINTS' CHURCH ROTHBURY

Plan after H.L. Honeyman 1937
