# St Michael and All Angels, Alwinton

Northumberland

**PETER F RYDER**  
B.A., M.Phil, F.S.A  
**HISTORIC BUILDINGS CONSULTANT**

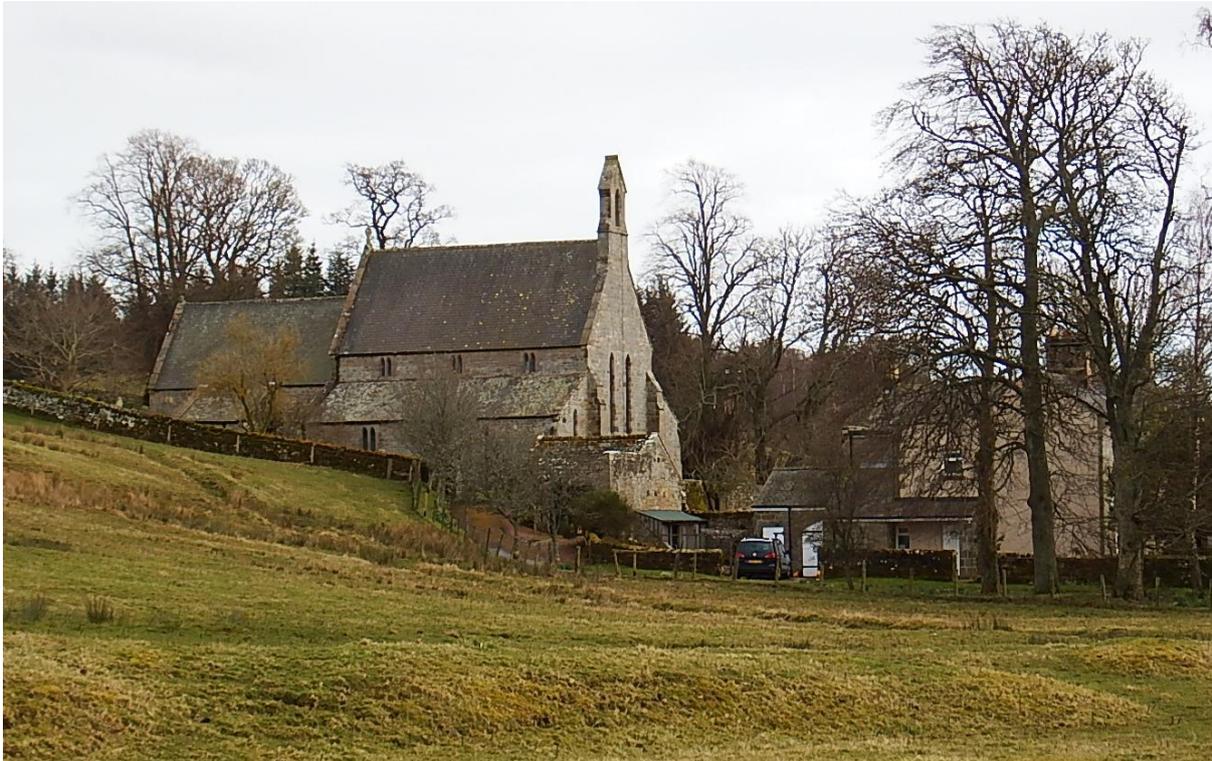
*The church from the north-west*

Although one's first impression is that the western parts of the church are all a product of Pickering's 1851 restoration, closer inspection shows that much earlier fabric survives. The lower courses of the north wall of the north aisle (except for the western third) are of large roughly-shaped stones and would seem to be medieval, although there is no sign of any north door, normally present in a medieval building but possibly omitted here as a security measure (might this wall be part of a late medieval defensive reconstruction, as at Elsdon and Corsenside, which also lack north doors?). The three windows higher in the wall are all of 1851 – two lancets with a double one further east – but near the east end of the wall the tooled ashlar blocks of the east jamb of a

square-headed 18<sup>th</sup> century window are visible, which according to pre-restoration drawings (now hanging in the Biddlestone Porch) was once the only opening in the wall. The east end of the aisle is 13<sup>th</sup> century masonry, with an undisturbed lancet window; to the south of it are the north-east quoins of the original nave, large roughly-squared blocks surviving up to a little below the level of the chancel eaves. Adjacent to the quoins is a column of renewed stone, patching for the flue of a heating chamber, removed in the later 20<sup>th</sup> century.

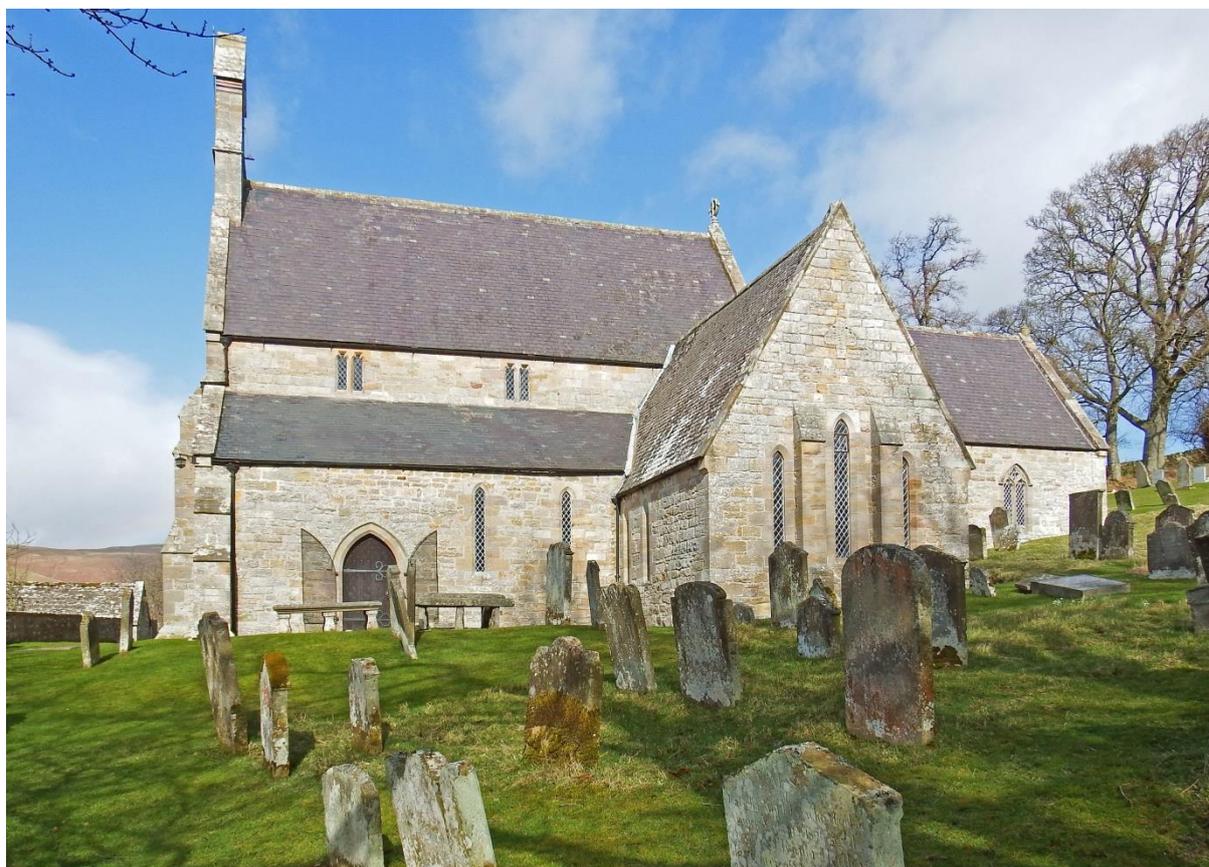
*The Church from the South*

The west wall has remains of a shallow square-topped plinth of 18<sup>th</sup> century character, and the jambs of another window, presumably of this date, are visible beneath the two tall lancets in the west wall of the nave, and the sills of others beneath the lancet in the end walls of the aisles. The buttresses are

clearly 1851 additions, and the bellcote and clerestorey are also obviously of this date. The south door has a plain chamfered arch; the old drawings show a similar doorway here, but the present one seems to go with the other architectural features of the wall, two 1851 lancets.

The Biddlestone Porch has two more lancets in its west wall and three in the south gable, with buttresses between. It is difficult to tell how much pre-1851 fabric survives; the lower quoins at the south end certainly look old. Re-set in the steep gable is an ornate cross dated 1672, which came from the lower gable of the old porch; on its upper arm is carved S (for Selby) above T and A (Thomas and Anne) above a shield with the arms of Thomas Selby and his wife Anne Lumsden, a baluster-shaped bend sinister in relief (Lumsden) impaling six bars, three sunk and three in relief (Selby).

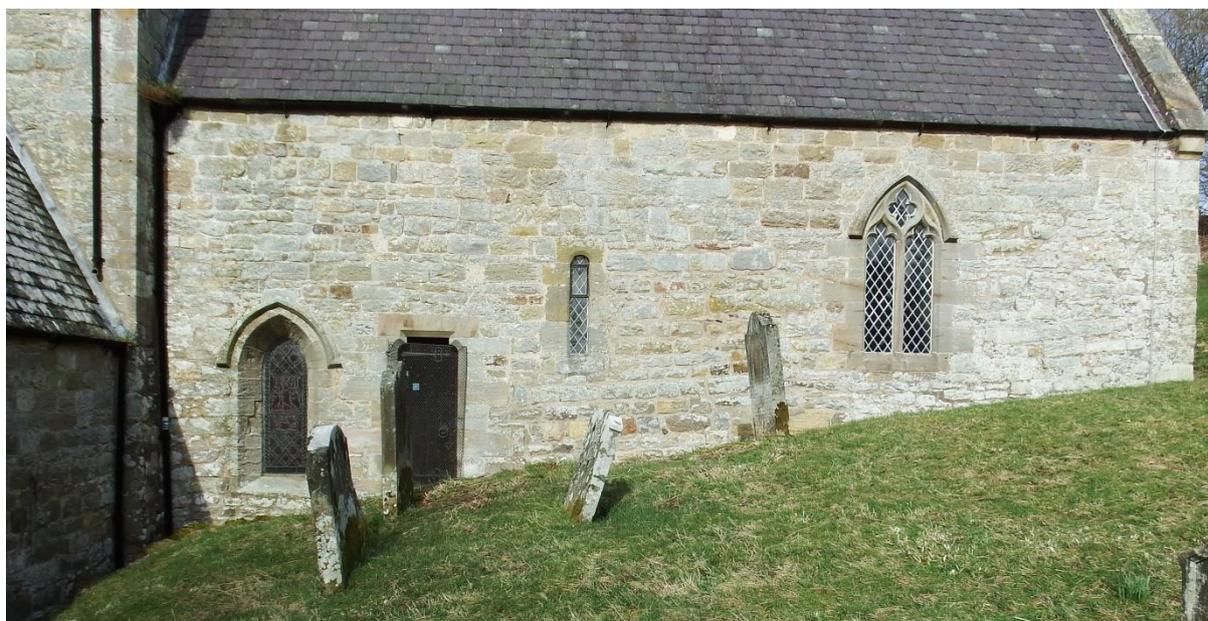
*The south wall of the Chancel*

The chancel is low compared to the lofty nave, and almost seems to burrow into the rising hillside; the upper parts of its walls and its steep roof are all of 1851, but lower down is much medieval fabric. Some quite small squared stones in the west part of the south wall are of 12<sup>th</sup> century character, as is a small round-headed window midway along the wall; to the east of this there appear to be two large quoins low down, suggesting that the eastern bay beyond them is an extension. In this section is a two-light window, most of its stonework 19<sup>th</sup> century but with a genuine 14<sup>th</sup>-century head, of two trefoiled

lights with a quatrefoil in the spandrel. Below the window a long roughly tapering block is re-used in the wall, which Honeyman thought may have been a cross shaft or tomb slab, but it bears no sign of any carving. At the west end of each side wall of the chancel is a low-side window, a short lancet, with its jambs splayed symmetrically from the centre of the wall. Honeyman sees these as 13<sup>th</sup> century in origin, but with their outer openings widened in the 17<sup>th</sup> century. The southern has been given an 1851 hoodmould.

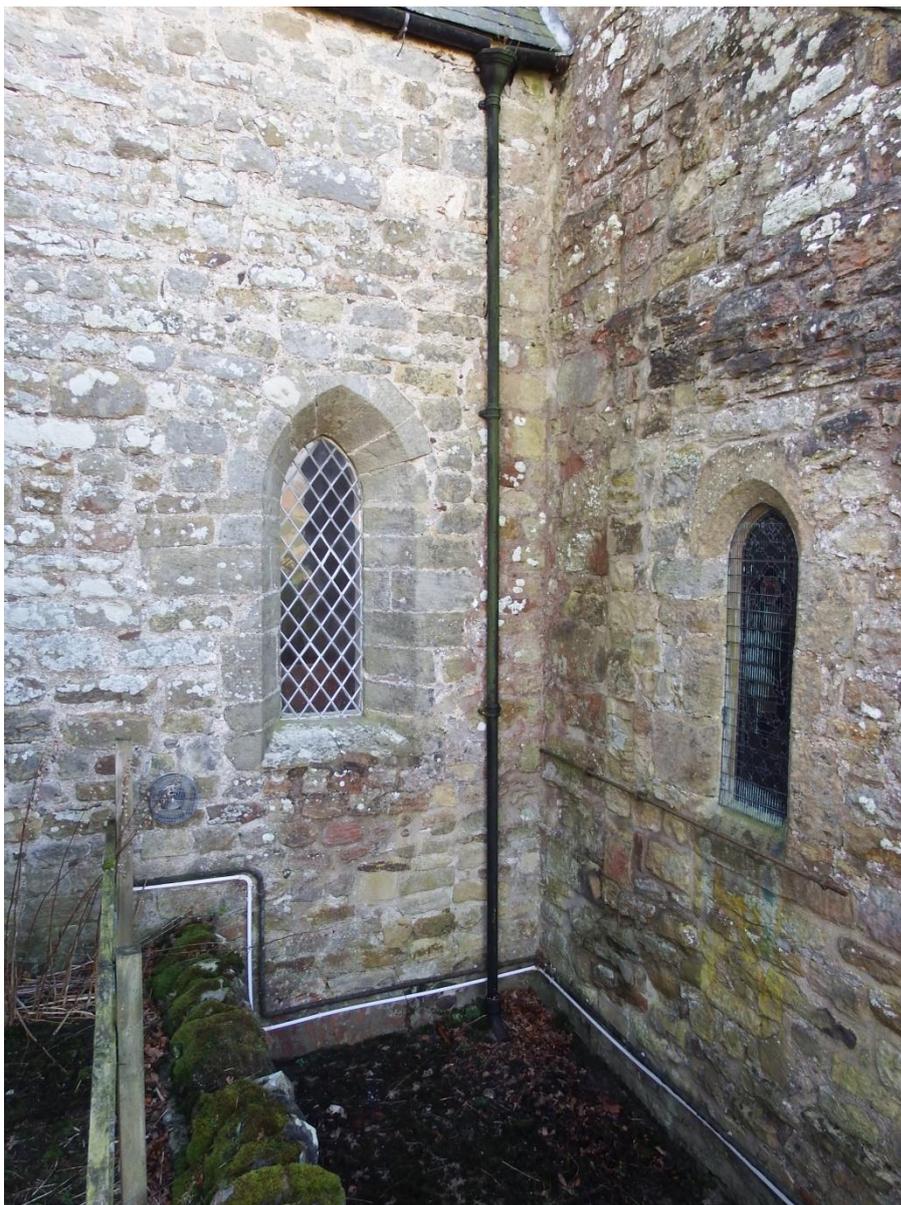
*The north wall of the chancel with its low-side window, and east end of the north aisle with a genuine 13<sup>th</sup> century lancet*

The east end wall seems to have been rebuilt above its lower courses (probably at some post-medieval date), and its three-light window is all of 1851, as if the vestry on the north. Below the northern low-side window, to the west of the vestry, the head of a brick arch is visible at the foot of the wall.

This formerly opened into the now-removed boiler house; Honeyman saw it as an entry to the crypt, but it seems more likely to be connected with the heating system.

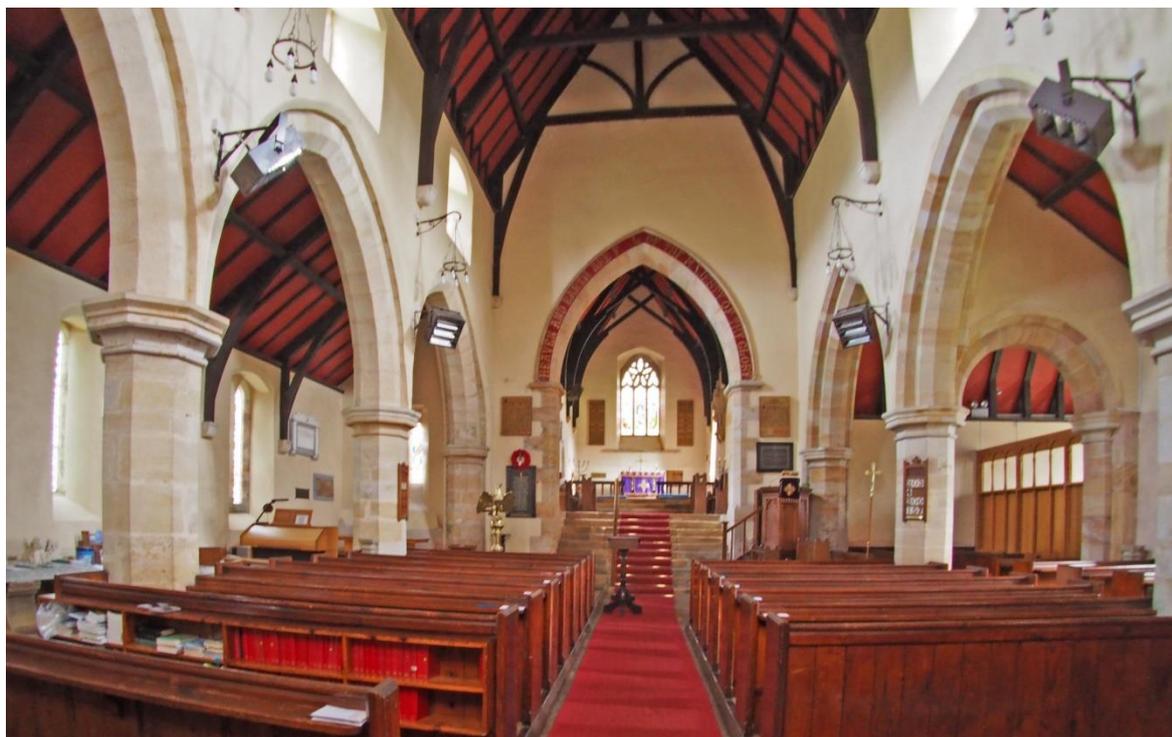
*Looking east*

The interior of the church is dominated by the fact that the floor of the chancel is raised ten steps above the nave, and there are three further steps up to the sanctuary. All walls are plastered and there is little immediate evidence of antiquity. The near-matching three bay arcades have pointed double-chamfered arches, octagonal piers and semi-octagonal responds, which have moulded capitals and bases. According to Honeyman all this, bar the eastern responds of the arcades, is of 1851, but a closer inspection shows that this is not the case. All the south arcade is Victorian (bar its eastern respond which has a renewed capital but an old chamfered base) but the north arcade is old; its stonework is of quite different character, and its outer order much narrower, and plastered over. The piers have at least been re-tooled, and their moulded capitals and bases are Victorian, as are those of both responds. The

eastern respond has an infilled slot, probably for a screen, and, tucked into the angle between it and the east wall of the north aisle is a tiny round-arched piscina, recessed into the lower section of the aisle east wall, which has a marked batter. The east window of the aisle has an old shouldered rear arch, behind plaster. The chancel arch is all of 1851; its predecessor (shown in an 1825 sketch by John Hodgson, seen by Honeyman<sup>2</sup>) was a very narrow arch with a heavy chamfered impost returned across the west face of the wall as a string course.

The impressive flight of steps up to the chancel is probably all of 1851; it conceals the entrance to the crypt or burial vault under the chancel; this was last used for burial in 1868 (Honeyman 415). The ninth step has sloping wedge-shaped joints so that its central section can be lifted out, which would allow the removal of the steps beneath to give access to the crypt.

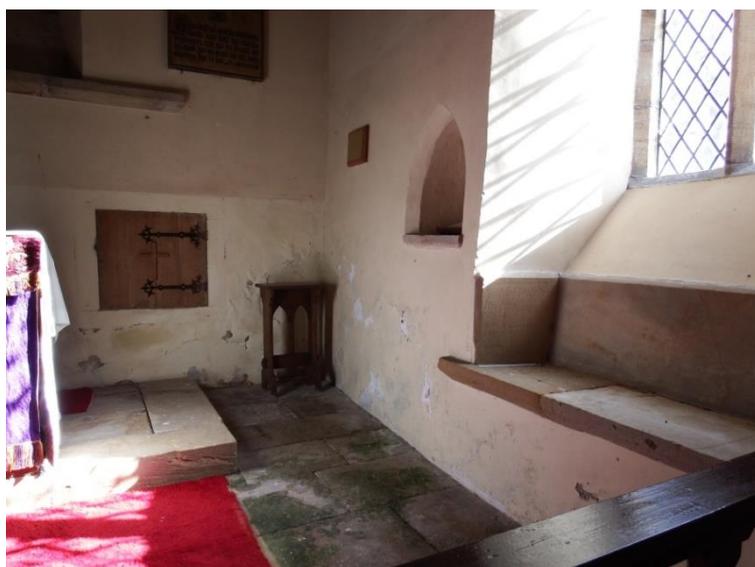
Nearby in the east wall is a square-headed aumbry, externally rebated for a door, but its dressings all look of 1851.

*The south-east corner of the chancel, with the medieval ritual arrangement of sedile, piscina and aumbry (with door)*

In the chancel, the two low-side windows each have trefoiled rear arches, and the Norman window in the south wall a plain semicircular one, behind plaster. The internal sill of the window on the south of the sanctuary is lowered to form a sedile, although its stonework (except perhaps for part of the seat) is all Victorian, but immediately to the east of it is a genuine piscina with a pointed chamfered arch and a shallow circular bowl, with a central drain. Its top is roughly domed, and seems to have a clogged central shaft, perhaps a flue<sup>3</sup>

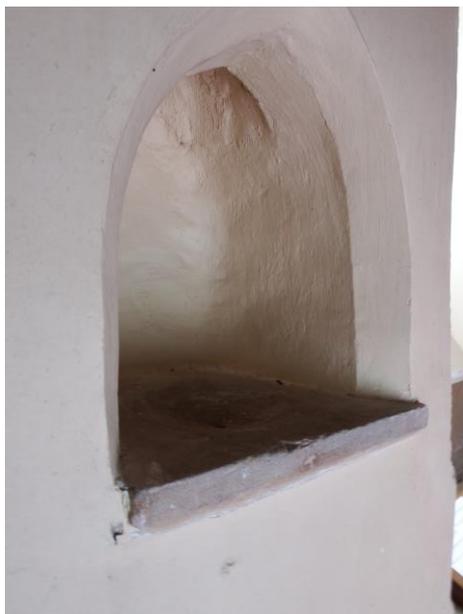
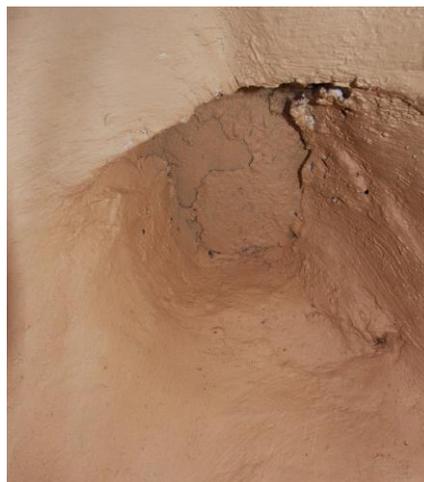
*The chancel  
piscina*

*(left) and its  
possible blocked  
flue (right); was  
this once an  
oven used in  
preparing  
wafers for Mass?*

<sup>3</sup> In the sacristy at Hulne Friary is a recess with a bowl, shelf and flue, thought to have been used in the preparation of wafers for Mass.

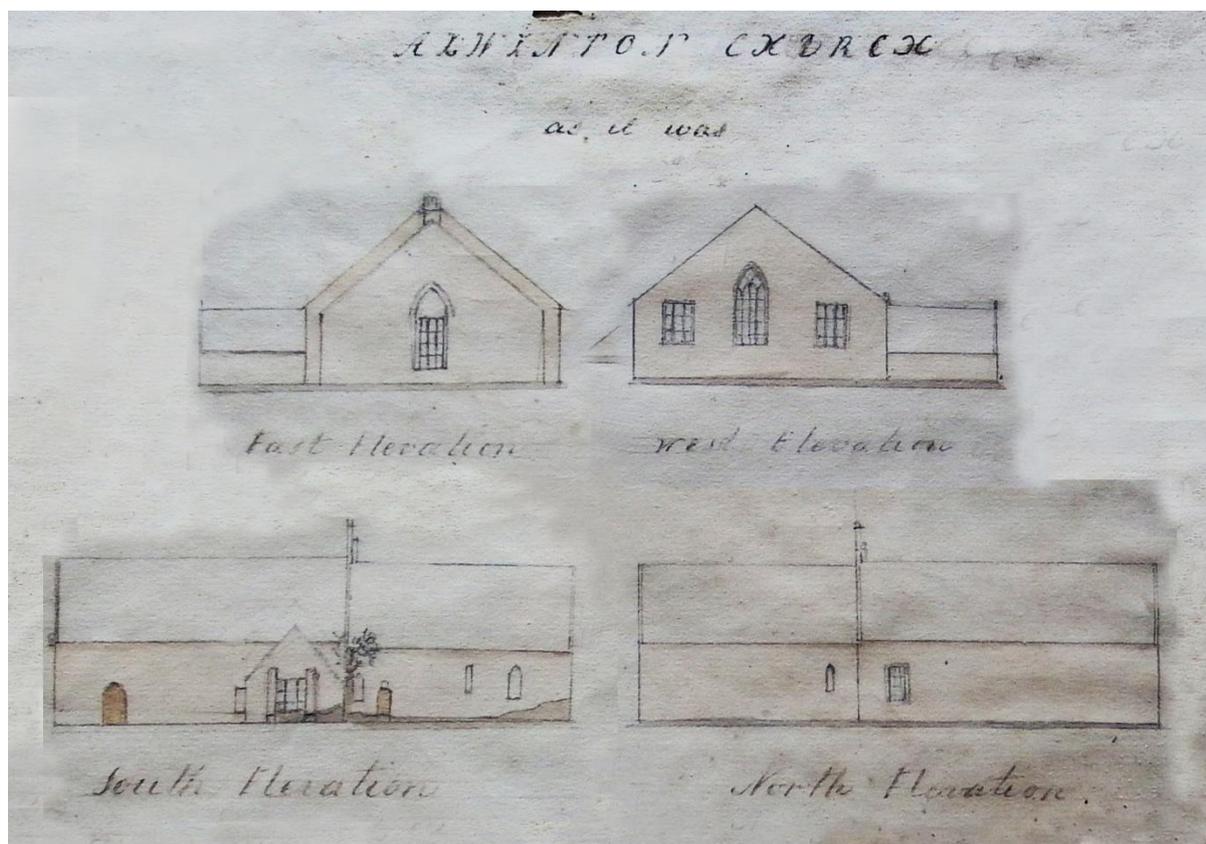
The drawings (above) show the nave and aisles as much lower than at present, and covered by a single gabled roof of fairly low pitch; the chancel had a roof of the same pitch, and was only marginally lower. The bellcote was unusually placed on the east gable of the nave. The west end had a Gothick-style window to the nave (holding a sash window with intersecting glazing bars) flanked by square-headed sashes to the aisles. The side walls of the aisles were almost bare of openings; the south aisle had an arched doorway and a possible small window hard up against the Biddlestone Aisle, and the north aisle had one square-headed window (remains of which survive) near its east end. The Biddlestone Aisle had a very low eaves line, and one square headed window set between a pair of buttresses in its south end wall.

The drawings give some clue to the earlier history of the building. Whilst there is now no direct evidence of defensible measures in the building, it seems highly likely, given the situation of the church and the troubled history of the area, that they existed. Although the nave and aisle walls were probably rebuilt c1720, their dearth of windows may perpetuate what was there before; there may have been a late medieval/early post-medieval reconstruction such as took place at Bellingham and Elsdon. The low eaves of the Biddlestone Aisle, and the fact that Honeyman records that it had thicker walls before the 1851 may imply that it was once vaulted even if, as the re-used cross suggests, it was rebuilt in 1672.

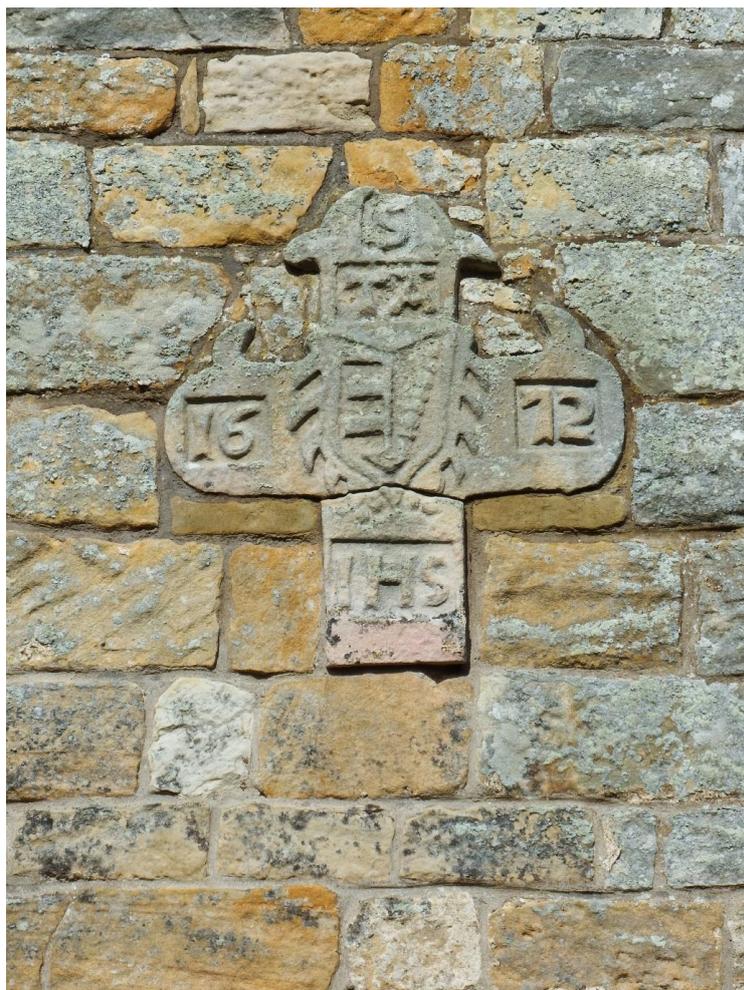
*The 1672 gable cross, with the Selby arms, and, unusually for this period, the Sacred Monogram.*

1672 One of the Selby family rebuilt the Biddlestone Aisle (the date on the re-set gable cross)

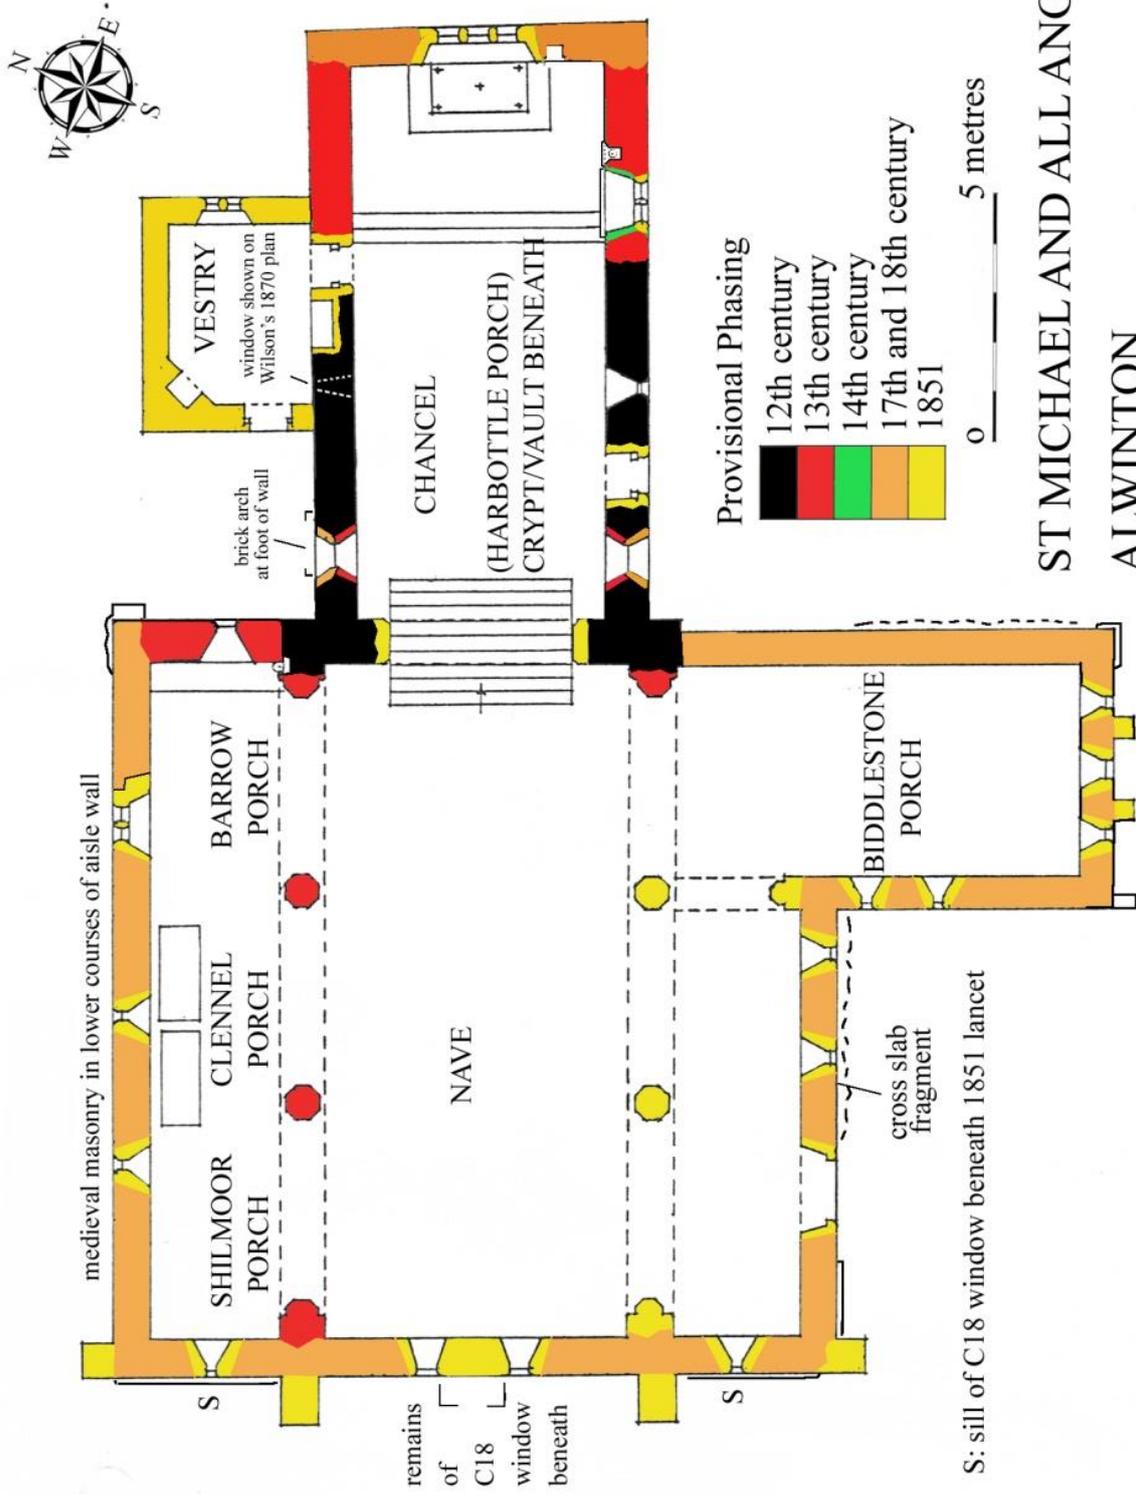
ST MICHAEL AND ALL ANGELS  
ALWINTON

Outline plan 1936/7 H L Honeyman, amended PFR 2020
