VENTILATION AND DRAUGHT PROOFING IN HISTORIC CHURCHES

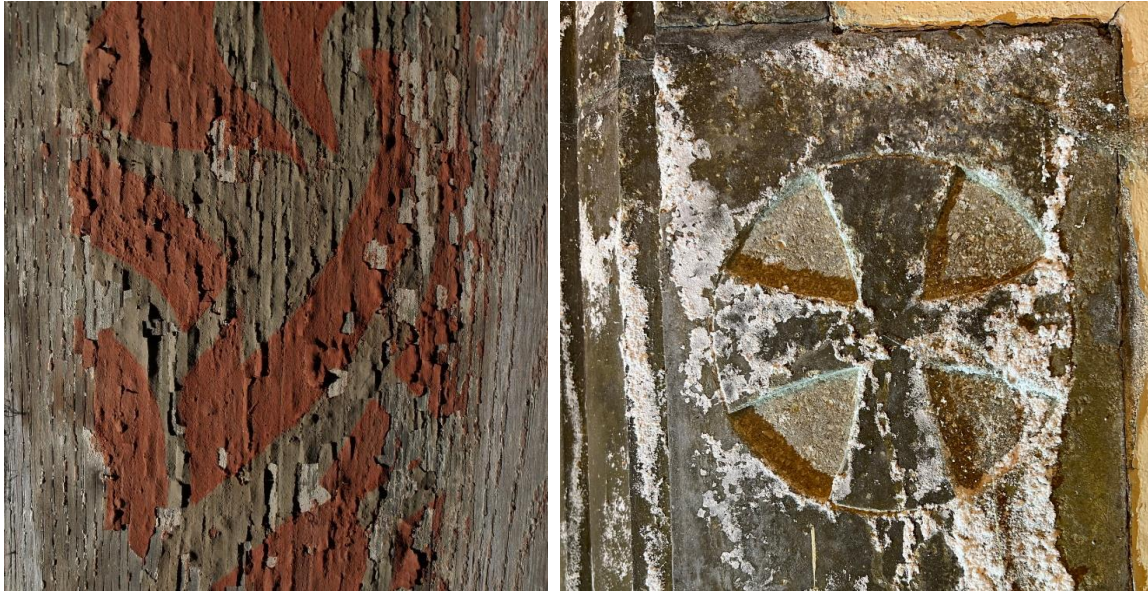
Damage to a painted ceiling and salt deterioration on masonry due to unstable environmental conditions.

In broad terms, effective conservation of the building fabric and the furnishings requires stable environmental conditions without an elevated level of relative humidity (RH). Large fluctuations in RH can cause timber furnishings to expand and contract, sometimes leading to cracking and splitting. If the timber is painted, such as on a ceiling or a rood screen, this can cause flaking and loss of the paint layer. Painted hatchments suffer from the same risks, with expansion and contraction of the canvas causing separation from the paint layers. High RH can also lead to mould growth on textiles, timber and books. On stone and plaster, and on wall paintings, large fluctuations in RH can cause salt activity leading to powdering, flaking and loss.

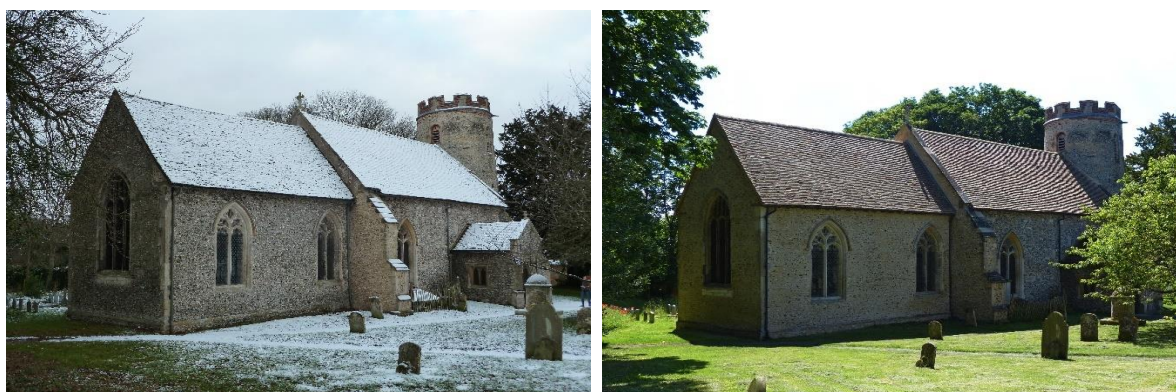
External temperature and humidity are far more unstable than internal conditions.

In a well maintained church, on a typical sunny spring day, the humidity and temperature inside the church is generally relatively stable, varying by less than 10% relative humidity and 2°C, which is beneficial for the conservation of the fabric and monuments. In contrast, external air may fluctuate by more than 50% and 10°C. Therefore, the introduction of this unstable air into the church will almost inevitably increase the conservation risks to the historic fabric and furnishings (see below).

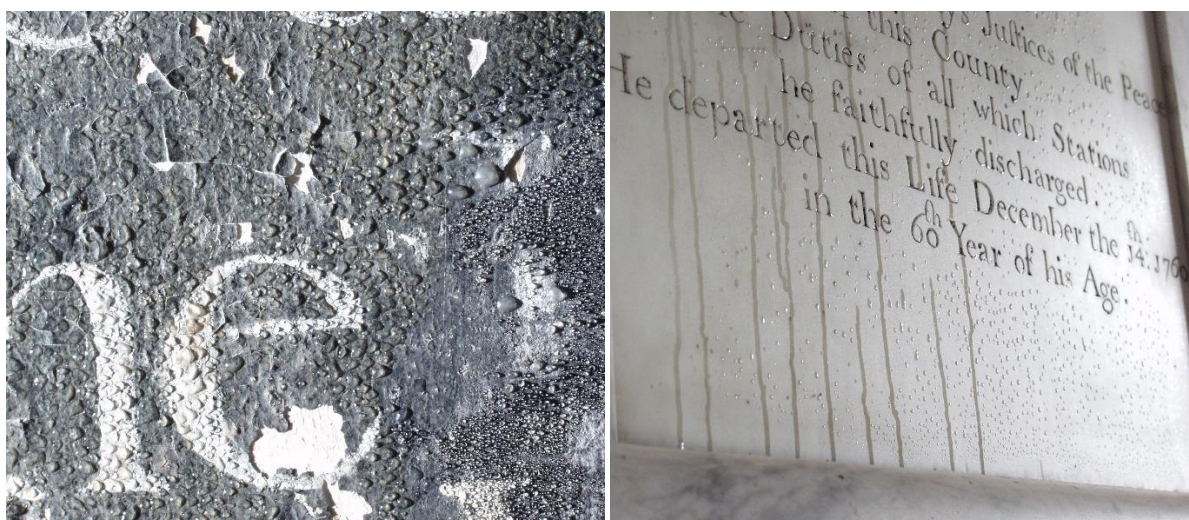
The introduction of warm, moist “fresh” air into a cold church can cause significant condensation and damage.

Due to the potential differences between temperature and humidity conditions inside and outside a church, poorly controlled air exchange can lead to condensation, causing significant damage to the historic fabric and furnishings. This can occur at all times of year, but is most prevalent in the spring when the masonry structure of the church, which is comparatively thermally inert (i.e. it changes temperature slowly), has been chilled over the winter. Outside, as the spring air warms, there is a large increase in the moisture content of the air due to water evaporating from the ground. If windows and doors are opened, sometimes in order to “air the church”, the warm, wet external air enters the building in large volumes. This air strikes the cold walls, decreasing in temperature until dew point is reached and condensation forms on the walls leading to the type of deterioration discussed above. Therefore, encouraging ventilation with external “fresh air” in these circumstances can be highly damaging.

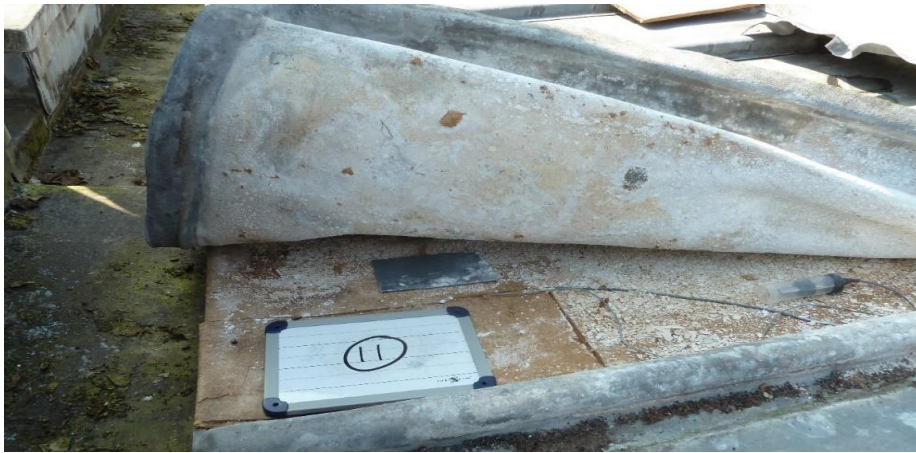
An example of underside lead corrosion: poorly designed roofs with insufficient roof space airflow can lead to severe condensation, resulting in underside lead corrosion.

This is a common occurrence, however, if there is sufficient ventilation around the wet lead, the moisture can evaporate with little damaging effect. In the event of insufficient ventilation resulting from air exchange and movement routes being blocked up, the lead can remain wet, causing underside corrosion and, in the most serious examples, condensation may run onto the adjacent timber, which may then cause dry or wet rot.

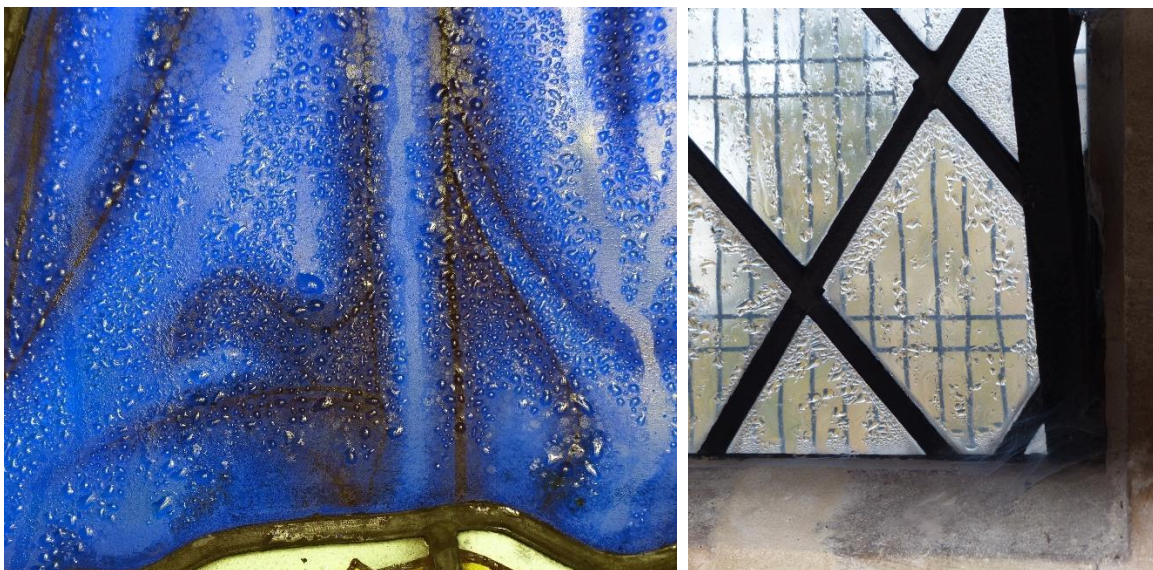
Severe condensation can form on cold surfaces, such as glass, causing damage to adjacent stonework.

In a similar way to condensation issues on roofs, this can also occur on church windows. Glass is generally more robust than lead, however historic stained glass is vulnerable to the effects of condensation, due both to the solubility of the body glass and the possibility of deterioration of the glass paint. The level of vulnerability of different types of stained glass varies depending on how it was made. In contrast to roofs, the surface of church windows are exposed, rather than being hidden behind sarking boards, and air exchange across the surface is generally good, which means that evaporation is easily achieved. Nevertheless, because there can be a significant accumulation of condensation on the relatively impermeable glass, this water can pool and run down the glass, causing damage to the masonry below.

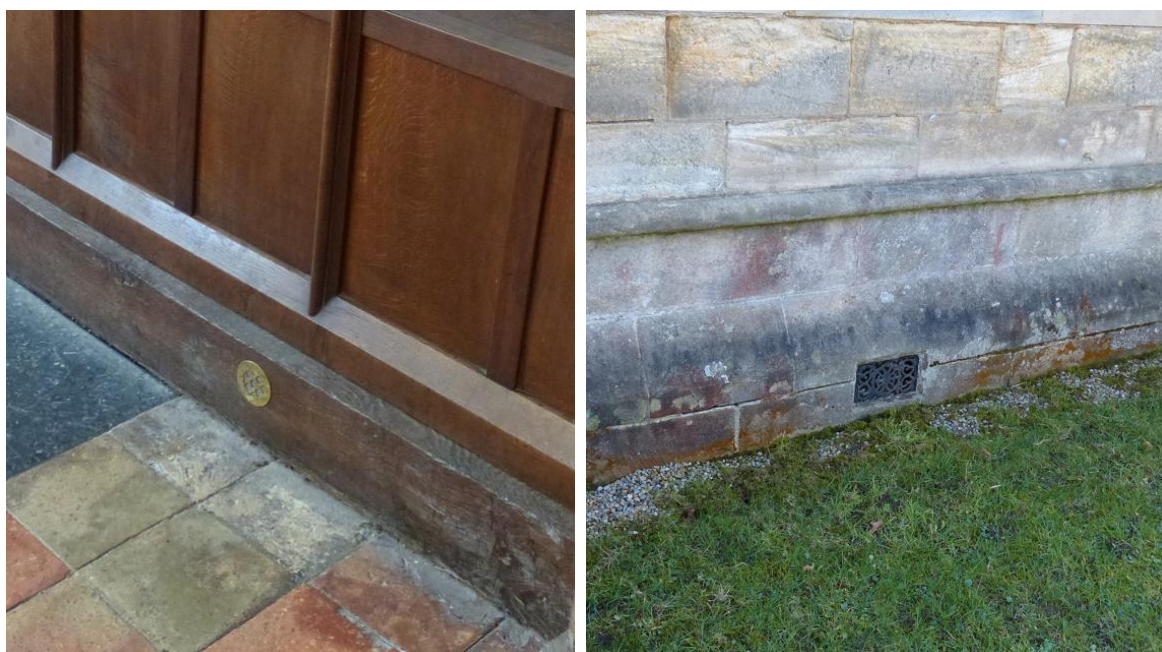
External and internal ventilation openings to under pew voids are designed to reduce moisture levels.

Traditionally, many of these spaces have been intentionally ventilated (external vents to under pew platforms and ventilation openings into wainscoting). However, many of these openings have been closed up either due to a misunderstanding of what they were for, or so as to prevent uncomfortable draughts.

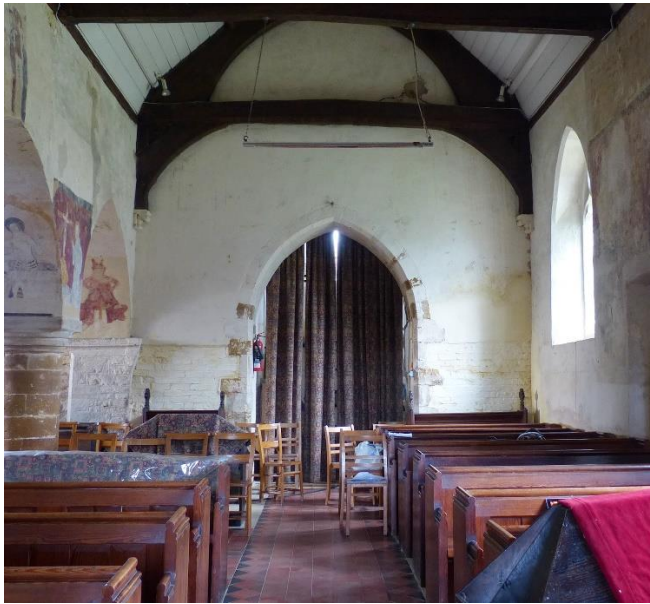
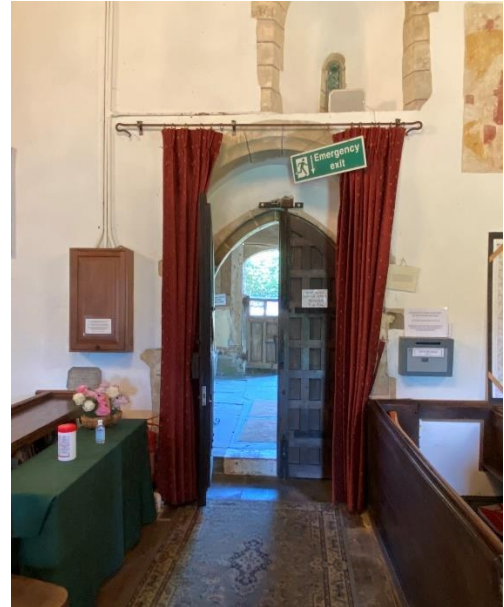
Tower curtains and external door curtains can significantly reduce air movement and draughts.

In the 19th century, a church would often have door curtains to block draughts, box pews, often upholstered, to create cosy, draught free spaces, and pew cushions and mats to reduce heat loss to the cold structure, thereby providing greater overall comfort. During the 20th century, as fashions changed, many of these features were removed from churches, making the building more vulnerable to draughts and sources of uncomfortable cold.
