Neston St Mary and St Helen – Bell frame

REPORT & QUOTATION

STRUCTURAL REPORT

Client: St Mary and St Helen, Neston, PCC

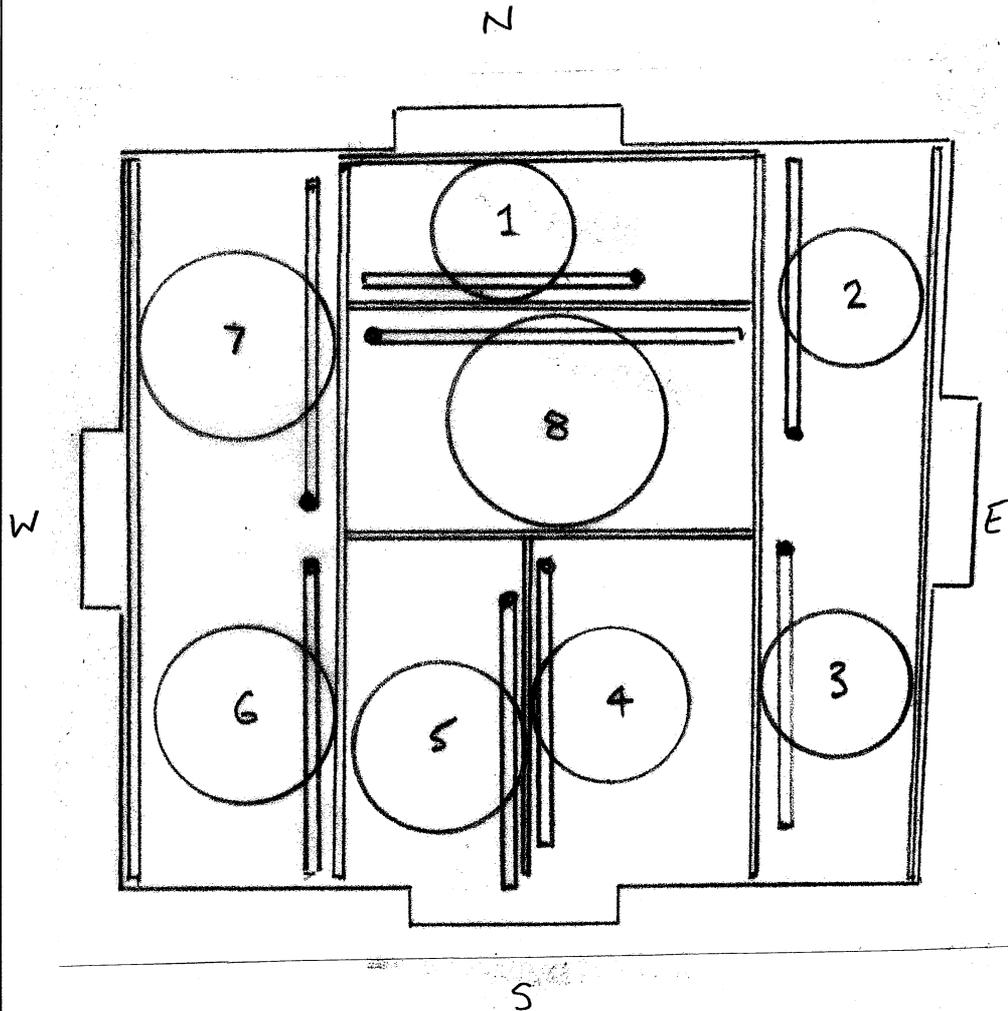
EXISTING BELL FRAME (DIAGRAMMATIC - N.T.S.)

The works that are proposed are, to replace the wooden bell frame with a steel frame. Over many years the frame has become cracked, worn and is showing signs of movement.
