Witton St Helen – Replacement of organ

Note to parish

Report on the pipe organ at St. Helen's Church Northwich after water damage to the swell chamber

SPECIFICATION of Work and Quotation for the repair of recent water damage to the organ:

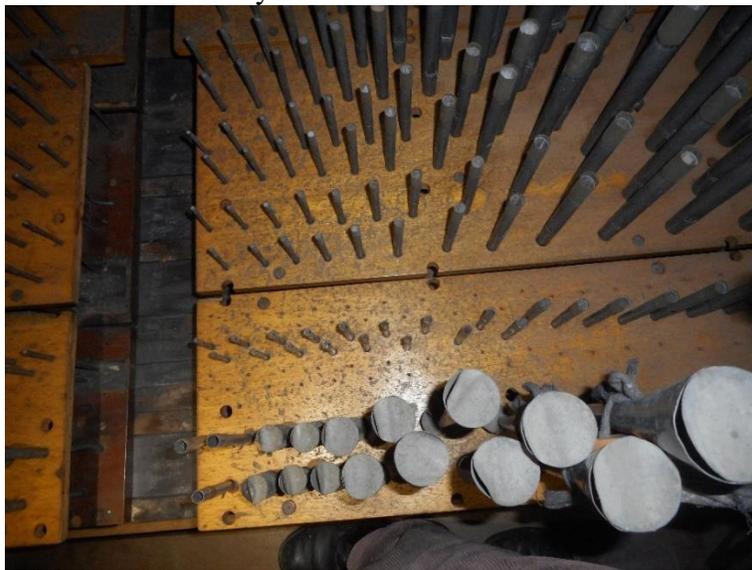
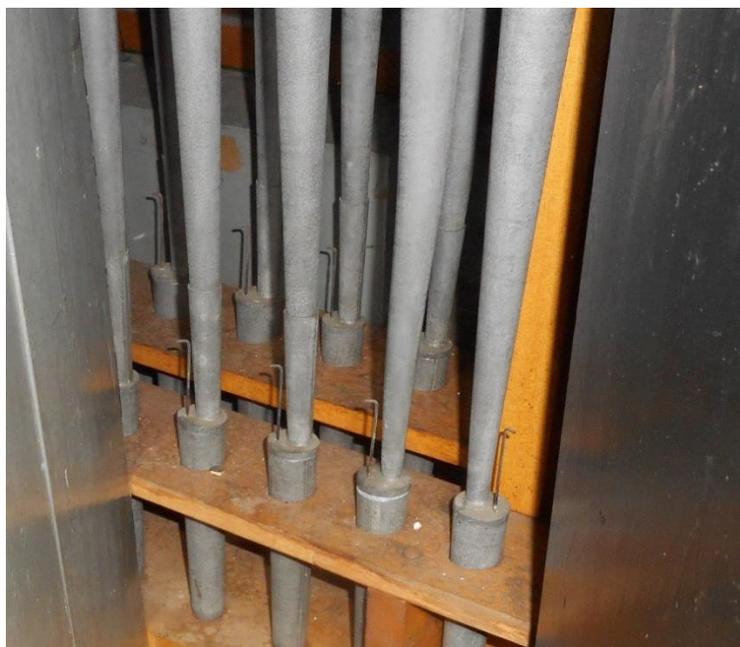
Heavily watermarked rackboards

To rectify the problems all affected parts need to be returned to the workshop for attention, the cost of which would be £87,080.00 plus vat.
