**The Parish Church of St Michael and All Angels,
Newburn-on-Tyne, and its West Tower**
Archaeological Assessment
combined with
Archaeological Recording of West Tower
after 2006 Fire

PETER F RYDER
B.A., M.Phil., F.S.A
HISTORIC BUILDINGS CONSULTANT

St Michael and All Angels, Newburn and its West Tower

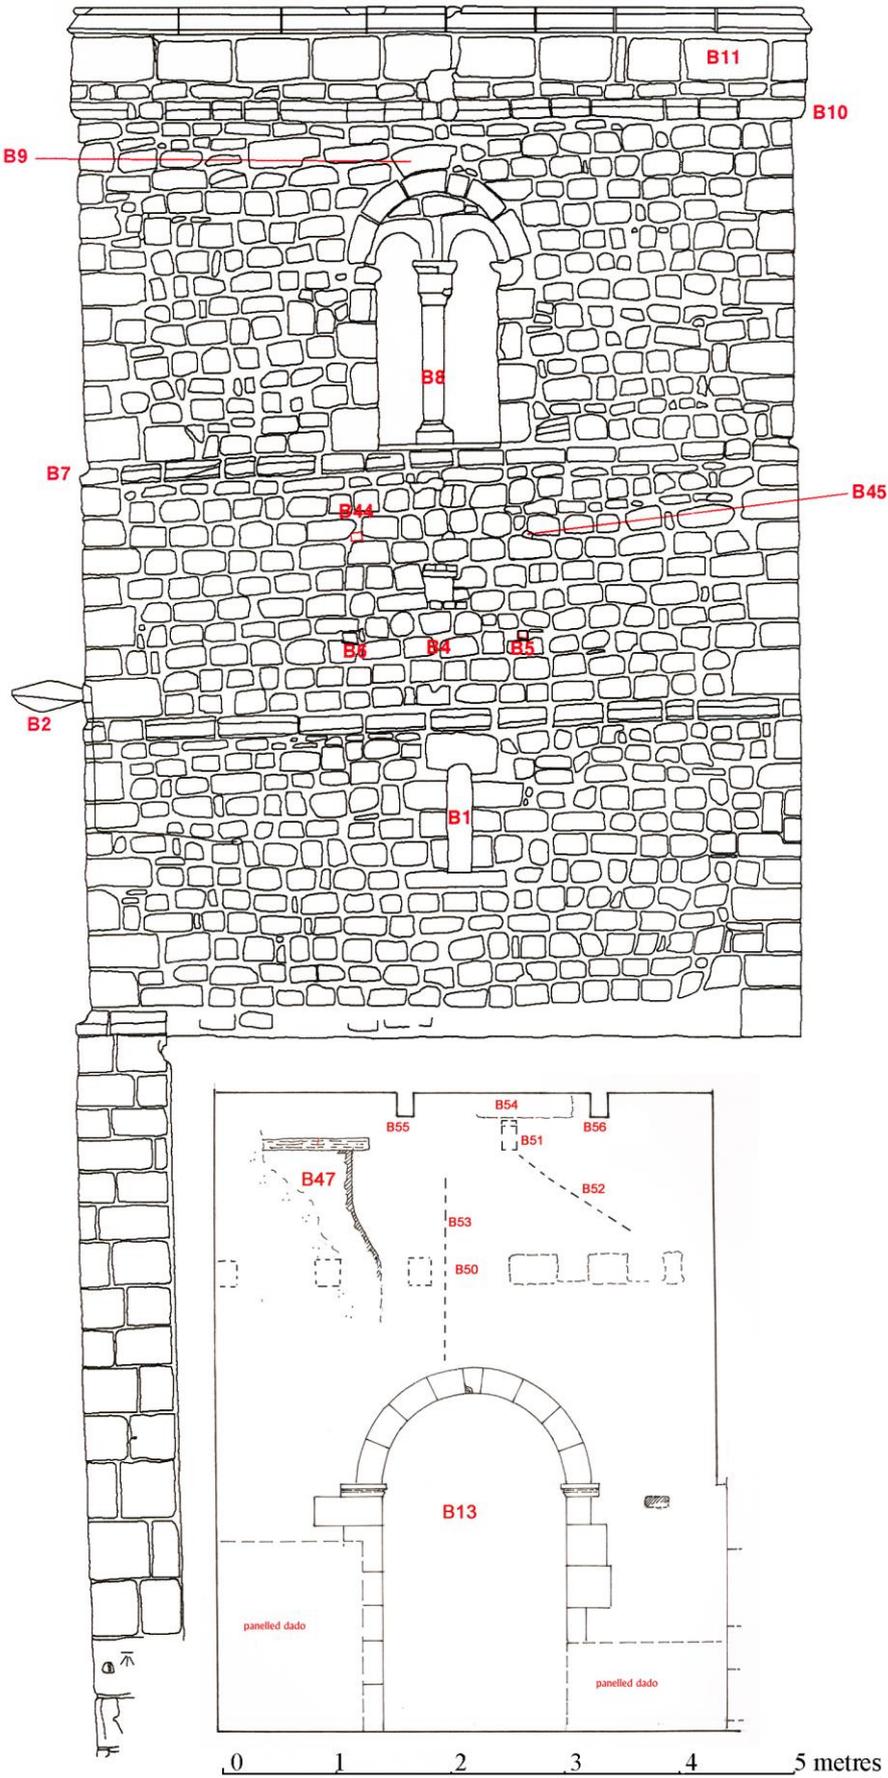
Fig.4
 West Tower
 Internal Elevation
 of South Wall

On the south of the tower (fig.3) is an archway into the south aisle (B13) of mid-to-late 19th century date, a plain square-section semicircular arch on jambs of same section, with imposts chamfered below and grooved like those of adjacent tower arch, all its dressings being of diagonally-tooled sandstone ashlar of 19th-century character, as with doorway C9 opposite. The doorway replaces a cupboard (B48) shown on the 1832/1833 plans, in the north wall of what was then a vestry, but which might conceivably have been an external doorway before the vestry was added in ?1826. The 1832 plan also shows a doorway (B46) and a cupboard (B48) to the west and east of the present archway respectively, which remain concealed by plaster. The 1833 plan shows the doorway B46 replaced a newel stair (B47), presumably of timber, is a square well occupying the whole thickness of the wall, replacing an earlier gallery stair at the north-west corner of the tower. This stair well – which must have threatened the structural integrity of the tower – must have been infilled after the present timber newel stair at the north-west corner of the tower was constructed late in the 19th century. During the 2006/7 works part of this infilled cavity was exposed, showing it to have been roughly quarried into the wall, with an overhanging and thickly-plastered east wall. The opening at the head of the stair showed on the internal face of the wall, from the gallery, as a blocked doorway (B16) 1.2m wide, with its west jamb only 0.25 m from the west wall. Returning to the south face of the wall as seen from the aisle, a row of sockets (B50) above and to the east of archway B13 probably related to the roof timbers of the early 19th-century vestry.

replaced. The open timber newel stair at the north-west corner also survived, although some members at the top have been replaced. Ascending to gallery level, on the south was exposed the blocked doorway B16 at the head of the 1833 newel stair, and a little above it a line of bricked-up sockets (B17 – B21) for the beams of a former floor, with similar features C13 and C14 on the north. On the west at this level the rear arch of window A9, of neatly-cut voussoirs, was badly damaged by the fire and is now plastered over. On the north is window C12, now opening into the roof of the aisle; its rear arch (fire damaged and now plastered over) is of rather distorted semicircular form, and seems an original 12th century feature, but the outer opening, square headed with a square-section surround, and a slightly-projecting sill, is perhaps of 18th or 19th century date.
