## Church of St. Gabriel Sunderland

The Care of Churches Measure 1991  
QUINQUENNIAL REPORT  
August 2018

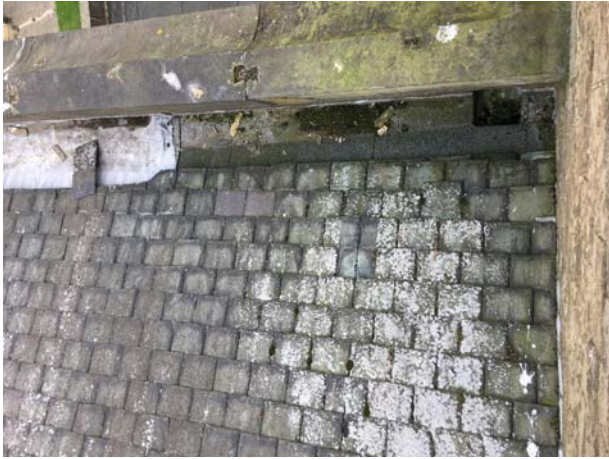
Photo 2:  
Slipped slate over organ

1.	Repair missing, loose and slipped slates	600
2.	Repair lead flashings above gutter and install new lead flashing to felt roof	600
3.	Replace sections of felt lined gutter	400
4.	Remove all seagull debris and vegetation from gutters	300
5.	Adapt Flower Room RWP to discharge to gully	300
6.	Clear all gullies and grille tops	200
7.	Adjust cisterns to stop overflows running	60
8.	Cut back shrubs around gullies	60
9.	Asbestos report for whole building	400
10.	Remove or treat asbestos as recommended to maintain 60min FR	?

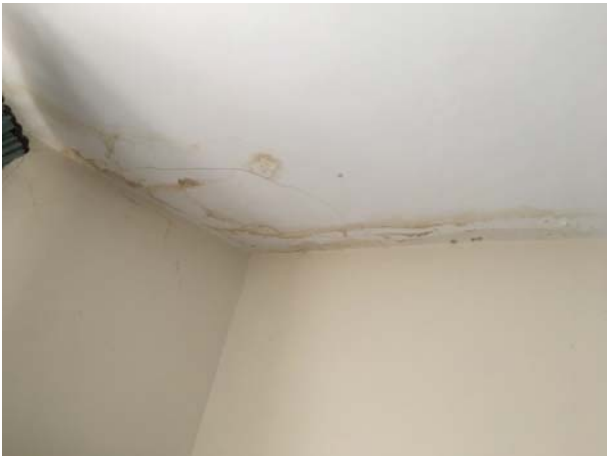
Photo 27:  
Water damage on Vestry ceiling

1.	Fit vent terminal to Vestry flue	100
2.	Repair/re-paint Vestry and Flower Room ceilings following roof work	600
3.	Prepare and re-paint corroded railings	600
4.	Prepare and re-paint steelwork on main notice board	300
5.	Repair WC door and closers to Undercroft	200
6.	Install discreet stainless steel ladders to access lower roofs	5000
