**QUINQUENNIAL INSPECTION REPORT
OF
ST. JOHN, THE EVANGELIST, BRANDON, COUNTY DURHAM**

QUINQUENNIAL INSPECTION AND REPORT

DATE OCTOBER 2020

David Beaumont BA (Hons) Grad Dip, RIBA, AABC

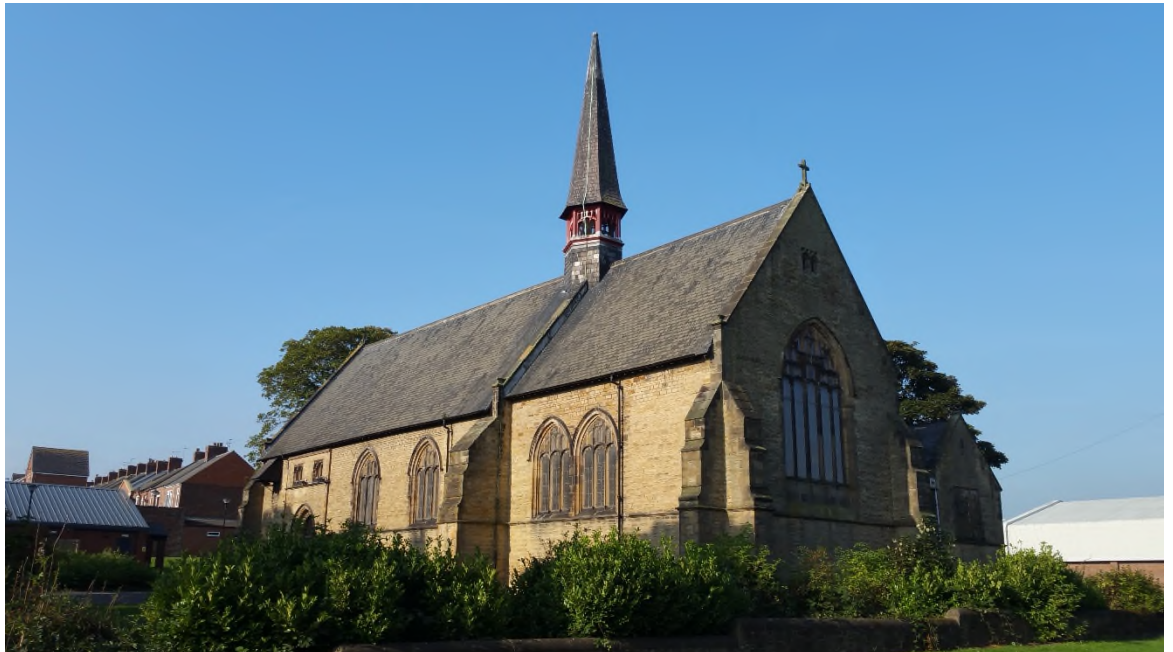
There are gullies around the building, some have grids, one downpipe doesn't quite connect to its gully and there is suspicions that one is blocked by the vestry entrance.

Grids needs to be replaced where missing.

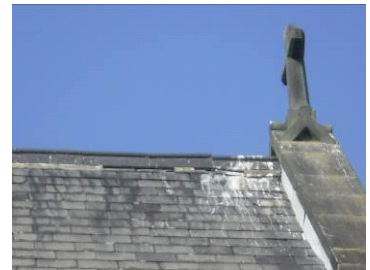
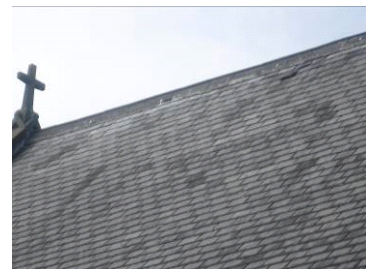
N side – Ridge pointing coming out, generally the abutments are ok, slating generally sound.

Recommendation: replace any missing slates and ridge bedding

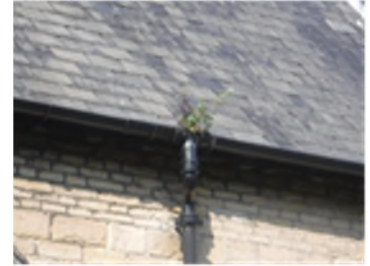
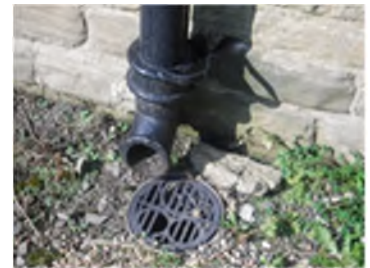
S – Weeds growing in the outlets to the downpipes suggesting that these are blocked, E most downpipe is loose and misses the gully, W has the cap into the ramp paving dislodged.

N – unable to see if there is a gutter.

Recommendation: clean out gutter weeds, unblock downpipes, check they discharge over gullies, replace missing gully grids, unblock blocked gullies and check for free running. Replace grey plastic with black cast iron.

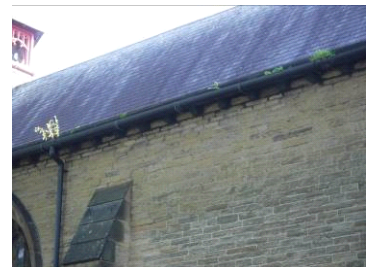
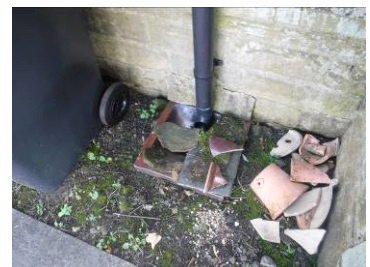
- **North Aisle:** Plastic gutter and two downpipes that are blocked at the outlets and there is grass growing in them, W most gully looks blocked - has standing water in it. W is ok, though it does have pottery to cover the grid to try and keep the leaves off.

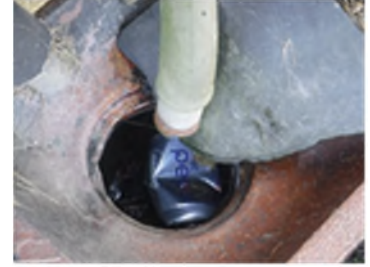
Plastic gutters and cast-iron downpipes, gully grid missing and it has got a drink can floating in the water, the gutter looks grey now because it doesn't get painted. There are various waste pipes going into the gully at this point, controversially one's a sink going into the soakaway.

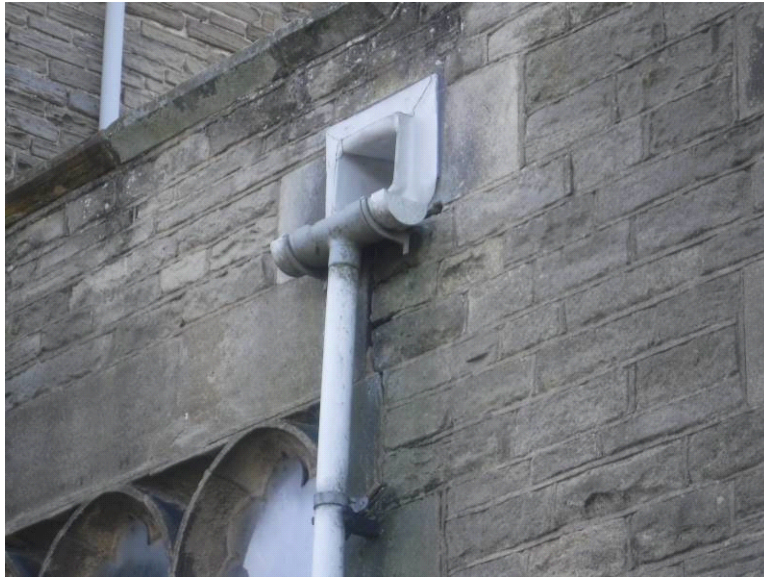
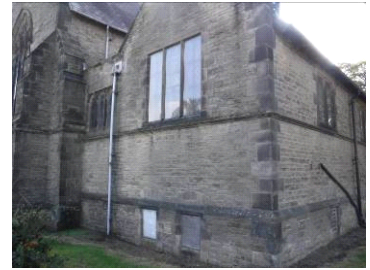
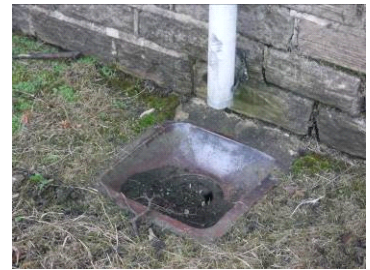
Serviceable but not really a dignified arrangement for a church. A box gutter would be preferable to a gutter and the goods to be in black to match the rest. The downpipe bottom doesn't have a shoe, is short of the gully and the gully is silted.

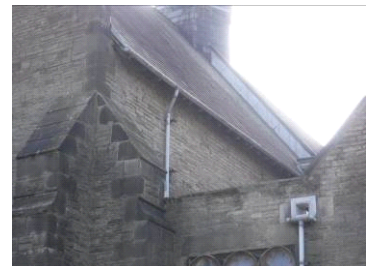
N side – Grey plastic gutter and downpipe, now with patches of algae on seems to be ok.

S side – Cast-iron gutter a bit missing at the E end. Downpipe is a little high and dry from the gully which has lost its grid and surround.

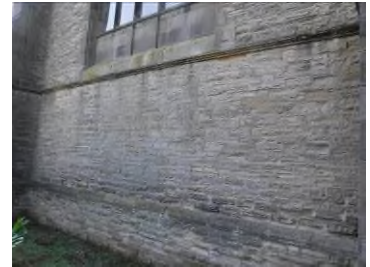
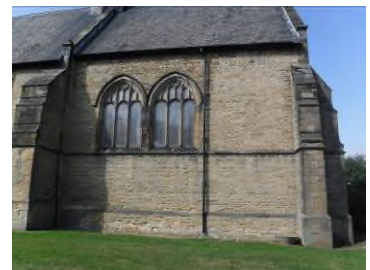
N side – Walling is generally ok, a little bit worn out below the plinth and just above it

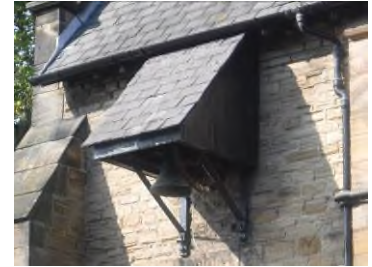
There is a single bell externally mounted under a sloping roof in a timber box on the N side of the aisle, it is look at by the church warden annually, it is still rung and it is reported to be in working order.

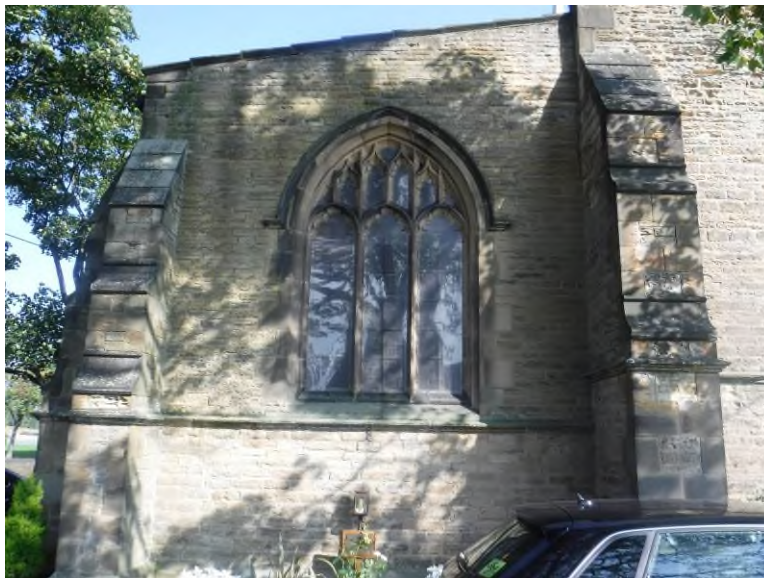
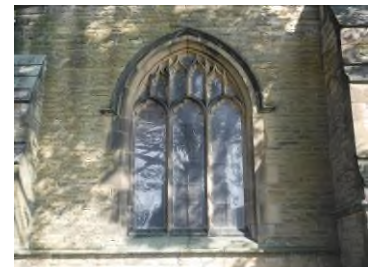
W side – Three light with tracery, hoodmould ok, tracery is ok, a slight open joint in the cill, all of those windows have polycarbonate.

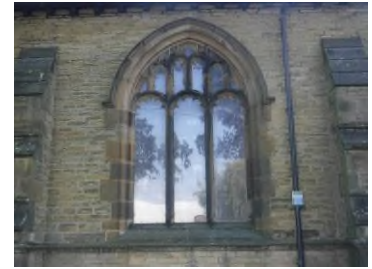
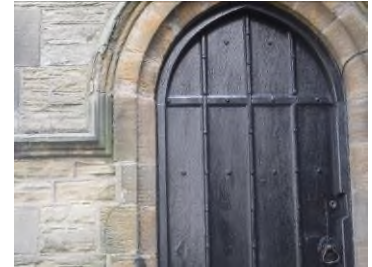
N side – Three sets of windows all of the same design, three light with trefoil and they are the same as the N side. E most looks to have cracking to the upper trefoils but it's actually the

construction joints. Hoodmould and jambs are ok as is the transom. All three are ok. Lancet doorway slight wear to the dressing but no problem, door itself is timber painted, not used and in fair condition.

Recommendation: none

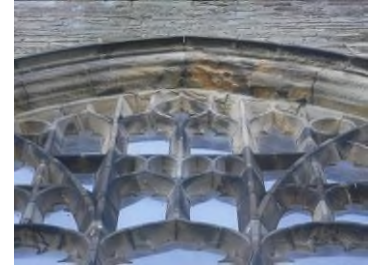
E side – Triple light apex window, same design as the W end, can't see it. Below that five light window same design as the W, open joint to the hoodmould and there is some water coming down that and is eroding the top of the tracery, there is a bit more erosion also to the N side, the jambs are ok, there is some slight wiggly movement but nothing major and mullions are alright though there is a chip in the base of one.

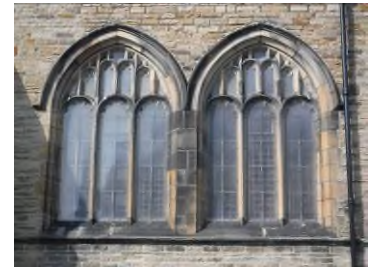
S side – Pair of three light windows, same design as the nave, there is a chip out of one of the stones by the apex on the W most, there is also an open joint at the cill of this window.

Recommendation: fill open joint

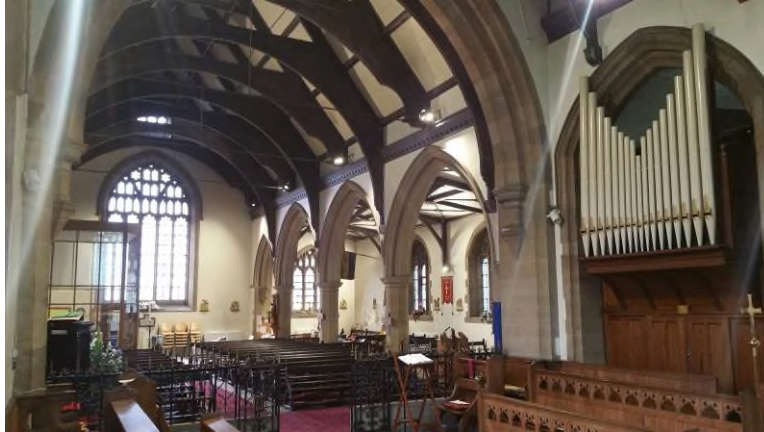
Four principle timber trusses with secondary, the secondary have tie rods and these in turn support purlins. The principle trusses sit on rounded corbels and the chamfers of the principle trusses are picked out in gold, there is also a longitudinal rod passing over the collars and these appear to be in good condition.

Recommendation: none

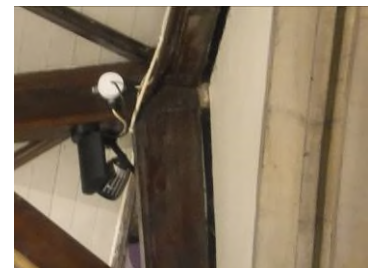
Roof is detached by approximately 25mm from the arcade at the apex and that is bowing out in the centre, suggesting that the N aisle N wall is leaning out. Highly likely to be historic but worth monitoring.

Recommendation: monitor

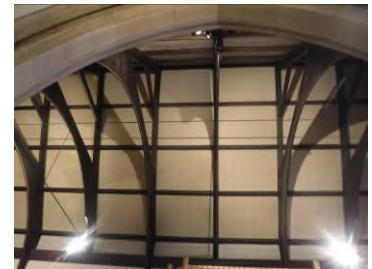
This is boarded exactly the same as the nave and it is a bit cobwebby up at the E end.

Recommendation: none

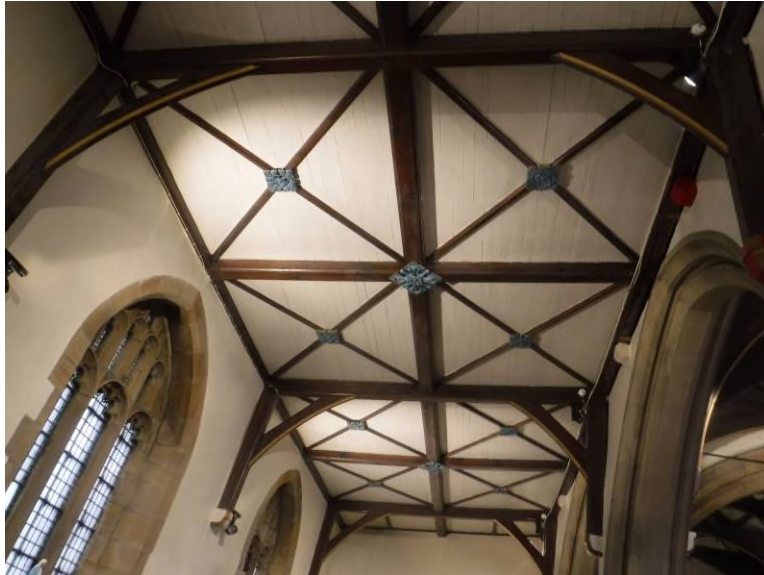
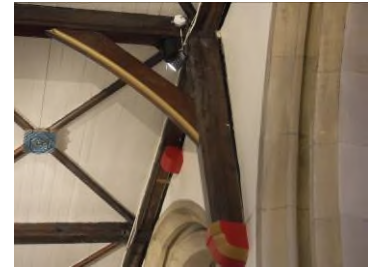
Diagonal ribs with painted bosses in bays which is very attractive with painted boarding. Boarding has some gaps to it but it looks as if its upkeep has been more than the harder to reach nave and chancel. See above about pulling away from the arcade.

Recommendation: none

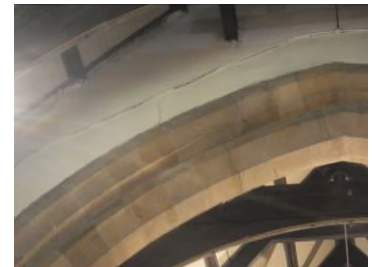
Quite a tall arch in ashlar stonework with chamfered mouldings, there is some cracking to both sides of the apex, though this does look historic, perhaps the greater is on the N side and that is borne out by some of the plaster cracking above it. The base of the arch has some damp and stone erosion but no action needed.

Recommendation: none

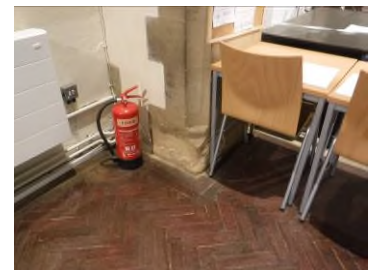
The arcade between the nave and N aisle has octagonal shafts and hollow moulded and chamfered lancet arches all structurally in good condition, no real or obvious suggestion of movement and the columns look quite perpendicular but see previous comments about the N aisle pulling away at the head. The bases of all of the columns within the arcade are good, the W end has a little erosion and there is probably a bit more at the E end adjacent to the chancel arch.

Recommendation: none

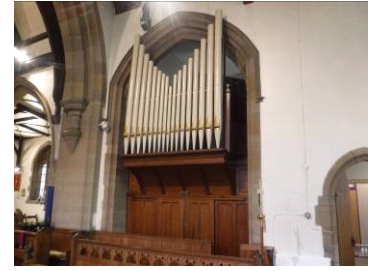
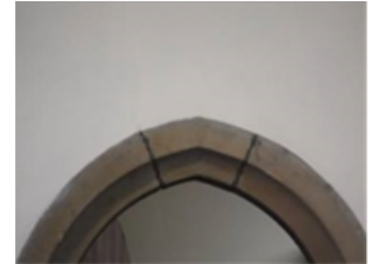
Arch from chancel to Clergy Vestry slight dropping of the keystone but this is historic.

Recommendation: none

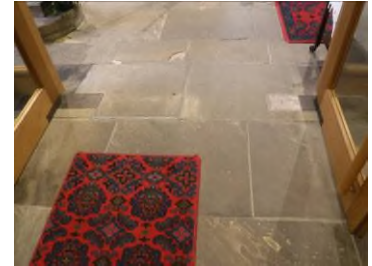
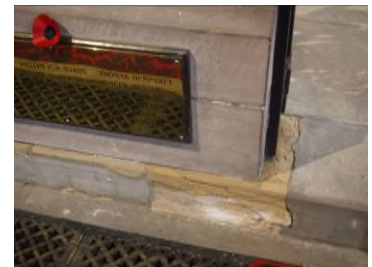
7.5.4 FLOORS, RAILS

Solid floors throughout the building. Within the nave it comprises flagstones and pewed areas in herringbone woodblock, these don't have a void underneath them, and they are fairly solid.

Some of the slabs are cracking and laminating, they have had the occasional cement patch that has broken up as well but there is little you can do about this other than not use cement next time.

There are some open joints and it undulates slightly at the entrance to the organ loft, the circulation areas are covered in carpet and there are former floor grilles underneath them particularly at the start of the step to the chancel and that does give the chance for a bit of a trip hazard. There are floor grilles at the junction of the nave by the chancel arch.

Recommendation: none

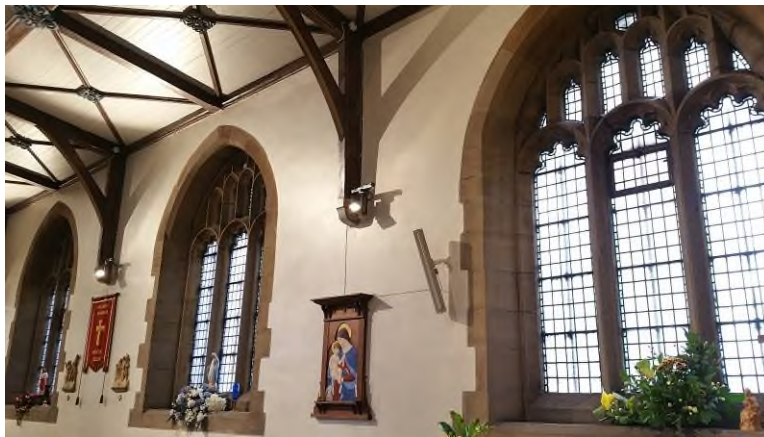
- **N Aisle:**

Obscure rectangular glazing as previous, dirty with a lot of markings against the saddle bars, some foreigner pieces of glass in, some clear in fact but don't really need anything doing to. The masonry all ok.

W – Same pattern as the W window, some of the replacement glass is missing its lead comes and it is very dirty and needs a proper clean down.

Middle – Very grubby up at the apex and a very poor repair of one large rectangular clear glass though it is now so dirty it is obscure.

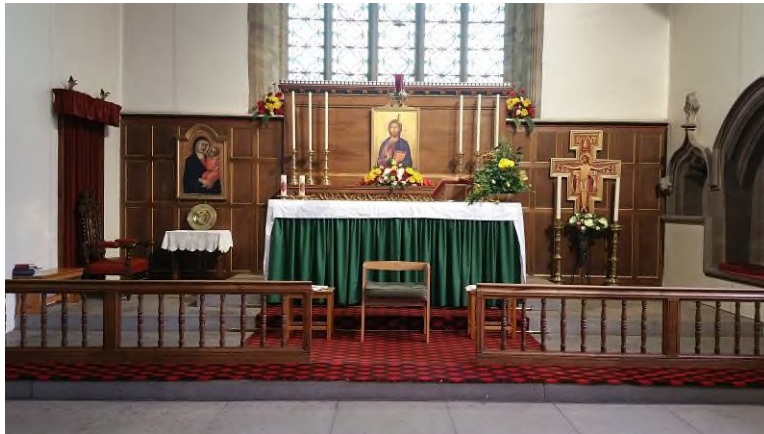
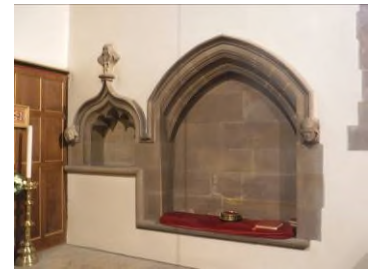
- **Chancel:**

Fine oak panelled reredos with gold decoration. Good oak altar, Bishop's chair and simple oak table, modern Priest's chair, there is also a stone sedilia on the N wall which is a nice feature. Oak altar rails, pitch pine tiered choir stalls. Organ case with painted pipes in plain colour, organ restored possibly 1974 rather choked with lots of pew cushions in one place here, and there is a Glastonbury chair and a Priest's desk in pitch pine.

Recommendation: none

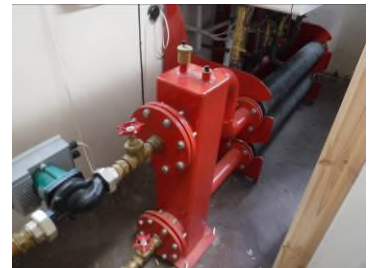
B Choir Vestry –

Fairly rudimentary sink units, tap dripping to the overhead water heater, the room has recently had partitions formed in order to house the boiler, there is also a bit of lumber in the room, there is some modern wardrobes and some built-in original wardrobes which are bursting a bit and could do with latching back better.

Recommendation: check water heater, remove lumber

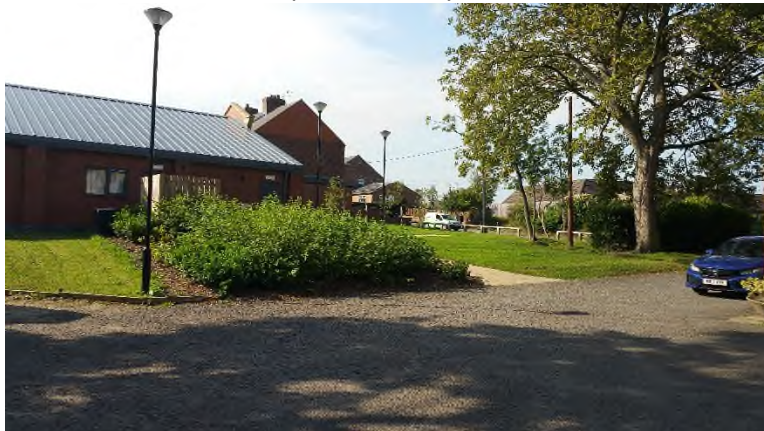
S side – Is a shrub and open boundary, no fence.

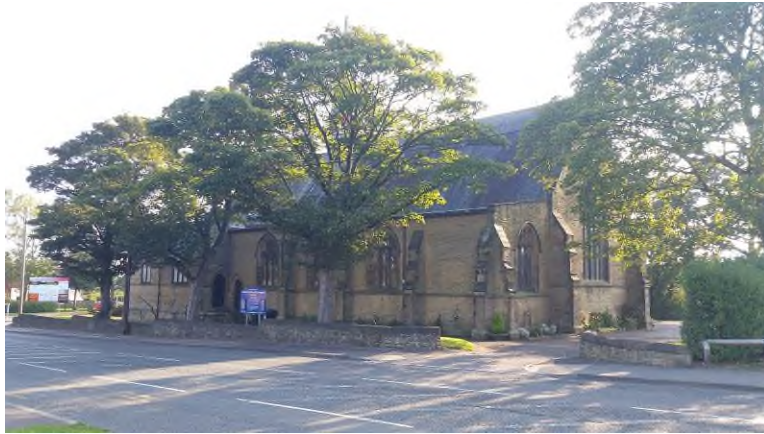
N side – Is to the highway which is a stone outer and a brick inner, must be like that on the other elevation as well. Open joints to it but it is generally sound.

Recommendation: none

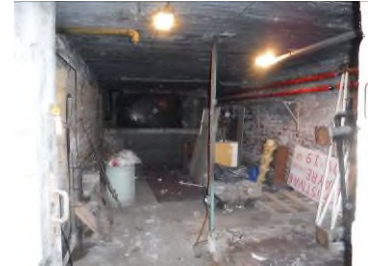
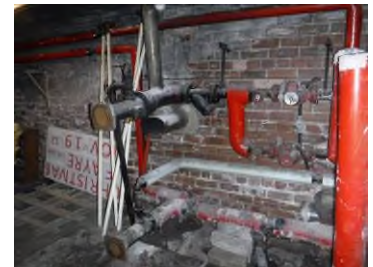
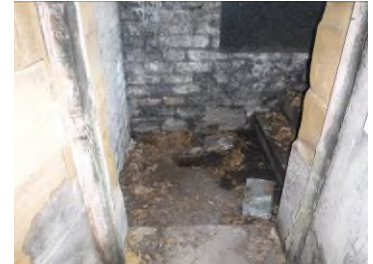
Door has lost its decoration, it generally just about functions. It has lost one of its louvres. There is steps down to a landing that has got a gully in it which is covered by a stone and that needs to be a better arrangement, there is water in the bottom of it and there is often quite a lot of leaf build-up, this is all barricaded by a metal sheet door that is losing its decoration.

Recommendation: tidy up room and ensure drainage is working.
