Diocese of Durham

CLEADON PARK
St MARK and St CUTHBERT
(4)

QUINQUENNIAL REPORT
on the architect's inspection on

25 May 2023

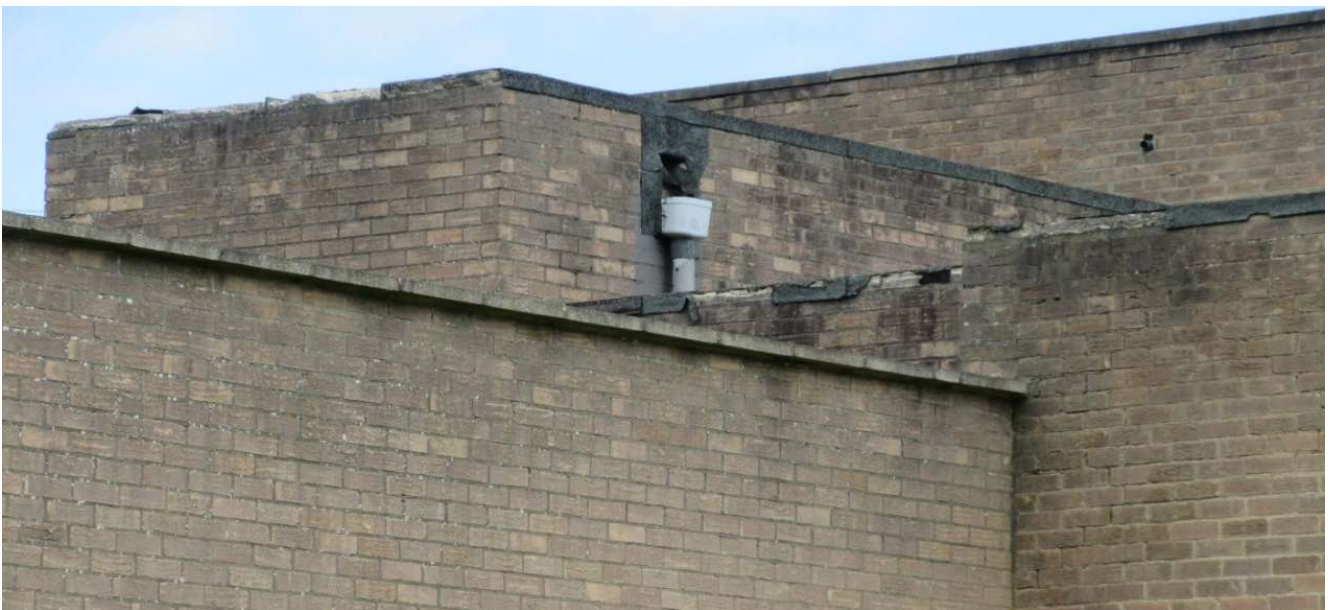
Detail of copings and parapets from the park – Church at top and Hall at bottom generally sound but between them the Stair and below it the Vestry/Meeting rooms both have decayed roofing felt over decaying cast stone copings. At top left the brickwork begins to crack apart (paragraphs 18 and 28)

18. The intermediate rooms all have green bitumen felt carried over the parapets and copings. In fair condition except
 - badly damaged and part missing where carried over decayed copings at both roofs above the Hall.

At NW the south facing render and many inner bricks (not facing brick quality) are decayed. If not covered soon by roof alteration the render should be repaired or covered with roofing material or rebuilt with facing bricks without render.

- Replace copings at Stair end and Meeting room over Hall with
relaying of disturbed bricks and cover with extended roofing felt 18, 28
- Seal or flash Hall roof to parapet at S corner 21
- Remove saplings against Church and Hall walls 33
- Restrain hardwood infills at Church windows 39
- Repaint outside of windows at stair, vestry, meeting room and Hall 40, 41, 42

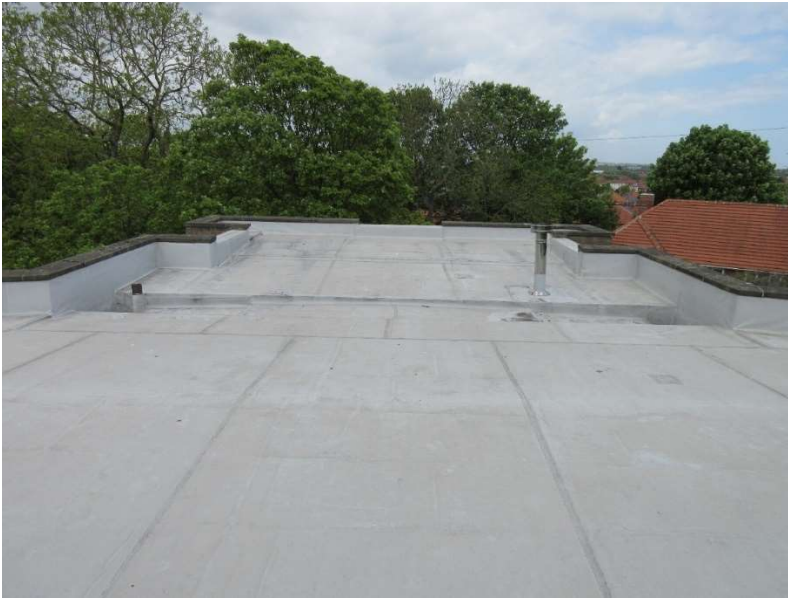
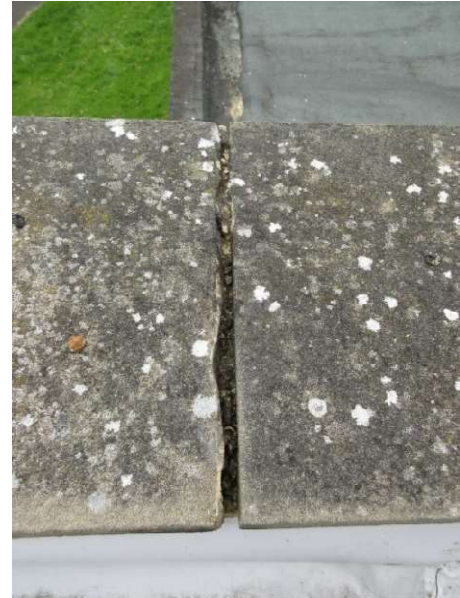
15. The roof and gutters are covered in light grey Sarnafil on foam insulation slabs on felt vapour barrier added over the original and repaired decking, replacing stolen copper. The slight falls are just sufficient especially at the gutters.
Collars at a soil vent pipe and recent metal flue pipe through the roof.
Several professionally fixed Sarnafil patches on the roof where intrusion caused tears and cuts.

16. The Sarnafil carries up inside low parapets and under cast stone copings or over the whole wallhead over windows where there were no original copings. Some open coping joints.

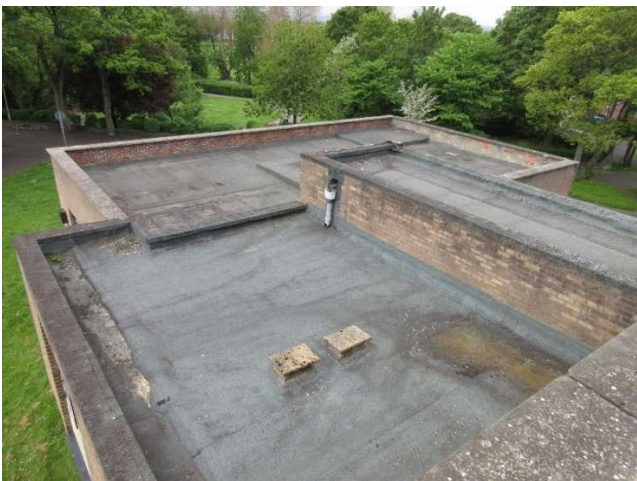
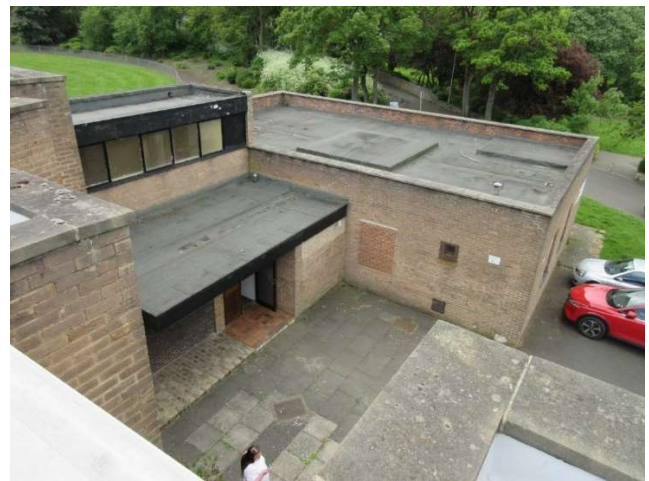
General views from the Church roof

Roof over vestries, ponded in corner over lobby, movement joint against Church wall

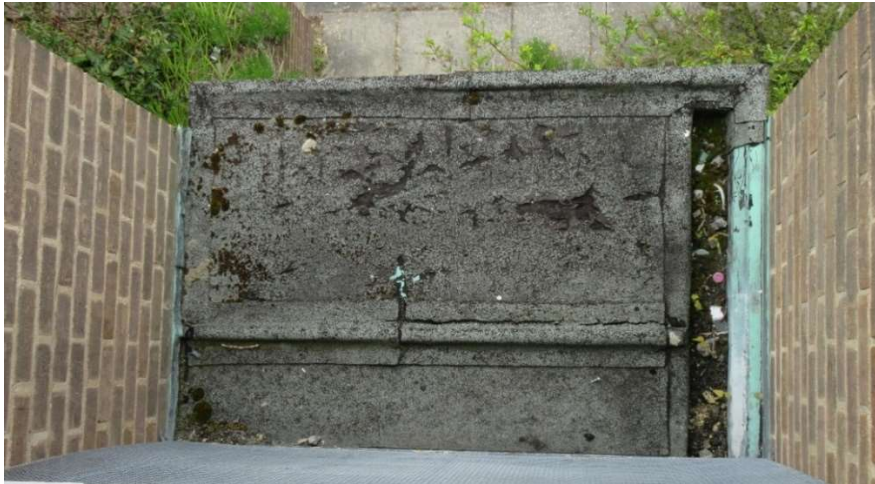
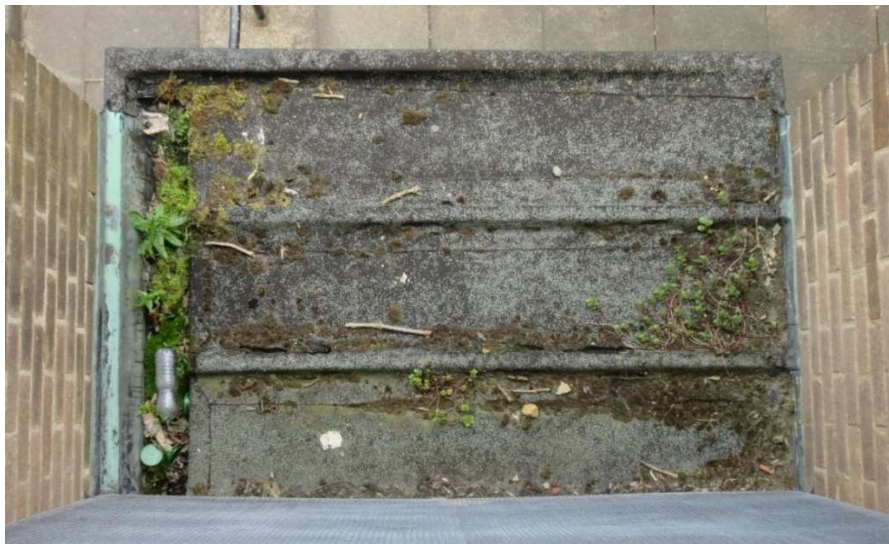
24. Two small felt roofs in the recesses over the Church doors (and former doors) with small amounts of remaining copper. Felt begins to break down. At W roof part of the edge drip is missing. Debris and plants in both internal gutters need to be cleared.

- At Hall NW replace parapet render or rebuild inner leaf in
facing bricks with roof upstand turned in, point coping joints 21, 29
- Clean low roofs and gutters over church doors and former doors 24

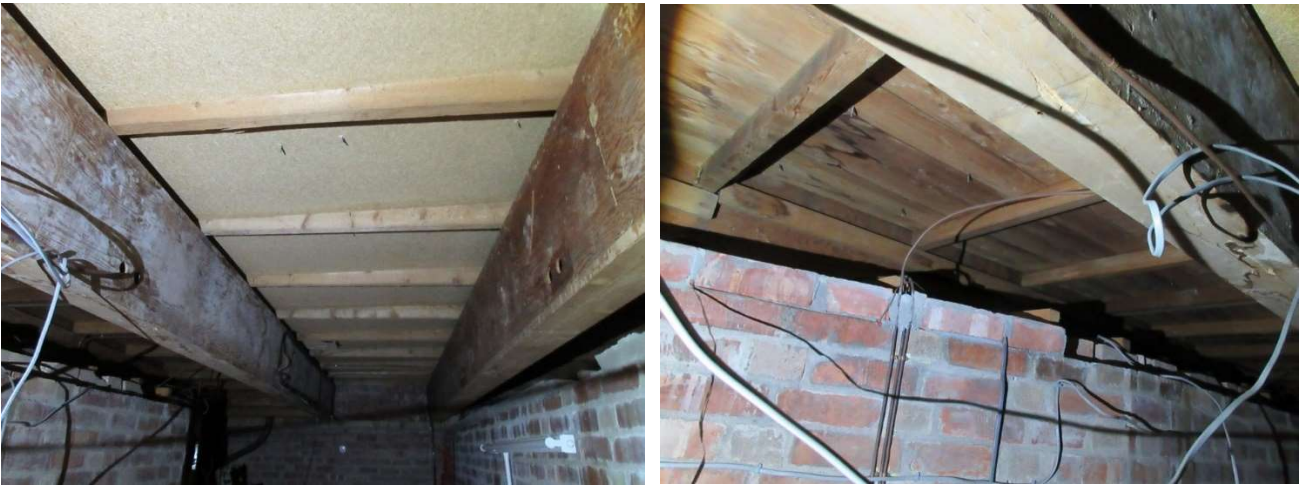
Church roof now exposed over the Store over the Church boiler room

48. No ceilings in the store over Church lobby and boiler room and Hall boiler room after removal of mineral fibre fire boards. Now exposed roof joists and deck at Church and exposed concrete slab at Hall. Former plaster ceiling over Church boiler room now broken out for new flue and lagged hot air duct.

81. The church boiler space is open to the store above which now has no ceiling protecting the underside of the church timber roof. Not known whether there is any fire barrier dividing the void under the roof. Any fire could therefore immediately reach the roof timbers (at least in part, perhaps the whole roof), risking very quick severe damage. It would be wise to replaster the upper ceiling to protect the roof.

- Restrain Church doors and windows 37
- Add door handle at Church entrance 37
- Repair and paint ceiling at Church wc 46
- Reduce fire risk by fixing new store ceiling under Church roof 43, 48, 81
- Add draught strips at Church and Hall doors 50
- Renew Gents floor 2, 63
- Review hot water in all lower wcs 84, 85
- Review access between all parts 87

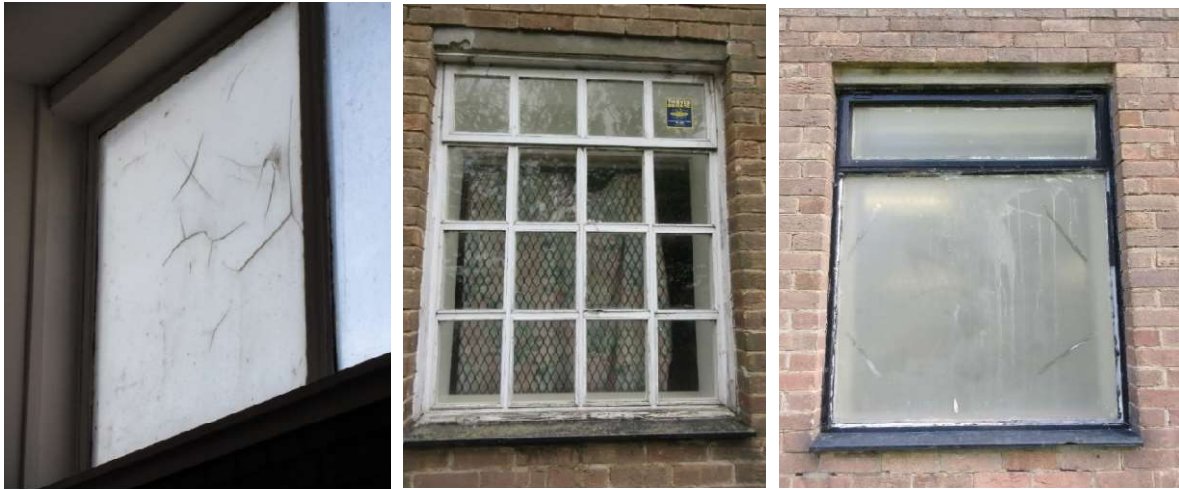
56. Church lobby and lantern clear single glazed with galvanised mesh protection. Sound but appears defensive. Church upper infills are polycarbonate sheet in hardwood frames. Some dirt.
57. Over the stairs polycarbonate is puttied into metal frames. It is dirty, paint splashed and mostly clouded (older polycarbonate soon clouds in sunlight unlike modern light resisting type). The 'pane' next to the Store is clouded and cracked, letting heat out. The Store window is filled with painted ply.

- Repoint open brick joints at Church, Hall & external retaining walls 31, 93
- Replace polycarbonate 'glazing' over stair with UV resistant type 57
- Consider same at Hall, Vestry and Meeting Room 58, 59
- Obtain new Periodic Electric Installation Test in 2026, keep report
in Log Book and review Church lighting 73 and Addendum

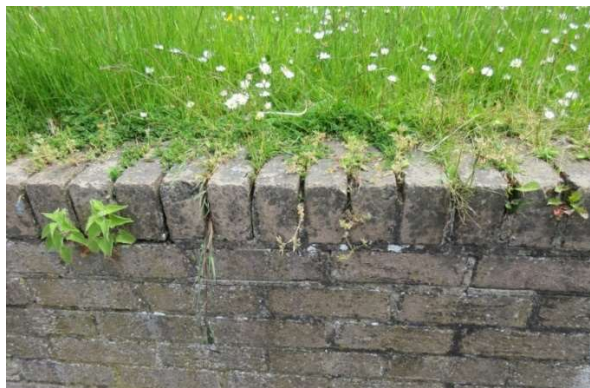
91. Open grounds maintained by the local authority, at corner of park and vulnerable to misuse but in fair condition. Lawns all sides. Mature trees at N and E. Flag path from E to Church.
92. Tarmac parking good.
93. Brick retaining wall close to the Church entrance is sound at present and plants growing in the joints of its brick on edge are attractive. However they mean the upper mortar joints are decayed, letting damp into the bricks. Eventually frost will damage the bricks so the joints should be well raked out and repointed.
