**Quinquennial Inspection**

**Church of St Helen,  
Low Fell**

**For  
St Helen Parish Council  
February 2022**

Church: Church of St Helen, Low Fell.  
Archdeaconry: Durham  
Diocese: Durham.  
Deanery: Gateshead  
Date of inspection: 11 January 2022  
Weather: Dry and sunny

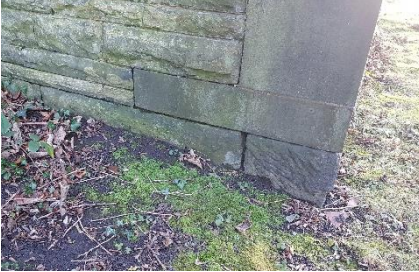
<p>3.2</p>	<p>The organ pump house walls are rendered externally. The render is breaking away at the base, though appears to be long term damage.</p>	<p>Monitor and re-render if the render deteriorates further within the next 5 years</p>	<p>D</p>

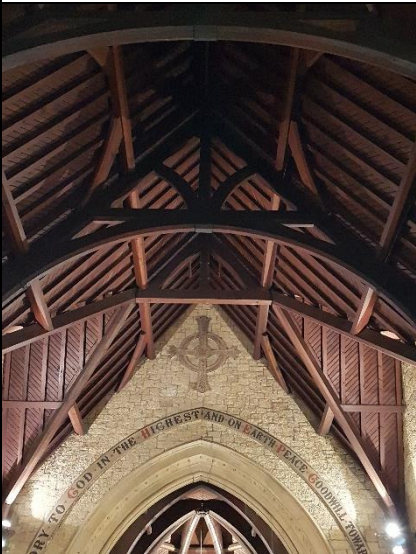
7.2	The rear choir vestry has an open roof structure, exposing the rafters, high collars, and 'V' jointed sarking boarding. All appear in sound condition.			
7.3	The front Vicar's Vestry has a boarded ceiling in sound condition.			
7.4	Tower entrance ceiling exposed soffit to floor boarding 4no. heavy timber beams, all in sound condition.

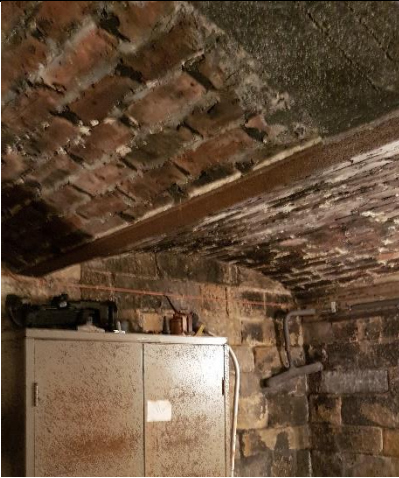
7.5	Boiler room has a double vaulted ceiling. Evidence of historic render repair to the vaulting, though all seems sound.

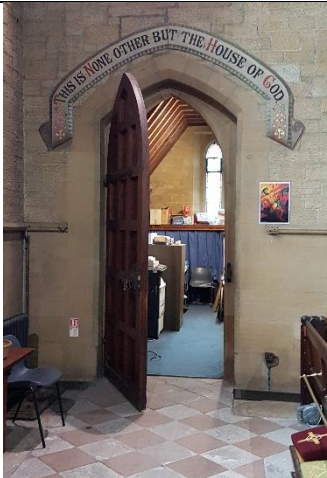
11.3	The lobby/nave door is the original of solid timber construction. All the ironmongery is the original and still serviceable.			
11.4	Rear Choir Vestry door is the original with its ironmongery, all still serviceable.

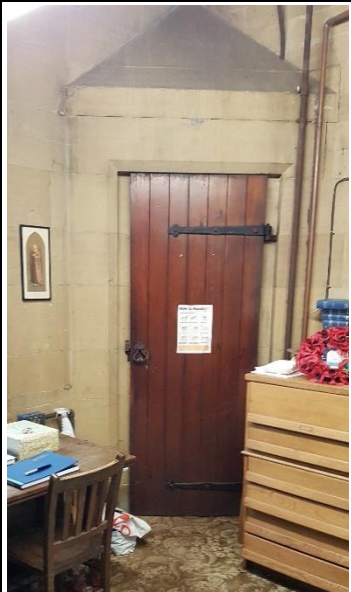
<p>11.6</p>	<p>Vicar's Vestry utility door is the original with its ironmongery, all still serviceable.</p>

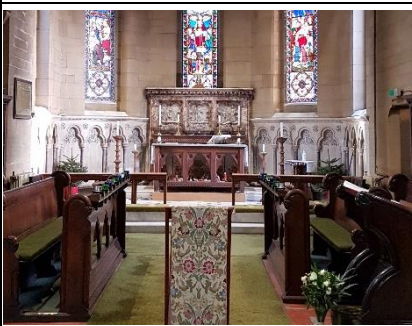
<p>12.0</p>	<p><b>Fittings</b></p>			
<p>12.1</p>	<p>Reredos to altar in carved marble with a carved oak shelf.</p>

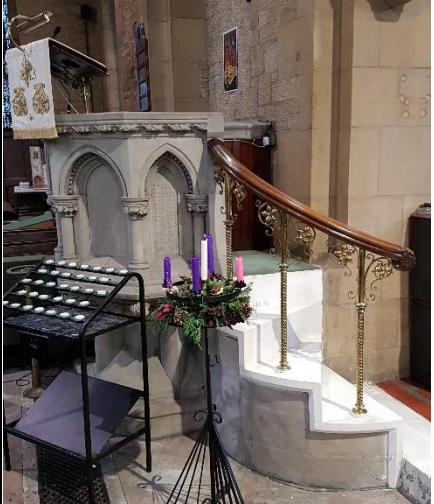
12.3	Choir stalls and timber panelling all sound.			
12.4	Timber altar rail and gate sound.			
12.5	Original pulpit: carved limestone with oak handrail and brass balusters.

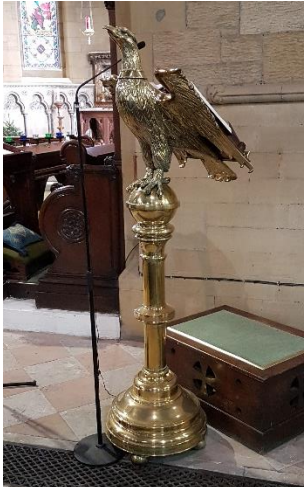
12.6	Very fine brass ambo.	It would be prudent to check on insurance for such pieces	A

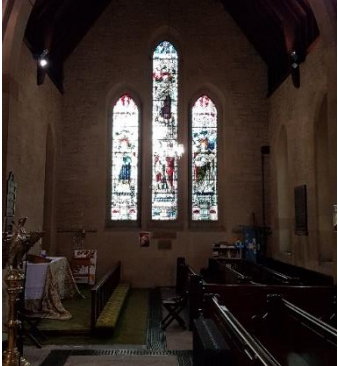
12.9	Side chapel in south transept. A relatively modern intervention (dedication 1987)

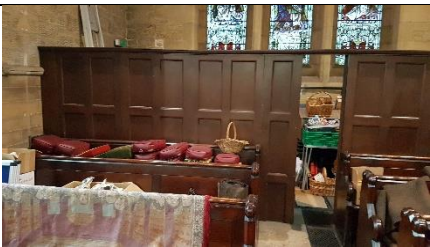
12.10	North transept has a modern dividing timber partition to provide a storage area. This is a useful space as the church has limited storage space. However, this is an intrusion and the storage area is a little unsightly.
