## St Aidan, Hartlepool

### Quinquennial Report

**7<sup>th</sup> November 2023**

Archdeaconry of Aukland  
Deanery of Hartlepool  
Grade II listed – Blaydon Conservation Area

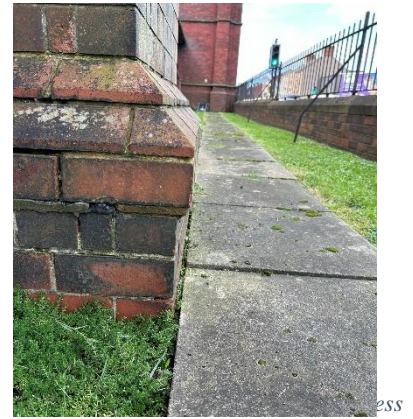
- East elevation – parapet looks ok. Erosion to the corbels. Pollution and damp proof course bitumen is exuding through the joint. Corner buttress has numerous open joints, particularly to its return onto the north elevation.
- North elevation – parapet appears ok and erosion as on the east to the corbels. The walling is generally sound, though it is breaking down at the joint of the damp proof course, this is projecting by 28.5mm and should be monitored. The west buttress has a larger area of mortar in the upper stage and some vegetation growing on this corner.
- West elevation – it is in fair condition.

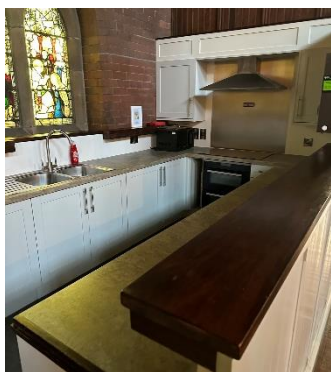
Figure 36 – new kitchen area

- 24.1 Greatly improved by south aisle re-ordering. Good hot and cold supply to kitchen sink with instant boiling water heater mounted on wall. Good accessible WC with sink.
- 24.2 Foul drainage: No details provided but assumed to connect to the highway or possibly to the former Vicarage system.
- 24.3 Surface water drainage: reported to be collected round the church and connected to the highway drainage system. No reported issues.
