CHURCH OF SAINT ANDREW HAUGHTON-LE-SKERNE

The Diocese of Durham
Listed Building Grade I
Haughton Conservation Area

Report on Quinquennial Inspection 2021

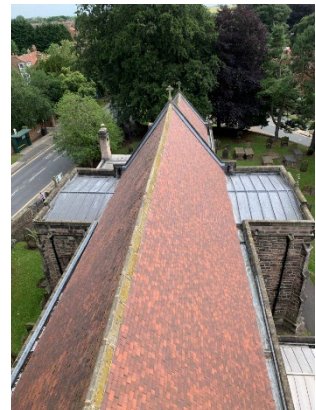
All new and in good order

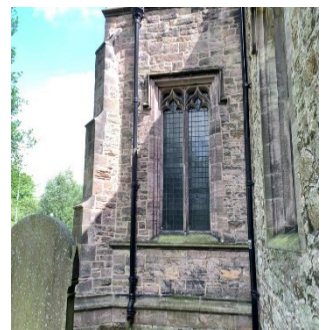
The north face has one window with three lights and tracery above, a 45 degree angled buttress and an orthogonally placed buttress.

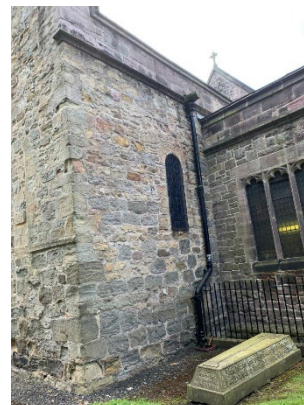
2.2.7.2. **Condition:**
No particular defects noted. New guards are stainless steel but fixed into stone.

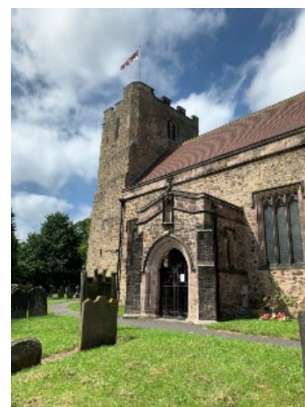
2.3.1.2. **Condition:**
This was not very visible from the ground but from ground level the window and walling appear to be in reasonable condition. Pointing was carried out in 2012.

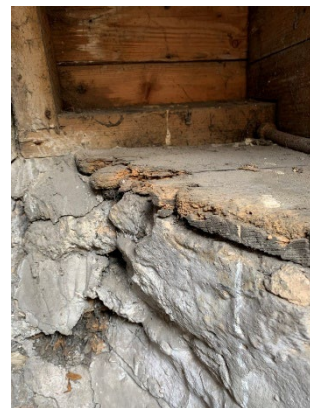
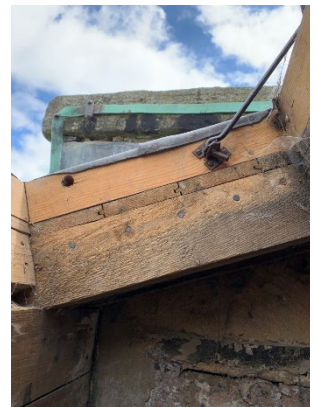
The beam ends are exposed adjacent to the access hatch and although decayed the bearing still appears adequate. Another report required.

The tower roof is leaded with bays running east and west to lead lined parapet gutters discharging through the north opening. The lead work was replaced in 1989 and is in good condition. The access trap is heavy but in good condition although around the trap area some vegetation regularly takes hold and this should be kept in check.

- C** • Report required as to the condition of tower roof timbers.
B • Monitor vegetation around trap area and keep in check.
C • Repoint top of stair near hatch.
B • Improve hatch access – very heavy.
B • Provide protection to low parapets.

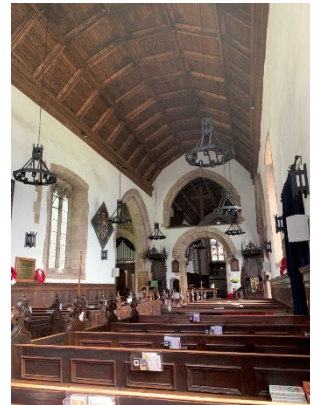
3.2.1.2. **Condition:**
Along the lower areas of the Nave wall behind where the heating pipes run, though generally in good condition, in some places the render is beginning to crack and fall away. The render is particularly affected towards the western end of the south Nave and a little also towards the western end of the north Nave.

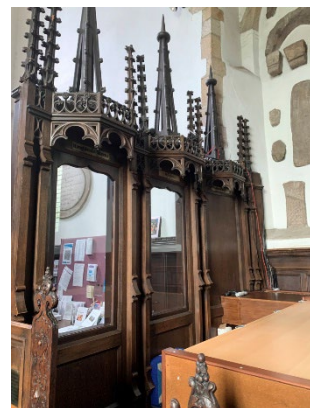
3.2.1.4. There is a timber screen leading from the base of the tower to the west end of the Nave. This was adapted using the original Cosin timber work and incorporates glazing which could well be removed and this would improve the overall look of the screen. Wireless aerials etc are located on top of the north side.

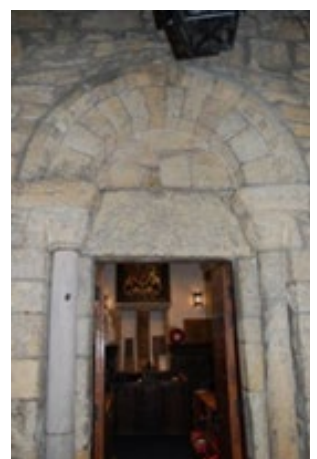
There is stone erosion at the lower levels and generally the porch is rather dirty and does not present a very welcoming approach and should be cleaned.

There is an open joint between the voussoirs of the relieving arch above the window. The east wall is more or less a mirror image of the west wall.

The north wall is the original wall of the Nave which has a Norman arched opening with interesting dentil moulding around the hood mould. Two free columns stand to either side of the doorway. The erosion should be monitored and some stone conservation considered. The cement mortars should be removed and repointed in lime.

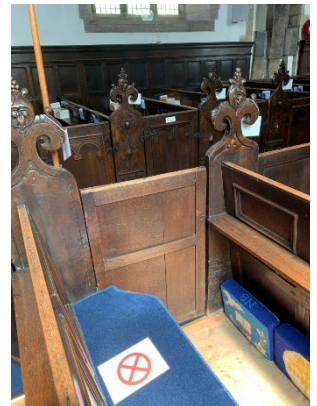
There are signs of some old furniture beetle attack, but this has been treated and the timberwork is regularly monitored and re-treated as necessary. It is essential that a proactive system of checking and regular repair is undertaken and it is recommended that a regular maintenance contract is taken out with a suitable craftsman.

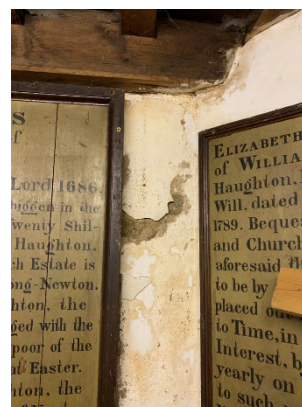
Within the mezzanine area of the vestry are two benefactor's boards. They are painted on board with a timber frame. They are of significant local interest and are vulnerable to the occasional water ingress in this area. These should be checked for damage regularly and moved to a safer place if possible.

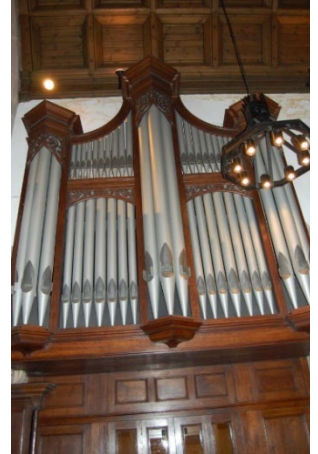
3.10.1.1. The organ is reported to require refurbishment.

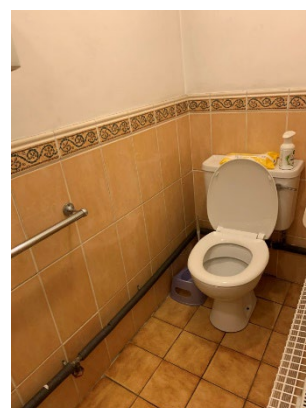
3.11.7.1. There is one WC with a wash hand basin off the vestry. It is small and not fully accessible. Consideration should be given to improve access to the toilet. There is a further basin in the vestry which is not in use: however steps from the church prevent access
