Diocese of Durham

**St PATRICK
HIGH SPEN**
(22A)

QUINQUENNIAL REPORT
on the architect's inspection on

2 November 2023

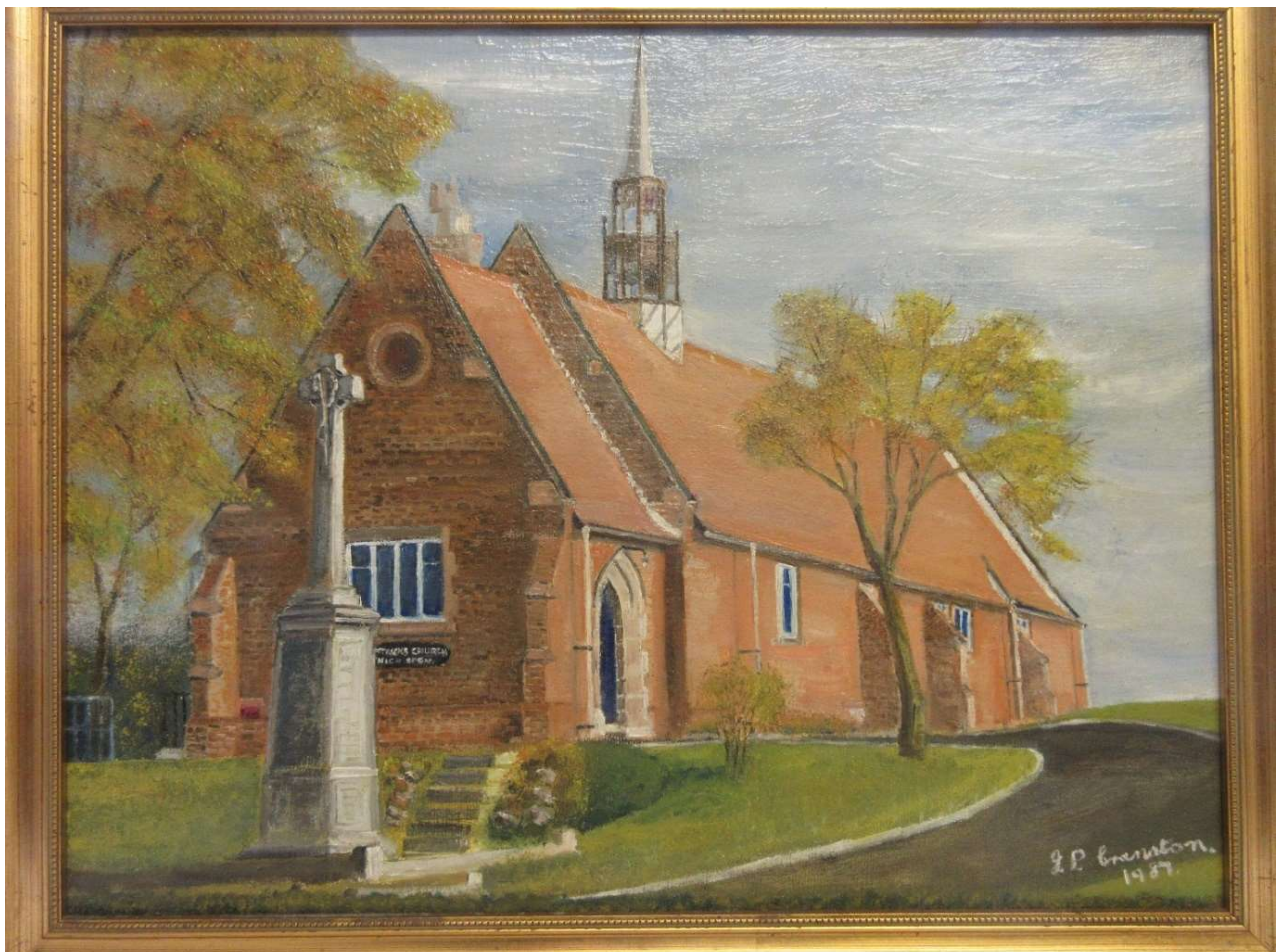
Painting in the Vestry – best illustration of the turret's original form

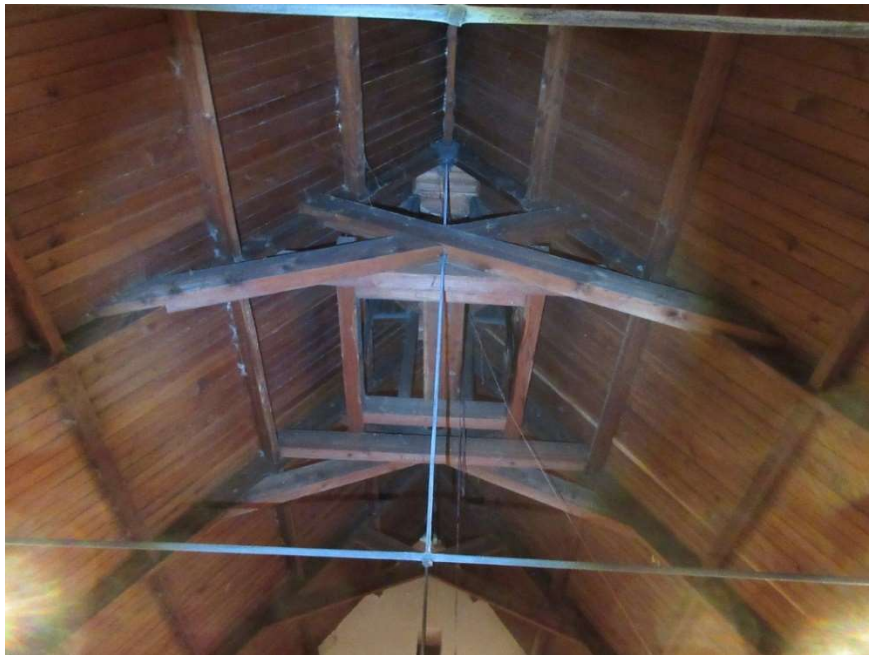
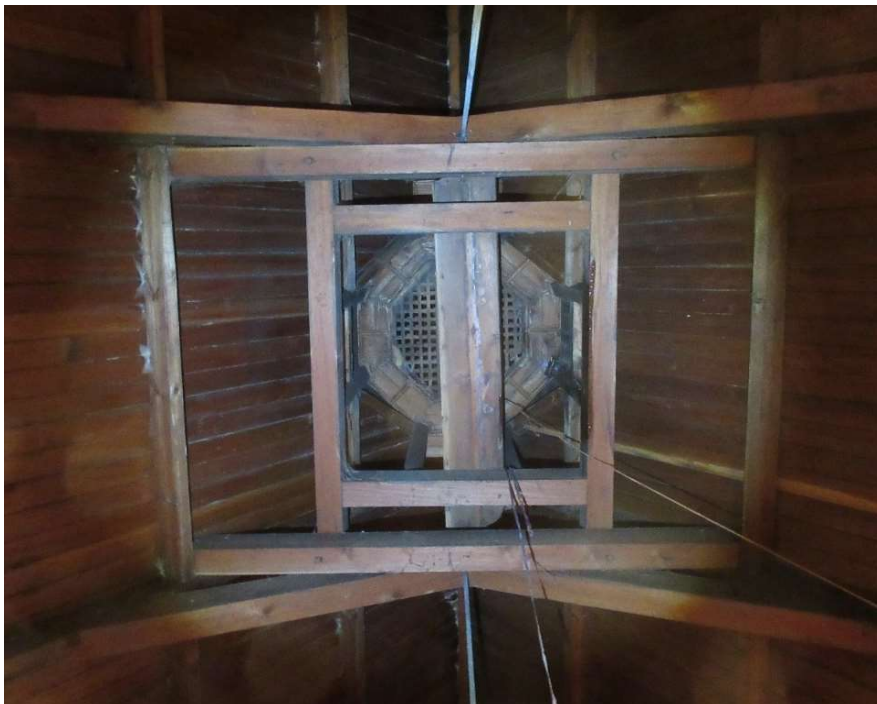
45. Exposed scissor trusses with iron tie rods, two in Chancel, seven in Nave. Turret on frame between two thickened trusses. Ridge and three purlins each side. All varnished softwood and seem sound.

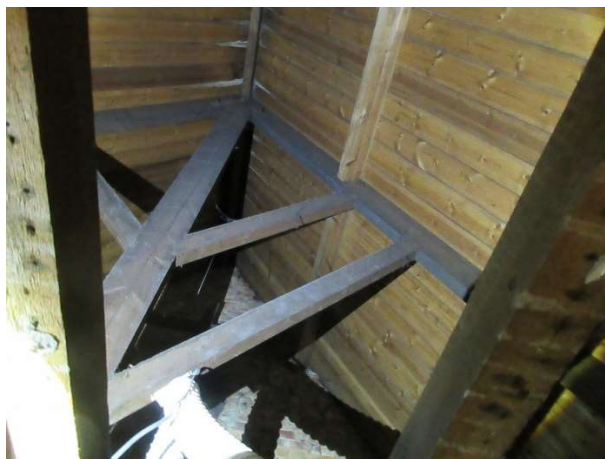
46. Over W rooms one concealed truss, purlins, sarking boards and ceiling joists, no visible defect.

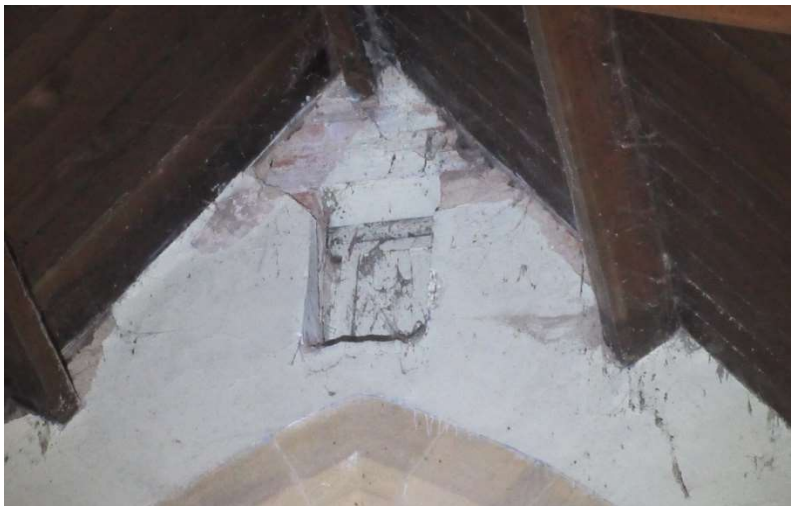
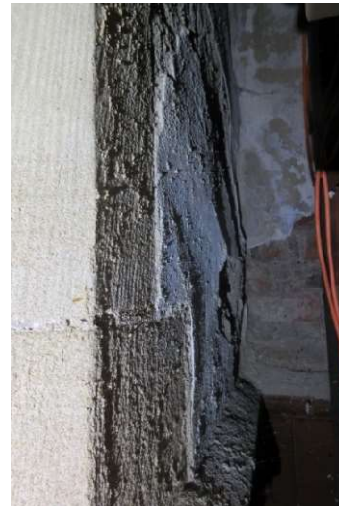
50. Chancel plaster fair. Slightly hollow at E, the NE corner and mid N side.
Some plaster missing at the E gable peak, perhaps caused by former poor pointing.

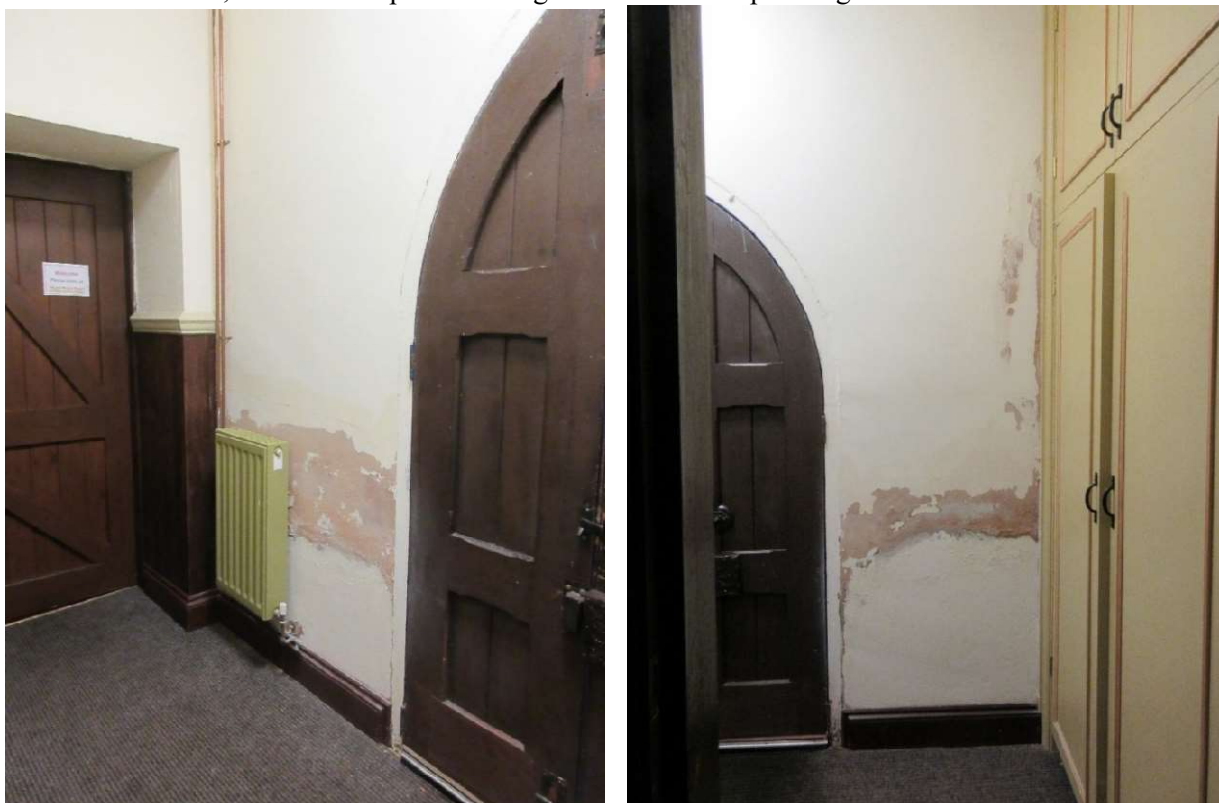
53. Porch fair but slight rising damp paint damage persists at the S wall each side of the outer doors. The causes could be a combination of:
the raised tarmac level outside, needed for level access
damp from the nearly adjacent high soil level in the planting bed against the W bay of the Nave
poor drainage from the nearest rainwater pipe which goes directly into the planting bed
If damp persists and cannot be solved by reducing soil level or clearing a blocked soakaway a solution may be to cover the lower wall with simple dado panelling and ventilated capping on the same principle as the dado in the church, which was a precaution against similar damp damage
