Diocese of Durham

St JOHN the Baptist JARROW
(106)

QUINQUENNIAL REPORT
on the architect's inspection on

7 November 2023

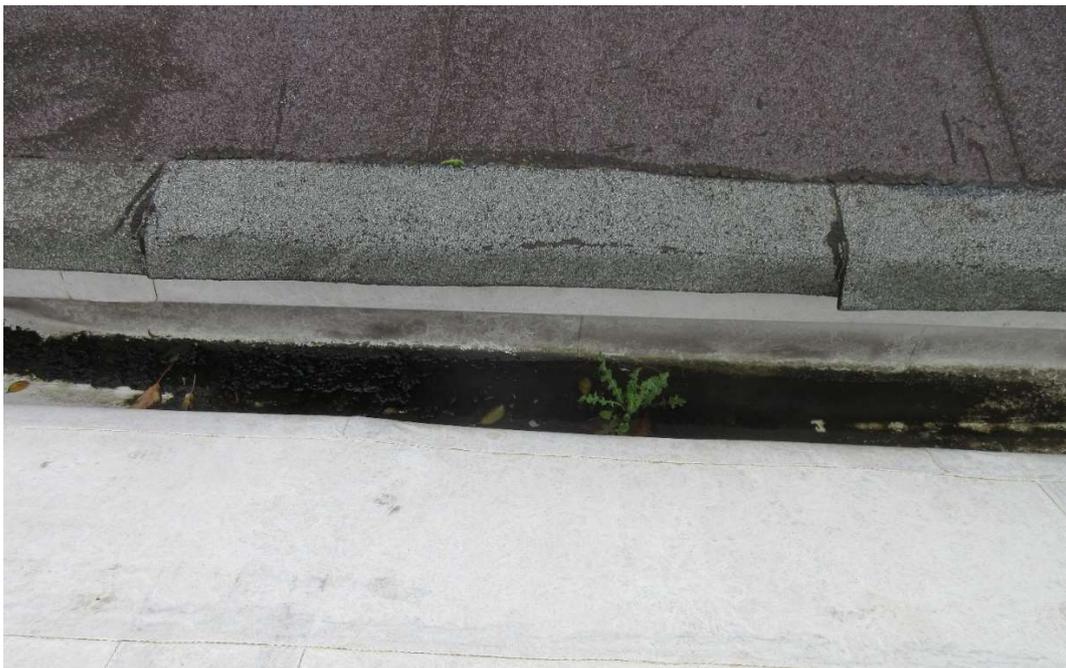
Internal gutter between Church and Hall - Plant in an outlet before part clearance at the inspection

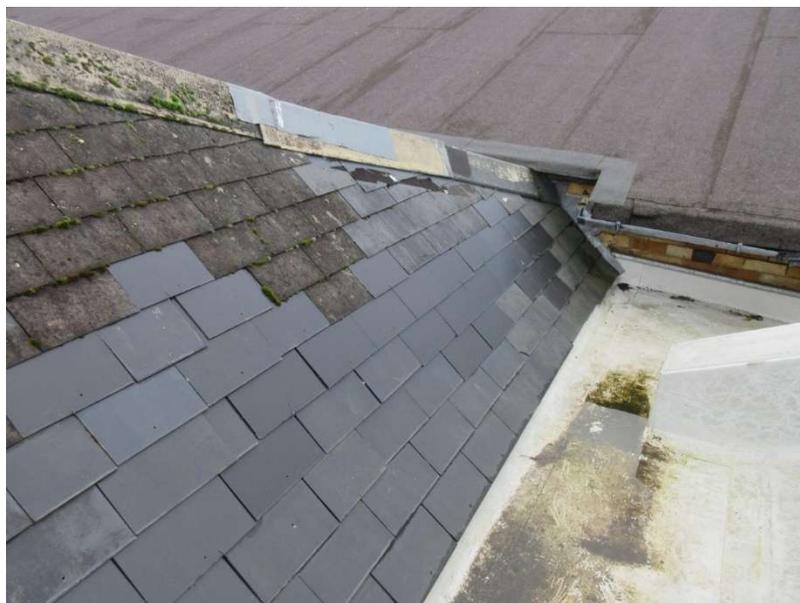
13. The Church's hidden hip and box gutter are covered in Sarnafil pvc membrane over earlier felt. The gutter drains the large hip and part of the Hall by four bottom outlets to two boxed internal pipes. Some of the silt and plants in the gutter were cleared at the inspection but one blocked outlet could not be cleared without tools. Full clearance and water testing to manhole is recommended.
14. The steeper N and S Church pitches have artificial fibre-cement slates down to low overhanging eaves. To deter climbing bands of the lowest slates and a band up the side of the Porch were covered in non setting anti-climb paint now mostly weathered away. Slate breakages have been repaired and the roof is in fair condition, though moss in N joints suggests the weathering surfaces hold some damp.

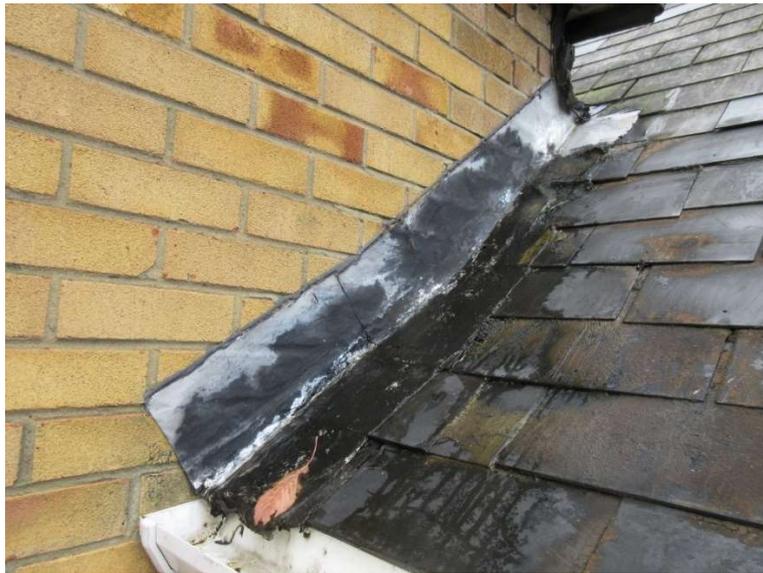
15. The S slates have a short narrow gutter butted against the SE lobby, under its felt overhang. It appears sound though again contains debris. Clearance needed. Its return over the slates has a Flashband flashing, now holed, stuck to bricks and slates.

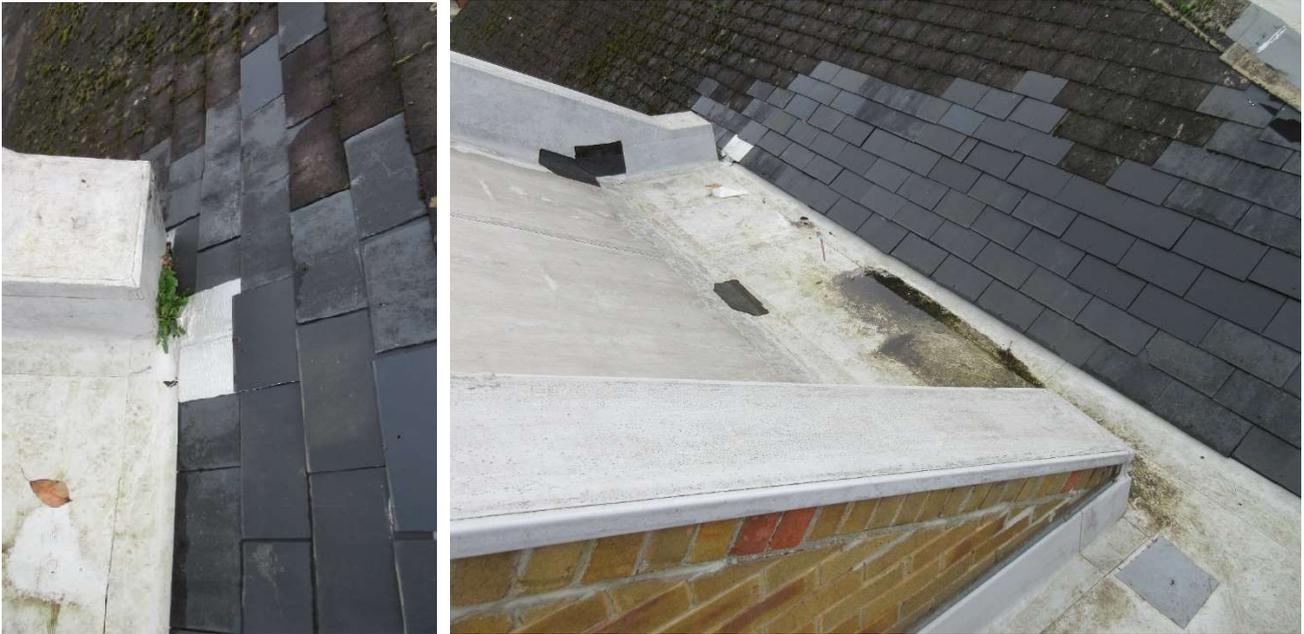
18. The steep **Porch** roof slopes inward against the church roof. Was bitumen felt, now covered in Sarnafil carried up over its brick parapets to protect them.
The roof appears sound but now has five small bitumen felt patches at the bottom of the slope. Bitumen is not compatible with Sarnafil so is not suitable for this use. Patching with Sarnafil itself would prolong the roof's life.

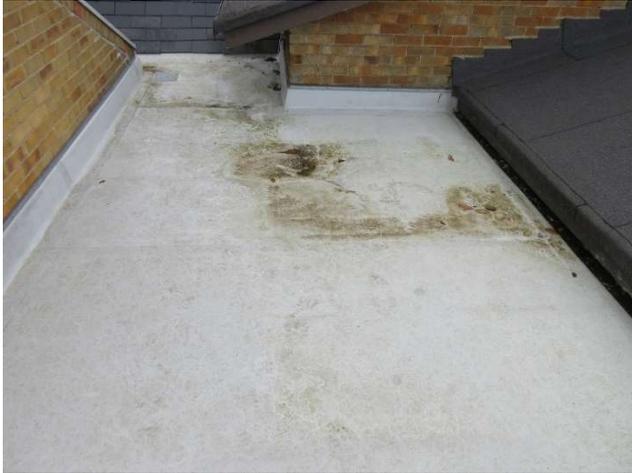
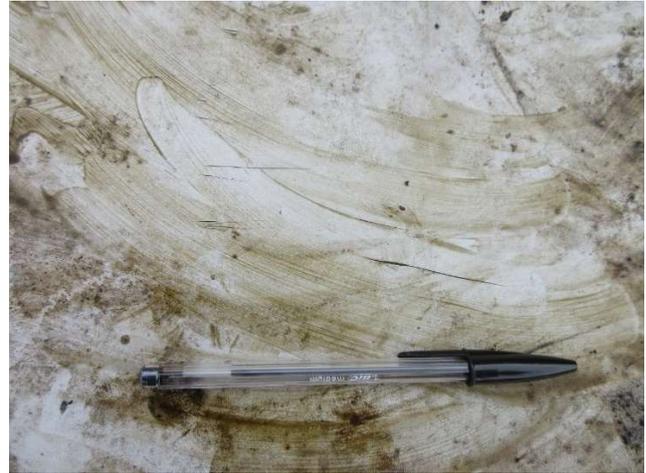
The recent fall of vestry ceiling plaster shows at least part of the deck and joists is saturated. The only apparent damage to the membrane is a group of very minor scores or cracks which may be the cause. Though they could be patched as a precaution the visible deck is so wet and sagging that it is not likely to serve again. So it seems at least part of the Vestry roof deck, insulation and membrane will need to be completely renewed.

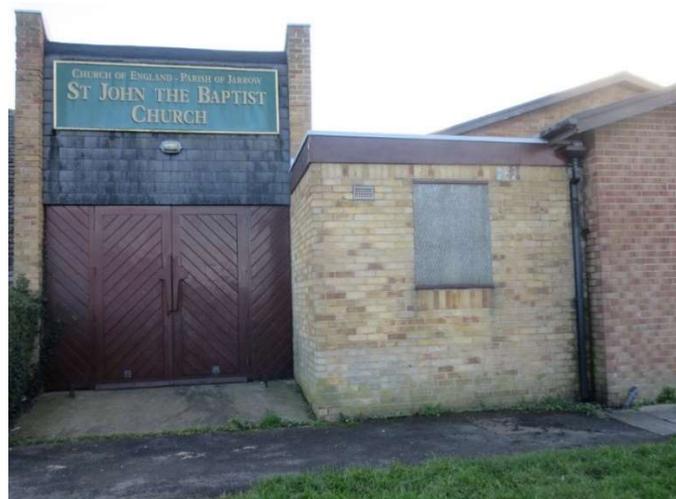
- 35. The upvc Church eave and gable fascias look smart.
- 36. Decay has set in at the deep painted fascias at the Vestry and Hall N entrance from their joints and at a bottom edge. May be best replaced with upvc like the Church E gable.

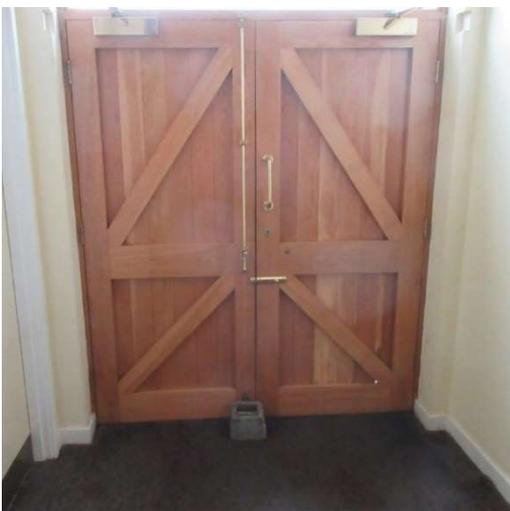
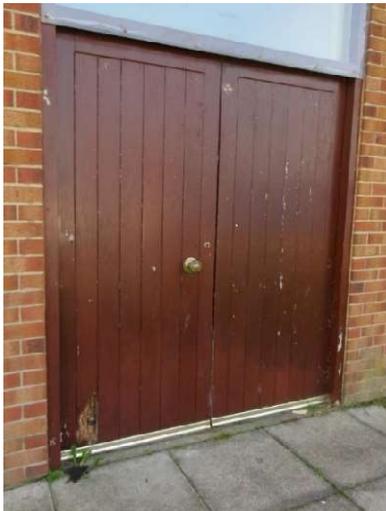
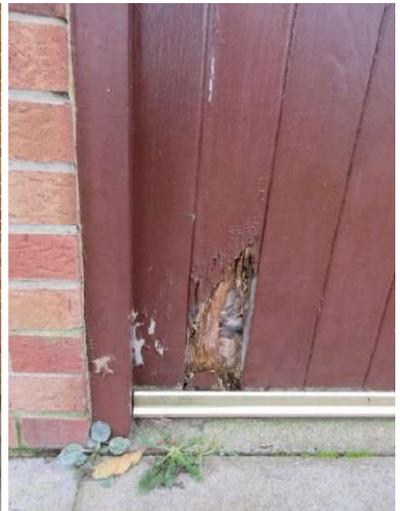
37. The Church Porch and Hall N entrance stained hardwood doors are sound except
- some decay at the feet of the Church N Porch door frame may have stopped
 - the 2004 oak N entrance doors are good except the bottom of one batten at bottom left has decayed

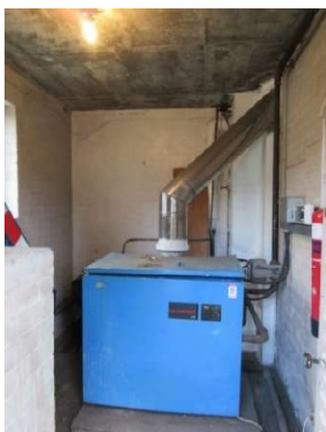
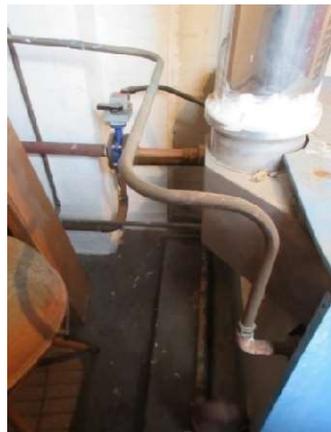
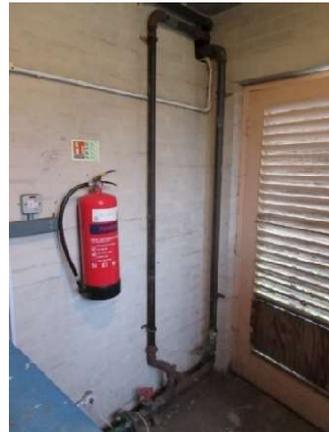
81. Meter, Clyde Combustions gas boiler dated 1981 and stainless insulated flue in boiler room ventilated by a louvre door. Missing bottom louvres are boarded over.
A mortar joint at the bottom of the flue has been paint sealed over.
Painted brick boiler room with concrete roof and floor.

82. The boiler said to function well but by its age it must be inefficient, sending more heat up the chimney than a modern boiler would. The heating as a whole is reported aging and in need of replacement.
Heating and general improvement of insulation and draught control should be considered together.
If the Church is reheated it could be combined with permanent solution to the floor cracking (paras 69-72).

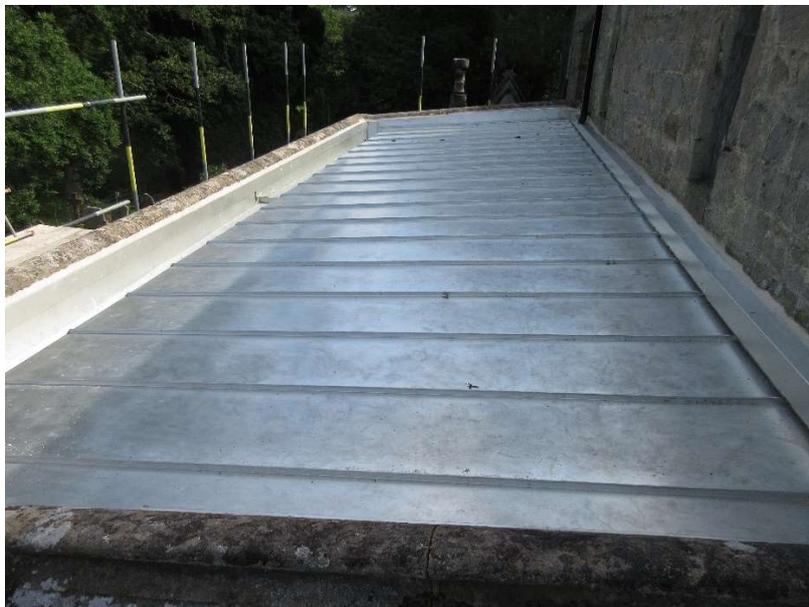
EXAMPLE OF STAINLESS STEEL ROOFING ON CHURCHES.

During laying on a shallow pitched roof. Stainless at the steeper roofs at St John would look similar.

115. The artificial roof slates may be coming to the end of their life. When they have to be replaced a change to say tough stainless steel could transform the church from a building with defensive deterrent paint into a confident and smart focus for the community. The pitched steel would be slippery, difficult to climb and impossible to break. See photo below.

Stainless could form its own neat ridges and be embellished with a simple decorative stainless finial (there being a cross already) to raise the appearance of the whole building. The same could be used on the Porch and Porch valley. Cost would be between new artificial and natural slates.
