2024 QUINQUENNIAL INSPECTION SURVEY REPORT

HARTBURN: PARISH CHURCH OF ALL SAINTS

Date of Inspection: 11th July 2024

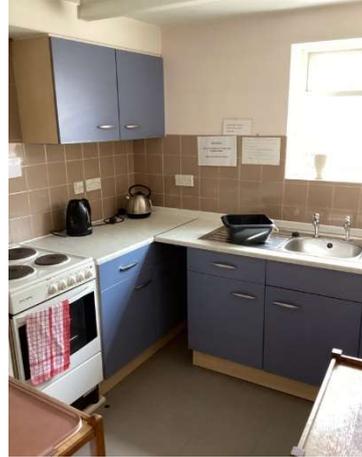
3.2 Ceiling has clearly been repaired in the past and there are some marks on it which could indicate some damp and condensation issues. It seems more likely that this is a condensation issue as there is a note asking users of the kitchen to use the fan to expel air when the kettle is boiled. Nonetheless, it would benefit from redecoration and tidying up when the lighting has been installed.

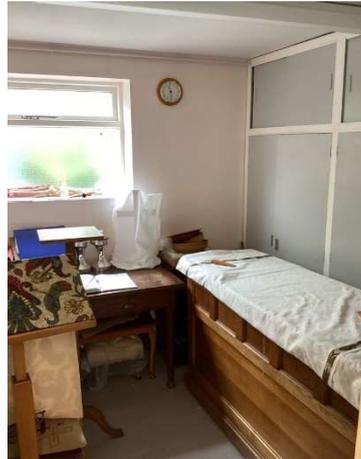
- 3.20 Plastered and painted, ceiling is in reasonable condition, although there is a plaster fracture running down the ceiling and there is also some water damage. The source of the water damage should be investigated and repaired. The area will need replastering and redecoration. Small plaster fracture can be redecorated and repaired at the same time.

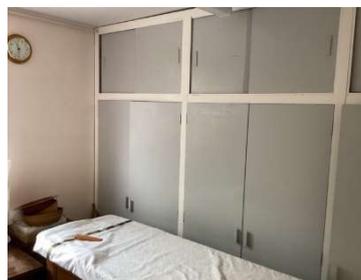
3.23 Aside from a small split in the vinyl towards the wall, the cupboard next to the flooring appeared in reasonable condition.

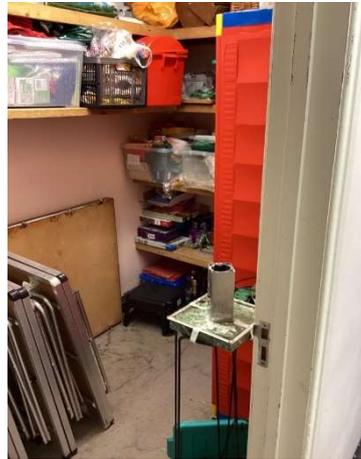
3.26 Walling and flooring is a little damaged from the moving of furniture, and it may be worth adding some protection to the walls to protect them from damage from furniture being leaned up against them, but this is a desirable improvement.

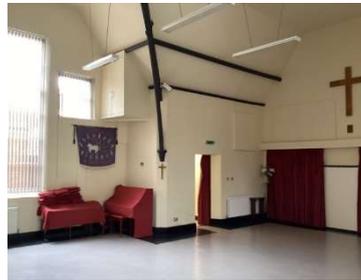
3.28 The ceiling seems to be in good condition. There is a little bit of unevenness in places, but there is no evidence of any leaks.

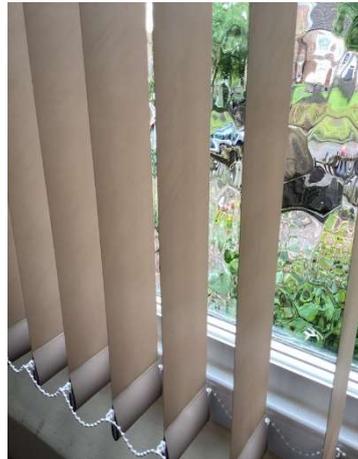
3.32 A desirable improvement would be for the windows to be double glazed, as they are currently single glazed, as the thermal performance will be better.

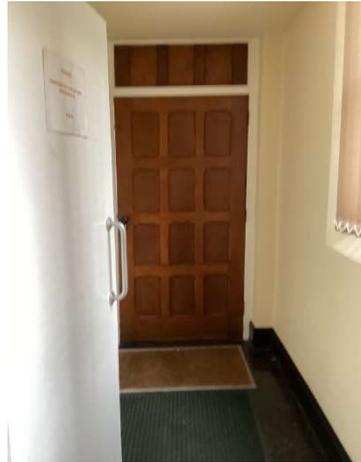
The entrance lobby is plastered and painted, with the same vinyl flooring and mat. It has been recently redecorated and appears to be in good condition.

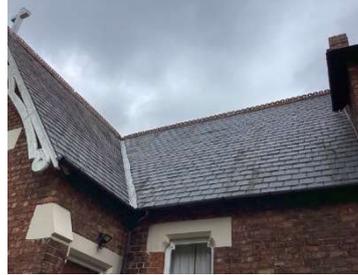
Roofs to the front elevation are generally Welsh slate with a clay ridge and a lead valley gutter. The roofs appear to be in good condition with no obvious slipped or missing slates. The lead flashing appears to be securely fixed and in good order.

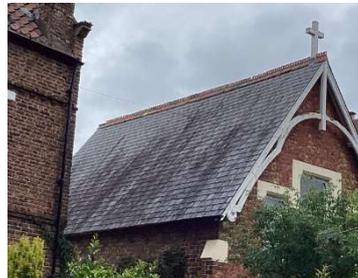
Right-hand side elevation of the building appears to also be in good condition. The Welsh slating seems to be in good order and the clay ridge seems to be securely bedded.

- 4.4 The cross will require redecoration within the next couple of years.

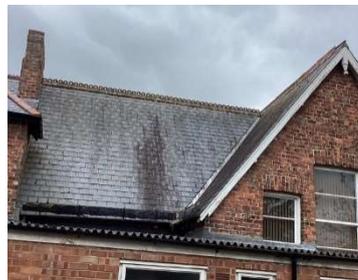
The rear elevation is also Welsh slate with a clay ridge and lead valley. Again, broadly speaking the roof seems to be in good condition, with no noted slipped or missing slates. Leadwork also appears to be in good order.

- 4.6 The remains of the snowboards towards the lower reaches of the roof should be removed as they are now heavily rotted.

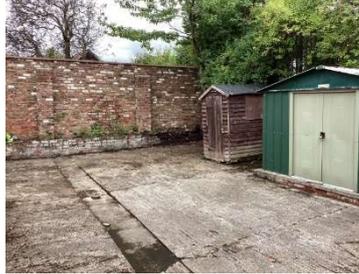
The rear garden is a concreted space, with two sheds, a brick boundary wall and a block retaining wall to the rear. The space is generally reasonably serviceable.

- 5.2 The re-built section of party wall with the adjoining property generally seems to be in good condition. The remaining sections that didn't collapse seem in fair order. Pointing is a little open and certainly cementitious, but it's in fair condition. Any vegetation growing out of joints should be removed and open joints should be repointed.

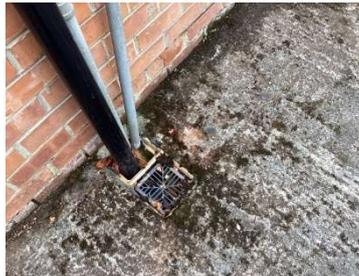
- 5.5 Rainwater gullies seem to be clear.

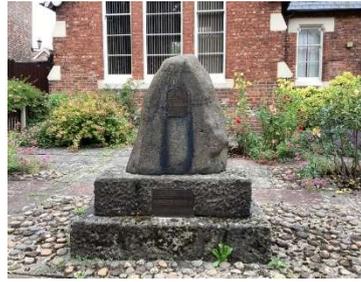
The front of the church is generally paved, with a large memorial stone with some public information and plenty of planting. It generally seems to be in a reasonable condition.

5.7 The front is bound by timber fencing with concrete posts. This looks a little decoratively tired and would probably benefit from a little bit of decoration and remedial work.

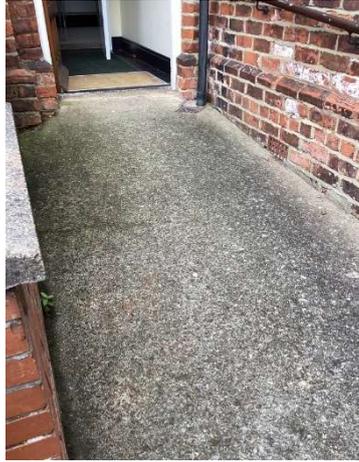
5.8 There is level access via a concrete ramp into the building.

5.9 A handrail should be provided on both sides of the path and the one present should be re-decorated.
