Diocese of Durham

**St JOHN the Baptist
STOCKTON on Tees**

QUINQUENNIAL REPORT
on the architect's inspection on

25 July 2019

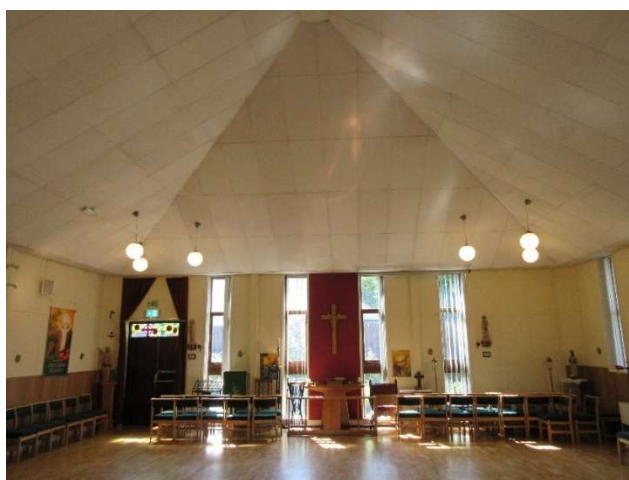
3. A multipurpose building of 1982 on a large open corner site. A standard Stocks Brothers light steel frame forming a pyramid roof over the Church/Hall with lean-to rooms on two sides, mostly accessed through the Church/Hall. A Chapel, Kitchen, Meeting room, Office/Vestry, store/meter room and accessible unisex wc. This report takes the side opposite the church doors as South.

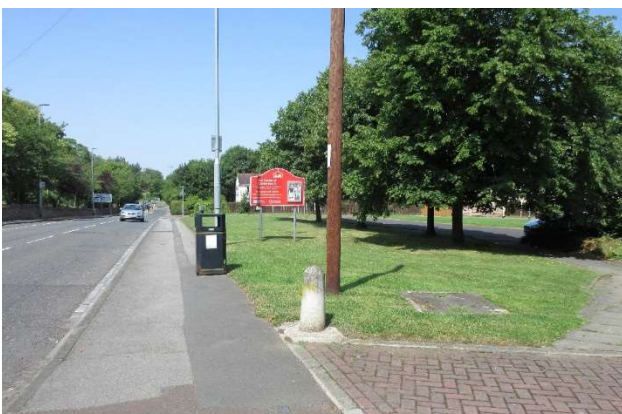
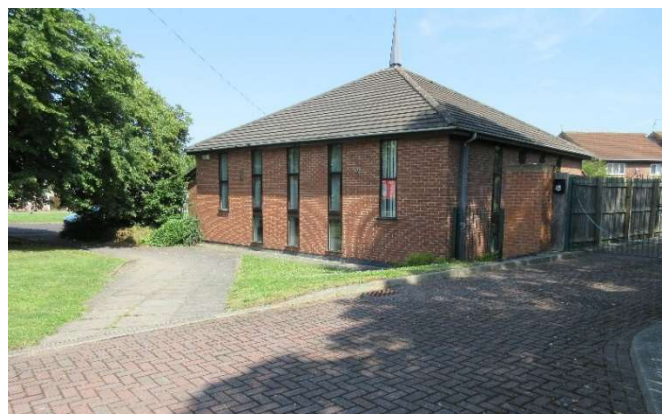
55. The church is not well seen from Durham Road, being of modest size and shape, partly hidden by the belt of trees and with its entrance facing the car park not the road. The road-side sign is the main clue.
