2024 QUINQUENNIAL INSPECTION SURVEY REPORT

STOCKTON-ON-TEES: PARISH CHURCH OF ST PETER

Stockton-on-Tees: Parish Church of St Peter

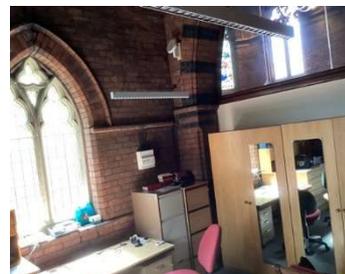
- 3.2 There is a lean-to ceiling, with purlins and a principal rafter with boarding between. In the south-western corner there is a significant amount of staining. This is understood to be historic from a now repaired roof leak. There are a couple of other areas of staining on the roof, particularly towards the lower reaches and they should be kept under observation.

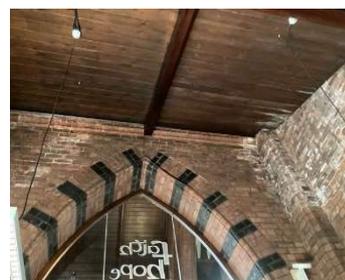
- 3.3 Walling is brick lined with a hard dark coloured mortar. The brickwork is generally in very good condition, with the exception of the south-western wall where there is salting. This is particularly noticeable in the south-western corner, and would benefit from being brushed off and repointed.

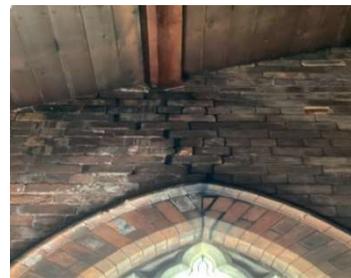
- 3.5 There is a fracture over the eastern window which was repaired during the recent works and the fracture has been filled with mortar for purposes of monitoring. On the day of the inspection the fracture was full and had not reopened. This should be reviewed at the next inspection to ensure that the intervention remains stable.

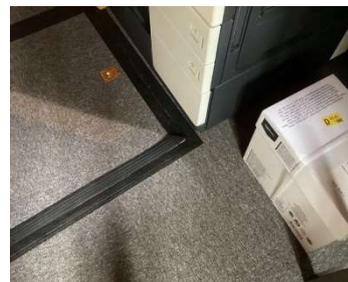
- 3.8 Flooring is generally in good condition, but there is a little bit of trim coming away from the floor hatch which requires resealing.

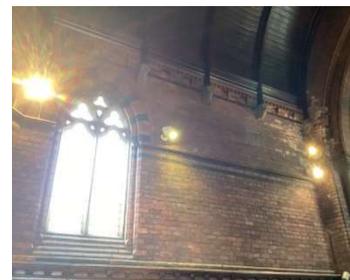
3.11 Walling is for the most part in good condition. Pointing is tight and bricks are in good condition. Like much of the rest of the building, it has suffered in areas where water ingress has taken place and where that has happened bricks are quite heavily salted.

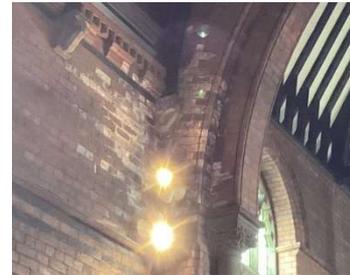
3.12 At either side of the chancel, although most pressing on the south side, there is a significant amount of salting. It seems likely, given the level of this, that this is due to either a flashing or a guttering issue. Once this issue has been resolved the brick should be carefully brushed off and the areas repointed, and the walling should very slowly dry out.

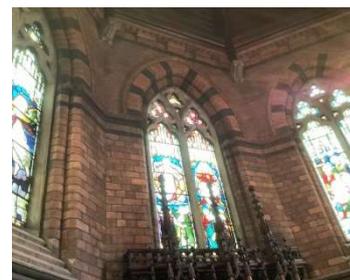
3.13 Three stained glass windows off the apse broadly seem to be in good condition. There is a little bit of bowing to the windows, but for the most part the glazing is straight, saddle bars tight and well fixed and copper ties are intact.

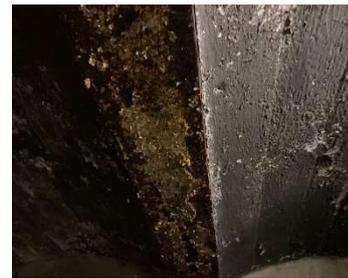
3.20 The ceiling is a steel and concrete vaulted structure. The steel beams require de-rusting and redecoration.

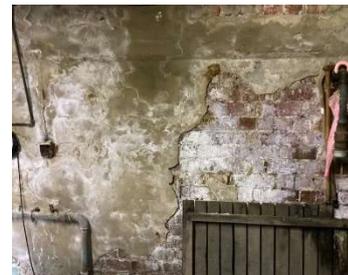
3.21 Walling is brick lined with a generally failing render. The render and the brickwork is heavily salted. In a subterranean space like this salting brickwork is not unusual. It can be assisted by repointing in a soft lime mortar. However, there are other priorities for the church.

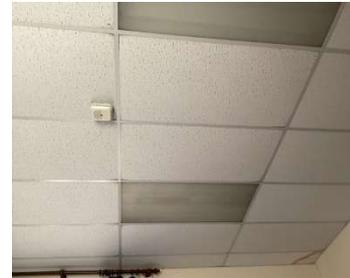
- 3.24 The grid system ceiling also houses the light fittings. There is a little bit of staining within the corners. However, this is understood to have been historic water ingress and has now been resolved. Ceiling is functional, if a little tired.

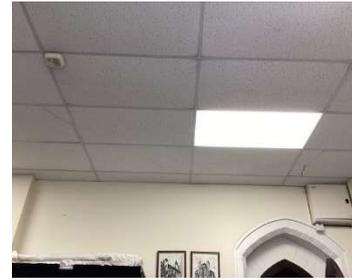
- 3.29 The ceiling is a little stained in places and there are now historic leaks which have left a mark on the ceiling tiles. There are also a couple of broken tiles which should be replaced.

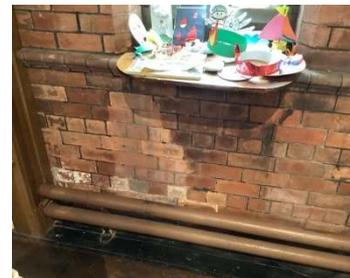
3.49 Walling is generally in reasonable condition, pointing is for the most part tight and there are a few areas of salting. On the southern wall there is a little bit of salting at high level which generally seems to be associated with the position of rainwater goods, which have probably failed or overtopped in places, and there is a little bit of low level salting. It's difficult to know whether this is to do with issues with heating or whether there are any leaking pipes or whether there is an issue externally. Again anything in places where they may well be associated with failing rainwater goods should be brushed off and the area should be repointed.

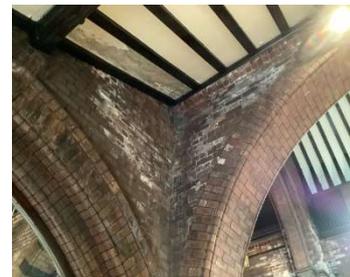
3.50 At high level in the south-eastern corner there is a significant amount of salting. This is from a failed high level downpipe. As this has now been resolved the salting will eventually wear away. However, brushing it and repointing the joints would be helpful.

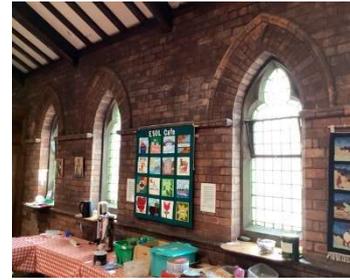
3.51 Windows are generally in reasonable condition, although the hopper vents are a little bit rusty, but for the most part the glazing is relatively straight, saddle bars and copper ties appear to be present and intact, and generally the windows appear to be in reasonable condition.

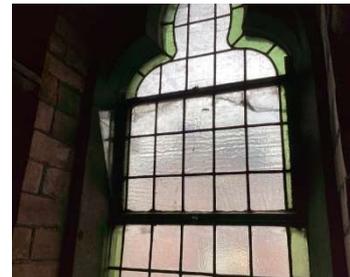
3.52 Hopper vents may require an overhaul. There are some areas of missing or damaged metalwork and damaged glazing. In addition, the hopper vent does not appear to be functional as the strings are missing. They should be overhauled so that they are in good working order.

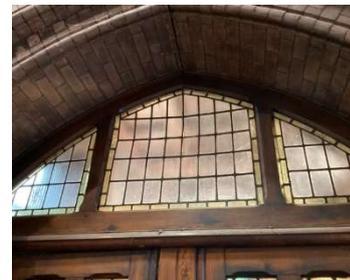
3.53 Within the screen at the western end of the aisle, the fan light panel has bowed and the bowing has fractured some of the glazing. This panel requires removal, replacement and repair. Lower down there is some broken quarries which could be picked up at the same time.

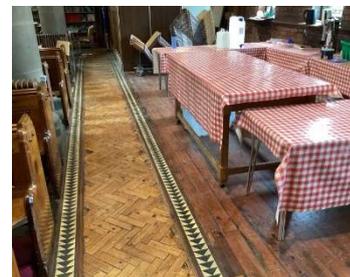
3.55 Flooring generally appears to be in good condition. There are boards where the pews have been removed in the northern part of the aisle and there is parquet along the aisle itself. There is a little bit of unevenness within the transition between the surfaces.

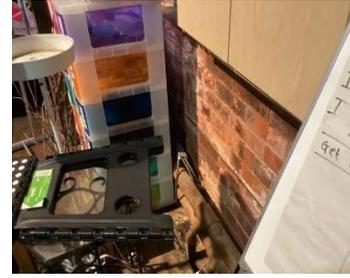
3.56 At the west end there is some salting at low level. This area is used for storage so it is a little difficult to see, however, some significant repointing and examining of this will need to take place as the toilet work is carried out.

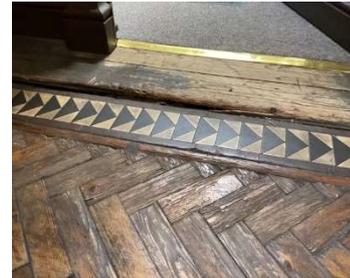
3.57 There is quite a significant dip in the floor and separation between the entrance to the vestry and the aisle floor. Both floors seem to be relatively stable, but there is a significant gap and a trip hazard here. It seems that this could probably be overcome with a simple timber fillet.

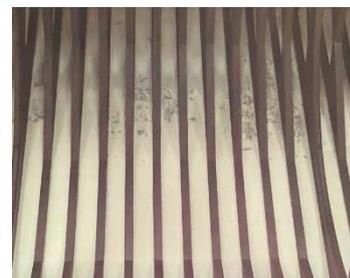
3.59 The roof structure looks to be in reasonable condition. However, the plastered panels between the rafters have suffered the same fate as those in the northern and southern aisle, and these plaster panels are in quite poor condition. Again, these will need to be examined at close quarters to establish if they are secure. There are quite a few fractures within some of these plastered panels and it's important to establish how well adhered the plaster is to the substrate. Access will need to be made available to examine these and then a decision can be made on their repair.

It is quite important that the PCC monitor this quite carefully, and should there be any plaster falls then it may be that netting is necessary to protect the users of the building.

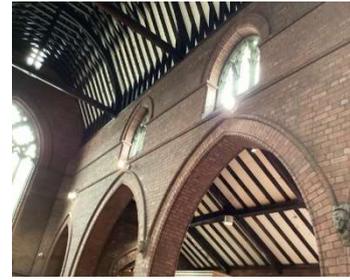
3.60 Walling is for the most part in good condition. There are some areas of salting, but generally the walls are well pointed and the brickwork is in good condition.

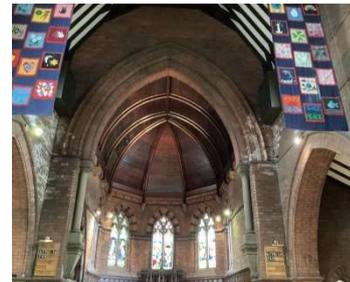
3.61 Salting and open jointing is mainly present at the eastern end where there have been failures in the rainwater goods. Certainly in the north-eastern and south-eastern corners adjacent to the chancel arch are the most notable areas. It is understood that this water ingress is now resolved and so it will take some time for the salting to work its way out of the brickwork. There are a number of ways in which this process can be sped up a bit. If access is available brushing off the surfaces and repointing will assist in the drying out process.

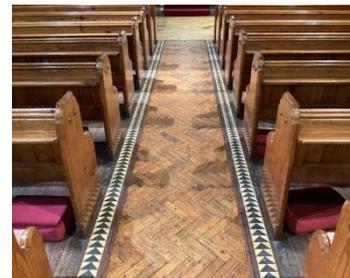
3.62 Flooring is generally in reasonable condition. There is a little bit of movement in the floor around the westernmost pillars and this is going to be repaired as part of the current works. Otherwise pews are sat on level timber platforms, with a parquet aisle, and generally appears to be in good condition.

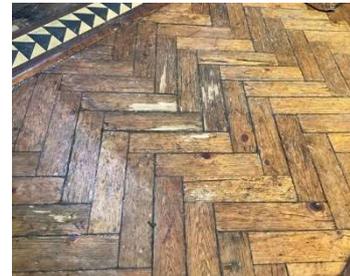
3.63 The PCC should, however, just keep an eye on some areas of the parquet where there does appear to have been suitably fresh damage. It might be that this is just from wear and tear, but it's also possible that it has come from a little bit of dampness within the timber. This should be kept under observation, and if there is a worsening of these areas, the architect should be informed so that a programme of treatment can be carried out in the future.

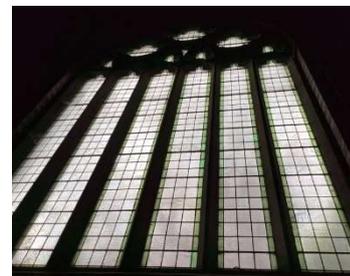
3.64 Large western window as viewed from below appears to be in good condition. The glazing for the most part seems to be relatively straight and saddle bars and copper ties, as far as could be seen, seem to be intact. The tracery areas were a little difficult to view from below, but broadly speaking looked in reasonable order.

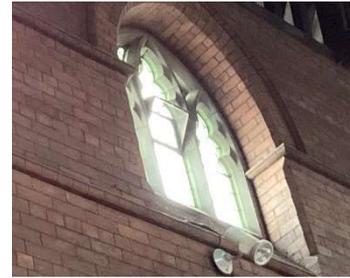
3.65 The tracery windows were somewhat difficult to view from below. However, from what could be seen, they appear to be in reasonable condition. The glazing is apparently straight, and from what could be seen, all elements such as saddle bars and copper ties seem to be intact, however, none of the hopper vents are operational which is a shame and it would be a desirable improvement to bring these back into use.

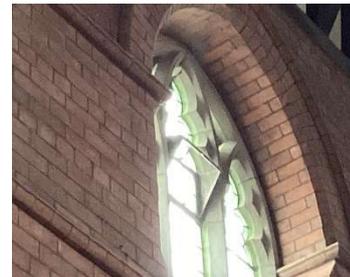
3.66 The hopper vents also appeared to be starting to rust and these will probably need redecoration during the quinquennium. They could be overhauled and brought back into use at the same time.

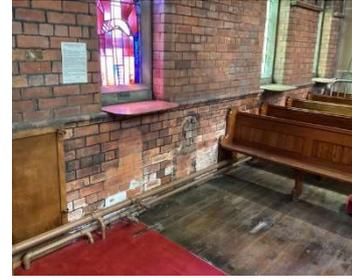
3.69 Walls are brick lined and the timber wainscoting extends part of the way down the aisle. Beyond this, particularly where the pews have been removed, there is quite a significant amount of salting. This should be brushed off and the joints raked out and repointed, which will hopefully help the salting work its way out of the walls. It is suggested that this is monitored over the quinquennium.

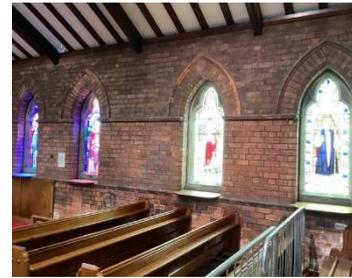
3.70 There are four stained glass windows in this aisle, a mixture of Victorian ones and relatively modern stained glass windows. All seem broadly in good condition. Saddle bars and copper ties appear to be intact across all four of these windows. There is, however, a little bit of bowing to the lower reaches of the two western Victorian windows, and they should be kept under observation.

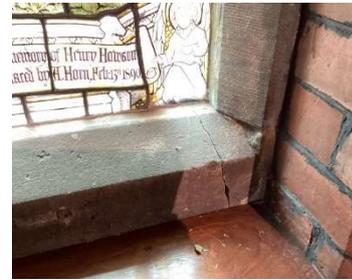
3.71 There is a fracture through the cill of the easternmost window and this should be repointed.

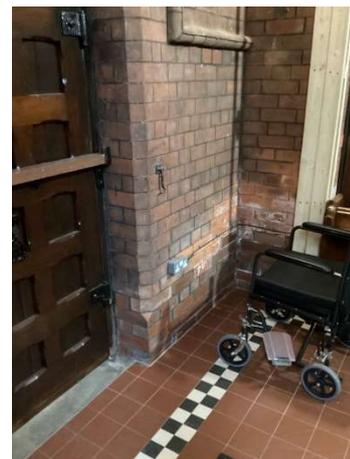
3.75 Walling appeared in reasonable condition. There is some low level salting in this space, as there is in other parts of the building. However, it is pleasing to see that this has improved over the last few months since the addition of the limecrete floor and some repointing, and so hopefully it will continue to dry out.

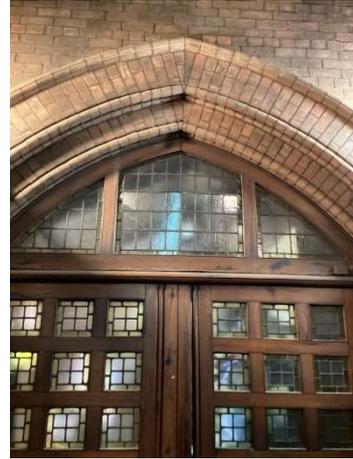
3.76 The timber doors and screens are generally in good condition, with the exception of the glazing and light to the east, which was noted in the aisle section of this report.

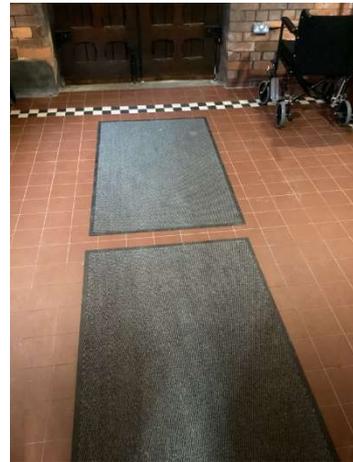
3.78 The new floor is generally in good condition, and appears to have bedded in very well.

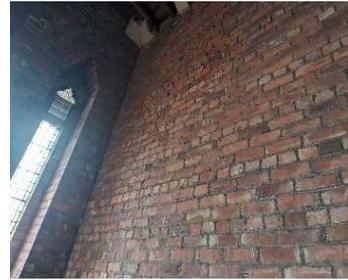
The tower is brick lined and the first stage had a timber floor and the ceiling is the underside of the floor above. There was a vertical hopped ladder to the next tower stage. Unfortunately on the day of inspection the volume of pigeon guano meant that it would be unsafe to climb any further into the tower.

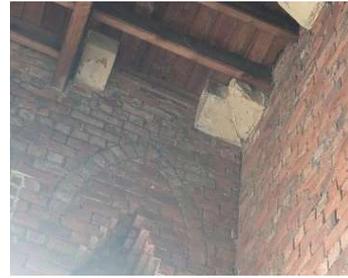
3.80 The floor above was supported on stone corbels. A couple of these were quite heavily spalled and should be kept under observation.

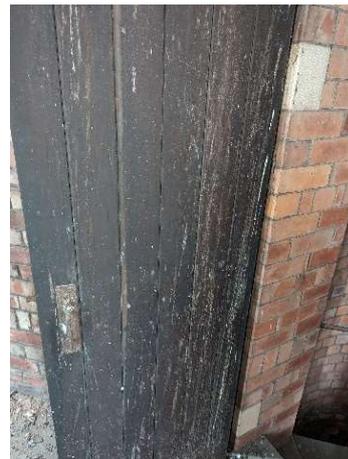
3.81 The entrance door requires re-decoration.

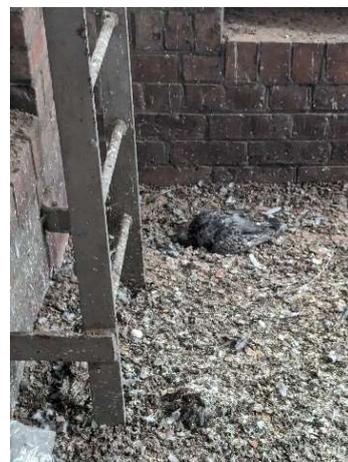
3.82 Pigeons and guano should be cleared.

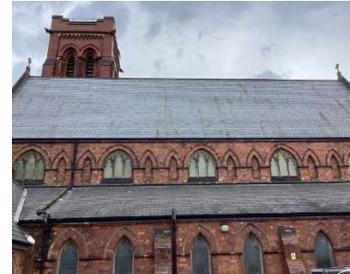
4.2 South Nave

The south nave roof is Welsh slate with a lead flashing and brick weathering course to each end. The ridge is clay. Generally the roof appears to be in good condition, with no noted slipped, chipped or missing slates. There are a couple of areas of slight unevenness, but generally speaking the roof appears to be in good condition.

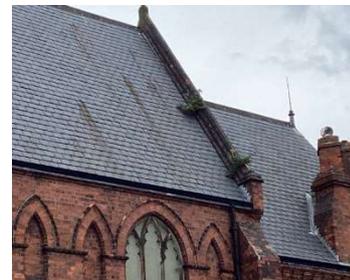
- 4.3 The significant vegetation should be removed from the parapet edges.

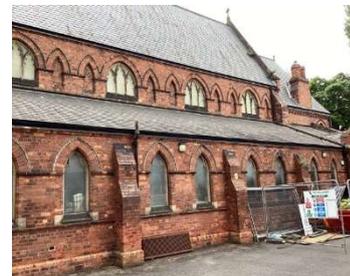
4.4 South Aisle Roof

The south aisle roof is also Welsh slate with lead substitute valleys and lead flashing against the nave and at the east end. The downpipes are carried over the roof. Generally it seems to be in reasonable condition. There is a single slate sitting in one of the valley gutters which should be cleared, but otherwise the roof seems to be in relatively good condition.

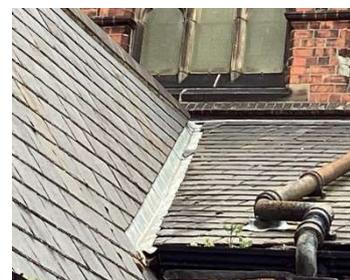
- 4.5 The slate sitting in the eastern valley gutter should be removed.

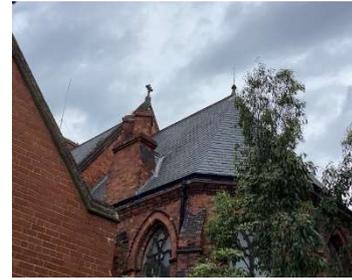
4.6 Chancel South

The southern elevation of the chancel is Welsh slate with a clay ridge. There is a lead flashing around the chimney set. Again, generally this appears to be in good condition. The slating looks to be relatively straight here, with no obvious chipped or missing slates. The lead flashings also appear to be in good order.

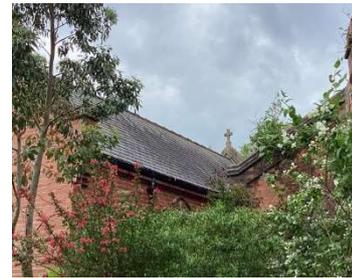
4.7 Meeting Room North

The northern elevation of the meeting room seems to be in good condition. It is Welsh slate with a modern clay ridge and lead flashings at each end. From what could be seen from the ground the roof covering appears to be in good condition, with no obvious chipped or missing slates. The valleys are in lead and seem to be in good order.

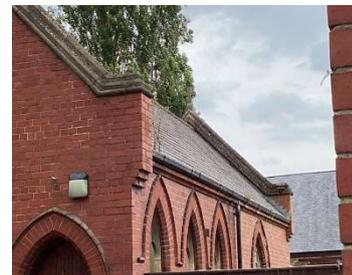
4.8 Meeting Room South

The south elevation of the meeting room is also Welsh slate with lead flashings and a clay ridge.

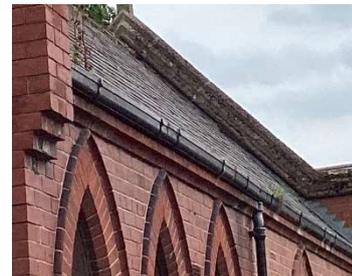
4.9 Pointing to the eastern flashing and the western flashing couldn't be seen from the ground, and so this should be inspected by a roofer. The missing pointing to the flashing should be repointed.

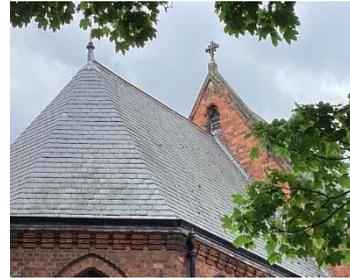
4.10 North Chancel

The northern elevation of the chancel is generally in reasonable condition. There is a little bit of moss cover to the side of the roof. Its Welsh slate with lead flashings against the nave and a clay ridge.

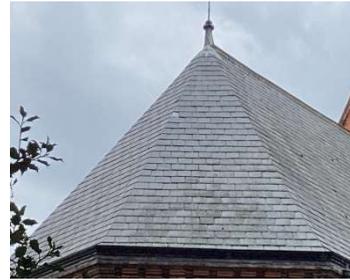
4.11 There is a slate missing from this section of the roof. This should be replaced when access is available.

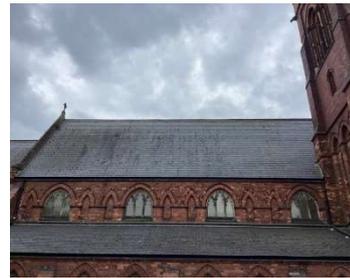
4.12 North Nave

The north nave seems broadly in good condition. It's Welsh slate with a lead flashing at each end and a clay ridge. Again, there is a little bit of moss on this roof which can wash down and block gutters. Broadly speaking it is in reasonable condition.

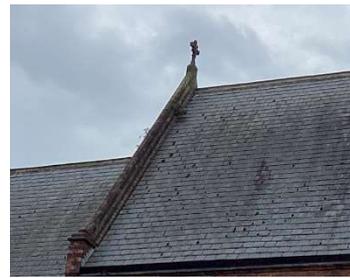
4.13 Again, there is some vegetation growing out of the roof and parapet which requires removal.

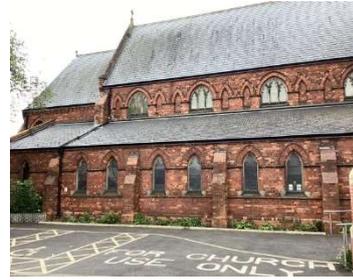
4.14 North Aisle

The north aisle is Welsh slate. There are lead flashings against the nave and a lead substitute against the tower. The rainwater goods are carried in cast-iron over this roof. Generally speaking the roof appears in reasonable condition.

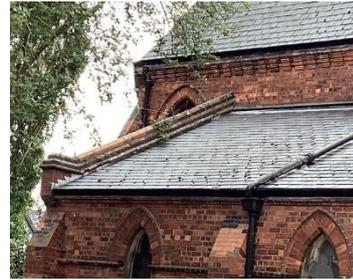
- 4.15 Vegetation should be removed from joints, and then treated with herbicide and repointed.

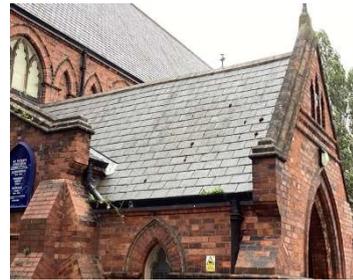
4.16 Porch West

The western elevation of the porch is Welsh slate with a clay ridge, lead flashings and a lead gutter. There is a little bit of moss on this roof, but generally speaking it's in good condition. Slating appears to be in good order.

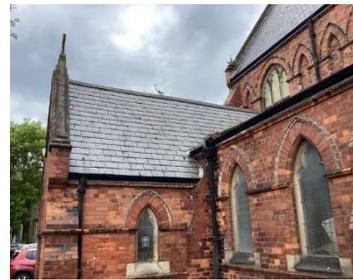
4.17 Porch East

The eastern elevation of the porch is generally in reasonable condition, again it is Welsh slate with cast-iron and lead flashings. Generally speaking, it appears in good condition.

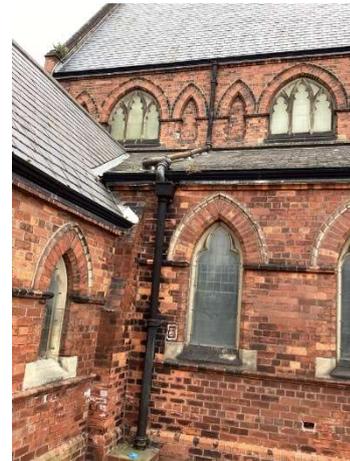
4.18 Rainwater Goods

Rainwater goods are cast-iron and generally large format. However, they are in desperate need of redecoration, particularly those that are carried over the aisle roofs. They should be redecorated.

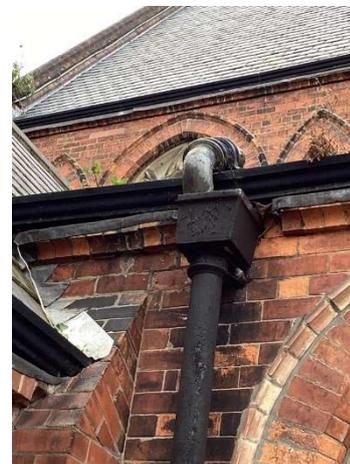
4.19 Rainwater goods are also in need of clearing. The gutters particularly had vegetation in them. It is suggested that the entire system is cleared and tested to ensure that it is functional.

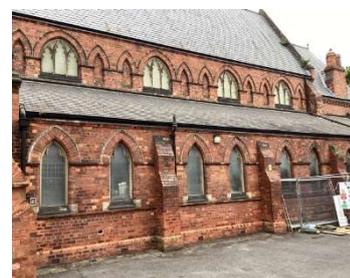
4.21 South Elevation

The southern elevation of the church has a brick built clerestory and south aisle. Generally across the elevation pointing is, for the most part, relatively tight, and generally the walling is in good condition.

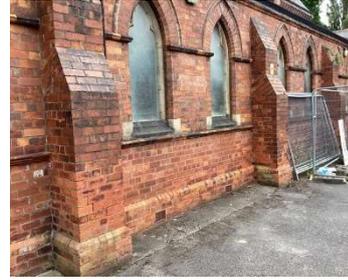
4.22 Particularly at low level there is some open jointing around the buttresses. A programme of raking out and repointing up, perhaps one elevation at a time picking up on open joints, would be beneficial.

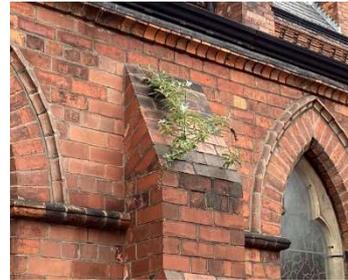
4.23 Areas of vegetation, particularly in the first buttress from the east. This should be removed, the open joint treated with herbicide and then repointed.

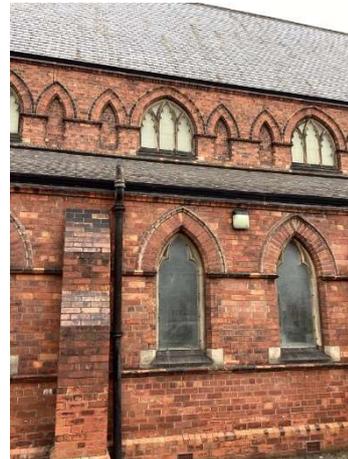
4.24 Clerestory and lower windows are all covered in a perspex protective cover. It would be a desirable improvement to replace this with a stainless steel window guard. Particularly as the plastic has become very discoloured and as such they are limiting the light that enters.

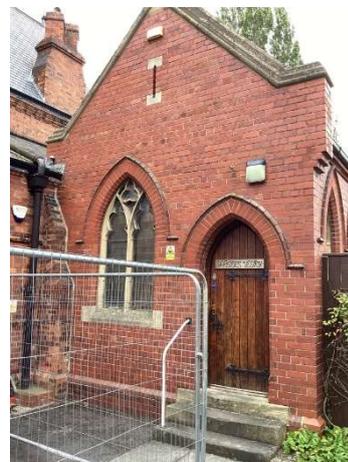
4.25 Meeting Room

The western elevation to the meeting room is generally in good condition. The brickwork and pointing seem to be in generally good order.

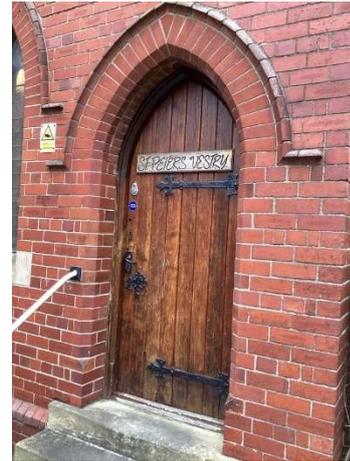
4.26 The door would benefit from redecoration.

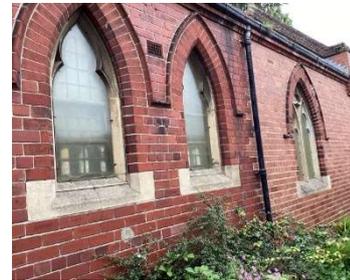
4.27 Vestry East

The eastern elevations of the vestry generally appear to be in good condition. Pointing generally seems tight and the elevation seems to be in good order.

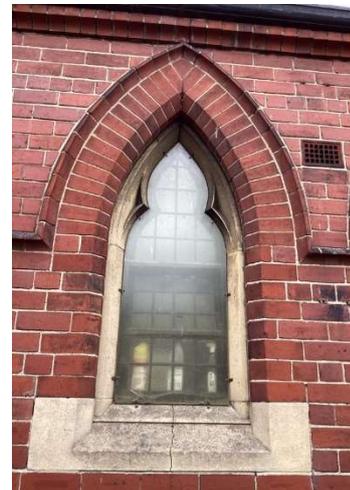
4.28 There is a little bit of evidence of the movement that has taken place over in the heads of the two westernmost windows and through the cill of the central lancet window. They should be repointed so that they can be monitored.

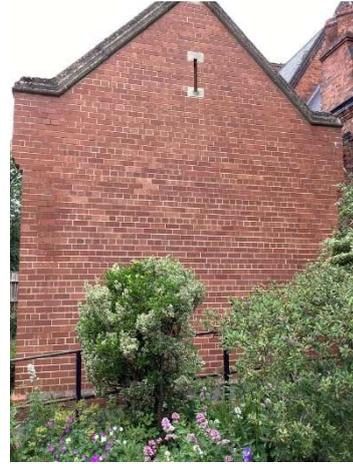
4.29 East Vestry

The eastern elevation of the vestry is a blind elevation. The brickwork and pointing appear to be in good order. However, the handrail of the ramp would benefit from redecoration.

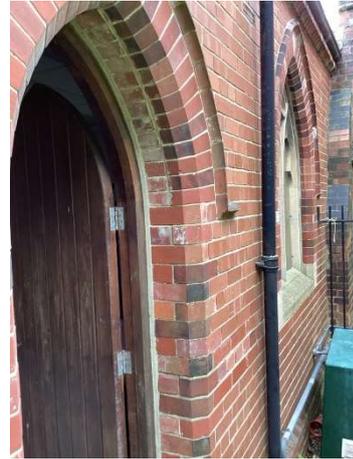
4.30 North Vestry

The northern elevation of the vestry is brick built, there is a window and door, and all appears to be in good condition. Pointing seems tight and brickwork is holding up well.

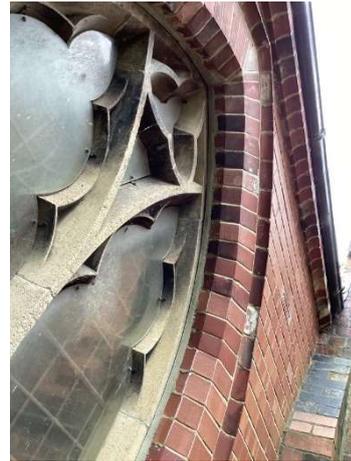
4.32 There is a slight separation between the upper section of the tracery and the hood of the window. They should be pointed and monitored. It may be that a mason actually secures this with some pins.

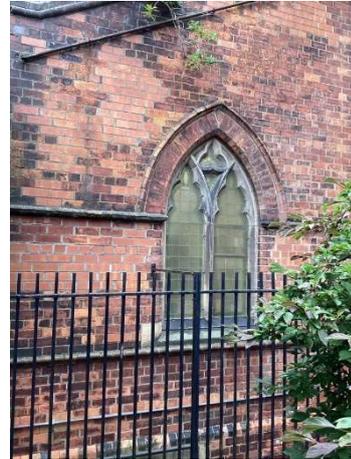
4.33 Meeting Room East

The eastern elevation of the meeting room is generally in reasonable condition. The brickwork is in good order and mostly pointing is fairly tight.

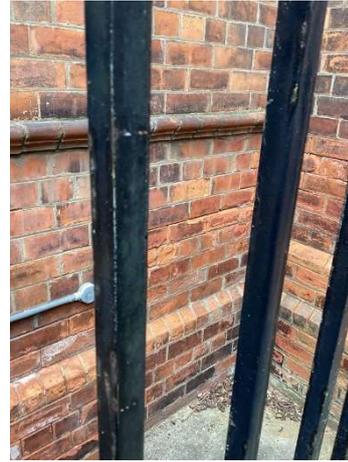
4.35 There is some open jointing through the brickwork, below the weathering course level, and this would benefit from being repointed.

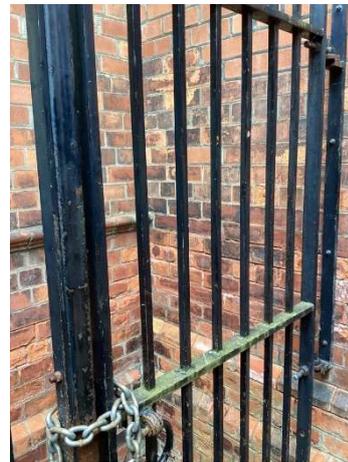
4.36 Ironmongery on the boiler house requires redecoration.

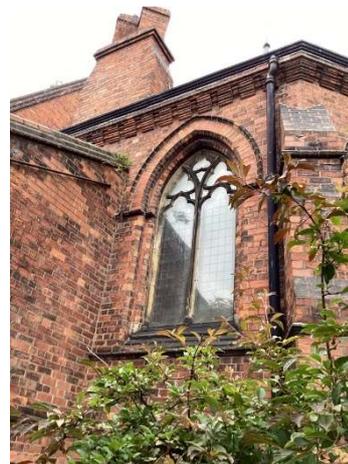
4.37 Chancel South

The south elevation of the chancel is brick built and slopes away as the apse is formed. At high level there is a significant chimney stack.

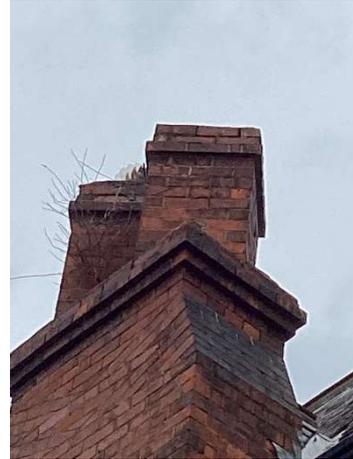
4.38 There is some open jointing to some of the brickwork to the upper reaches of the chimney stack and there is some vegetation slightly lower. This should be removed.

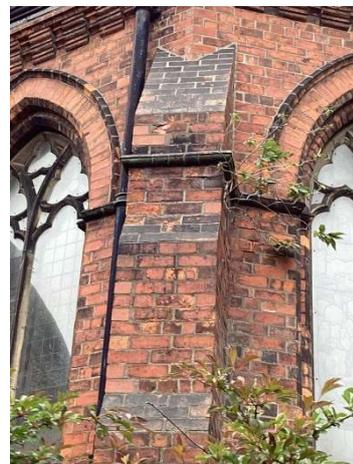
4.39 There is vegetation growing at high level, particularly around the buttress. This requires removal and the surrounding open joints to be pointed back up.

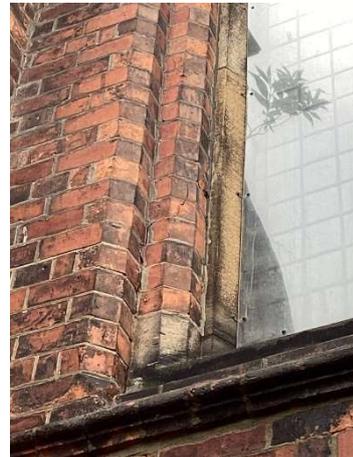
4.40 The fracture running through the reveal of the window should be pointed and kept under observation.

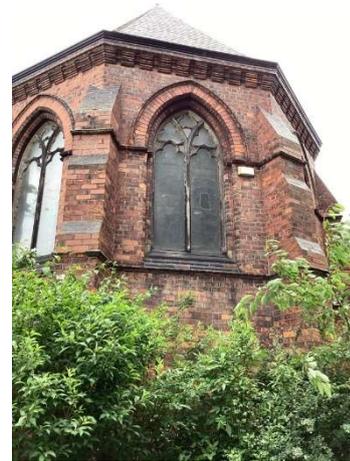
4.41 Chancel East

It was a little difficult to view the eastern elevation of the chancel due to the amount of vegetation growing around the base. However, generally speaking it appears to be in reasonably good condition. The brickwork seems to be in good order and the pointing, for the most part, was fairly tight.

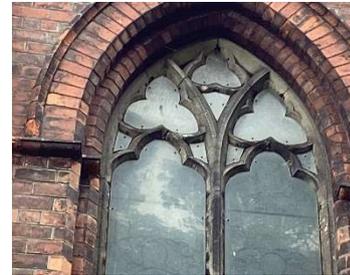
4.42 There are open joints to the tracery of the easternmost window. They should be repointed.

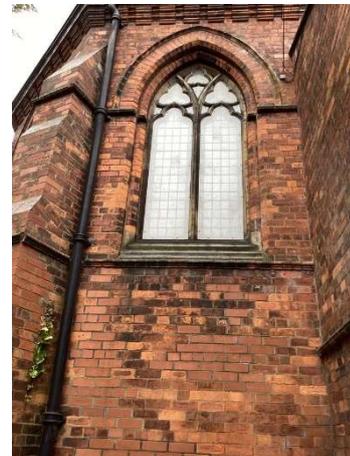
4.43 The northern elevation generally appears to be in good condition. For the most part, repointing seems in relatively good condition, as did the brickwork.

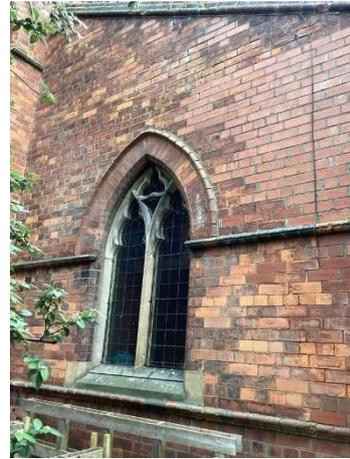
4.44 North Aisle East

The eastern elevation of the north aisle was also in reasonably good condition. The brickwork and pointing, for the most part, was in reasonable condition.

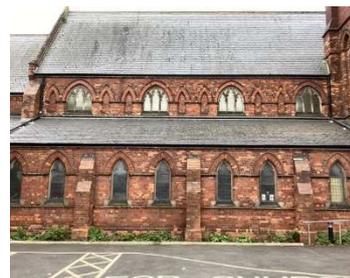
4.46 North Elevation

The north elevation of the nave is brick built and generally in reasonable condition. Pointing and brickwork is, for the most part, in good condition.

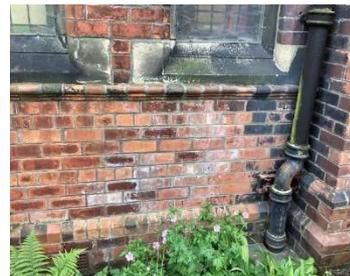
4.47 Towards the west end of the north aisle there is quite a bit of salting. This area has been repointed and it does look as if it may now be drying out.

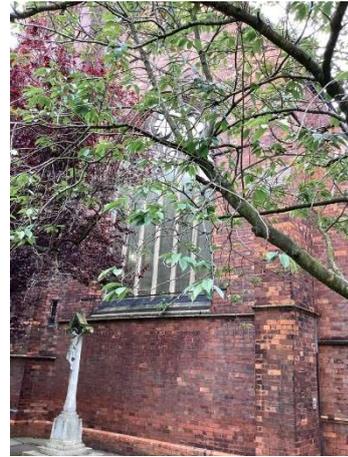
4.48 West Elevation

The west elevation is also brick built and houses the large western window. Like the other elevations, generally speaking the pointing and brickwork is in good condition, with a few exceptions.

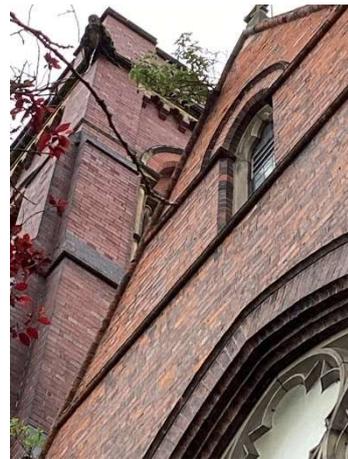
- 4.50 At high level within the gable there is some vegetation growing. This requires removal and the area treated.

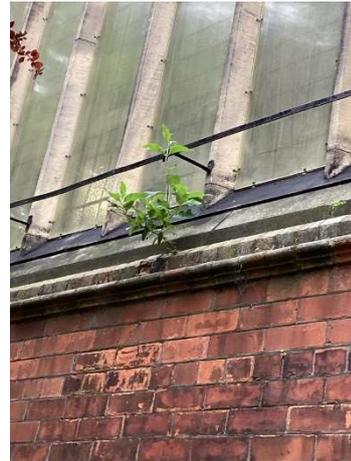
4.51 And again with the window, there is quite a bit of vegetation.

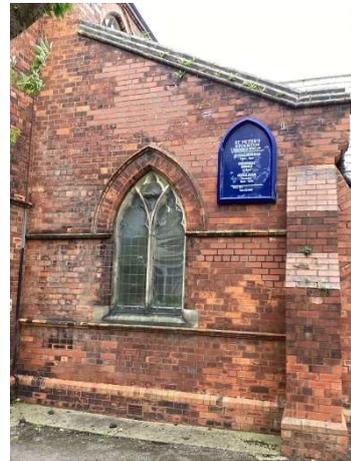
4.52 South Aisle West

The western elevation of the south aisle is also in reasonably good condition, with the exception of the buttress.

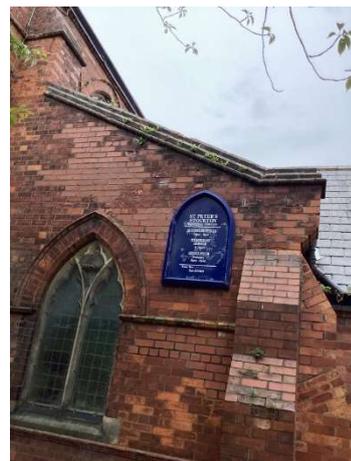
4.53 Both the buttress and parapet have quite a bit of vegetation growing out of them, these require raking out and repointing.

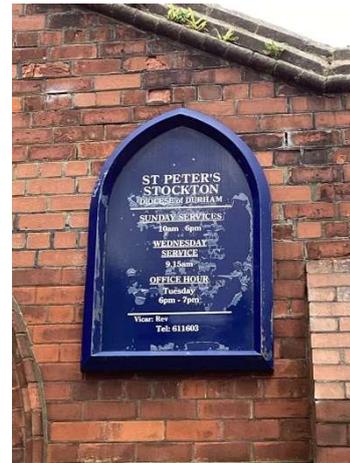
4.54 The signboard requires redecoration.

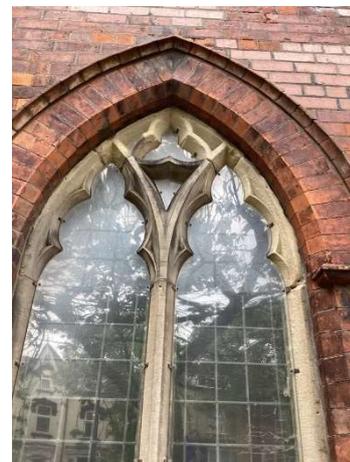
4.55 Tracery is quite soft and the joints are quite open, and it would benefit from raking out and repointing.

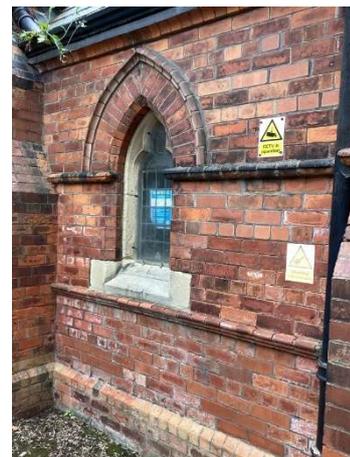
4.56 Porch

This elevation of the porch is quite open jointed in places, particularly through the middle section. It would benefit from being raked out and repointed where joints are open. This is essentially between the two weathering courses.

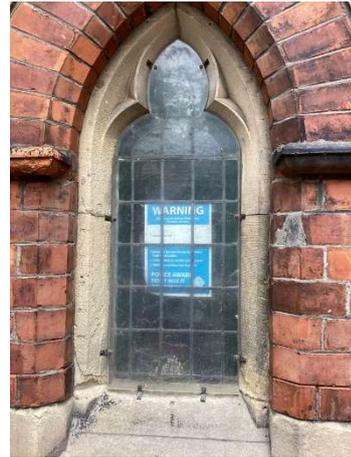
4.57 The stonework to the window is quite soft and stonework replacement would be beneficial to the northern side, and repointing to the remainder.

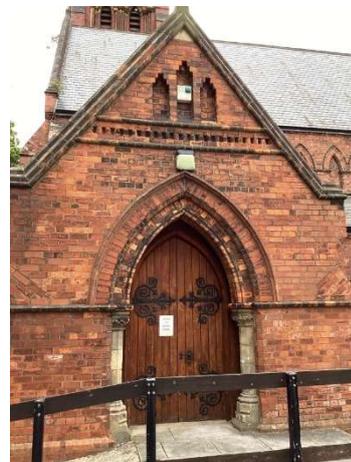
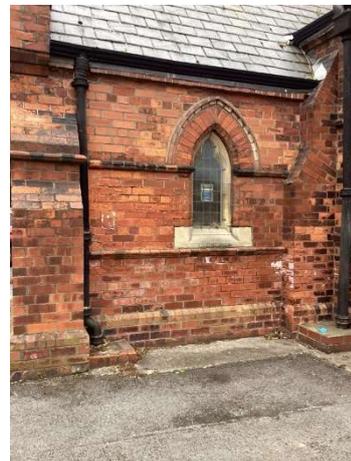
4.58 The southern elevation is generally in reasonably good condition, pointing and brickwork are generally in reasonable order.

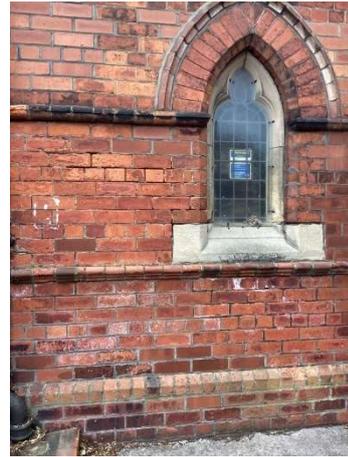
4.59 There is some open jointing and soft brickwork. This would benefit from being repointed.

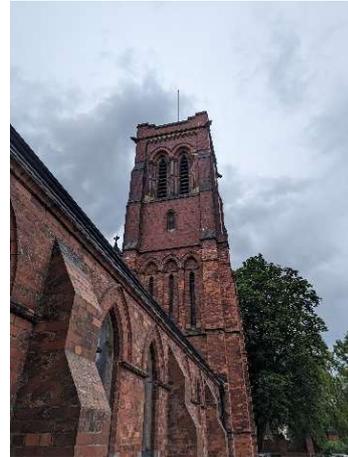
4.61 Tower East

The eastern elevation of the tower, as viewed from the ground, is broadly in good order. There is some open jointing which would benefit from being filled, but this is a low priority at present.

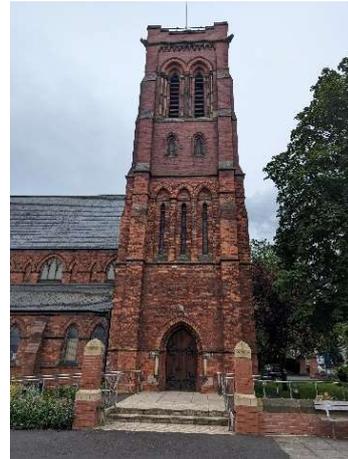
4.63 Tower North

The northern elevation of the tower is broadly in good condition. Brickwork is reasonable, although there are some spalled and open jointed areas. It is a low priority at present though.

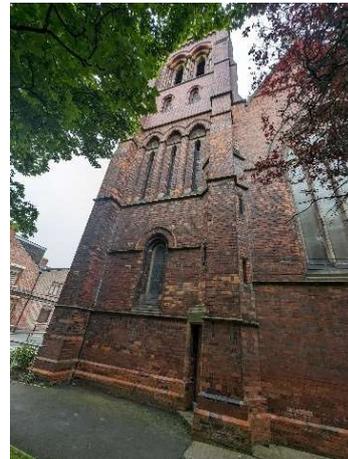
4.64 Tower West

The western elevation of the tower is broadly in good condition. Brickwork is reasonable, although there are some spalled and open jointed areas. It is a low priority at present though.

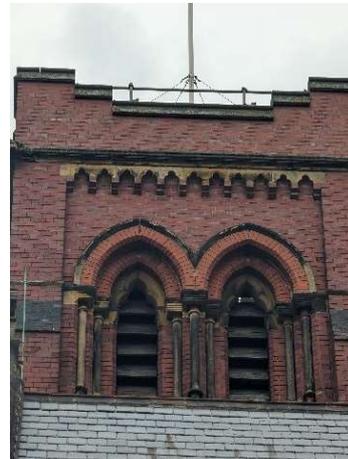
4.67 Tower South

The southern elevation of the tower is in broadly similar condition to the others. Some open jointing, but repair is a low priority.

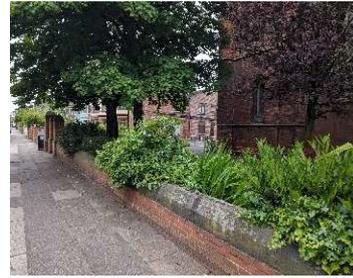
- 5.1 The church is surrounded by a brick wall. There are no burials on the site.

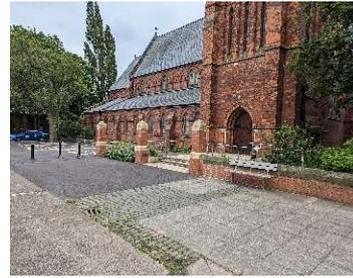
- 5.2 The walling and new entrance is in good order.

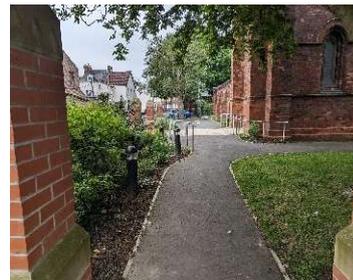
- 5.3 The new level equal access is in good condition.
