QUINQUENNIAL INSPECTION REPORT
of
THE MINSTER CHURCH OF SAINT MICHAEL AND ALL ANGELS AND SAINT BENEDICT
BISCOP, SUNDERLAND

SUNDERLAND MINSTER

QUINQUENNIAL INSPECTION AND REPORT October 2017
David Beaumont BA (Hons) Grad Dip, RIBA, AABC

REPORT ON THE 2017 QUINQUENNIAL INSPECTION

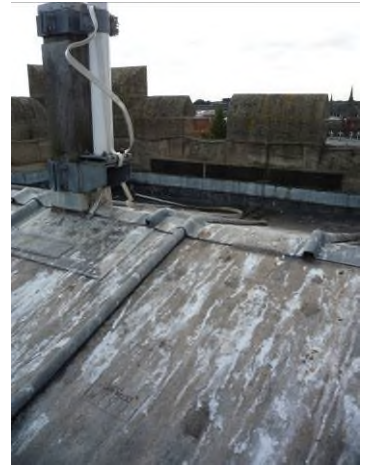
The hatch is heavy and could do with being put on hinges with a strut and catch inside.

Recommendation: repoint edge of flashing, and fix better hatch arrangement.

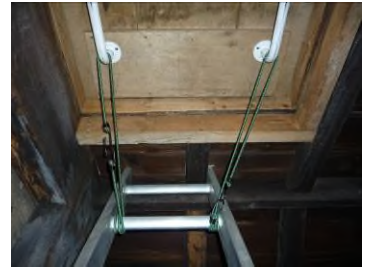
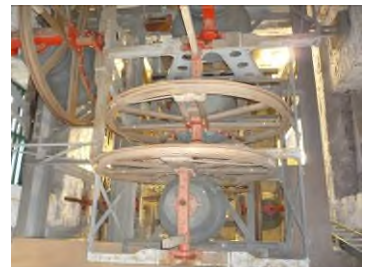
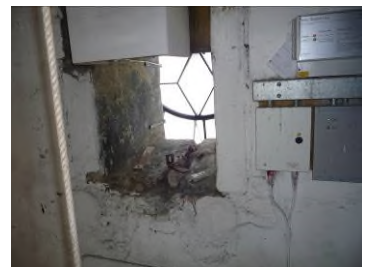
D **Bell Chamber:**

- Walls – OK. They are lime washed and in reasonable condition. Wall thickness here approximately 900 and core exposed at the dial positions.
- Ceiling –ok no water penetration. Hatch held by bungees.
- Floor – Has some dust and old bird debris on it.

Clock installation appears satisfactory.

Recommendation: sweep floor.

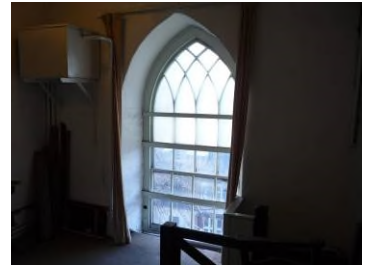
D Deafening Chamber:

Fair condition.

Image from 2013 Q1

Recommendation: Repair window, sweep out floor.

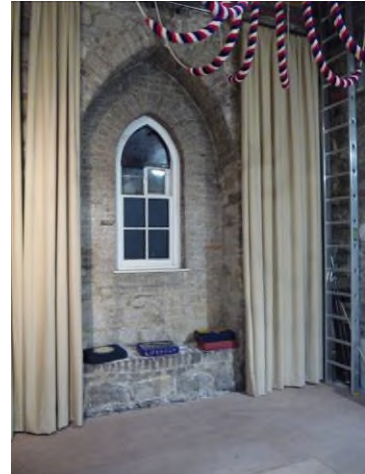
Ringling Chamber:

- Floors – The floor is plain sheeting. Is carpet better for ringers?
- Windows – The west window has its glazing blacked out in the top arch paint there is a painted wooden board and a better arrangement is required. It is part of the earlier church. It is part enclosed by the narthex so little can be made of it other than perhaps unifying the glazing to all black but a very low priority

Recommendation: none

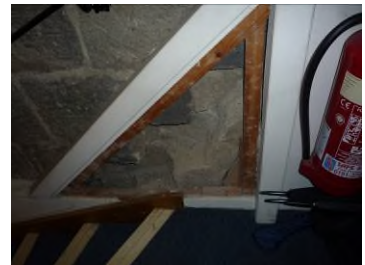
E Stair lobby to office:

Slight cracking to the south wall within the joints approximately 1mm.

Strand wood board infill into the borrowed light area of the door.

Recommendation: Infill stone area, replace strand wood board.

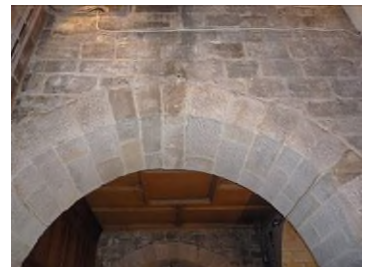
Base of Tower:

No sign of cracking to the arches, there is a slight amount of pointing fallen out of the southern arch but no action required.

Memorial panelling in good condition.

Recommendation: none

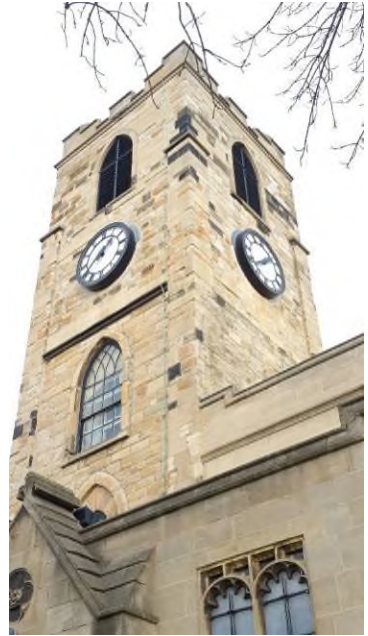
Tower

Louvres appear in good condition. The clock dials also. West window requires decoration and cill repair.

Recommendation: Repair window.

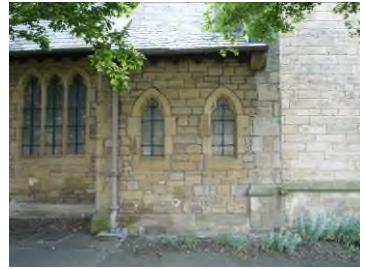
- D** **Small area over the W.C:**
Some ferns growing in the slating.

Recommendation: remove

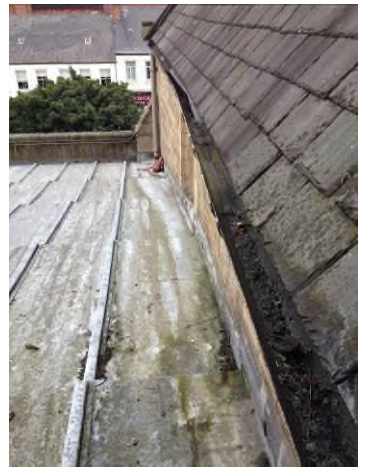
North transept:

Image from 2015 inspection

Recommendation: carry out repair in 2018

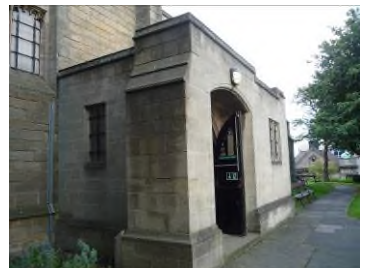
- **North Porch:**
Mineral felt flat roof. Serviceable.

Recommendation: none

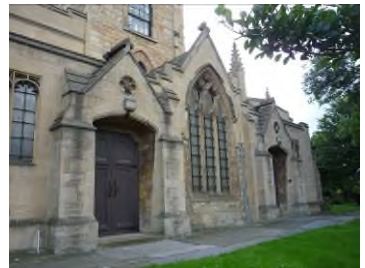
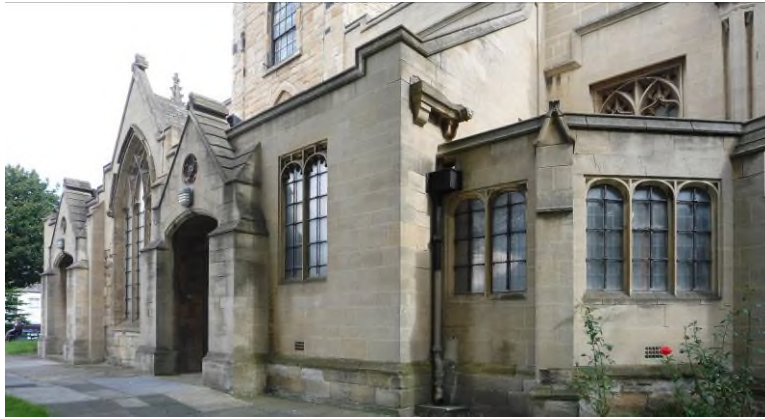
- **WEST SIDE**
Comprises a group of Narthex plus Ladies and Gents W.C's. The W.C's have flat roofs in mineral felt. The narthex roof is tiled and appears ok looking down from the tower.

Recommendation: none

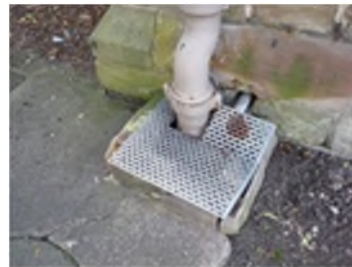
Roof by W.C. – Slight dip in the gutter and the bracket looks to have dropped slightly and the decoration's beginning to fade on the gutter. Downpipe ok although there is some rusting at the collar. The secondary grid is loose.

Recommendation: remove rust and decorate. Fix grids.

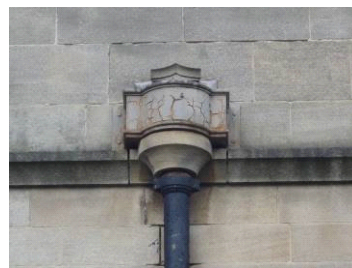
North Aisle:

Three downpipes with rusting ornamental hopper heads and anti-climb paint is wearing away a bit at the upper levels. The remainder of the pipes coming down to the ground look sound, though there is some slight rust marks on them, these all discharge to gulley's with secondary mesh grids.

Recommendation: to be repaired as part of the 2018 GPOW works.

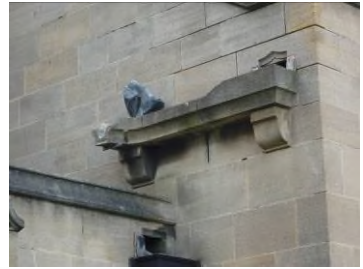
South Side – Lead work here is intact.

Recommendation: repair leadwork

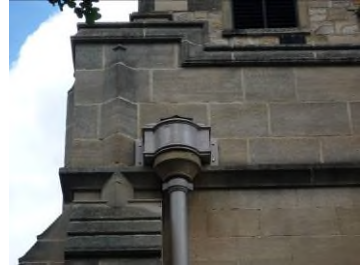
South Aisle:

Three downpipes and ornamental hoppers all recently refurbished and looking good.

Recommendation: none

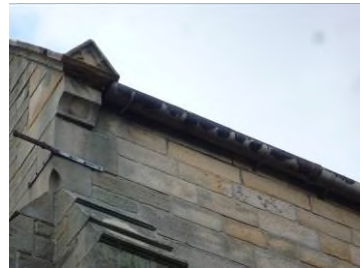
East side- showing signs of breaking down decoration and rust.

Recommendation: remove rust and decorate.

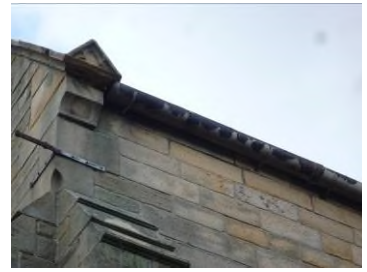
Bede Chapel:

Rusting to gutter and the swan neck particularly. Downpipe down to area enclosed by shrubs so not able to inspect.

Recommendation: remove rust and decorate, inspect downpipe when next inspecting roof

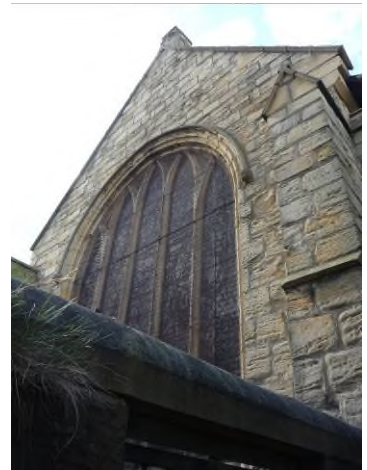
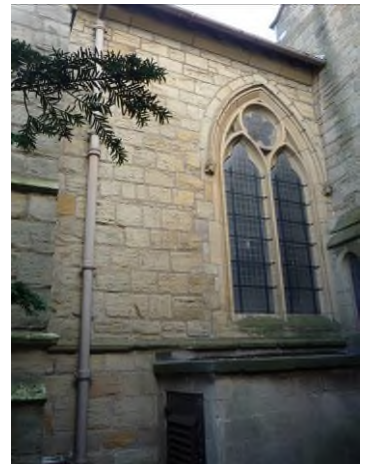
Over sailing course in ashlar ok. Walling is good, some erosion to the string course but no action required. Two light window with polycarbonate appears ok.

Recommendation: none

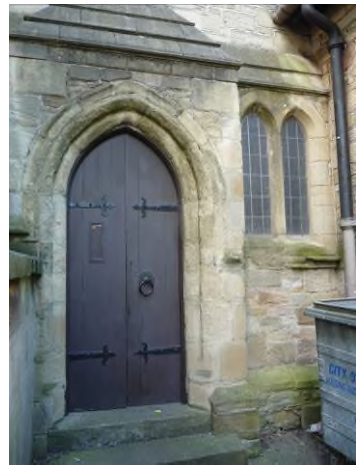
- **East Entrance:**

Ground floor stage has sloping ashlar band of stonework with slight open joints occurring at the doorway.

This has a pair of double lights either side of a central doorway, the lights have been glazed in with polycarbonate and cement pointed in. The door surround has lost its moulding and is shaling slightly. The cill is broken to the northern side and showing slight areas of damp but not really a problem, probably from the downpipe that has leaked in the past.

Recommendation: none

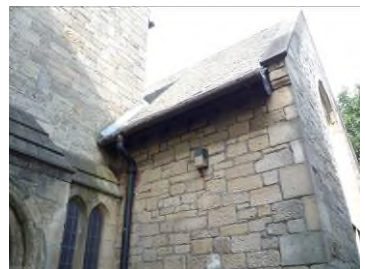
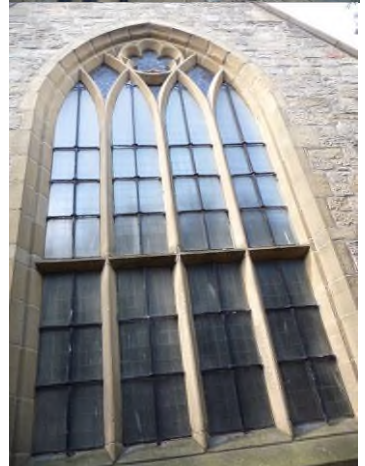
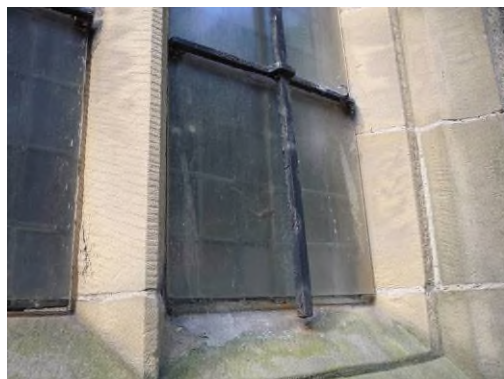
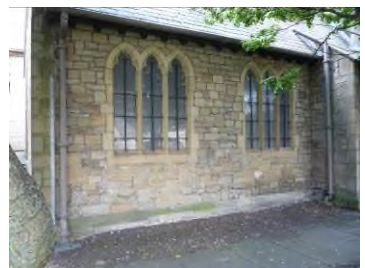
A little more in the way of open jointing on this elevation requiring some attention in the next 5 – 10 years. 2 no. three light windows with ashlar dressings in good condition, slightly rusting ferramenta supporting polycarbonate, probably wise to start to decorate this ferramenta now.

Recommendation: put a plan into place to decorate the ferramenta and polycarbonate of all the windows

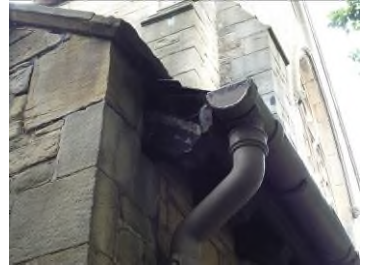
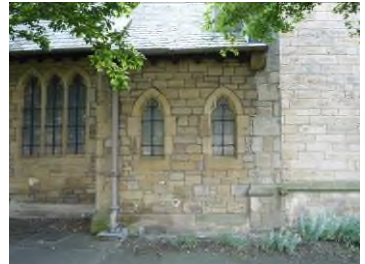
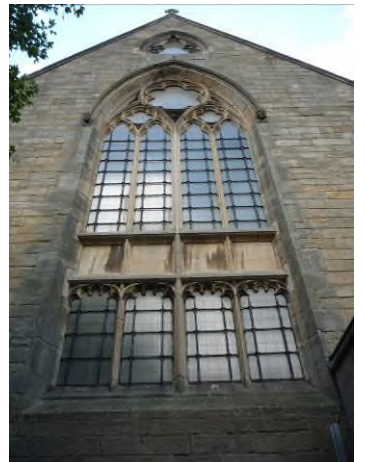
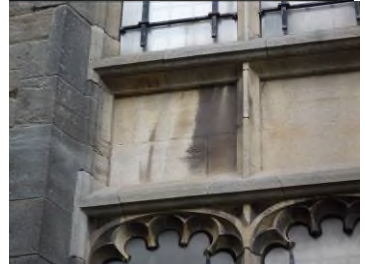
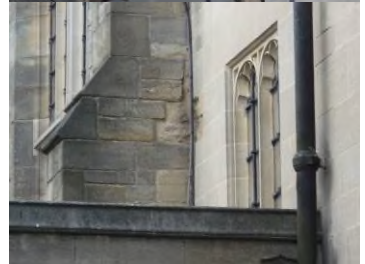
Four light window with quatrefoil windows with sexafoil central window. The upper mullions have been replaced (fine grain sandstone) in recent times and they are fine, the lower mullions are ok for the mean time. There has been a horizontal band of limestone inserted when Caroe modified the transept to insert the gallery floor. There doesn't seem to be any chemical reaction to the sandstone surrounding it. Slight open joints to the arch stones and hoodmold.

Large quatrefoil above it which appears ok. Both of these windows have polycarbonate over glazing. The larger window has ferramenta and this looks to need redecoration now.

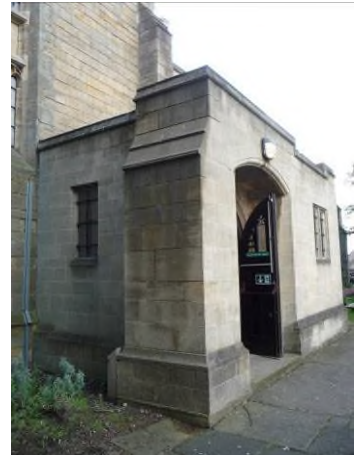
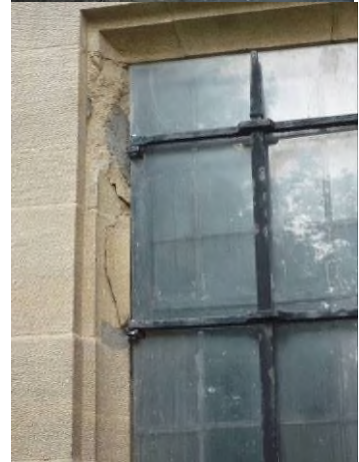
D North Aisle:

North Side –

Open joints to the parapet coping plus chipping to one of the stones, the middle band of walling has open joints at the downpipe position and buttress though these will need to be worse than they are to really attend to them. The elevation has 3 no. three light windows plus 1 no. two lights over the north porch. The north porch window looks ok though it does have a bit of rust to it and just to the left of that window there is some erosion to stonework.

The three major windows are in fair condition though there is some open joints to the tracery but they are sound. They have ornamental ferramenta with polycarbonate and the polycarbonate is dirty and the ferramenta rusting slightly.

Recommendation: ferramenta repair, polycarbonate and glass cleaning and repairs to the parapet are part of the GPOW works in 2018.

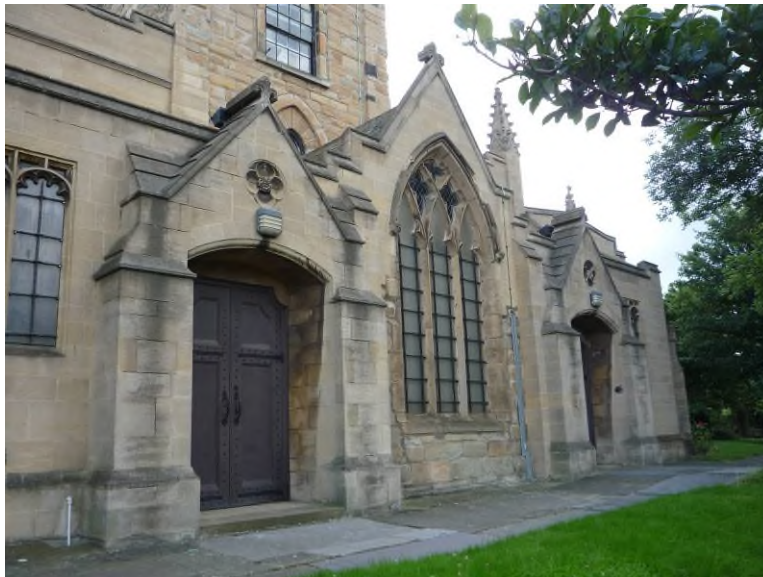
C **Narthex:**

Open joints at high level just above the external hopper.

The doors are generally sound though their hinges are rusting and the door decoration is fading now.

Central Part: Major pediment ok apart from some slight open joints in the walling attached to it. The hoodmold to the three light tracery window is broken and due for repair as part of the 2018 GPOW works. The tracery within it also is beginning to wear away but will last another 5 years.

Generally the walling is sound, and interestingly, this is the only part of the 1930's work where Caroe has retained the original sandstone (apart from the tower) and this is shaling slightly.

Recommendation: repoint open joints to the central section- this is more urgent than routine repointing elsewhere and perhaps to be added into the 2018 GPOW works?, attend to door decoration and rusted ironmongery

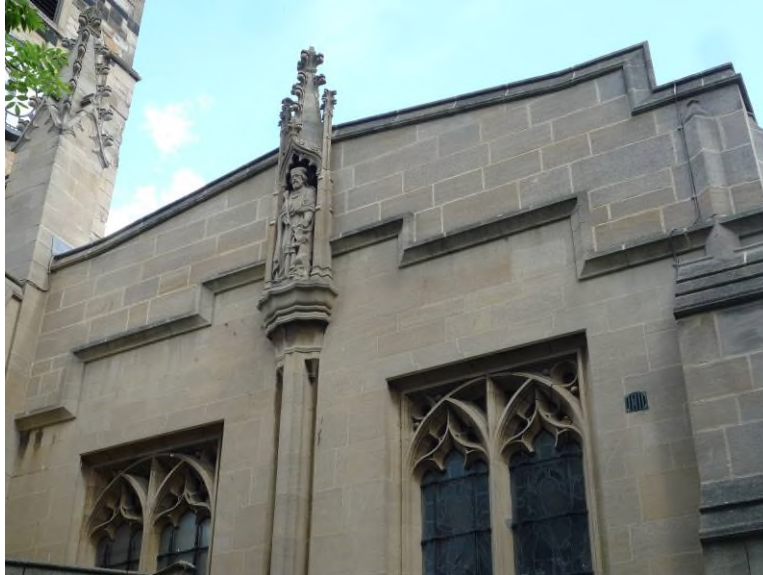
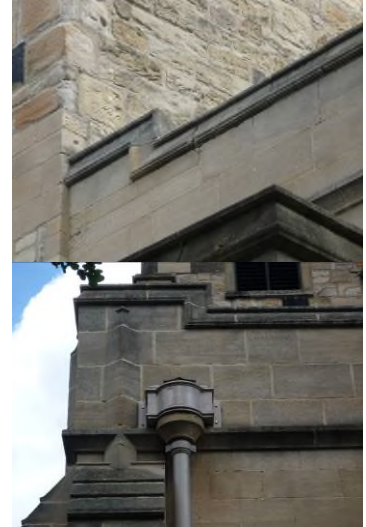
South Aisle:

Repointed as a result of the 2015 work and in good condition, the cills to the kitchen window are slightly open jointed. The plinth below is in sandstone and is eroding.

The parapet upper level was repointed as part of the 2015 works. There are some open joints above the window heads and at the buttresses. The plinth is sandstone and eroding. The windows are the same as the north side, here the polycarbonate has been cleaned but the ferramenta is rusting slightly.

Recommendation: see general comment of ferramenta repairs and polycarbonate cleaning, repoint open joints

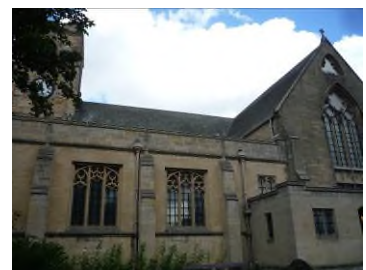
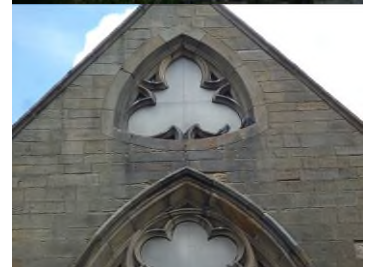
The principal window has more pigeon/gulls presence on this elevation so there is a bit of guano on the top. Some slight shaling to the hoodmold but if it broke it would only fall onto the flat roof, it doesn't look too high risk.

The mullions have been replaced in the recent past (like the

north), looking ok, polycarbonate is looking ok and is likely that the ferramenta is rusting a bit though it is not obvious from here. Slight open joints at the newly introduced limestone panel from Caroe's works.

The buttresses to the transept have open joints though whether they require attention in the next five years is debatable.

Recommendation: see general comment of ferramenta repairs and polycarbonate cleaning, repoint open joints

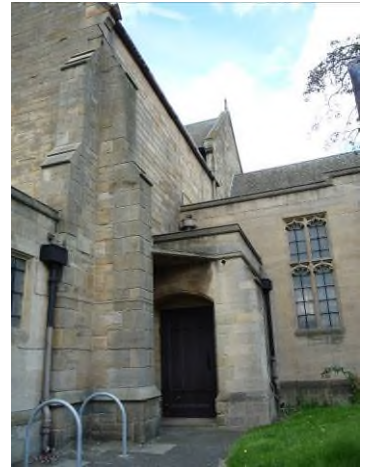
Bede Chapel:

Open jointing at upper level but not really needing attention. Open joints just at the cill. Dirty polycarbonate and rusting ferramenta, one of the bars looks to be loose.

Open joints at high level, shrubs concealing the base so not able to be inspected. Rusting ferramenta over the polycarbonate.

This features a projecting bay with a stone roof to it, it is not possible to see the jointing here. Some slight open jointing at higher level by the hoodmold of the window. Polycarbonate with rusting ferramenta. Lower area not able to be seen because of bushes.

This abuts the chancel and has open joints just as it hits the window. Two light window below like the rest and the walling below that can't be examined because of the planting.

Recommendation: see general comment of ferramenta repairs and polycarbonate cleaning, Cut back bushes to enable inspection.

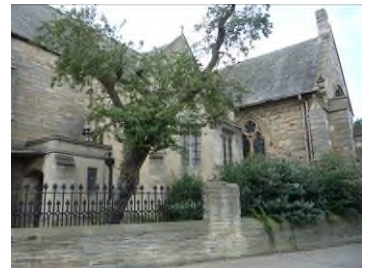
Chancel: South Side –

Sandstone walling appears in good condition, the two light lancet window is partially obscured with planting but seems fair. The ferramenta is rusting. Bottom of the wall not able to be inspected due to planting.

Recommendation: see general comment of ferramenta repairs and polycarbonate cleaning, Cut back bushes to enable inspection.

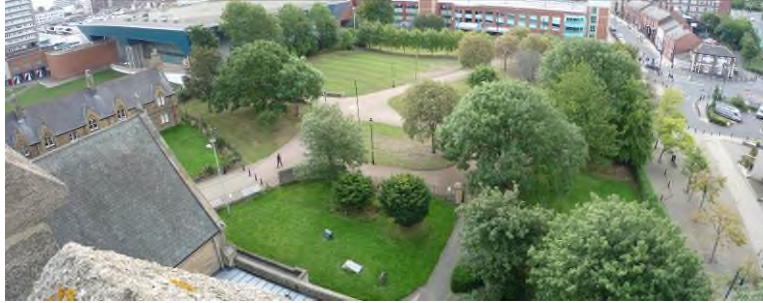
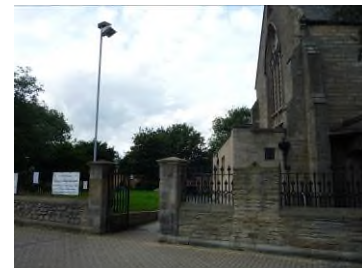
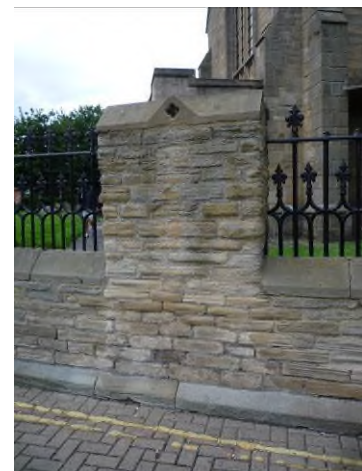
C **East Boundary:**

Northern Side – Mixed sandstone and concretionary limestone (showing coralline concretions) masonry wall in fair condition, some slight cracking to the right of the doorway been repaired in cement but no action required. Pair of gate pillars in sandstone much eroded, no longer in use and there is a rather rickety door to it now, badly grazed and looking a little derelict. To the left of the sandstone pier is a crack to the wall, looks to be about 5 - 6mm which needs repair assessment.

The secondary half of the boundary comprises a low sandstone wall with metal railings. This has multiple open joints in the stonework and where the railing connects to the stonework, it's rusting, expanding and breaking the bond slightly. Some parts of the railings are missing and broken.

Pair of double metal gates ok though there is no plinth in the ground to hold them in a closed position but suspect they are not used in this way. This is the 'Front Door' to the Minster.

As the wall comes to the south side, the dwarf wall stonework is a poorer quality. It is cement pointed and very rocky, it also has a concrete cap to it and a modern and slightly cheap and rusting railing.

High wall- repair door and redecorate, assess repair needs of wall cracking, remove cement pointing and repoint in lime, remove expanding railing parts in stonework, repair stonework and railings and redecorate. Make closed shut fixing for gates.

Low wall- Remove cement pointing and repoint in lime, replace concrete capping with stone, replace railings with a more fitting quality,

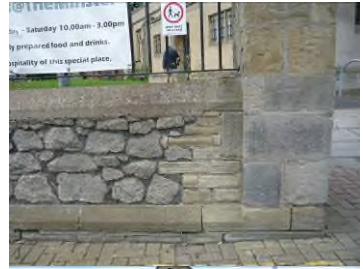
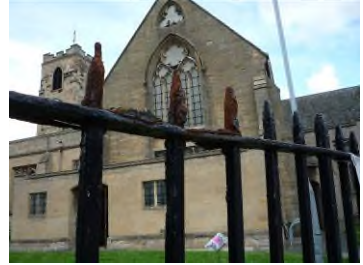
South east facet:

This is a high wall on the facet on the angle of the road which may well have been installed at the time of the Caroe works, it has a large crack down the middle of it. It has cracked stone as well as the jointing. In cement pointing.

Recommendation: assess repair needs of wall cracking, remove cement pointing and repoint in lime

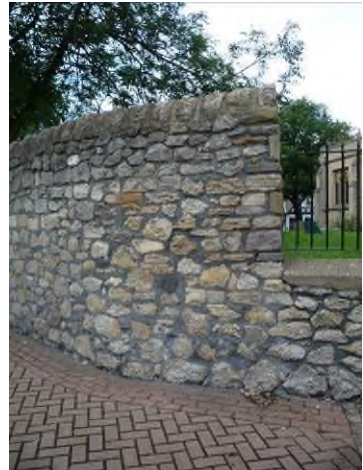
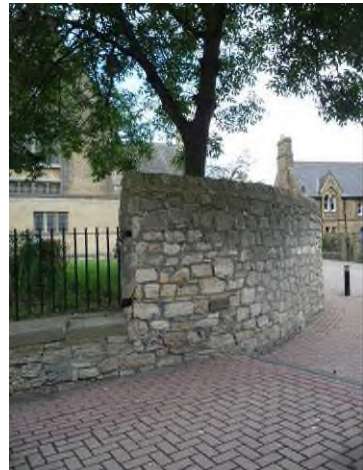
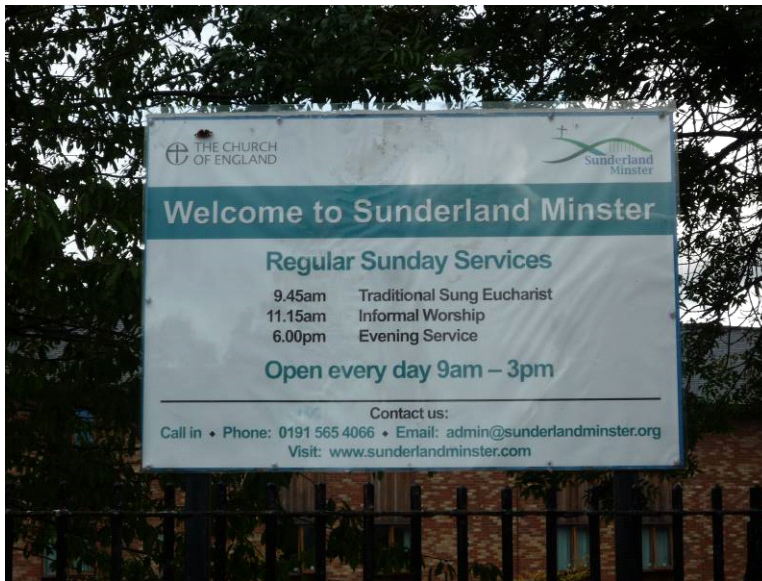
South side:

As the wall turns the corner it turns into a full height wall, there is ash tree growing very close to it and is threatening the wall. There is a bulge and cracking to it, it has been heavily repointed in cement which is breaking away at its junction to the railings of the adjacent low wall, where the old fixings are rusting.

The twin gates are rusting now and require oiling on the hinges at least. If there were funds a full overhaul would be favourable. The sandstone piers are massive and in fair condition though they are shaling slightly but they are sound enough. This entrance no longer makes sense- it was for when the church was accessed at the west end and so to use it makes for a dog leg path within and an indirect approach from The Green.

The wall turns south this is breaking at the tree position. Pier cap is also rusting up at the split level of the railings. There are

The noticeboard has water behind the clear sheet and spoiling the artwork.

Recommendation: two trees threaten the walls and should be removed if allowable, if not then the wall needs rebuilding to accept the tree expansion. Remove cement pointing and repoint in lime, repair gates, repair walling broken by railings, repair or replace railings depending on funds, renew notice board

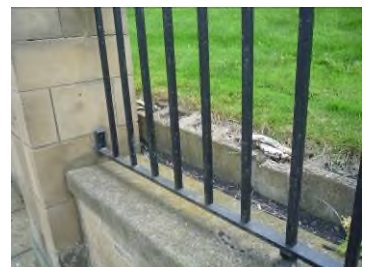
The wall here comprises of low level wall with stone copings supporting an ornamental metal balustrade of good quality. Balustrade is rusting but it is not breaking the joints in the stone

pillars. The wall itself has been repointed in cement in the past and would be better in lime if funds allow. The very edge of the burial ground is being held back by hollow cell concrete blocks and this is unattractive.

Recommendation: repoint in lime if funds allow, remove rust from railings and redecorate, replace concrete blocks

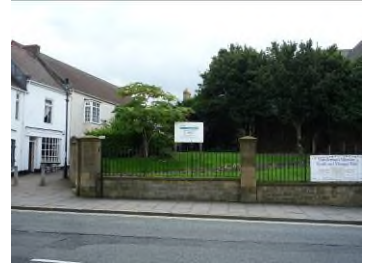
Pair of ashlar stone piers supporting a pair of metal gates, which operate ok but are unable to be kept fixed in a closed position, some rust .

Recommendation: enable gates to be restrained when open, redecorate and oil hinges

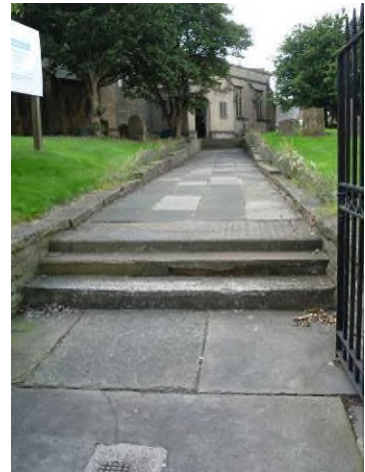
C Interior of Graveyard:

Stepped and ramped approach to the north side has some slight unevenness to the paving and open joints. At the edges is a stepped retaining wall made up of slabs and these are coming apart.

The paving around the building is modern concrete slabs, grave slabs and natural paving, it has open joints to it and some slight unevenness to the surface but would require major work make it perfectly level. There are hopes for a ramp in the future and so it might be that these defects can await the arrival of the ramp works.

Against the building there are pockets of shrub planting which is looking a little down at heel in places. The remainder of the land is set aside for grass and there are some small trees within it. These trees need to be kept in check particularly at the north east part of the site as they shield intruders.

Recommendation: assess repairs needs to path against possible future ramp, keep trees well cut back in NE corner

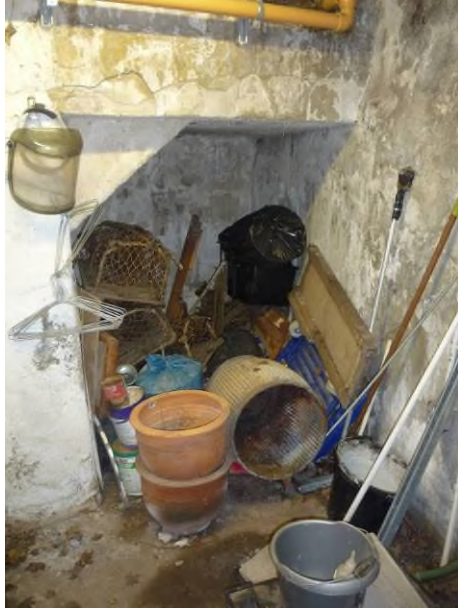
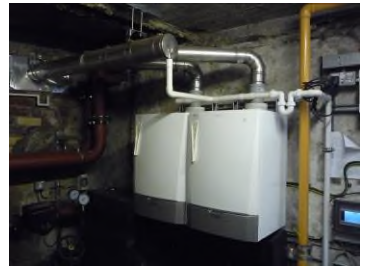
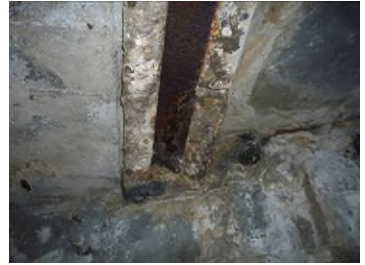
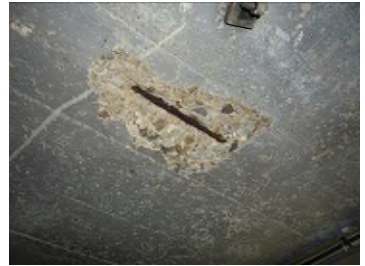
Boiler Room:

Renovated roof in 2016, no reporting damp coming through. The steel beam continues to rust though it doesn't look as if action is needed. Generally the walls are fairly old and of their time. Brand new boiler installation of Remeha Quinton Pro double boilers with Grundfos pump and boiler control system. Some lumber to clear out.

Recommendation: remove unwanted items

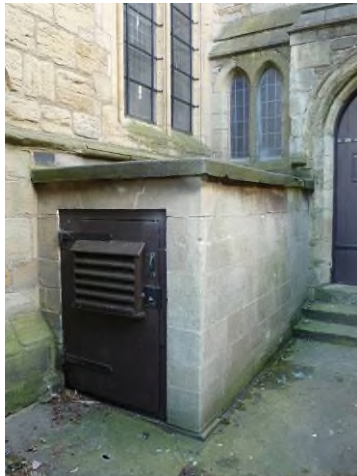
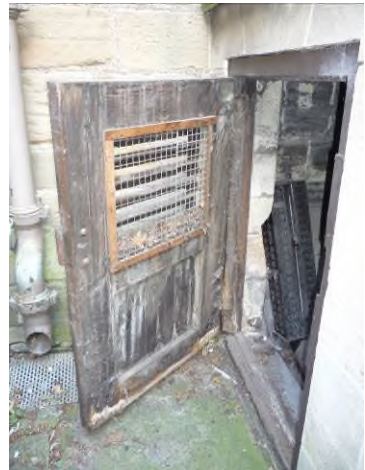
Blower Room:

Has some dust in it but generally ok, the door jams in the frame and has rusty hinges.

Recommendation: ease door and oil ironmongery

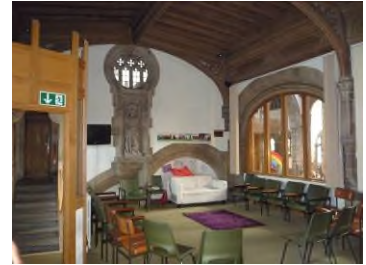
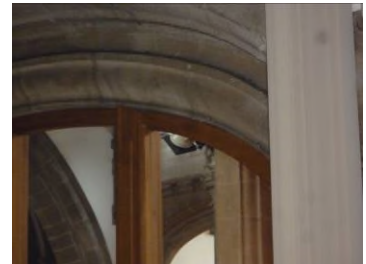
Meeting Room 2:

Some staining on the roof boarding at the lower reaches but not as significant as the western end. Dust marks washing down the walls at the eastern end close to the figure of Saint George. Walls are ok. The glazing between the arcade columns has a slight gap, showing minor shrinkage at the eastern most. Floor creaks as the meeting room 1. Flotex carpet looks a little grubby.

Recommendation: screw down the floor when the carpet is to be changed, fill gap to arcade infill screen, dust off walls and consider redecoration.

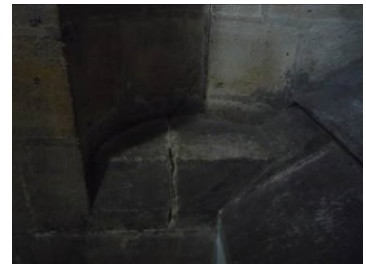
North transept Gallery:

Crack to the stair wall at the landing approximately 2mm and no different to the last QI report. Underside boarding looks good, walls are ok. Some dust at the partially open ventilator facing west. The north large window appears ok but both the polycarbonate and the glass are dirty. The area is pewed out and that contains a lot of loose items at the upper levels and the space is used for storage.

The door at the foot of the stairs is binding on the floor.

Recommendation: clean glass, ease door, close the ventilator? remove unwanted lumber.

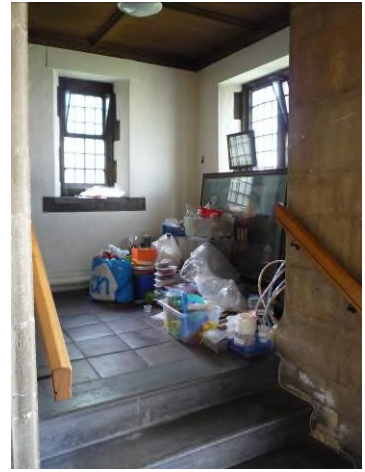
D North Entrance Porch:

Some water staining to the archway leading up to the upper floor office as last QI, windows all look rather dusty and dirty.

Archway into the church ok. Small lobby formed of double doors, kept open by a kneeler perhaps a better hold back arrangement required. Glass is bowing slightly in the opening as reported in the last QI report but nothing needed.

Recommendation: clean windows, provide door hold back, remove lumber.

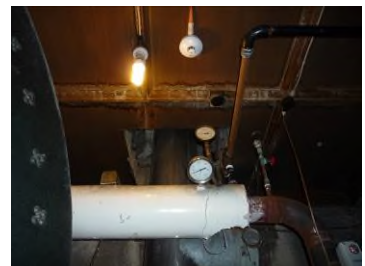
Some water staining on the ceiling, noted on the last QI, suggests that we ought to have a look at the flat roof material. Eastern wall features an early remnant doorway. Ideal Concorde Super S4 Module 50 boiler.

The room is full of various storage items for maintenance and so could with being shelved out or items that aren't required removed. The disused door has got cabling all over it and its decoration is breaking down and the hinges are rusting.

Recommendation: inspect roof, shelf out, monitor door condition

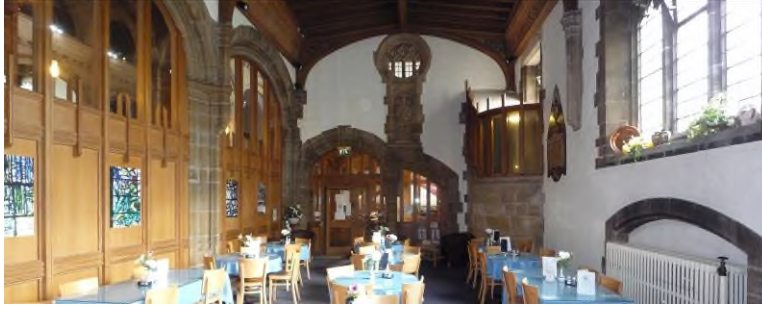
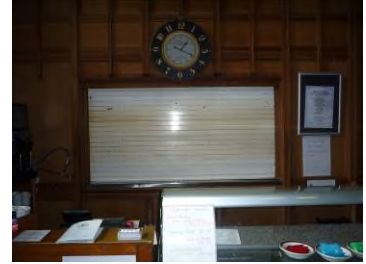
Café:

Ceiling has water marks from previous water entry though there doesn't look to be anything new. Part of the cornice was cleaned in 2015, as where the south window internal lintels. Glass is clearer on this elevation, as it was cleaned as a result of the works in 2015. Flooring is looking a little marked but it is a café. The roller hatch looks a little dirty and the paint's coming away. Glass door to lobby is dirty.

Recommendation: redecorate roller hatch, clean door glass

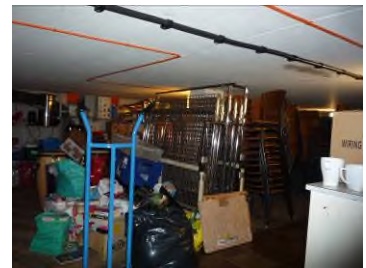
Undercroft:

This room is full of old chairs and storage materials, it is in full use, needed to be kept tidy.

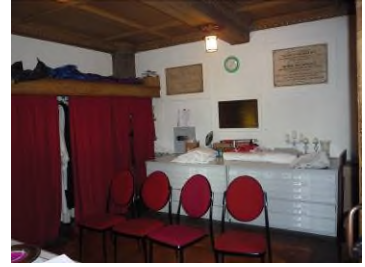
D Sacristy:

This is underneath the organ chamber. Ceiling is in good condition. Walls are all decorated well. Contains clergy vestments within a curtained area and racking for various hymn sheets etc. Partial ceramic tile and herringbone flooring- matching the general areas, all in fair condition. The door catches on the floor and the hinges squeak.

Recommendation: ease door

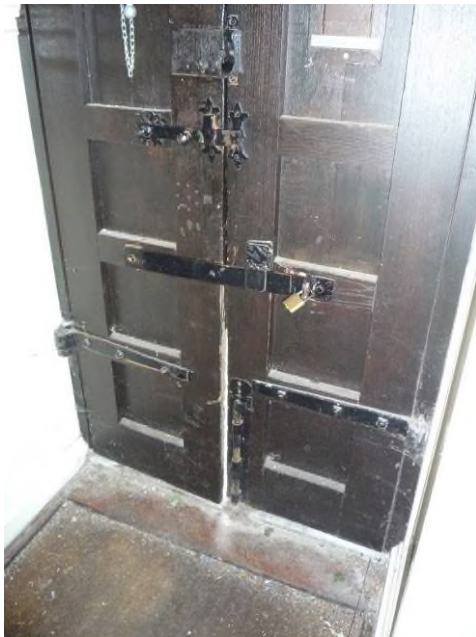
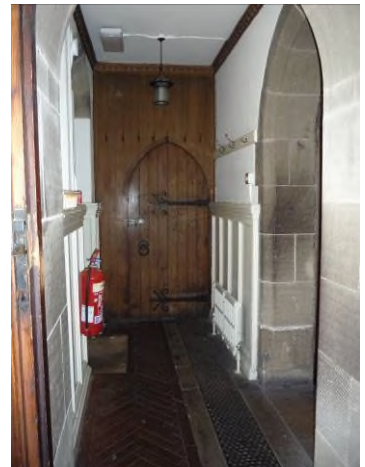
E East Lobby:

Some water penetration in the past on the choir vestry side, perhaps is condensation? Wind blowing detritus through the doorway, the door itself doesn't close adequately even though it is adequately bolted up but it does let in rather a draught.

Recommendation: draught proof the door

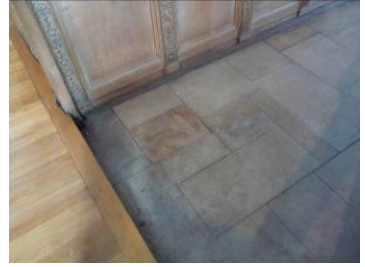
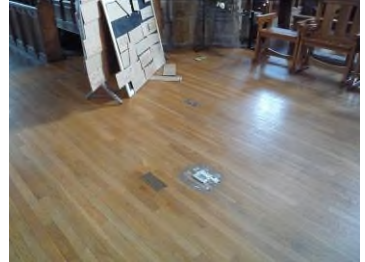
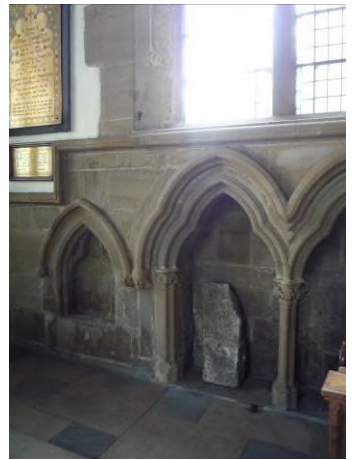
Has a couple of loose flooring stones, they have been lifted in the past and they are not bedded on very much, looks like two or three of them have been rebedded in the past. The platform is ok apart from some gaffer tape repairs.

Recommendation: rebed loose flooring

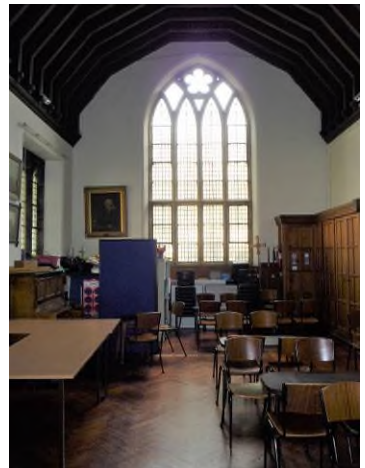
Clergy Vestry:

Ceiling appears in good condition as are the walls, albeit they look a little outdated and could do with some decoration. The panelling is fine. The herringbone flooring is looking a little scuffed.

Recommendation: update decoration when funds allow

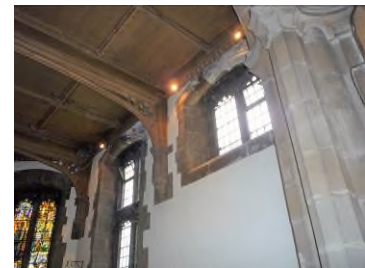
B Bede Chapel:

No real change here from the last QI report. The flat ceiling is unblemished. The walls have some lead marking particularly to the south side at the lintels. The walls are in good condition and there is no cracking to the arches that look onto the chancel and to the south inner aisle. Flooring is a mixture of herringbone and floor slabs and the floor slabs are rocking in a couple of locations.

Recommendation: reset loose floor slabs

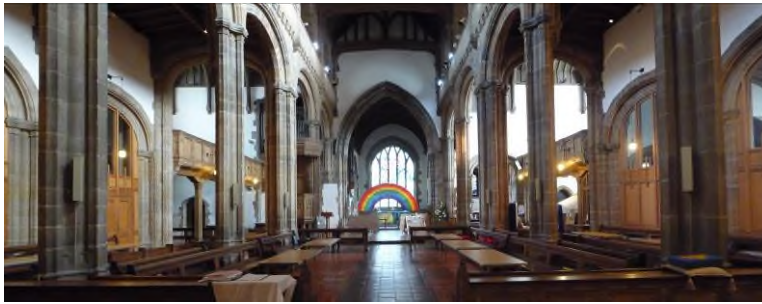
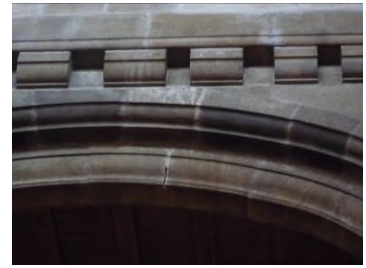
- **Nave:**

Open rafted ceiling with boarding, no water marking apart from one dark board noted in the past, so there is no change. The walls are mostly arches.

At the west end is the tower with an opening joint at the bottom arch approximately 1-2mm, this doesn't look different from the last QI.

Both of the arcades are in good condition apart from the penultimate westward one on the south side which has pointing missing and a slight crack through the stone itself suggesting some differential settlement but this is an old crack. The chancel arch is ok.

Floor is a combination of clay tile and timber herringbone in good condition. The pews are loose and can be arranged in different configurations. The cresting to the relocated chancel screen at the west end, south side has been recently repaired due to intruder damage.

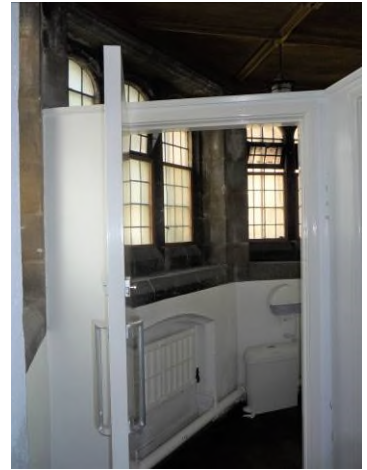
Recently remodelled and appearing satisfactory, the windows are as the previous QI, in that they are obscure, still dirty and the ventilators looks as though they may not be working.

Recommendation: clean the glass

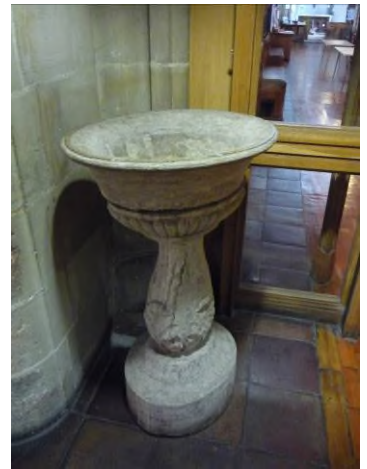
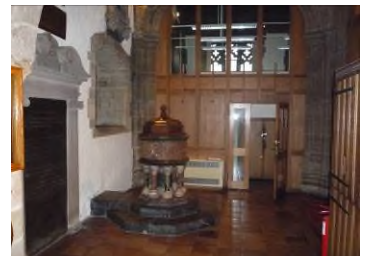
Double height space to open boarded ceiling which has slight water marking though I think this is historic. Walls are mostly arches and glazed in on two side which appear ok, the arch to the tower has approximately 1mm crack in one of the keystone joints.

Space contains redundant octagonal Victorian font.

Recommendation: consider status of the redundant fonts (including the font under the office stairs)

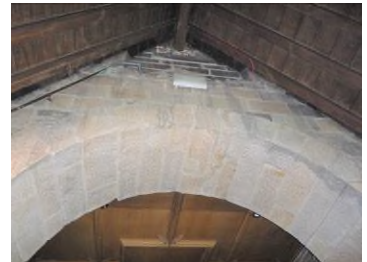
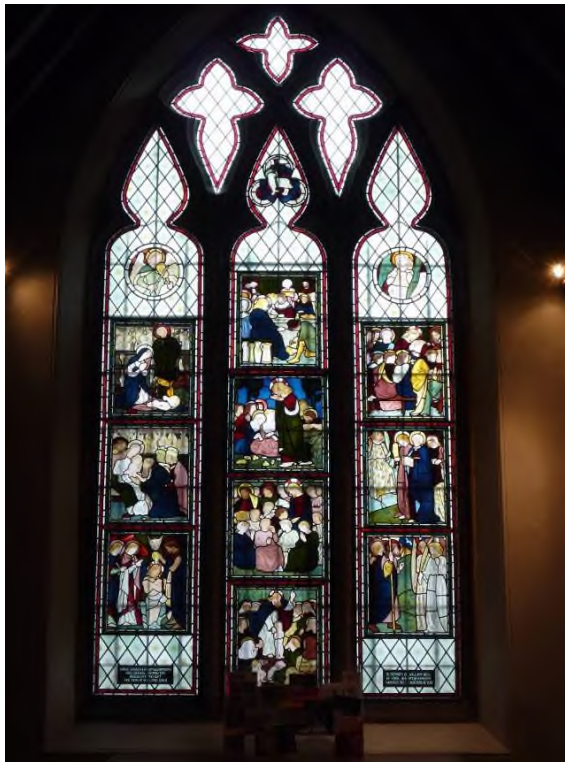
Narthex:

Ridged open boarded roof with ridge beam that goes into the old porch, partially enclosed by the tower with rather rough brickwork, that is inset between a larger opening, there is also some cable about and pipework. Old water marks on there and there is also a 1mm crack to the arch. No change since last QI

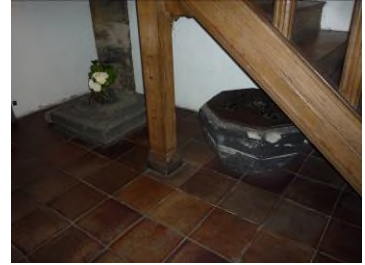
Open boarded ceiling looks ok, as are the walls, no cracking to the arches. Contains the emergency exit door. Some slight water marking at the eaves coming down the wall, stonework is dirty in places. All as the last QI. Tiled floor in good condition. Timber stair leading up to the office. Door at landing recently repaired due to intruder damage.

Stairway at the foot of which is a door that has been repaired recently as a result of intruder attack. Redundant font under stair.

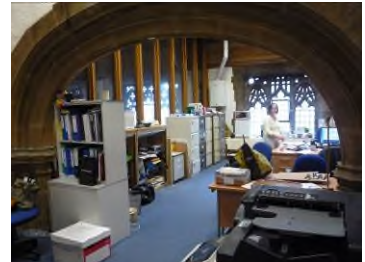
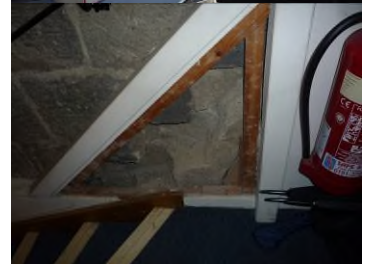
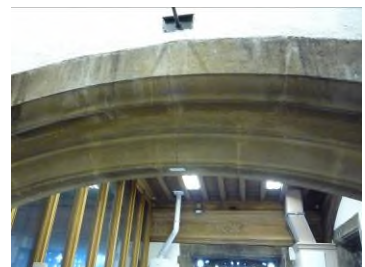
D **Office:**

This is formed on top of the kitchen. The roof is open boarded and has signs of historic water staining that has also gone down the walls in places. The south entablature has been cleaned as a result of the 2015 south aisle works. The joinery at the western end over the kitchen by the two windows and above it is quite badly marked and could do with being refurbished when funds allow.

The glazing has been cleaned on the south side but is starting to dirty up again and one of the windows on the west is left to do. The arch that divides the space has a 2mm crack and this is historic and constant. The carpet to the floor is ok, there are some slight squeaks to the floor.

Recommendation: clean glass, screw down floor when carpet is replaced in time.
