Diocese of Durham

St Mary and St Peter's Church, Springwell Road, Sunderland, SR3 4DY

Quinquennial Inspection

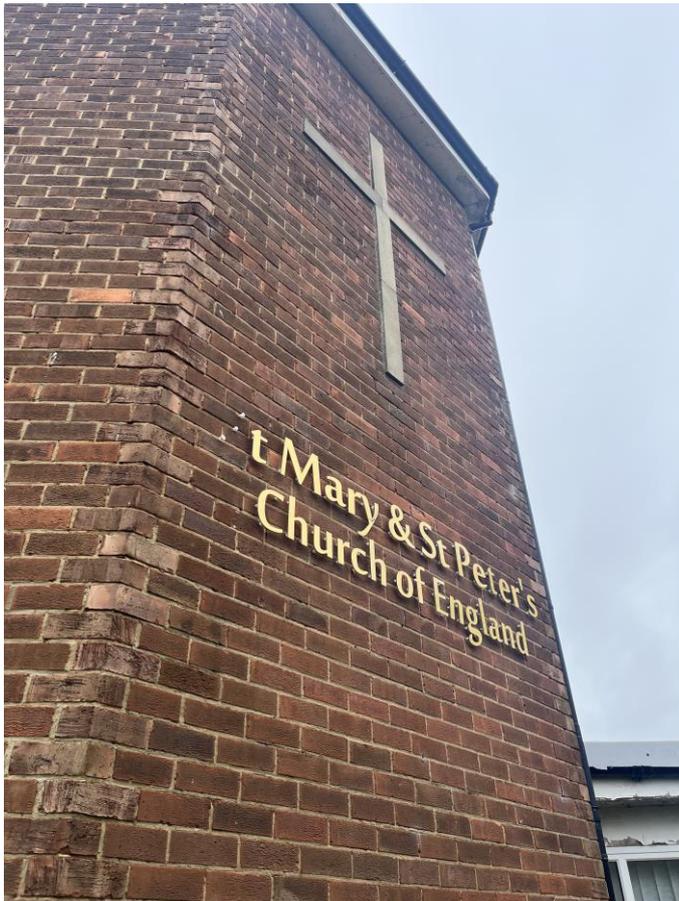
The roofs are flat and covered with a grey single ply membrane covering. The nave roof was recently re-covered. The lantern may still be felt but it was too difficult to confirm due to the heights without a drone or ladders.
