**QUINQUENNIAL INSPECTION REPORT
OF
TRIMDON, ST. MARY MAGDALENE, COUNTY DURHAM**

**DIOCESE OF DURHAM
ARCHDEACONRY OF DURHAM
PARISH OF THE UPPER SKERNE**

2014 QUINQUENNIAL INSPECTION AND REPORT

DATE: JANUARY 2025

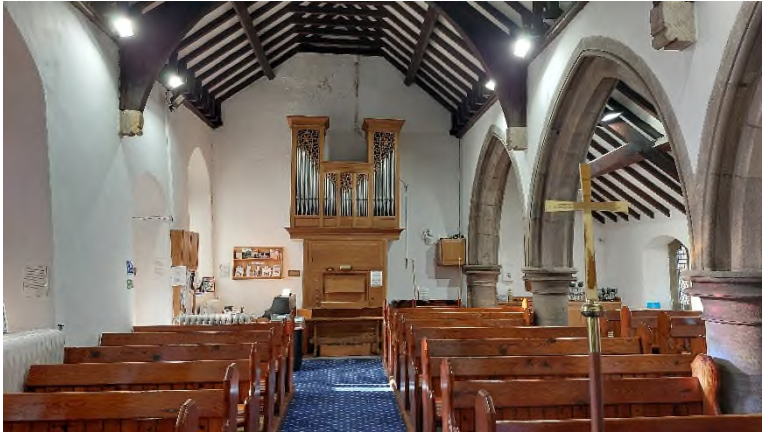
C **Organ:**

Pipe organ by Church and Co, installed in 1982, it is in use and plays well, annually serviced. It would be wise to have a good look at the back of it to see its condition since the west gable repairs.

Recommendation: check the back, decorate above

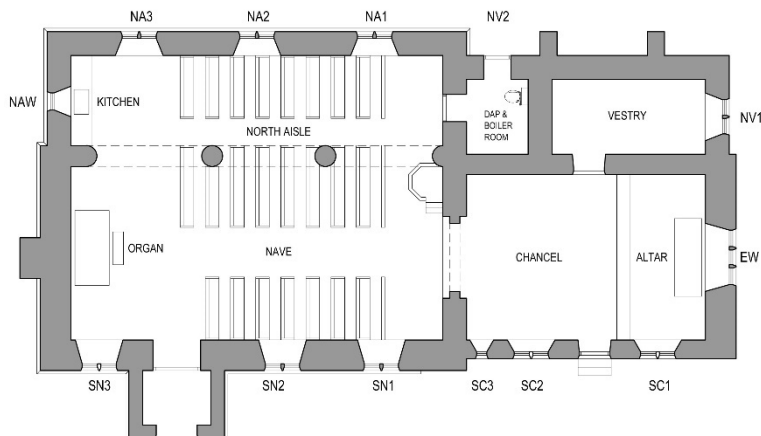
FLOOR PLAN

NV1 – Pair of square leaded light windows with polycarbonate over glazing, framed surround ok.

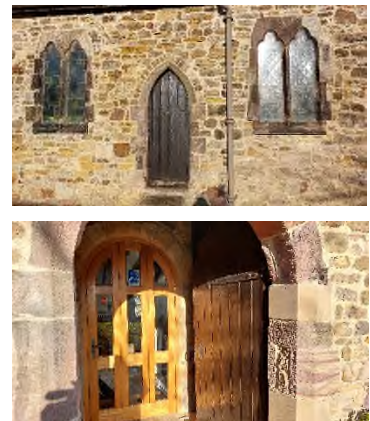
Porch – Heavy boarded door ok and the arched surround has had masonry repairs or replacement units in the jambs.

Recommendation: update the chancel south door

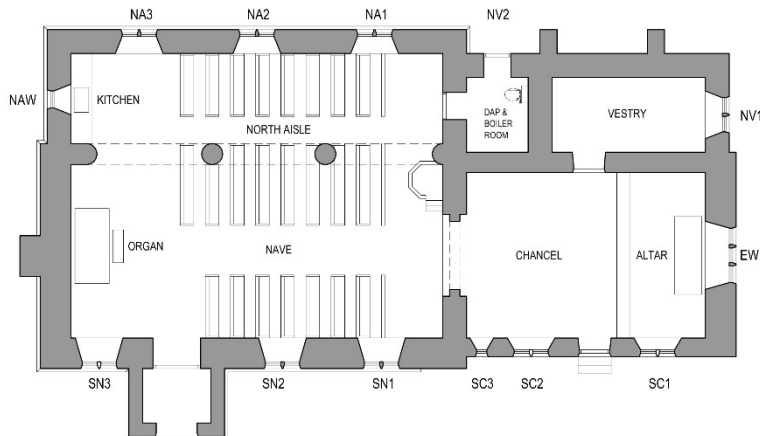
FLOOR PLAN

NV1 – Check photo.

NV2 – our drawing not quite right as this is the gas meter door.

Recommendation: clean glass and protection

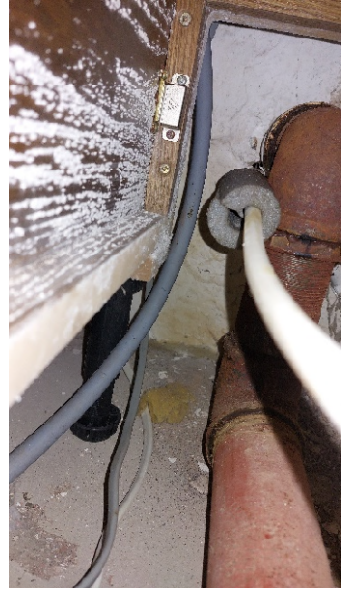
A modest servery is formed at the west end of the north aisle with oak fittings with a sink, it is macerated pumped waste connected by a long pipe along the north wall to the drainage of the w.c. Problem with damp as mildew has formed on the surfaces due to a lack of ventilation.

Recommendation: Ventilate the unit.

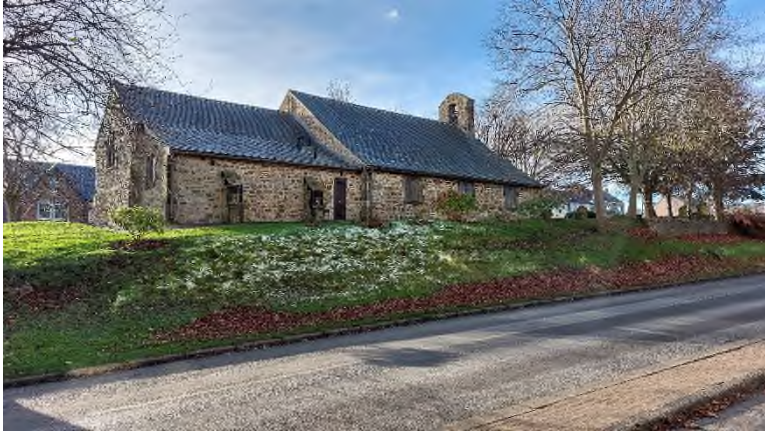
West Side – Metal gate kept open with a timber chock, perhaps that could do with a bolt, slight cracking either side of the gate and as it comes round to the south boundary heavily cement pointed, the churchyard is approximately 3 feet above the external level, mixture of trees on this boundary, large Yew on the south east corner beginning to look straggly.

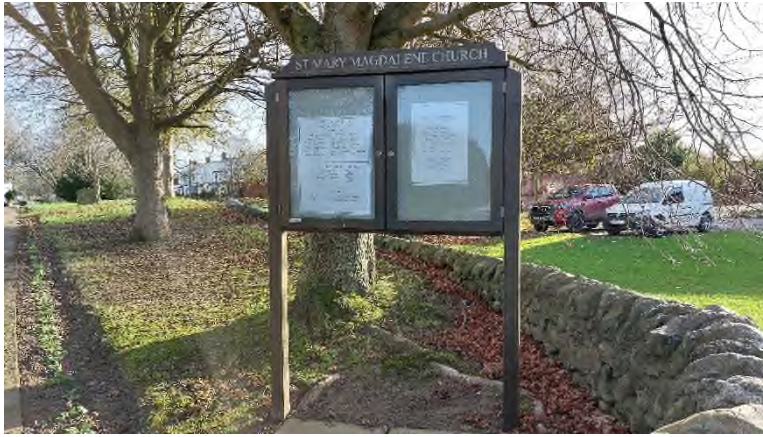
South Boundary – random rubble low wall retaining grave yard

Notice Board : good condition

Recommendation: none
