## The Parish Church of St Cuthbert, Norham

### Analysis of the Fabric and Archaeological Assessment

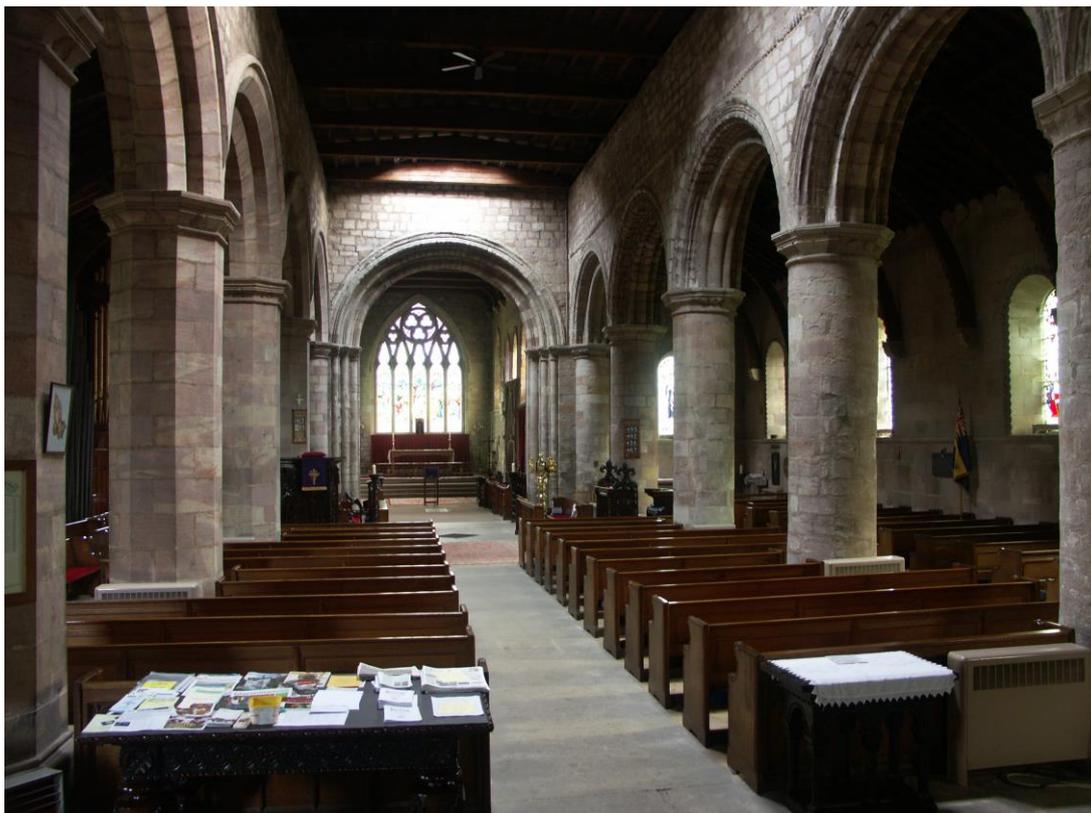
Interior looking east

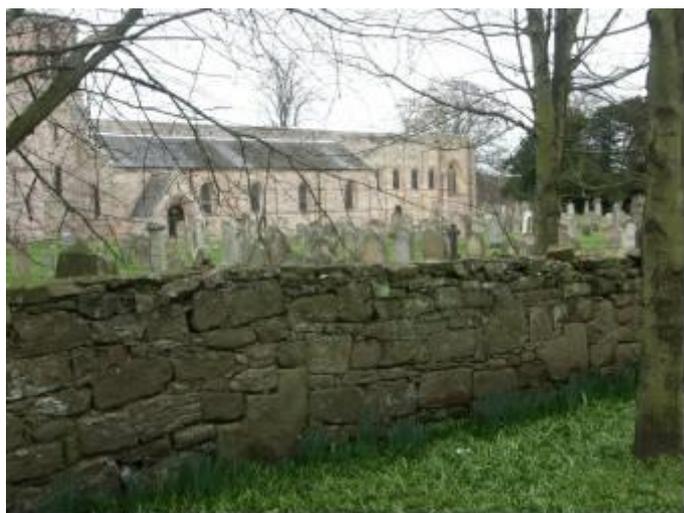
Re-used material in the south wall of the churchyard; note large 'stepped' blocks.. There is a considerable amount of similar material in the other churchyard walls and in the old walls around the Old Vicarage garden.

The south wall of the churchyard, in particular the western section fronting onto the drive of the former vicarage, has a number of large L-shaped blocks built into its external face, clearly re-used from some earlier structure. The two walls which abut against the church tower are also of considerable interest. Both seem of considerable antiquity, and their relationship to the church itself is interesting<sup>10</sup>. The wall extending west has a distinct break c 2.5 m from the church; the eastern part, of larger blocks, may have either have been built after the shortening of the west end in 1838, or retain or more likely retain fabric from the post-medieval north-west tower. The taller wall running north contains several phases of fabric; c 14 m from the church there is a large block built in near the top of its west face, that has a tapering circular hole pierced through it; could this be a simple Saxon monolithic window?

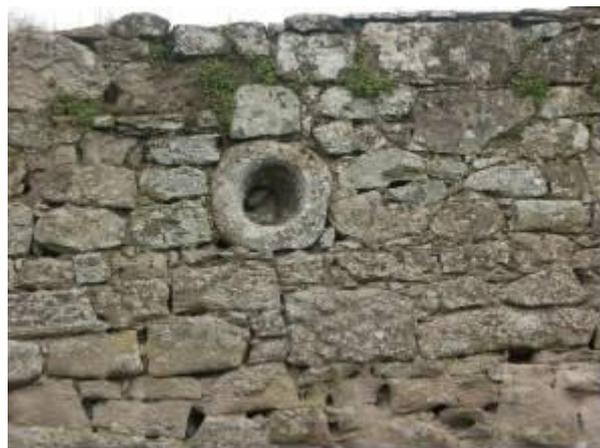
Re-used feature, possibly a small monolithic Saxon window, in the west face of the garden wall of the Old Vicarage, that abuts against the north side of the church tower.

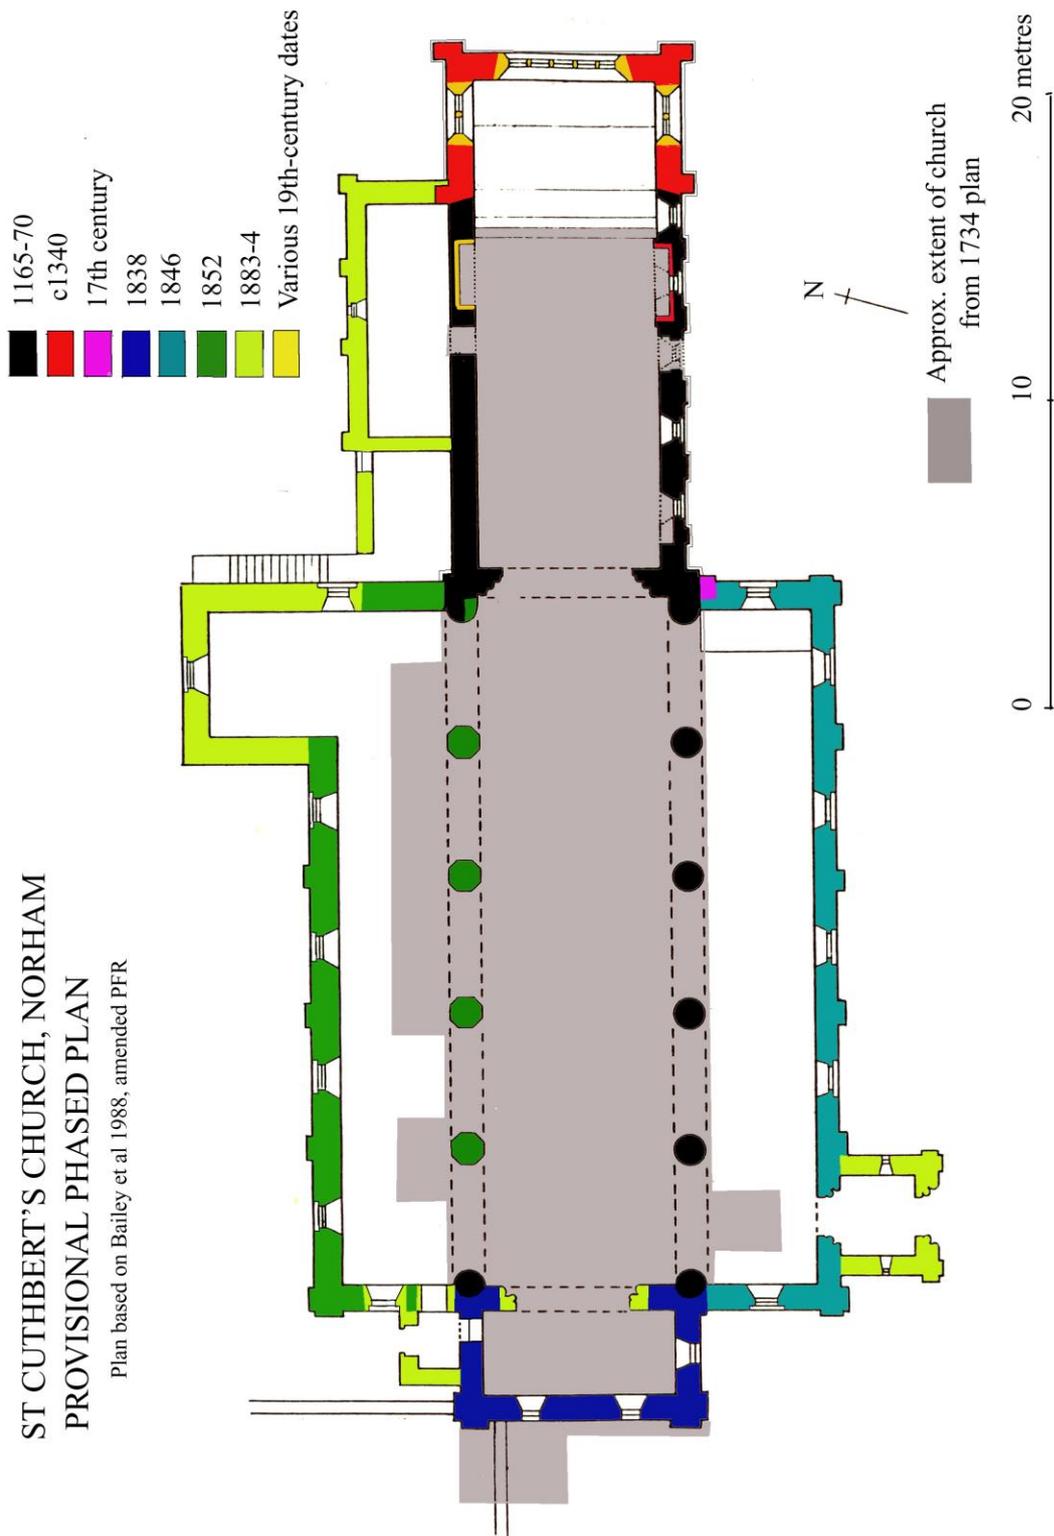
# ST CUTHBERT'S CHURCH, NORHAM PROVISIONAL PHASED PLAN

Plan based on Bailey et al 1988, amended PFR
