**PARISH CHURCH OF ST EDMUND
BEARPARK**

DIOCESE OF DURHAM

**QUINQUENNIAL INSPECTION
2020**

Tony Barnes BArch RIBA

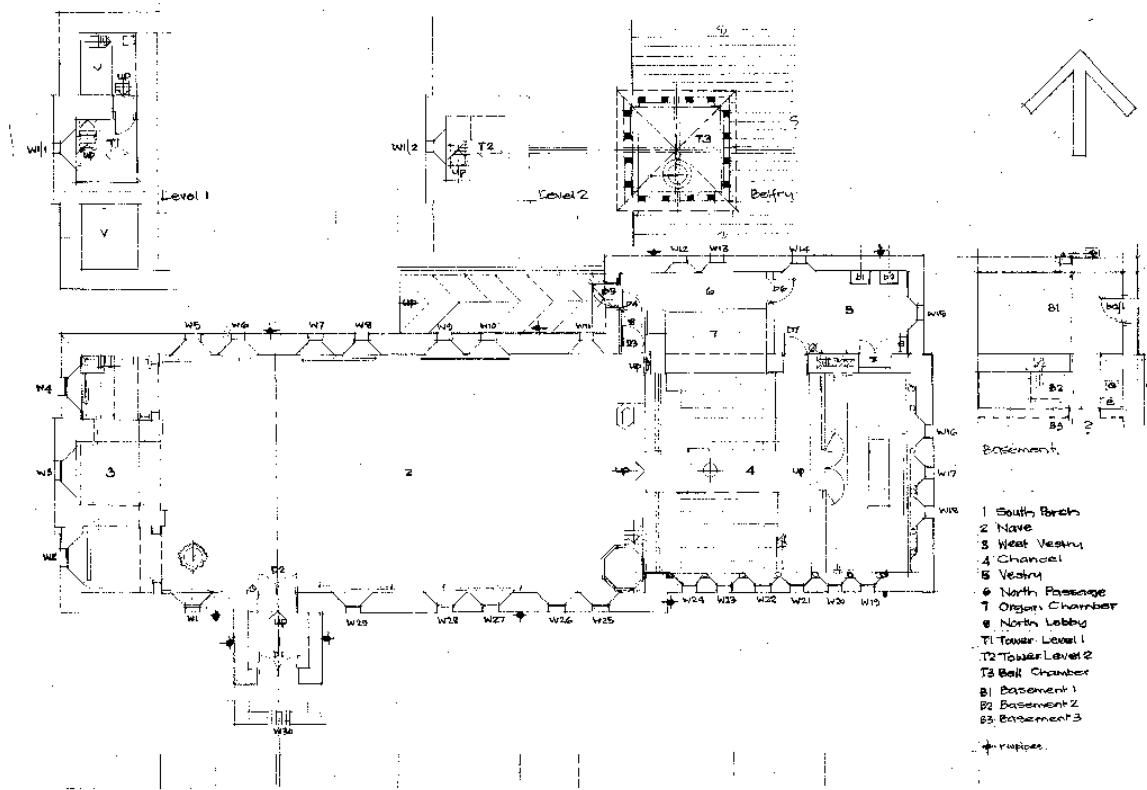
St Edmund's Church, Bearpark 2008
 Ground Floor Plan E1
 1:100 app @ A3 30.01.21

- 1 South Porch
 - 2 Nave
 - 3 West Vestry
 - 4 Chancel
 - 5 Vestry
 - 6 North Passage
 - 7 Organ Chamber
 - 8 North Lobby
 - T1 Tower Level 1
 - T2 Tower Level 2
 - T3 Bell Chamber
 - B1 Basement 1
 - B2 Basement 2
 - B3 Basement 3
- + ripples.
