2023 QUINQUENNIAL INSPECTION REPORT

CHURCH OF HOLY TRINITY, HARTLEPOOL

(Ref: 2317)

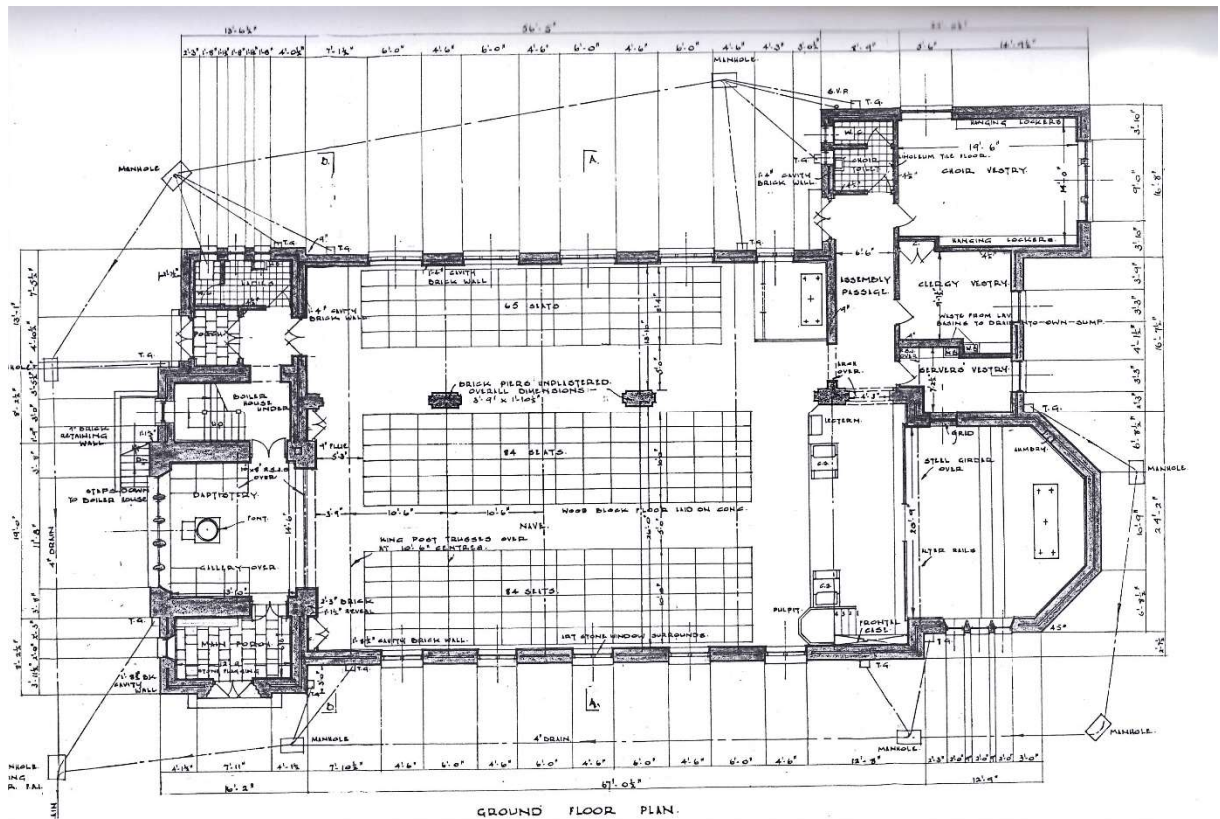
4. Plan of the church

Completed in 1958 to designs of GE Charlwood of Newcastle, the building has a north-south rather than an east-west orientation. For the purpose of this report all directions follow normal liturgical convention. It consists of nave and north aisle, polygonal-apsed sanctuary, west tower with baptistry, entrance stair, gallery and belfry, with vestries to north of sanctuary. There is a WC next to the exits at the northeast and northwest, and the main entrance is to the southwest.
