2. THE CHURCH YARD CROSS

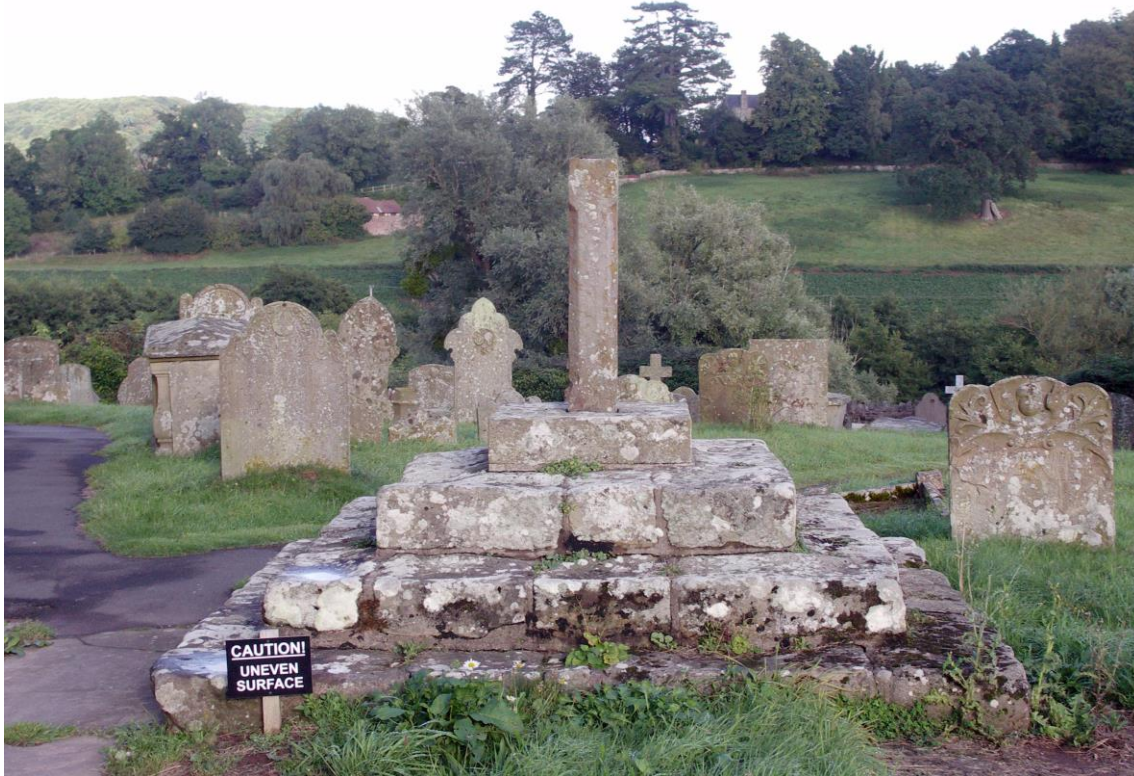
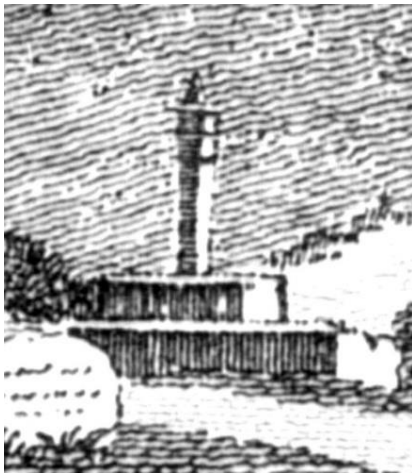
The earliest known representation of the cross is in an etching of the church published by Richard Godfrey in 1782 (left). Only two steps to the base are visible in the etching, though there are actually three old steps; these show the same evidence of wear and do not seem to have been moved. The current top step looks newer, possibly added to hold the shaft more firmly when the cross was restored for the coronation of Edward VII in 1911, according to the plaque on the step.

When the Historic Monuments surveyors visited the church in 1927 their handwritten notes said that above the square-stepped base there was a short length of square shaft with stop chamfered angles. The printed version of the survey says that the shaft was octagonal with initials T. W., W. B. 1691.

The initials TW and WB and the date 1691 cannot now be found, but Thomas Weare and William Boughan were churchwardens in 1691. The 1782 etching is interesting in that it shows rather more at the top of the shaft than is now there, though not a cross. It is quite possible that the cross was vandalised during the Civil War, as possession of Goodrich castle changed hand several times. Richard Tyler, constable of the castle during the Civil War, lived near the church.

The handwritten version of the 1927 survey said that a 'modern' (i.e. post 1720) sundial had been put on top of the shaft, the printed version just 'a sundial'. This is octagonal, missing its gnomon which may have been pulled out as the brass is split.
