THE ROOFS

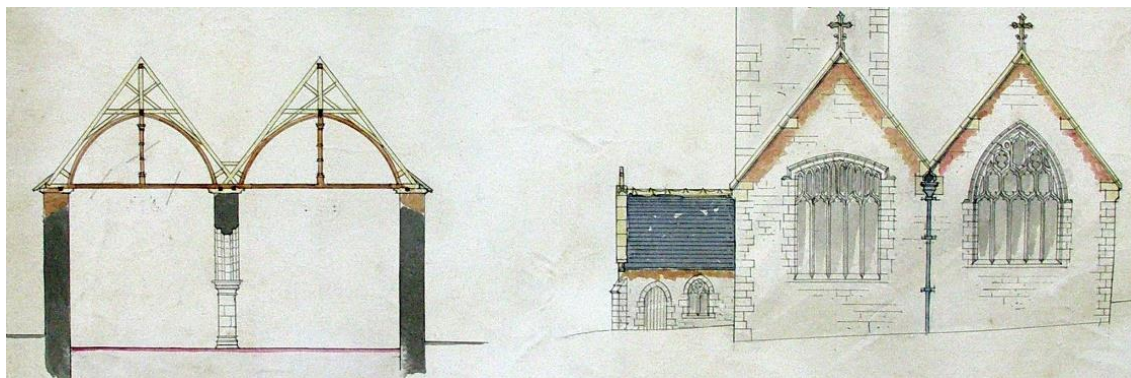
The two separate roofs were rebuilt in the 1870s restoration and are now of equal height, as per J P Seddon's plan above. Any original timbers seem to have been lost.

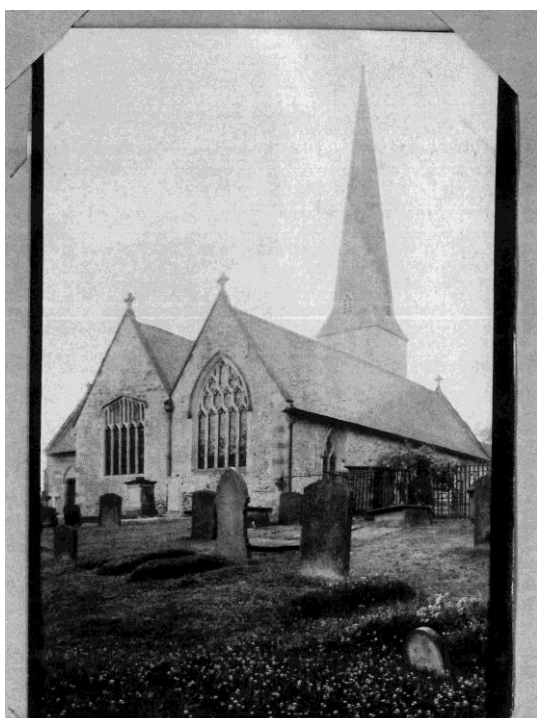
This view of the east end of the church was taken by the Royal Commission surveyors in 1927. The view is much the same as today except iron railings can still be seen around the graves - they were not removed until WWII.

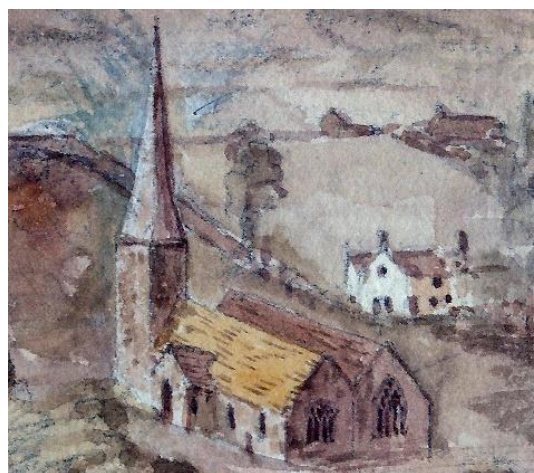
Earlier paintings (see right above for 1849) show a scar on the eastern tower wall so the southern roof was originally higher. The view above right is unclear but almost suggests the roof was thatched, as does the view shown in item (3), the Tower and Spire. Possibly at that time it was covered in plants growing on the mossy stone roof tiles.
