St Mary's Church, Holy Island.

St Mary's Parish Church stands immediately to the west of the ruined Lindisfarne Priory, on the southern edge of Holy Island village. The church consists of a four bay-aisled nave with a western bellcote, north and south porches, and an aisleless three-bay chancel. The distinctive silhouette of the building is provided by the lofty bellcote, and the shallow-pitched roofs of the broad aisles contrasting with the steeply-pitched ones of nave and chancel.

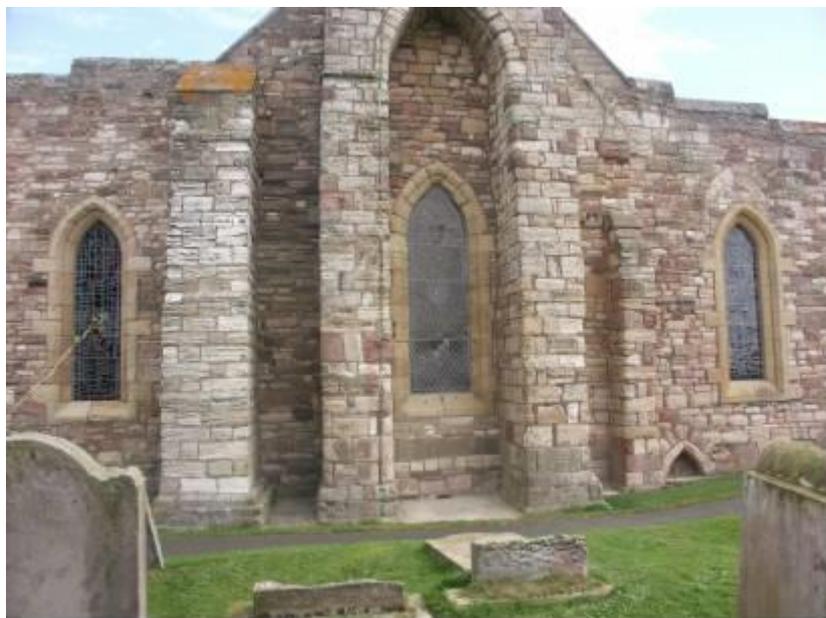
The west end of the **Nave** is built of coursed roughly squared stone of a variety of colours including pink, bluish-white and yellow/brown. In the centre of the wall, between the two buttresses which carry the bellcote, is a broad and tall lancet with a double-chamfered surround; although its dressings, of yellowish sandstone, are fairly worn that may be no older than the 19th century. The large buttresses on either side have a chamfered plinth (unlike the wall behind) and a series of chamfered off-sets; they are linked by a tall two-centred arch, of plain square-section, that carries the bellcote; there is a string course, chamfered on its upper angle, at the level of the springing of the arch, and above that a series of chamfered set-backs on the sides of the bellcote, which itself appears to be an 18th-century rebuild, and is of pink

sandstone. There is a square band at its base, then in each face a segmental-headed arch, with a square impost band and raised keystones; above this is a moulded cornice, now much eroded, and a pyramidal cap carrying a weather vane.

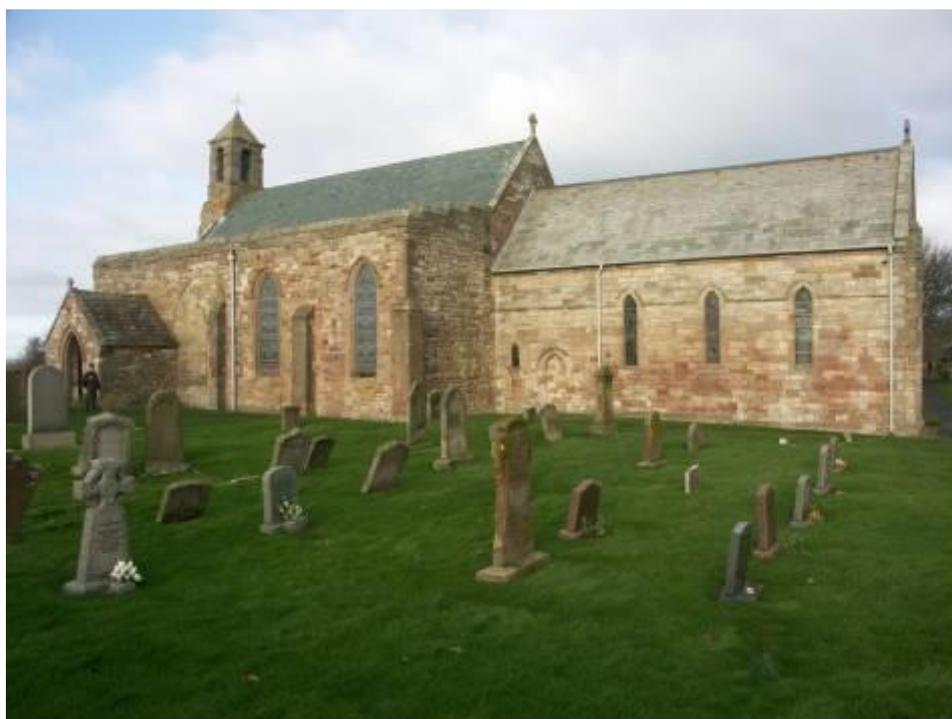
The south wall of the **Chancel** is of coursed square stone in quite large blocks, with some pinkish stone in the lower wall, the upper courses being mostly white; there are considerable areas of 20th-century refacing, mostly below the windows. There is a chamfered plinth, which steps down twice as the ground drops away to the east; there are, or have been, two string courses. The lower is stepped over the low-side window and adjacent priest's door as a hoodmould, and then ran below the three lancet windows further east, although most of this section has been replaced in recent stone without the string being reproduced. The upper string is carried over the heads of the lancets as a hoodmould. forms heads of lancets. There is also a projecting course, chamfered on its lower angle, at eaves level.

The low-side window at the west end of the all has a very eroded chamfered surround with an internal rebate; it has a transom at mid-height, the lower light being blocked. The string/hoodmould drops vertically alongside its east jamb and is then carried up again over the adjacent priest's door, which has a two-centred arch

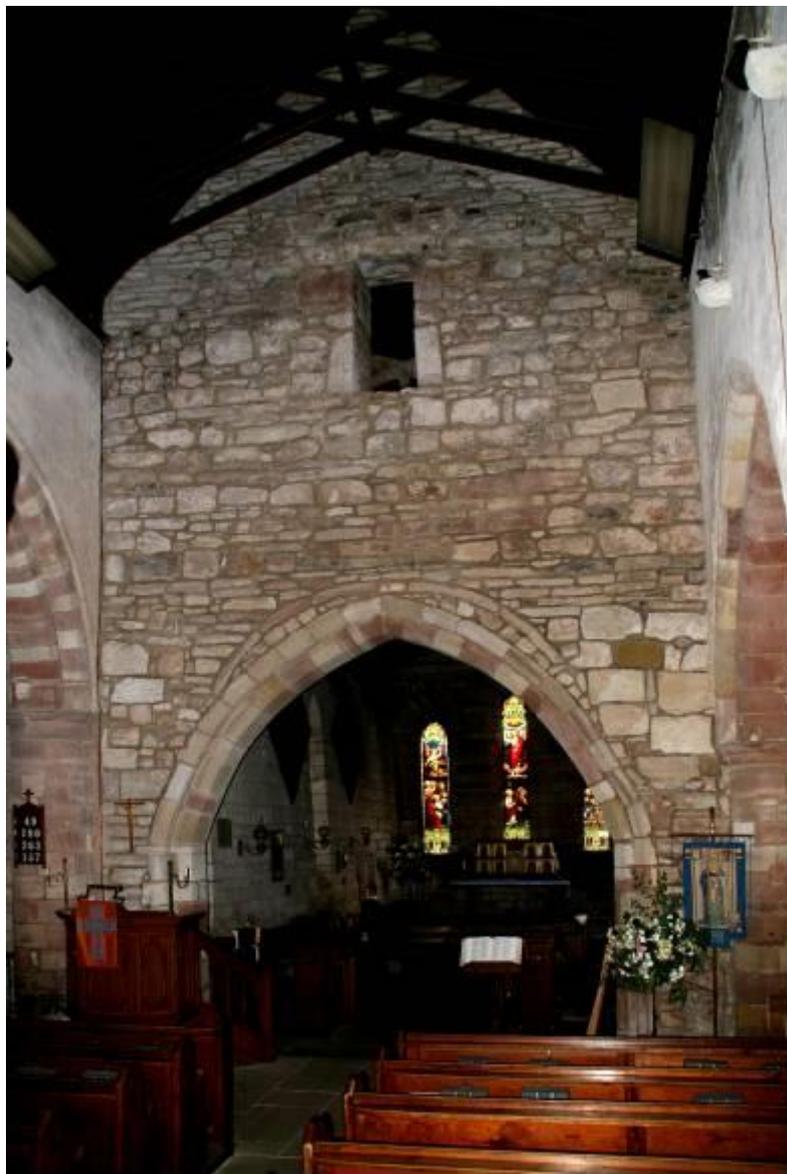
The arch into the **Chancel** is set a little north-of-centre in the east wall of the nave. It is considerably lower than the arches of the arcades, and is of segmental-pointed form and of two chamfered orders, which towards the nave are continued down the jambs with no signs of any imposts or capitals, or bases. In the southern spandrel of the arch are four courses of big squared blocks, but in the northern a mix of rubble and larger blocks. The arch has no

hoodmould; immediately above it are the remains of what looks like the cut-back hoodmould (or stripwork surround) of a narrower semicircular arch. The wall above this contains some coursed and quite elongate thin blocks and some larger ones; higher up is a square-headed opening with its jambs, the lower part of which is formed by a single large upright slab on each side, cut square to the wall. The present head of the doorway may be secondary; it coincides with a low-pitched roof-line, spinning from the present eaves; above, in more thinly-coursed fabric, is a second older roof-line, well below the pitch of the present 19th-century roof which has scissor-braced common rafters and a central purlin below their intersections.

On the east face of the wall, towards the chancel, the outer order simply dies into the wall. On either side of the arch are odd buttress-like projections of wedge-like plan, in the same coursed near-ashlar whitish sandstone fabric as the whole interior of the chancel; their faces are continuous with the western internal splays of the two low-side windows. On this side there is only one fragment of the cut-back hood of the earlier semicircular arch visible; the walling above is of very elongate thin blocks. Only the lower section of the high-level opening is visible.
