the Conservation
and repair of bells
and bellframes

Code of Practice

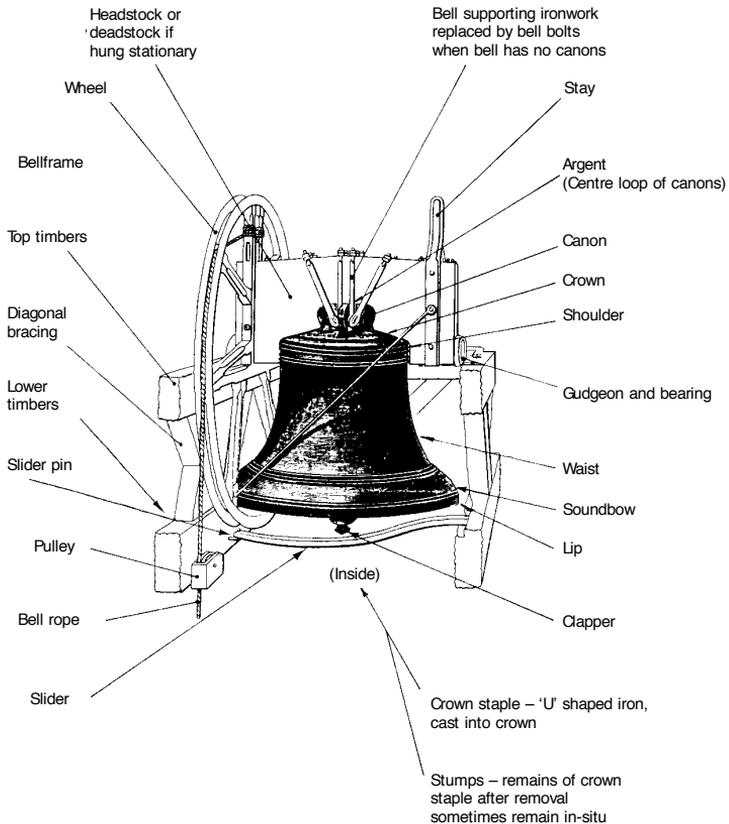
fig. 1
Diagram of
a bell and
fittings

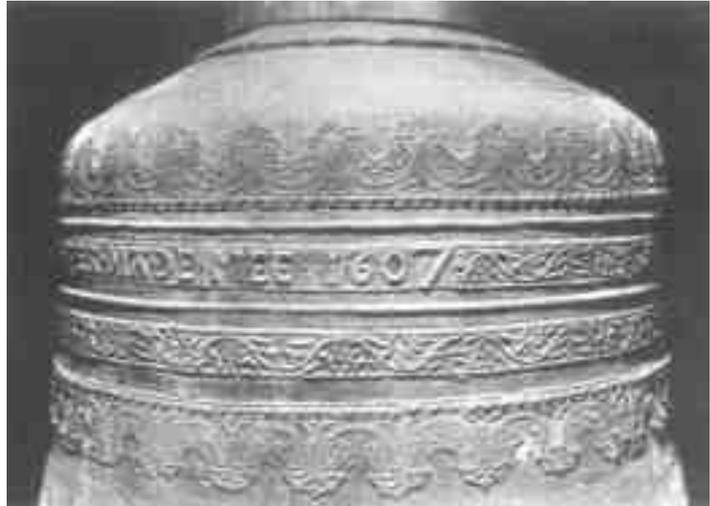
fig. 2
 Early
 seventeenth-
 century bell
 with ornate
 inscription,
 cast by
 Newcombe of
 Leicester
 (St Mary's
 Church, Astley,
 Warwickshire)

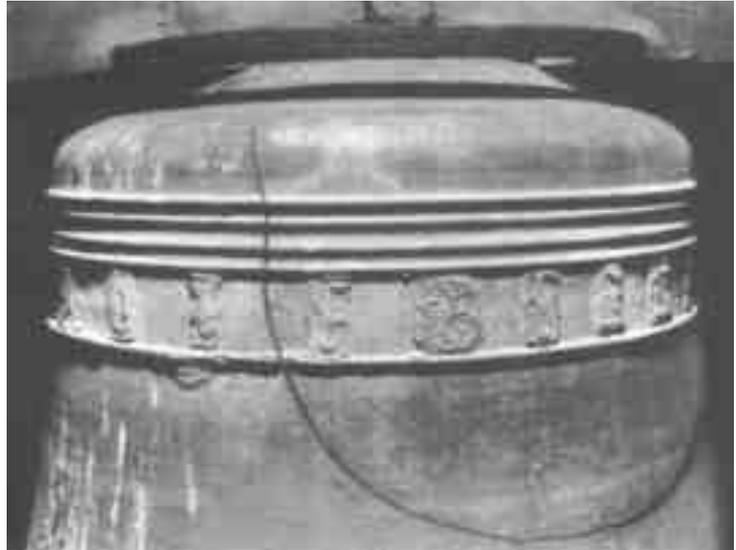
fig. 3
Typical crown-
staple crack
(Church of
St Mary
Magdalene,
Sparkford,
Somerset)

Research links these with crown cracks, and concludes that it is desirable to remove as much of the iron stumps as possible to avoid future trouble.

Crown cracks due to cast-in staple stumps account for at least half of all cracks in bells. Although these cracks can now be repaired by welding, it is desirable that they do not occur in the first place. The evidence shows that, when the stumps are close together, drilling a central hole minimizes the risk of cracking. If it is assessed that very little or none of the iron can be removed by drilling a central hole, then it is recommended that the stumps be drilled out separately.

It is totally inadequate for the staple to be cut off flush with the inner surface of the crown of the bell without at least drilling a stress-relieving central hole.

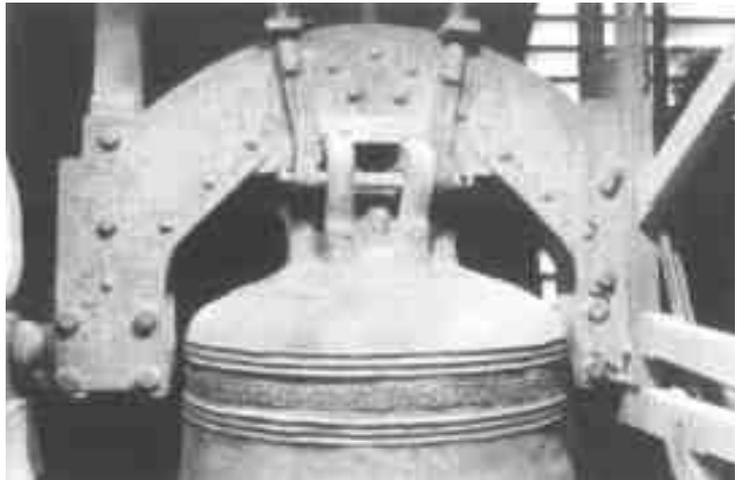
fig. 4
Steel canon-
retaining head-
stock. The bell
has been
quarter-turned.
(St Peter's
Church,
Mancetter,
Warwickshire)

Where canons are retained, headstocks and deadstocks should be designed so that the canons are visible. Although canons were designed to carry the whole weight of the bell, the cutting away of the cast-in crown staple and the drilling of a central hole permit the fitting of a centre bolt which will carry much of the bell's weight. Additional support should be provided by metalwork designed to support the bell by its canons, although bell bolts may be used where holes already exist, or where the bell is not identified as of historic significance and cast after 1800.

Where fewer than six canons remain and there are no holes through the crown, 'U' bolts may be fitted around the surviving canons and that part of the deadstock or headstock over the stumps of the broken canons extended to butt on to the crown.

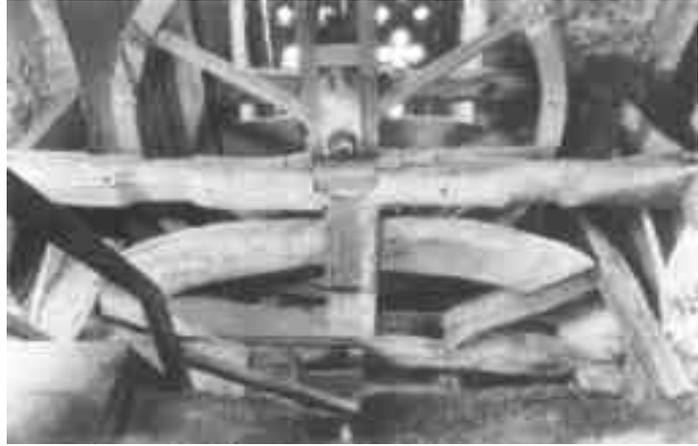
fig. 5
Fourteenth-century frame with later long heads (Church of St Peter and St Paul, West Newton, Norfolk)

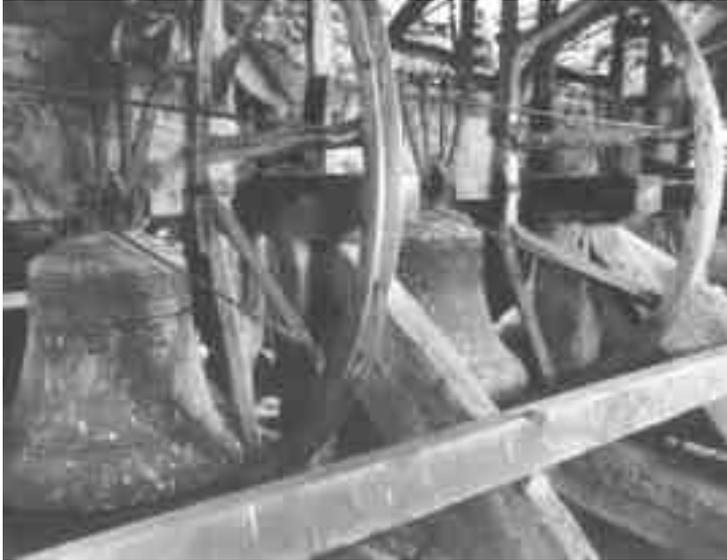
fig. 6
Short-headed
queenpost
frame
(All Saints'
Church,
Knipton,
Leicestershire)

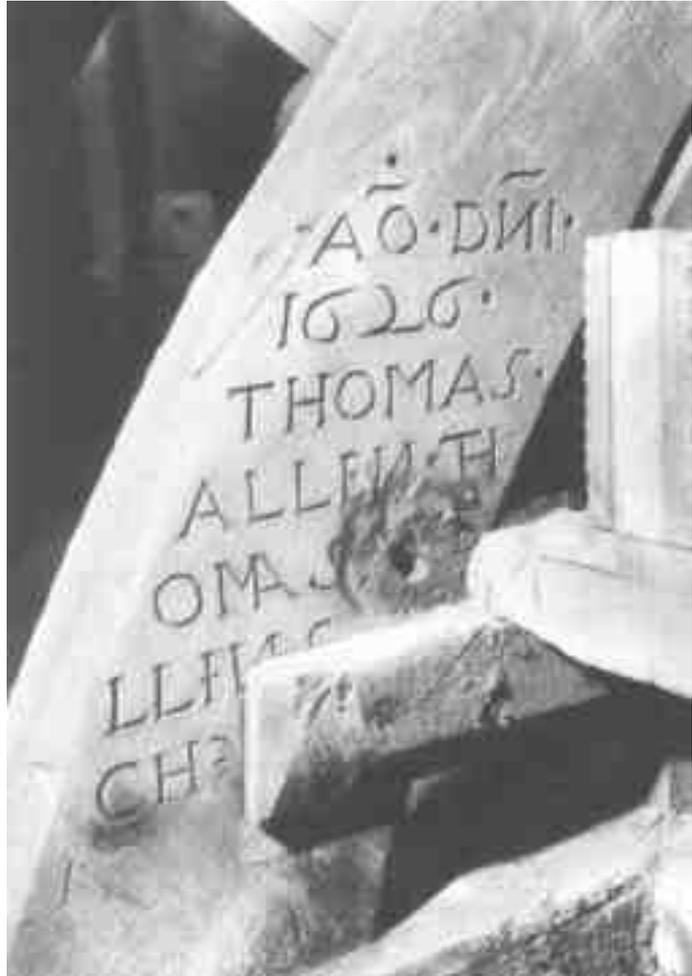
fig. 7
Inscribed
frame
(St Michael's
Church, Onibury,
Shropshire)

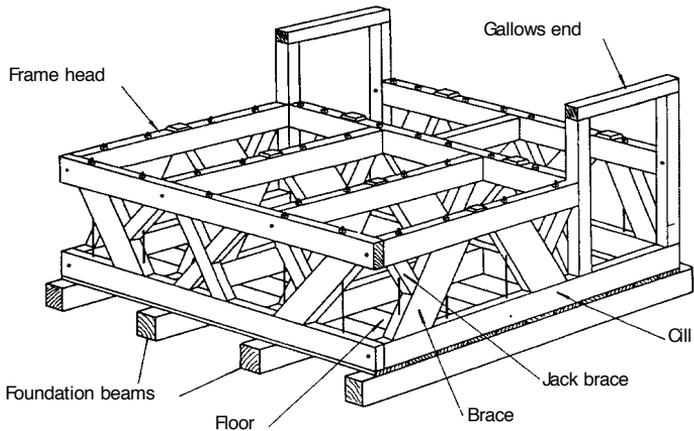
fig. 8
A typical
timber
bellframe

Before a suitable strategy can be chosen, the bellframe, including the foundation beams supporting it, should be assessed for structural adequacy. It is possible that a frame carrying bells for full-circle ringing may need additional foundation beams so that vertical deflection is reduced and horizontal forces are distributed between all four tower walls.

The extent of repair should be considered before deciding technique. If the bellframe needs to be partly dismantled (perhaps to replace a decayed cill), this will allow foundation beam ends to be repaired from above as well as from below.

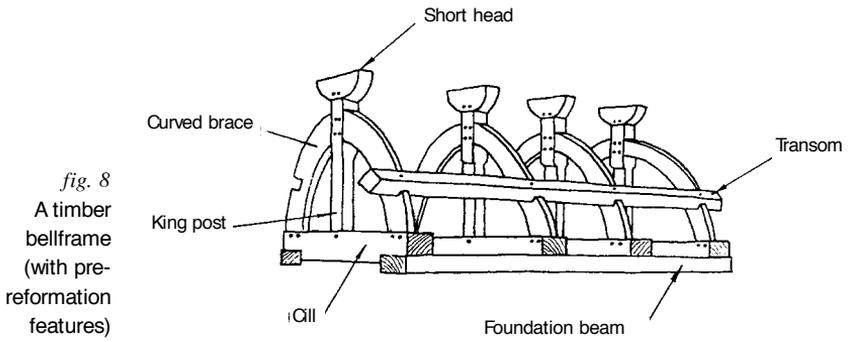
<i>fig. 1</i> Diagram of a bell and fittings	2
<i>fig. 2</i> Early seventeenth-century bell with ornate inscription	3
<i>fig. 3</i> Typical crown-staple crack	7
<i>fig. 4</i> Steel canon-retaining headstock	11
<i>fig. 5</i> Fourteenth-century frame with later long heads	13
<i>fig. 6</i> Short-headed queenpost frame	14
<i>fig. 7</i> Inscribed frame	15
<i>fig. 8</i> Diagram of a typical timber bellframe	23
<i>fig. 9</i> Diagram of a timber bellframe with pre-Reformation features	24
