Care of Churches and Ecclesiastical Jurisdiction Measure 1991 – Quinquennial Inspection
THE CHURCH OF ST COLUMBA, DARLINGTON

Diocese: Durham
Archdeaconry: Auckland
Church Code: 613 229

Date of Inspection: 28th April 2023
Inspection undertaken by: Jamie Holden BA (Hons) RIBA RIAS
Previously Inspection: 2014 by Malcolm Cundick

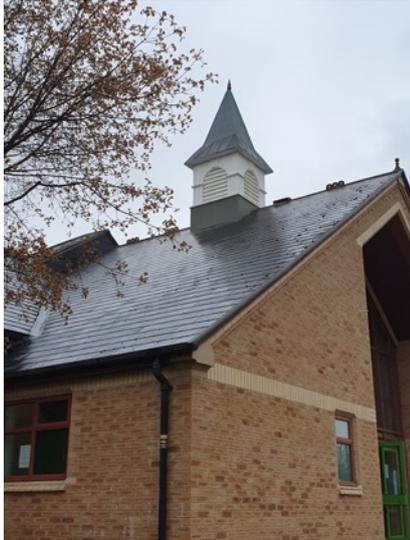
a) West slope of the entrance foyer

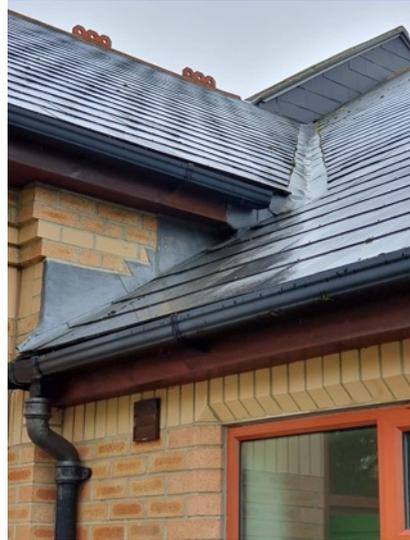
b) Valley gutter and abutment flashing

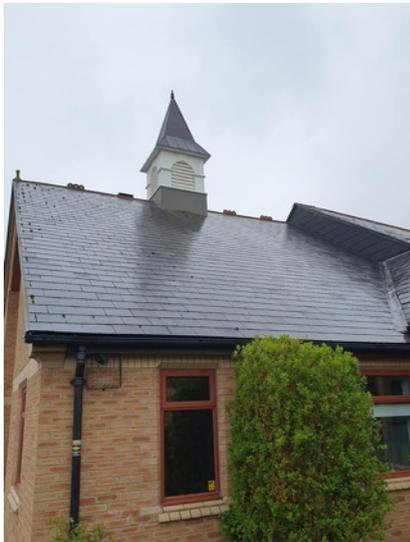
a) east slope of entrance foyer

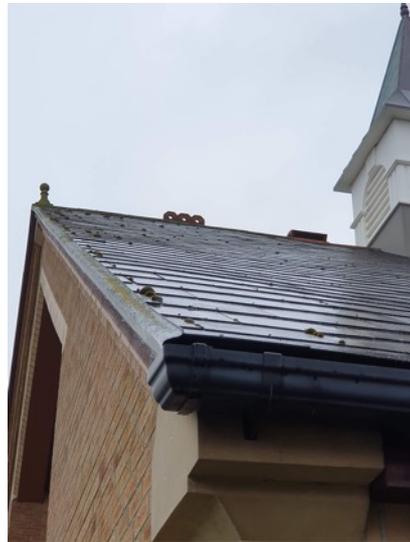
b) Capped verge and guttering

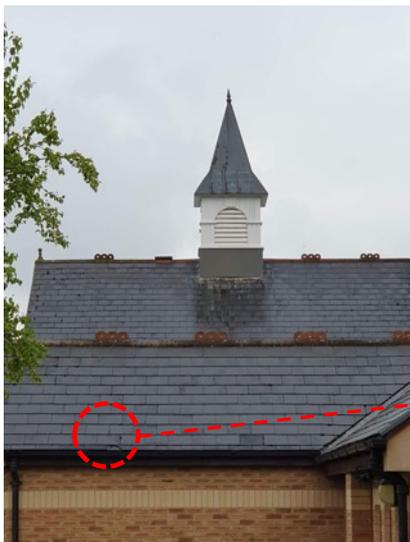
- 2.1.7 There is a notable build-up of moss growth on the north slopes in comparison to those which face southwards. This is not uncommon due north facing roofs being shaded from the sun and, as a result, remaining relatively damp for long periods creating conditions conducive for moss and lichen.

a) East slope of Lady Chapek

- 2.1.8 Excessive moss growth with the associated moisture retention can be damaging for some roof finishes, therefore, the moss ought to be carefully removed. However, this is not a matter that requires urgent attention. The PCC is advised to consider how the moss growth can be controlled as part of the general maintenance regime for the building with the aim of action being taken at some point during this quinquennium. 4

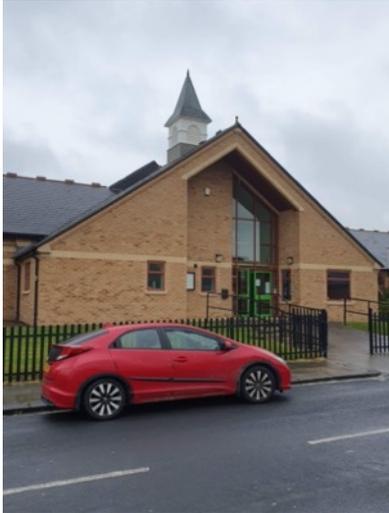
a) South elevation

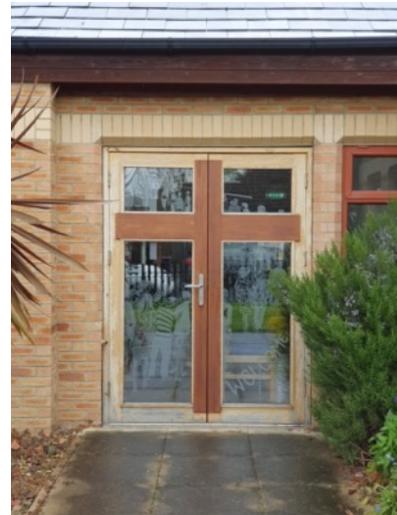
- 3.1.7 The church has its own entrance doors in the south elevation at the west end of the nave. The doors are oak with a stained veneer over the meeting stiles and transom which form a cross when the doors are closed. The oak is weathering to a silvery grey which is a characteristic of the material.

b) Oak doors with veneer forming the cross

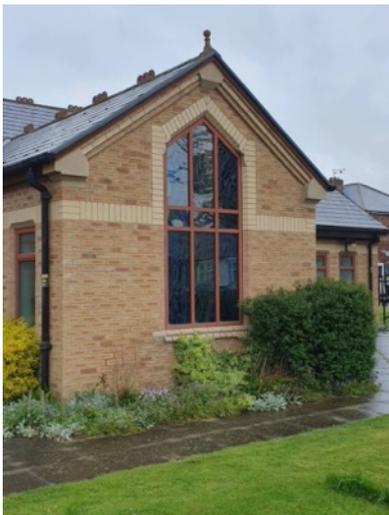
a) Decorative glazing in south window of the lady chapel

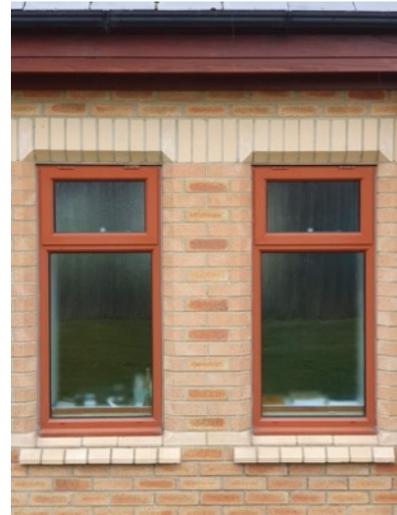
b) Typical window detail

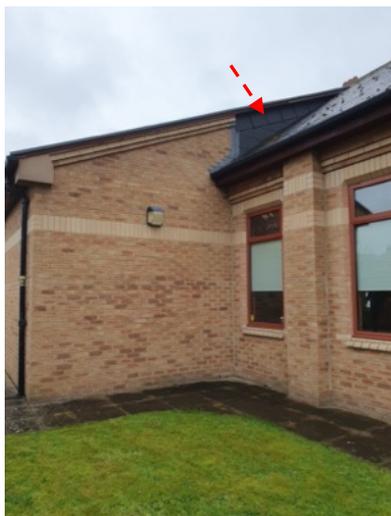
a) Abutment flashing where roofs of differing pitch intersect

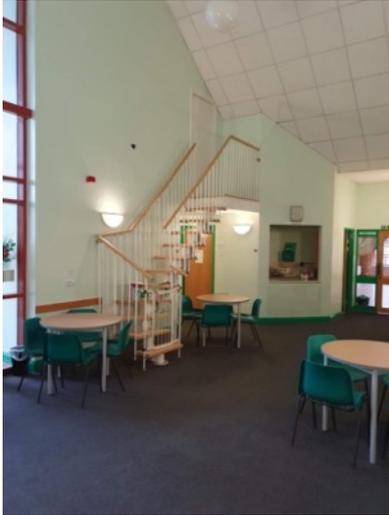
4.2.4 There is a metal staircase within the foyer that provides access to a storage loft where a header tank is also located. The stair is quite steep and feels a little bit flimsy. It is understood that members of the public are prohibited from using the stair. It is advised that anybody with permission to access the store does so with caution especially when carrying storage items. **2**

a) Stair access to storage loft

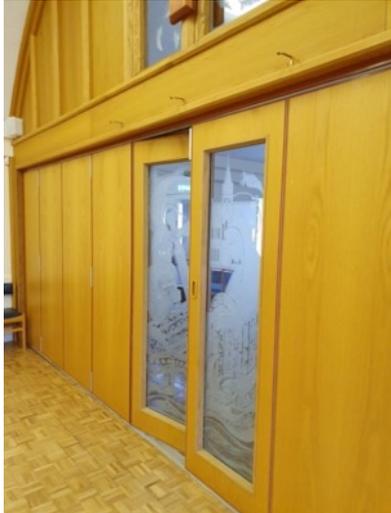
a) Folding/ sliding doors enable the hall and nave to be used as a single space.

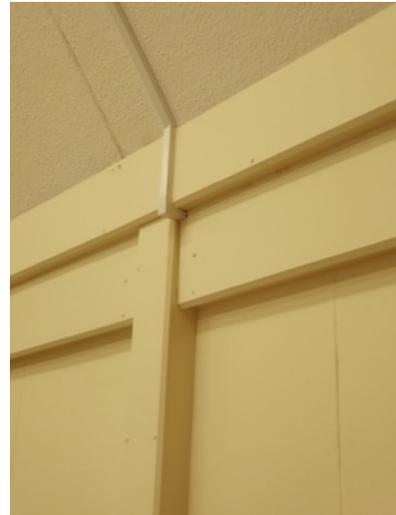
b) The post and panel structural system of the 1950s church is a visible part of the interior.

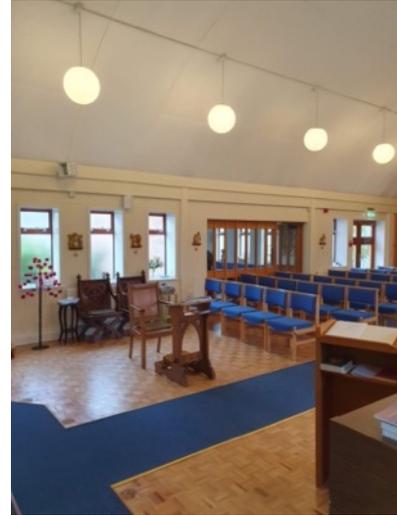
4.4.13

b) South wall with glazed screen to separate the lady chapel

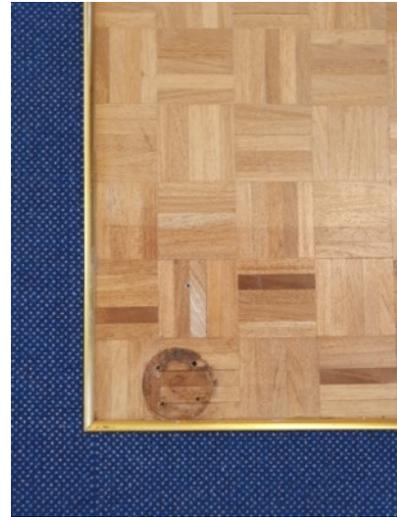
4.4.14

b) Marked from where an altar rail was once fixed.

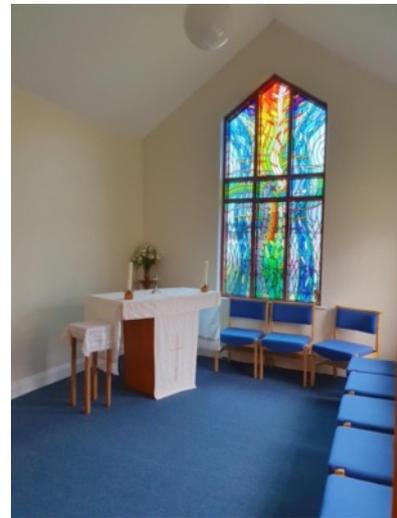
4.5.2 There is a tall window in the south wall featuring a stained glass design with three regular-sized windows in the west wall.

b) South window

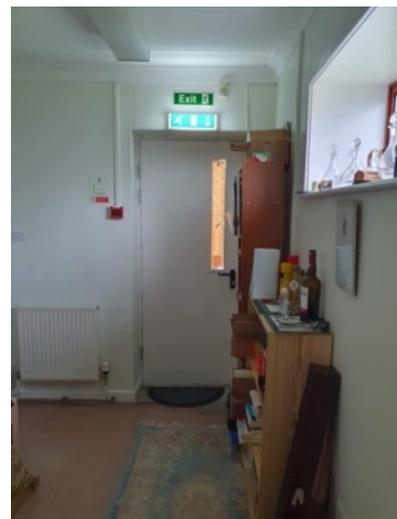
b) Escape door in north wall of the lobby

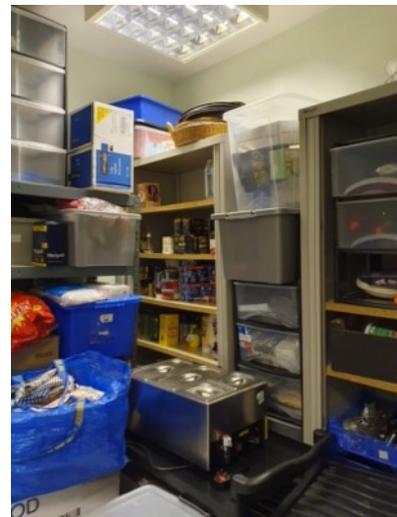
4.7.6

4.7.4 Meeting room 2 is used for storage purposes. Surface finishes and their general condition as per meeting room 1, although walls are largely concealed by shelving and cannot be properly inspected.

b) Walls largely concealed by shelving

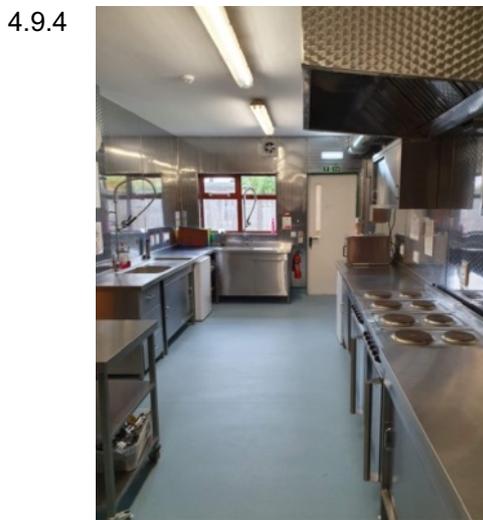
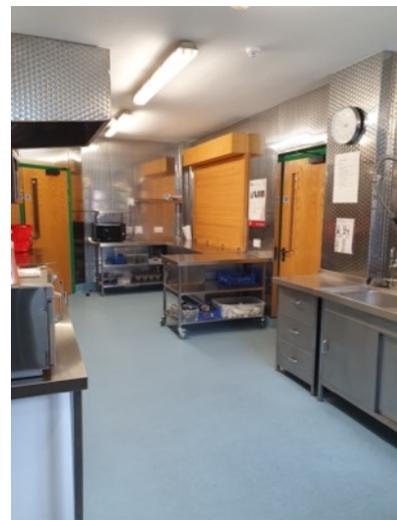
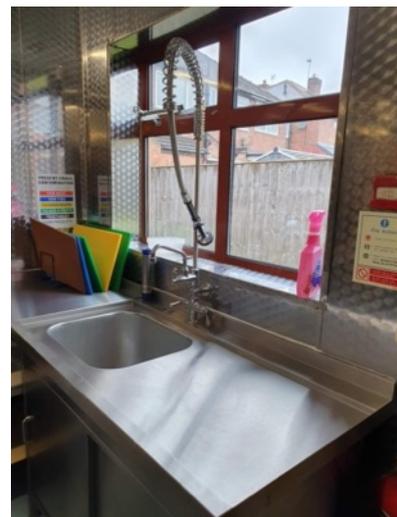
4.9.1 The kitchen is understood to have been fully refurbished earlier this year, 2023, and now benefits from stainless steel worktops and units throughout and is fully fitted with sinks and appliances. Walls are fully lined with stainless steel panels. The floor is covered with a suitable non-slip vinyl sheet with coved skirtings. All is in excellent condition.

a) Kitchen fully refurbished in 2023

b) Kitchen fully refurbished in 2023

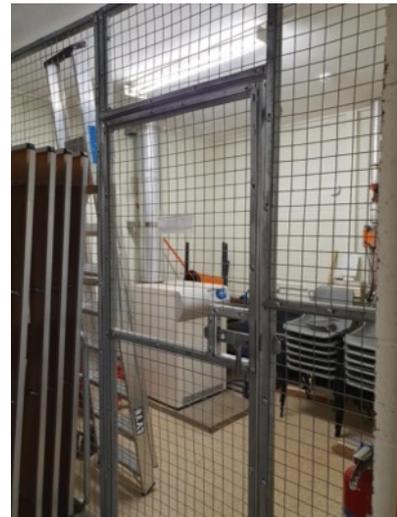
b) secured plant room
