## **QUINQUENNIAL REPORT**

*For the Parish Church of  
St John, Gateshead Fell*

***Report Date: July 2024***

Inspecting Architect:  
Becky Smith BA(Hons), MArch, ARB

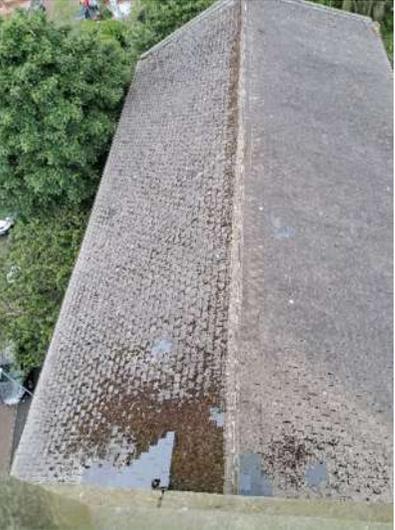
Image & Location	Description	Condition	Repair Needs	Category
<b>Roof - See Appendix Images 01</b>				
<p data-bbox="85 236 206 261"><u>Nave Roof</u></p>

<p data-bbox="607 236 817 820">The main roof of the church was originally covered with green Lake District slates but in 1983 these were replaced completely by dark grey, fibrecement artificial slates. Some isolated repairs have occurred over the years which visibly do not match the originals.</p>	<p data-bbox="862 236 1400 335">The slates to the nave roof appear to be in working order barring a small isolated area of missing slates to the south roof slope.</p> <p data-bbox="862 376 1400 542">The ridge generally appears to be well pointed apart from a small section to the west of the roof where more recent slates have been installed and pointing to the ridge has been lost.</p> <p data-bbox="862 584 1400 785">Mesh over chimney tops to the East Nave gable appears to be missing which is possibly becoming a bird nesting area. This is not obvious however so needs inspecting and the condition of the flaunching to the pots should be checked at the same time.</p>	<p data-bbox="1444 236 1991 335">Missing slates should be replaced to match the existing slates to prevent any possible water ingress to this area.</p> <p data-bbox="1444 376 1991 475">Area to west of roof to be repointed where it has been lost to prevent any possible water ingress to this area.</p> <p data-bbox="1444 584 1991 647">Inspect chimney tops and flaunching to establish works required.</p>	<p data-bbox="2085 236 2107 261">1</p> <p data-bbox="2085 376 2107 402">2</p> <p data-bbox="2085 584 2107 609">2</p>

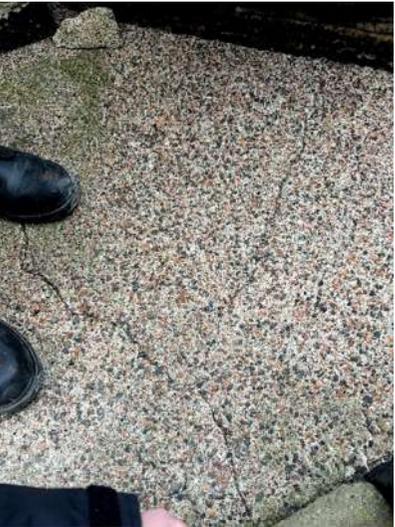
<p data-bbox="85 868 219 893"><u>Tower Roof</u></p>

<p data-bbox="607 868 817 1069">Concrete roof surface surrounds the base of the spire with stone parapet surrounding.</p>	<p data-bbox="862 868 1400 1069">There are several cracks visible to the concrete parapet gutter (see left image). These cracks may be admitting water which may be contributing to the erosion of the stonework of the corbelled-out masonry within the Belfry.</p> <p data-bbox="862 1110 1400 1174">The gutter to the tower roof is blocked with vegetation and debris.</p>	<p data-bbox="1444 868 1991 932">Properly assess concrete to parapet gutter and explore options for waterproof tanking.</p> <p data-bbox="1444 1110 1991 1142">Gutter to be cleaned of vegetation and debris.</p>	<p data-bbox="2085 868 2107 893">3</p> <p data-bbox="2085 1110 2107 1136">1</p>

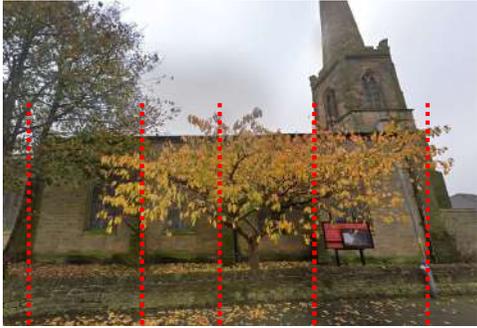
Image & Location	Description	Condition	Repair Needs	Category
<b>External Walls &amp; Structure – See Appendix Images 03</b>				
<p data-bbox="85 236 264 260">North Elevation</p>

<p data-bbox="143 635 483 659">Bay 1 Bay 2 Bay 3 Bay 4</p>	<p data-bbox="607 236 817 783">The external walls are of local, honey-coloured sandstone, the general walling being of large regularly-coursed square blocks, finely joined, with quarry-dressed finish as a contrast to the smooth ashlar dressings of the architectural features.</p> <p data-bbox="607 826 817 1305">The building has evidently suffered considerable movement in the past, possibly due to a legacy of ancient and undocumented mine works, the clergy vestry appears to have been rebuilt at some point in it's history.</p>	<p data-bbox="862 236 1400 435"><u>General Elevation:</u> This elevation is overshadowed by overgrown trees to the area and on my second visit water was dripping off of the trees onto the ground immediately in front of the walls and splashing onto the walls.</p> <p data-bbox="862 480 1400 715">Areas of open and hungry joints with failing mortar to whole elevation particularly to buttresses. Junction to left side of window surrounds appear wider and show more obvious signs of historic cracking with hairline cracking between stone and mortar suggesting the mortar may be to hard.</p> <p data-bbox="862 759 1400 922"><b>Bay 1:</b> Damp evident to the base of the elevation. Cracking visible above window however this is obscured by overgrown trees. The vent is position very low and is covered by the external ground level.</p> <p data-bbox="862 967 1400 1166"><b>Bay 2:</b> The width of the joint to the left hand of the window is wider and is showing signs of hairline cracking. A previously historic repointed crack is starting to reopen below the left side of window with some new hairline cracking appearing in the vicinity.</p> <p data-bbox="862 1211 1400 1235"><b>Bay 3:</b> Cracking to stone surround of window.</p> <p data-bbox="862 1382 1400 1445"><b>Bay 4:</b> Historical cracking below starting to reopen with new cracks starting to form.</p>	<p data-bbox="1444 272 1982 400">Vegetation should be trimmed so it does not come into contact with the stonework and reduces the issue with water dripping at the base of the walls.</p> <p data-bbox="1444 480 1892 536">Repoint open and hungry joints where required using lime mortar.</p> <p data-bbox="1444 759 1982 855"><b>Bay 1:</b> Cracking to be monitored to window. Vent should be dug out and a recess formed with edging to protect from filling with debris.</p> <p data-bbox="1444 967 1960 1062"><b>Bay 2:</b> Monitor historic cracks for any future further movement. Repoint cracks where required using lime mortar.</p> <p data-bbox="1444 1211 1960 1339"><b>Bay 3:</b> Investigate whether embedded metal has caused section to spall and repair stonework. If there is embedded metal it would be beneficial to remove it.</p> <p data-bbox="1444 1382 1937 1477"><b>Bay 4:</b> Repoint cracks with lime mortar. Visually monitor to ascertain if there is any ongoing movement.</p>	<p data-bbox="2078 272 2112 296">M</p> <p data-bbox="2078 480 2112 504">4</p> <p data-bbox="2078 759 2112 783">3</p> <p data-bbox="2078 967 2112 991">4</p> <p data-bbox="2078 1211 2112 1235">4</p> <p data-bbox="2078 1382 2112 1406">4</p>

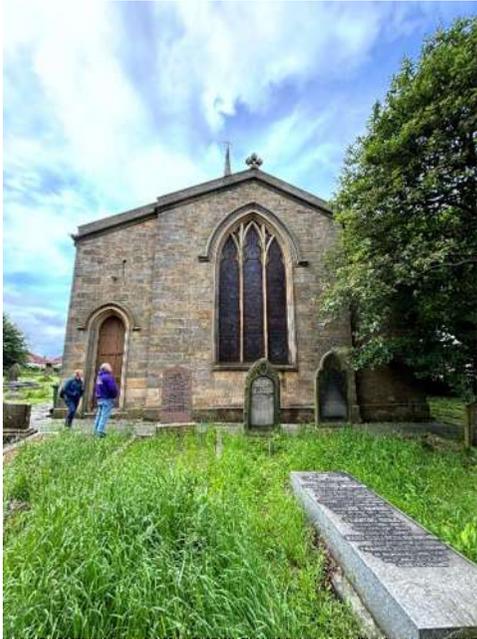
Image & Location	Description	Condition	Repair Needs	Category
<b>External Walls &amp; Structure – See Appendix Images 04</b>				
<p>Chancel Overview</p>

<p>The external walls are of local, honey-coloured sandstone, the general walling being of large regularly-coursed square blocks, finely joined, with quarry-dressed finish as a contrast to the smooth ashlar dressings of the architectural features.</p> <p>The building has evidently suffered considerable movement in the past, possibly due to a legacy of ancient and undocumented mine works, the clergy vestry appears to have been rebuilt at some point in it's history.</p>	<p><u>General Elevation:</u> Areas of open and hungry joints with failing mortar to whole elevation. Joint to left side of window surrounds appear wider and show more obvious signs of historic cracking with hairline movement suggesting the mortar may be to hard.</p> <p><b>North:</b> Loss of pointing to left side of window and cracking evident above window. Low level dampness to elevation – possibly due to dripping off the trees. The overgrown tree is now able to touch the elevation.</p> <p><b>East:</b> Loss of pointing to string course with crack through last left stone and into a section of wall above.</p> <p>Loss of pointing to metal fixing to centre of wall.</p> <p><b>South:</b> Significant loss of pointing to lower left side of window and buttress.</p> <p>Hairline cracking appearing where previous historical repointing has occurred with some cracking also visible to left side of upper window.</p> <p>Cracking visible to right hand side of window surround.</p>	<p>Repoint open and hungry joints where required using lime mortar.</p> <p><b>North:</b> Vegetation should be trimmed so as not to touch elevation.</p> <p><b>East:</b> Repoint areas of lost pointing and cracking using lime mortar and crack to string course.</p> <p>Repoint around metal fixing.</p> <p><b>South:</b> Repoint open and hungry joints where required using lime mortar.</p> <p>Repoint cracks with a lime mortar and monitor cracks for any future further movement.</p> <p>Repoint open and hungry joints where required using lime mortar.</p>	<p>4</p> <p>3 then M</p> <p>3</p> <p>3</p> <p>4</p> <p>4</p> <p>4</p>

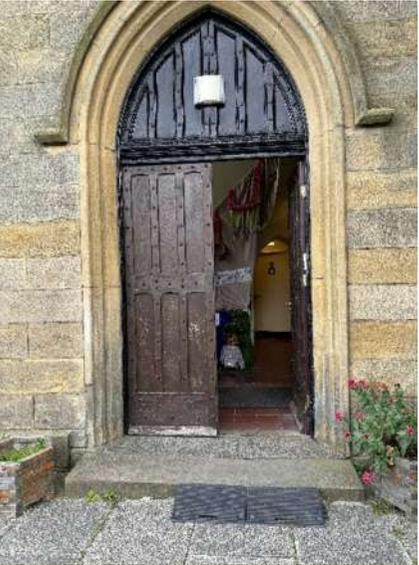
Image & Location	Description	Condition	Repair Needs	Category
<b>Exterior Doors &amp; Timber Work – See Appendix Images 07</b>				
<p data-bbox="85 236 159 261"><u>ED.01</u></p>

<p data-bbox="607 236 817 858">The main entrance doors were renewed completely prior to the 2005 inspection, in reasonably faithful copy of the originals which were beyond economic repair. There is stepped access to entrance with portable ramps for wheelchair access as required.</p>	<p data-bbox="862 236 1400 368">The doors appear to be in reasonable condition but there is evidence of flaking paint more significantly to lower sections of the doors.</p>	<p data-bbox="1444 236 1848 261">Doors to be treated and repainted.</p>	<p data-bbox="2040 236 2152 261">3 then M</p>
<p data-bbox="85 919 159 944"><u>ED.02</u></p>

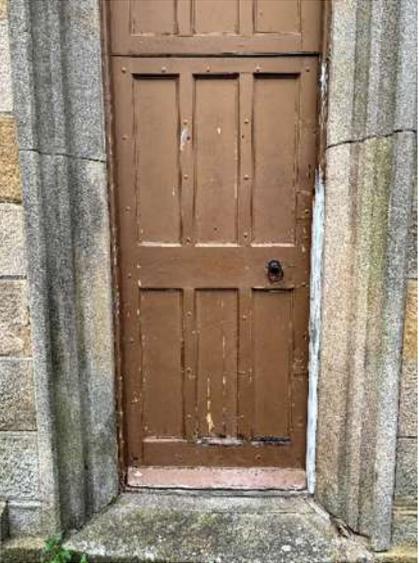
<p data-bbox="607 919 795 1015">Painted timber door with stepped access.</p>	<p data-bbox="862 919 1377 1015">Door showing evidence of rot to lower half with significant flaking of paint to right hand side of door.</p>	<p data-bbox="1444 919 1937 1015">Door to be repaired or if beyond economic repair replaced with a like-for like replacement.</p>	<p data-bbox="2085 919 2107 944">3</p>

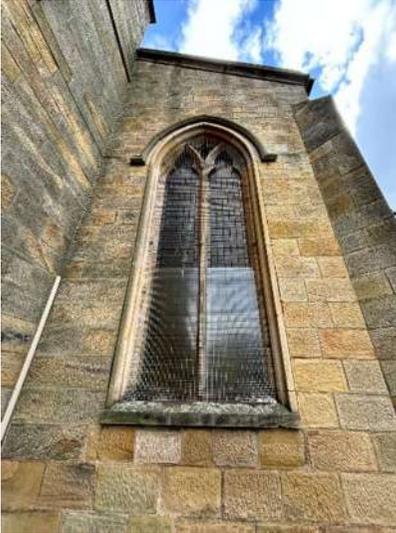
Image & Location	Description	Condition	Repair Needs	Category
<b>Windows – See Appendix – Window Monitoring Document</b>				
<p data-bbox="85 236 474 263"><u>W.01, W.04 &amp; W.10 – Monitoring</u></p>

<p data-bbox="607 236 786 403">Windows have uncoloured or slightly tinted glass in regular leading.</p> <p data-bbox="607 448 819 751">Internally mullions and surround have been painted with a non-breathable paint during an earlier refurbishment programme.</p>	<p data-bbox="860 236 1330 368">The three windows identified within this section are showing signs of significant cracking – this is primarily evident to the mullions.</p> <p data-bbox="860 411 936 435"><b>W.01:</b></p> <p data-bbox="860 443 1361 576"><u>Externally:</u> Significant crack to lower half of upper mullion where metal grill fixing is attached. Significant loss of pointing to window surround.</p> <p data-bbox="860 584 1384 927"><u>Internally:</u> The internal section of the mullion is badly cracked possibly due to missing saddlebars. Lead canes are coming loose and not dressed securely onto the glass which could let wind blown rain in. Flaking paint is evident to window frame. Crack visible to lower left side of window cill. Left hand side surround has recently been re-plastered and was re-painted with a Beck mineral paint. Some cracking to panes of glass.</p> <p data-bbox="860 967 936 991"><b>W.04:</b></p> <p data-bbox="860 999 1368 1094"><u>Externally:</u> Significant crack to upper part of lower mullion where metal grill fixing is attached.</p> <p data-bbox="860 1102 1384 1166"><u>Internally:</u> Some cracking of paint and plaster visible to mullion and frame.</p> <p data-bbox="860 1206 936 1230"><b>W.10:</b></p> <p data-bbox="860 1238 1339 1334"><u>Externally:</u> Significant crack to centre of mullions where join and where metal grill fixing is attached.</p> <p data-bbox="860 1342 1330 1406"><u>Internally:</u> Some cracking of mortar fillet visible to mullion and surround.</p>	<p data-bbox="1442 236 1727 260"><u>Monitoring Programme:</u></p> <p data-bbox="1442 268 1989 435">This is the first time the architect has inspected this church and cannot see any prior reference to cracking within the mullions of the window. It is therefore hard to ascertain whether it has been ongoing for some time.</p> <p data-bbox="1442 480 1995 647">The recommendation is to initially monitor future movement to these windows by taking a series of regular photos at by-monthly intervals to monitor any future further movement prior to repair or replacement.</p> <p data-bbox="1442 687 1980 783">The intention of this monitoring programme is to carry out repairs or replacement of mullions.</p> <p data-bbox="1442 823 1973 847">See Appendix – Window Monitoring Schedule</p>	<p data-bbox="2040 236 2145 260">Ongoing</p> <p data-bbox="2040 687 2152 855">4 (or before if condition deteriorates)</p>

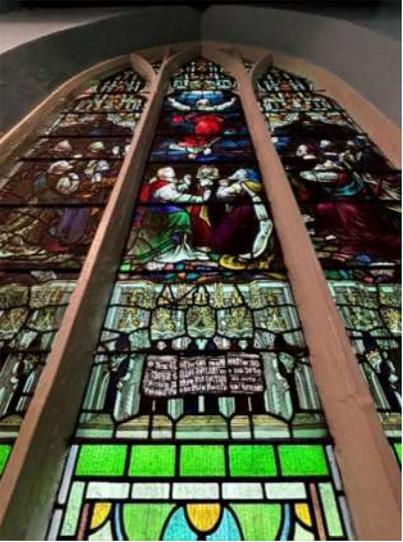
<p>The stained glass window identified as W.07 has a depiction of the Transfiguration, dating from 1916, with no obvious signature.</p>	<p><b>W.03</b>  <u>Internally:</u> There are signs of mould/mildew to window surround with some cracking to paint. The mildew is possibly due to internal environment conditions.</p> <p><b>W.07</b>  <u>Externally:</u> The window appears to be in fair condition but it has been noted in previous reports it can leak during storm conditions. <u>Internally:</u> Significant cracking is becoming evident to paint and plaster of left mullion – this could be due to rusting saddle bars or movement. Some hairline cracking to all mullions.</p> <p><b>W.11</b>  <u>Internally:</u> There is paint and plaster cracking evident to mullion and left side of window which may be to due to movement. There is evidence of paint cracking to upper elevation. Externally one section of stonework to the surround has spalled possibly due to embedded metal work.</p>	<p>Clean off mould growth to window surrounds.</p> <p>Monitor frequency of leaks and consider re-leading in the foreseeable future, as suggested previously. Inspect and repair stonework to window when windows are repaired.</p> <p>Repair stonework, checking for any embedded metalwork which should be removed if possible.</p>	<p>3</p> <p>4</p> <p>3</p>

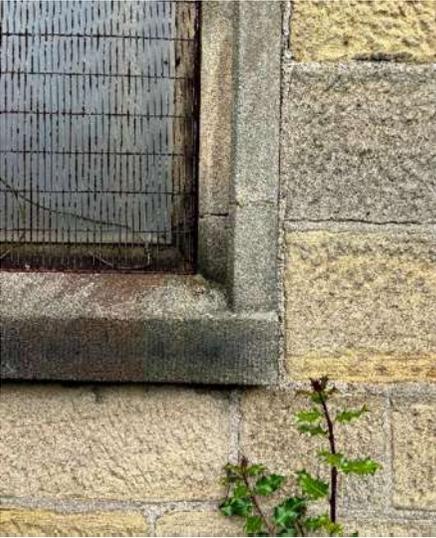
Image & Location	Description	Condition	Repair Needs	Category
<b>Window Guarding and Protection – See Appendix Images 09</b>				
<p data-bbox="85 236 414 263"><u>Window Guarding &amp; Rusting</u></p>

<p data-bbox="607 236 817 678">Galvanised wire guards externally, generally set too far out from the glass and therefore obscuring much of the architecture of the stone surrounds and mullions of the windows.</p>	<p data-bbox="862 236 1377 406">In places these guards have failed to protect the windows from having objects behind the apertures, and polycarbonate sheeting has been inserted behind to protect the lower panels.</p> <p data-bbox="862 443 1377 582">The guards are becoming increasingly rusty which is more significant to some windows than others with some resultant staining to masonry.</p>	<p data-bbox="1444 236 1982 438">To some of the windows the rust which is being given off is staining the stonework therefore as mentioned in previous reports replacement should be considered soon. The form of protection used on the church may need to be reconsidered in light of the issue.</p>	<p data-bbox="2072 236 2116 263">4</p>

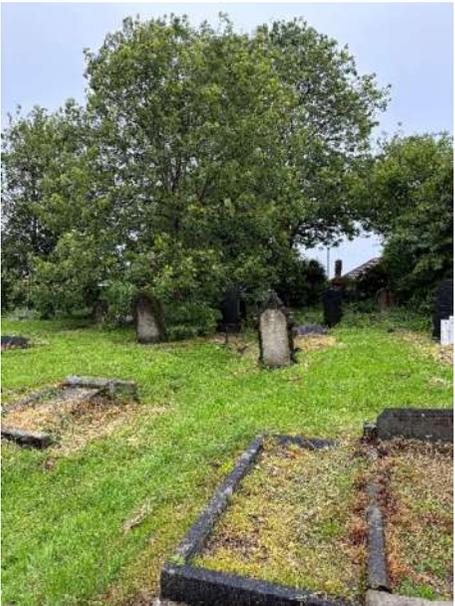
Image & Location	Description	Condition	Repair Needs	Category
<b>Churchyard &amp; Boundaries – See Appendix Images 10</b>

<p>The churchyard extends for some distance to the south of the church. It contains a considerable number of headstones, giving it quite a distinctive character. It is a closed churchyard so repairs noted should be raised with the Local Authority.</p>	<p><u>Noticeboard</u>: The metal posts are showing signs of rust and the timber board frame is rotting in places.</p> <p><u>East End Gate</u>: The gate to the east end of the church is showing evidence of rusting.</p> <p><u>North End Gate</u>: Appears to be in fair condition, some cracking to steps on approach.</p> <p><u>Boundary Walls</u>: The South wall has been rebuilt by Gateshead Council in 2023/24. The north wall entrance was rebuilt by Gateshead Council in 2024.</p> <p>The East and West walls are in poor condition where the back onto properties in multiple areas including fallen parts of the wall and missing stones.</p> <p><u>Pavement</u>: The pavement has some cracks and is uneven in areas where some slabs have become raised.</p> <p><u>Headstones &amp; Trees</u>: Many of the headstones have fallen or are leaning significantly. There are significantly overgrown trees to the church yard and East and North elevation. The overgrown trees to the North and East elevation are likely contributing to the damp evident at the base of the elevations as water dripping off the trees is ponding in front of these elevations.</p>	<p>Metal posts should be treated with an anti-rust primer before repainting. Timber board frame to be repaired.</p> <p>Gates should be repainted as part of ongoing maintenance programme.</p> <p>Walls to be rebuilt in parts and repair works to remaining walls are required including consolidation and repointing works.</p> <p>Monitor raised paving slabs to ensure they do not become a significant hazard and carry out ongoing repairs as required. Consider relaying paving if condition deteriorates. If paving is relaid it would be beneficial to look to relevel the area and remove the step to the church.</p> <p>Remind Gateshead Council of their responsibility to inspect graves and trees periodically.</p>	<p>3 then M</p> <p>3 then M</p> <p>3</p> <p>5</p> <p>M</p>

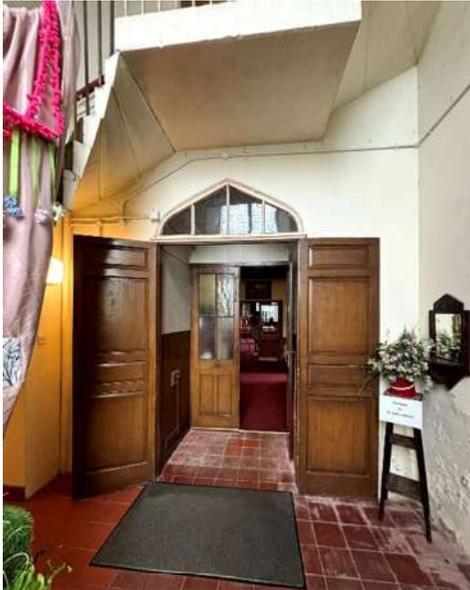
Image & Location	Description	Condition	Repair Needs	Category
<b>Internal Spaces – See Appendix Images 11/12</b>				
<p data-bbox="85 236 190 260">Entrance</p>

To the entrance area there is some significant blistering and damage to the plaster surrounding the doors (ED.01) which may be being made worse due to the lack of heating / ventilation to the space. The plaster to the lower section of the wall could be removed to this areas neatly in order to allow the walls to dry out fully which may assist with this issue, before replastering with lime plaster in the future.

<p data-bbox="607 236 806 507">Walls plaster painted. Floor is tiled. Ceiling painted. ED.01 timber doors. Staircase leading to gallery and Belfry Tower.</p>	<p data-bbox="862 236 1400 403"><b>Walls:</b> Significant blistering to paint and plaster around main entrance generally. Area appears damp. Mould evident above entrance doors. This could be being made worse due to lack of ventilation / heating to area.</p> <p data-bbox="862 443 1220 467"><b>Floor:</b> Glazing lost to floor tiles.</p>	<p data-bbox="1444 236 1991 331"><b>Walls:</b> Remove plaster to blistering areas in a neat way and allow walls to dry out fully before replastering using lime plaster.</p> <p data-bbox="1444 443 1937 507"><b>Floor:</b> Visually monitor to ensure condition doesn't deteriorate further.</p>	<p data-bbox="2038 236 2150 331">3 (removal of plaster)</p> <p data-bbox="2083 443 2105 467">M</p>

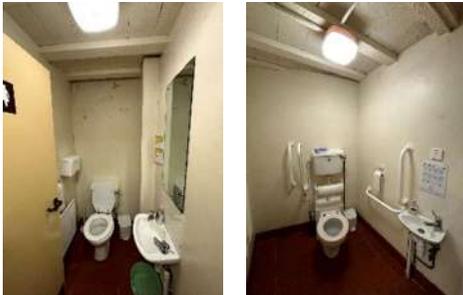
<p data-bbox="85 927 380 951">Unisex &amp; Accessible WC's</p>

<p data-bbox="607 927 817 1193">Tiled floor to both WC's. All walls plaster painted. Concrete beam and block ceiling paint finished. Single light fitting to each WC.</p>	<p data-bbox="862 927 1377 986"><b>Unisex WC:</b> Flaking paint and some cracking to WC wall.</p> <p data-bbox="862 1026 1388 1265"><b>Accessible WC:</b> Some evidence of mould to ceiling possibly due to lack of ventilation. WC, Grab Rails, Sink and Baby Changing Facility appear to be in working order. The accessible WC door is inward hung which as previously mentioned would not comply with current accessibility regulations.</p>	<p data-bbox="1444 927 1971 986">Address when this area forms part of ongoing maintenance redecorating programme.</p> <p data-bbox="1444 1026 1960 1090">Clean off mould from ceiling. Aim to ventilate space as much as possible.</p>	<p data-bbox="2083 927 2105 951">M</p> <p data-bbox="2038 1026 2150 1050">1 then M</p>

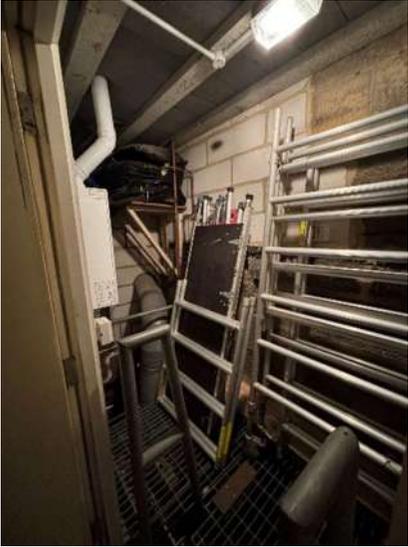
Image & Location	Description	Condition	Repair Needs	Category
<b>Internal Spaces – See Appendix Images 13/14</b>				
<p>Boiler Room</p>

<p>Over two levels with a metal grille at main floor level incorporating a hatch for access to the lower level. Concrete roof, unpainted stone walls. Steel louvre assembly in the opening in North Wall with stainless steel wire mesh internally.</p>	<p>Verbally informed that the boiler was condemned as the engineer believed there to not be enough ventilation within the boiler room and that it should be ducted. The church explored installing a flue however this wasn't cost effective so had the boiler replaced in June 2023 which only heats part of the church.</p>	<p>Continue to explore options to heat the remainder of the church.</p>	<p>2</p>
<p><u>Foyer</u></p>

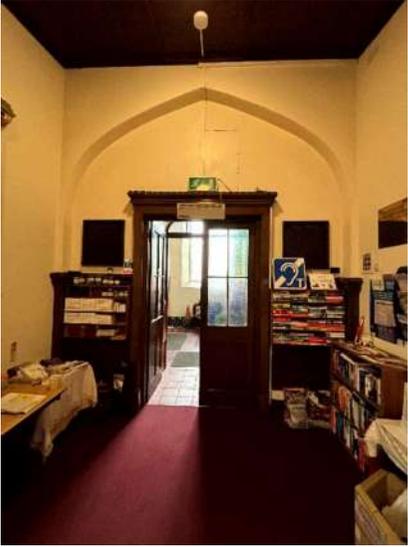
<p>Carpeted throughout space. All walls plaster painted. Ceiling is softwood boarded which is sub-divided with simple mouldings.</p>	<p><b>Walls:</b> Minor flaking to paint/plaster in places but currently not of issue.</p>	<p>Repainting as part of routine decoration.</p>	<p>M</p>

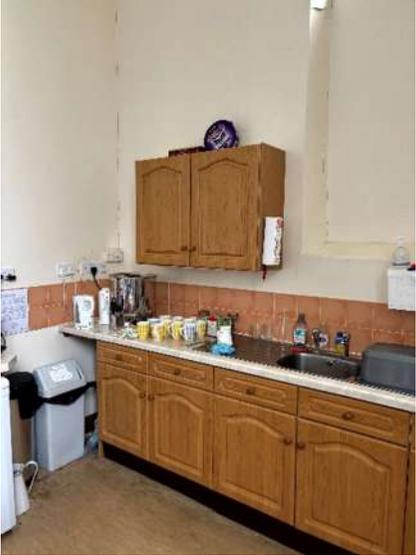
Image & Location	Description	Condition	Repair Needs	Category
<b>Internal Spaces – See Appendix Images 15/16</b>				
<p><u>Kitchen</u></p>

<p>Floor carpeted over a timber base with vinyl sheet flooring in front of the run of kitchen units. All walls plaster painted with tiles above, behind and surrounding units. Sloping plaster ceiling painted. Two radiators and 4 ceiling lights. High level window to West wall.</p>	<p><b>Walls:</b> Flaking paint visible to window reveals and part of walls. Mould is visible under radiator. There are tiles missing to the north wall which is due to a planned oven replacement. Currently the gap left for the oven is not wide enough and therefore there are discussions around installation of new kitchen units and new tiling to replace existing.</p> <p><b>Windows:</b> There are several cracked glass panes and rusty saddle bars.</p> <p><b>Floors:</b> Appears to be in good working order.</p> <p>Some appliances currently in process of being replaced as mentioned above but all others appear in good working order.</p>	<p>Repaint walls as part of ongoing maintenance programme.</p> <p>Tiles to be reinstated to kitchen area as part of maintenance plan once a decision has been made about the kitchen units.</p> <p>If the glass panes remain secure and held in place and appear fine then they can be left. Consider painting saddle bars.</p>	<p>M</p> <p>2</p> <p>5</p>

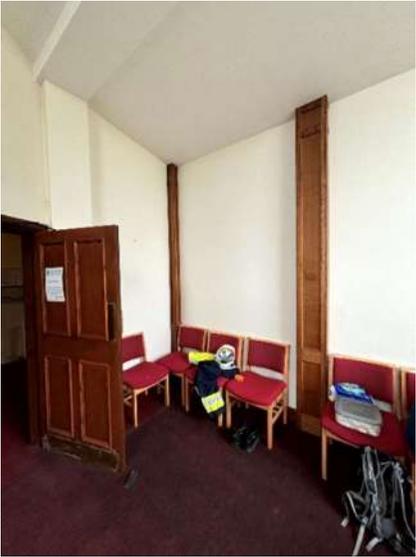
<p><u>Meeting Room</u></p>

<p>Carpeted floor throughout room. All walls plaster painted. Sloping plaster ceiling painted. Two radiators and 4 ceiling lights. Wooden panelling to parts of walls.</p>	<p><b>Walls:</b> Generally in fair condition with some areas of flaking paint. Cracks visible up walls and through ceiling where junctions between solid plastered wall and stud wall meet. Area re-plastered due to cracking and painted with Beek Mineral Paint to left side of W.01.</p> <p><b>Skirting:</b> Rot visible to left side of W.01 to corner of room.</p>	<p><b>Walls:</b> Skim flaking areas of paint and repaint all walls with a Beek Mineral Paint. However, W.01 requires monitoring and therefore it is suggested that unless required the space is not redecorated as W.01 may require some future opening up works.</p> <p><b>Skirting:</b> Remove damaged sections – allow area to fully dry out before installing new.</p>	<p>M</p> <p>3</p>

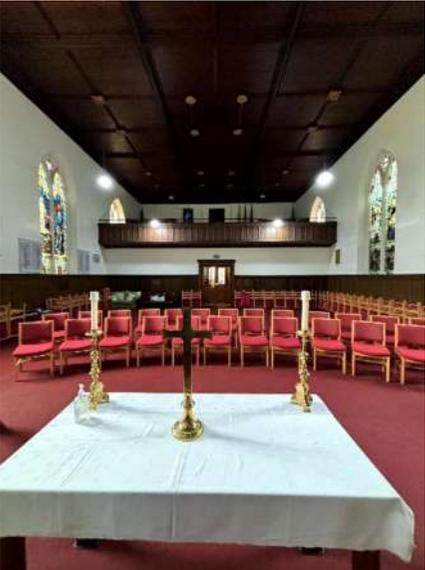
Image & Location	Description	Condition	Repair Needs	Category
<b>Internal Spaces – See Appendix Images 17/18</b>				
<p data-bbox="85 236 145 263"><u>Nave</u></p>

<p data-bbox="607 236 817 715">Walls of painted plaster with dado panelling to lower part of walls. Timber ceiling of softwood boarding sub-divided by moulded softwood ribs and with painted bosses at the intersections. Carpeted floor.</p>	<p data-bbox="862 236 1377 331">The nave generally appears to be in good condition. There are some cracks and flaking paint to window surrounds.</p>	<p data-bbox="1444 236 1915 300">Repainting in line with planned ongoing maintenance programme.</p>	<p data-bbox="2072 236 2116 263">M</p>
<p data-bbox="85 884 145 911"><u>Organ</u></p>

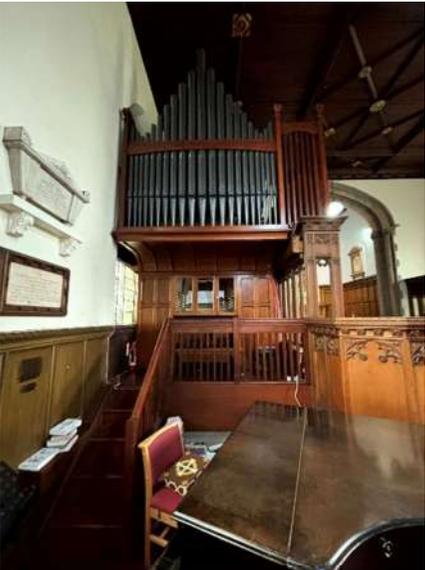
<p data-bbox="607 884 817 1225">A Harrison &amp; Harrison instrument brought from the redundant church of St. Aidan's, Blackhill, and adapted and installed here in 1999.</p>	<p data-bbox="862 884 1377 948">The organ is understood to be in frequent use and is maintained regularly.</p>	<p data-bbox="1444 884 1960 911">Continue to have organ maintained annually.</p>	<p data-bbox="2072 884 2116 911">M</p>

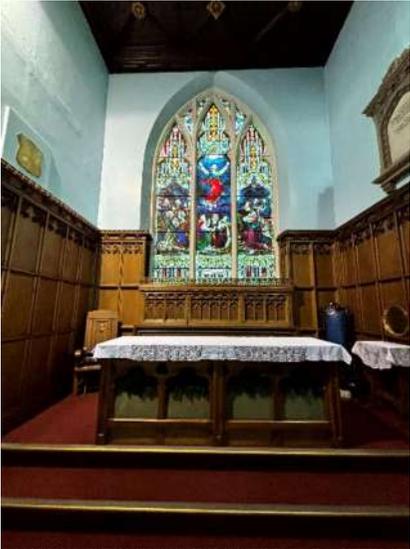
Image & Location	Description	Condition	Repair Needs	Category
<b>Internal Spaces – See Appendix Images 19/20</b>				
<p data-bbox="85 236 203 261"><u>Sanctuary</u></p>

<p data-bbox="607 236 817 715">Walls of painted plaster with dado panelling to lower part of walls. Timber ceiling of softwood boarding sub-divided by moulded softwood ribs and with painted bosses at the intersections. Carpeted floor.</p>	<p data-bbox="862 236 1400 368">Uneven plaster finish to East but painted over and not showing any new issues. Paint appears to be vinyl so non-breathable. Mullions are painted and saddlebars rusting.</p>	<p data-bbox="1444 236 1812 261">Consider repainting saddlebars.</p>	<p data-bbox="2085 236 2107 261">5</p>
<p data-bbox="85 879 230 904"><u>Choir Vestry</u></p>

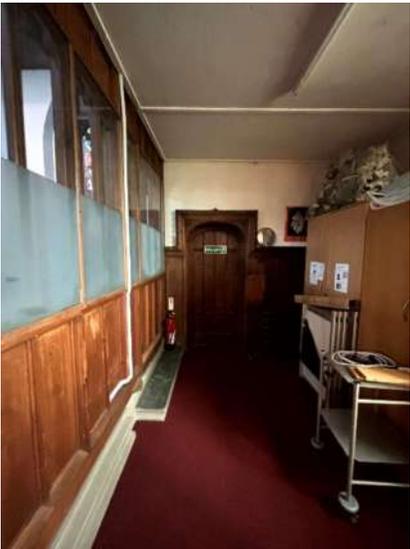
<p data-bbox="607 879 817 1114">Walls of painted plaster with dado panelling to lower part of walls. Plaster painted ceiling. Carpeted floor.</p>	<p data-bbox="862 879 1377 938">Flaking paint to window surround otherwise area appears to be in good working order.</p>	<p data-bbox="1444 879 1906 938">Repainting in line with planned ongoing maintenance programme.</p>	<p data-bbox="2085 879 2107 904">M</p>

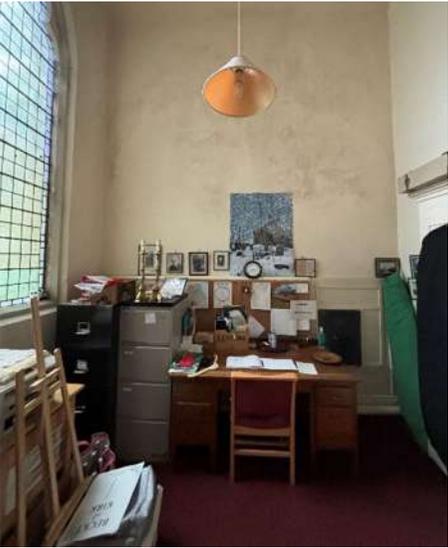
Image & Location	Description	Condition	Repair Needs	Category
<b>Internal Spaces – See Appendix Images 21/22</b>				
<p data-bbox="85 236 237 264"><u>Clergy Vestry</u></p>

<p data-bbox="607 236 817 368">Painted plastered walls. Carpeted floor. Plastered ceilings.</p>	<p data-bbox="862 236 1400 300"><b>East:</b> Mould/mildew to wall and some cracking and flaking of paint.</p> <p data-bbox="862 341 1400 507"><b>North:</b> Hatch into roof space. Very high ceilings and small opening. Crack to right hand side of wall and cracking between wall and windows. Debris visible behind window and missing saddlebars.</p> <p data-bbox="862 549 1400 612"><b>West:</b> Mould/mildew to angled wall with some cracking visible.</p>	<p data-bbox="1444 236 1982 300">Remove mould/mildew to walls. Repaint as part of ongoing maintenance strategy.</p> <p data-bbox="1444 341 1982 405">Investigate and make good areas of cracking when space next decorated.</p> <p data-bbox="1444 549 1982 580">Clean off mould/mildew to walls.</p>	<p data-bbox="2040 236 2150 268">2 then M</p> <p data-bbox="2085 341 2105 373">5</p> <p data-bbox="2040 549 2150 580">2 then M</p>

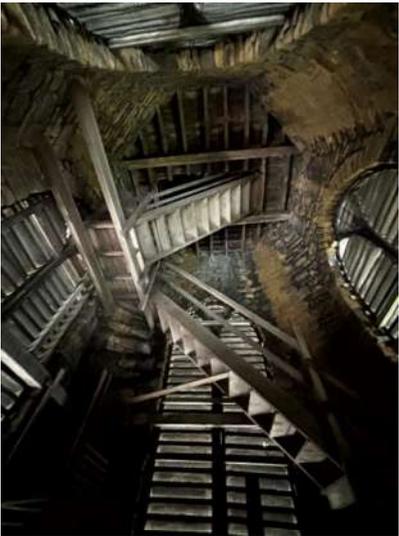
Image & Location	Description	Condition	Repair Needs	Category
<b>Internal Spaces – See Appendix Images 23</b>				
<p data-bbox="85 236 324 263"><u>Belfry &amp; Belfry Stage</u></p>

<p data-bbox="607 236 817 438">The Belfry walls are of coursed squared rubble masonry. The Belfry louvres are of softwood.</p>	<p data-bbox="862 236 1339 335">There is good access to tower for maintenance purposes although some sections are easier to access than others.</p> <p data-bbox="862 375 1400 542">Belfry louvres are of softwood and are broken / missing in parts. Whilst this doesn't currently appear to be presenting as an issue for bird access it may become a problem if netting behind fails.</p> <p data-bbox="862 582 1400 646">Wooden staircase leading to tower appears to be in working order.</p>	<p data-bbox="1444 375 1915 438">Timber louvres to be repaired / replaced where required.</p>	<p data-bbox="2072 375 2105 406">3</p>

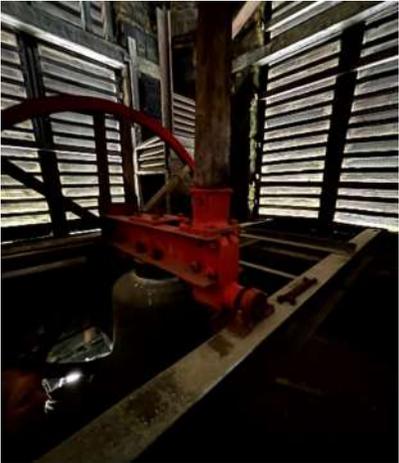
<p data-bbox="85 879 145 906"><u>Bells</u></p>

<p data-bbox="607 879 817 1284">The Belfry contains a single bell bearing the date 1610. The bell is reputed to have originated in Russia, being transported as ballast on one of the ships trading in the mid-19<sup>th</sup> century.</p>		<p data-bbox="1444 879 1960 941">Bell Diocesan Advisory to be asked to inspect the bells if this has not happened recently.</p>	<p data-bbox="2072 879 2105 909">M</p>

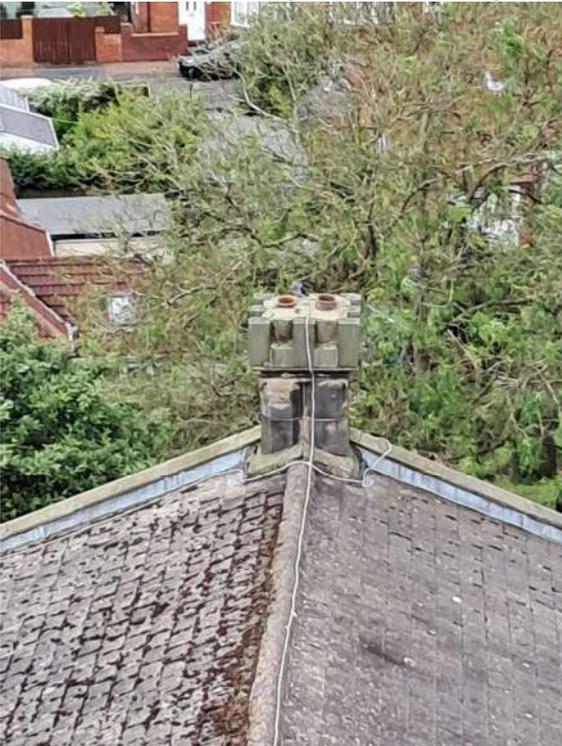
Mesh may be missing to top of pots & condition of flaunching needs checking

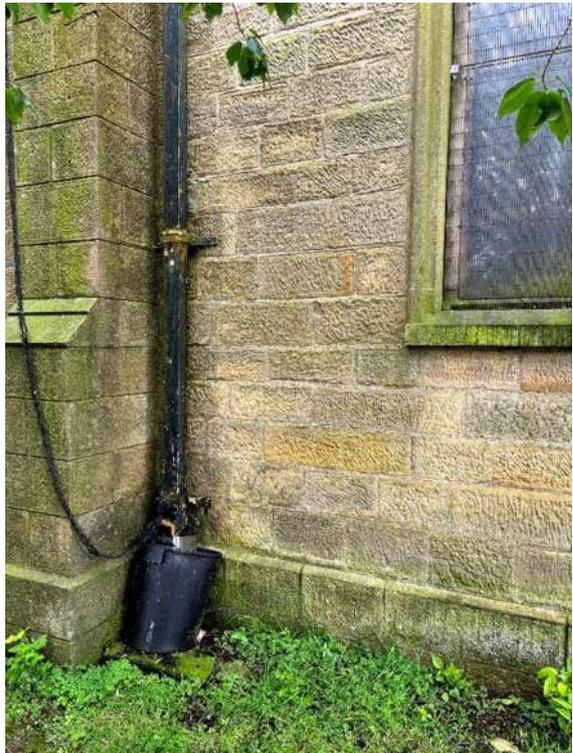
Gutter has been shortened to North Elevation Bay 3 to allow water to be collected.

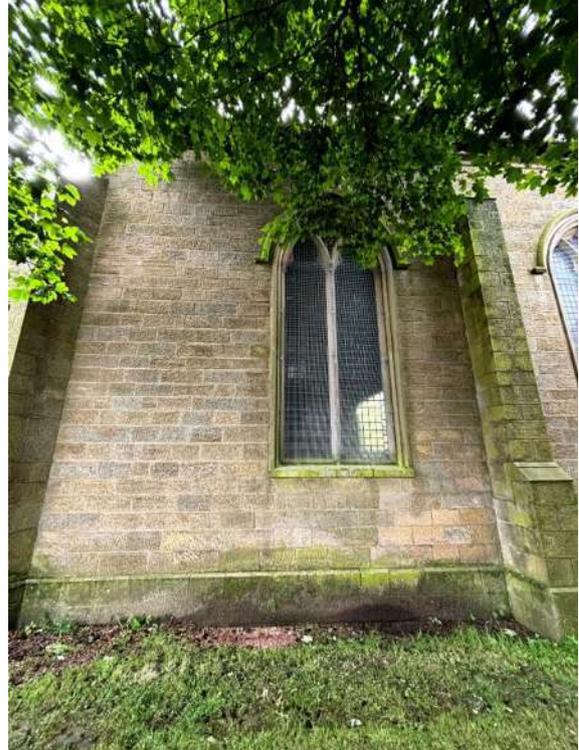
Overview of North Elevation Bay 1.

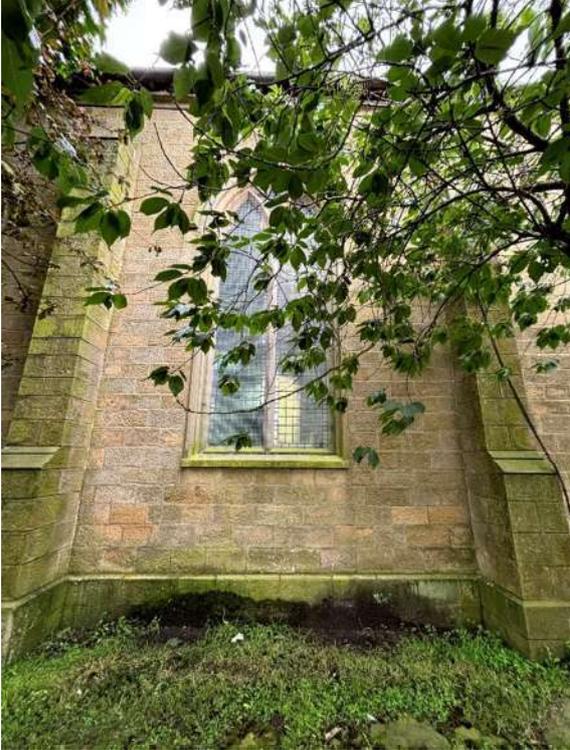
Overview of North Elevation Bay 2 – obscured by trees.

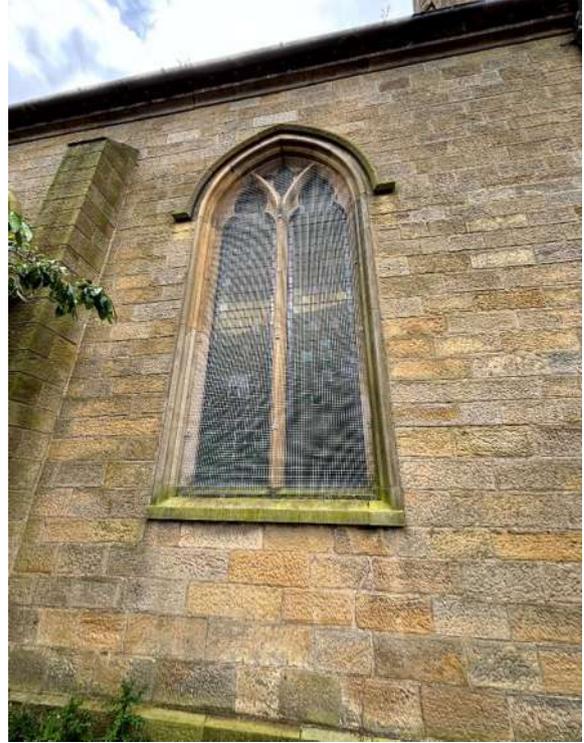
Overview of North Elevation Bay 4.

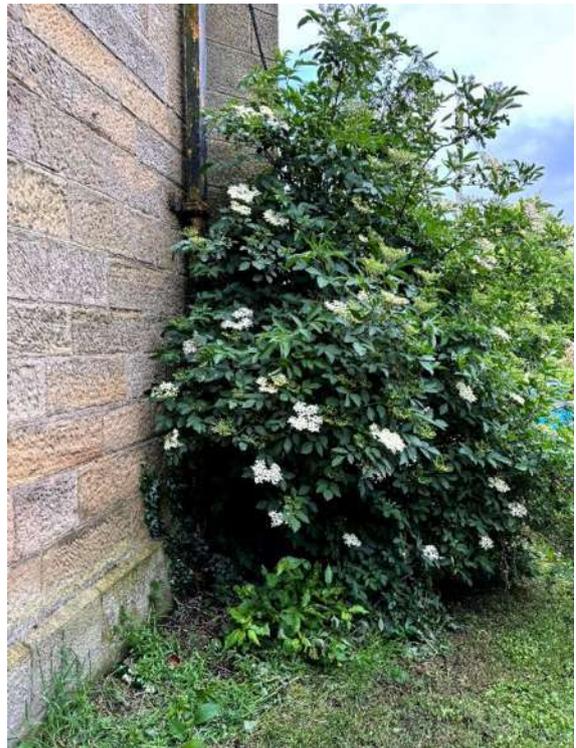
Overgrown vegetation to front of elevation and ivy present.

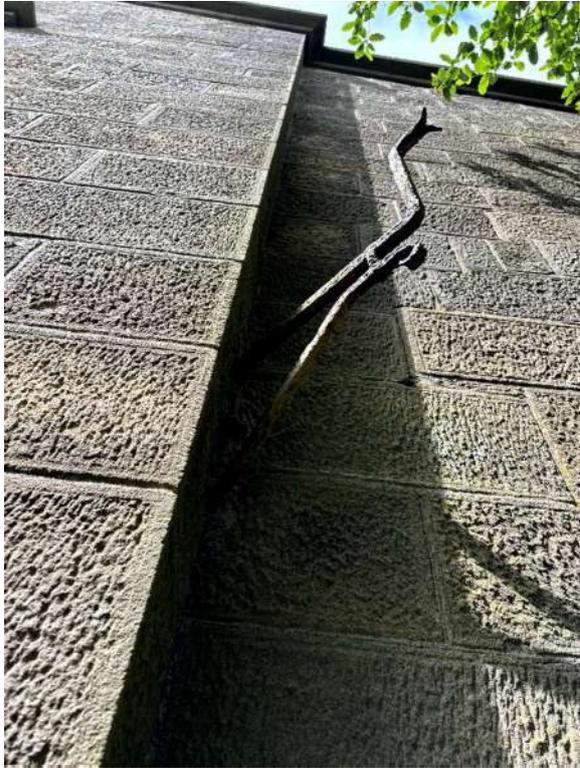
Metal fixing to elevation.

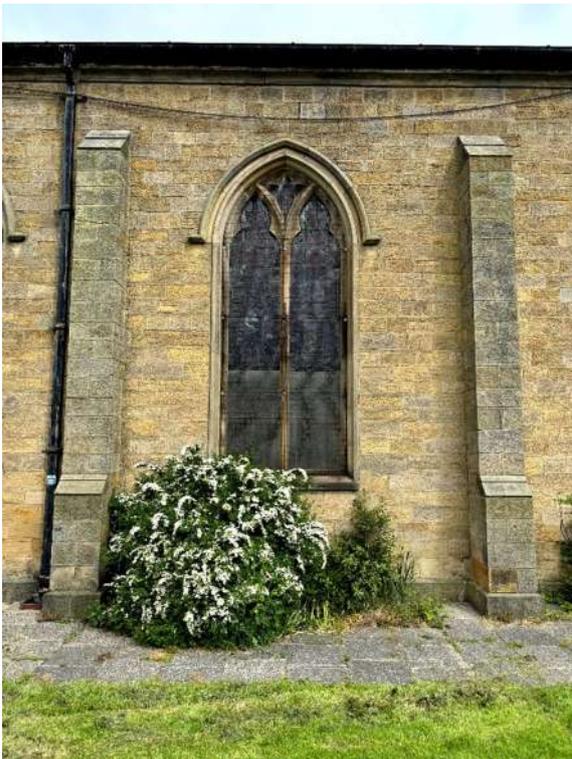
South Elevation – Bay Two Overview with overgrown vegetation shown.

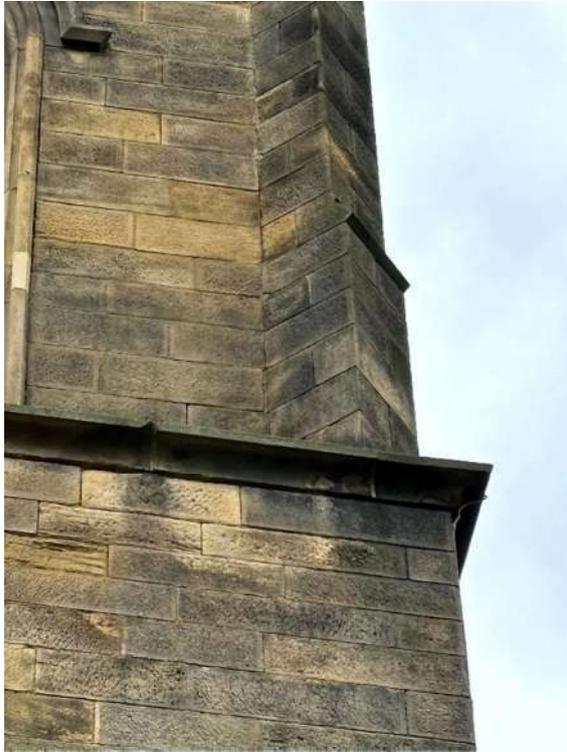
Loss of pointing below water tabling.

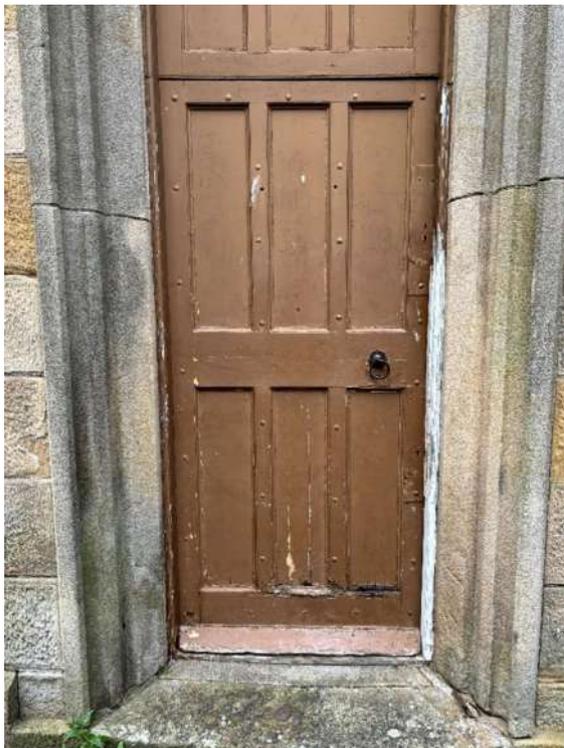
ED.02 showing signs of rot and deterioration to the frame.

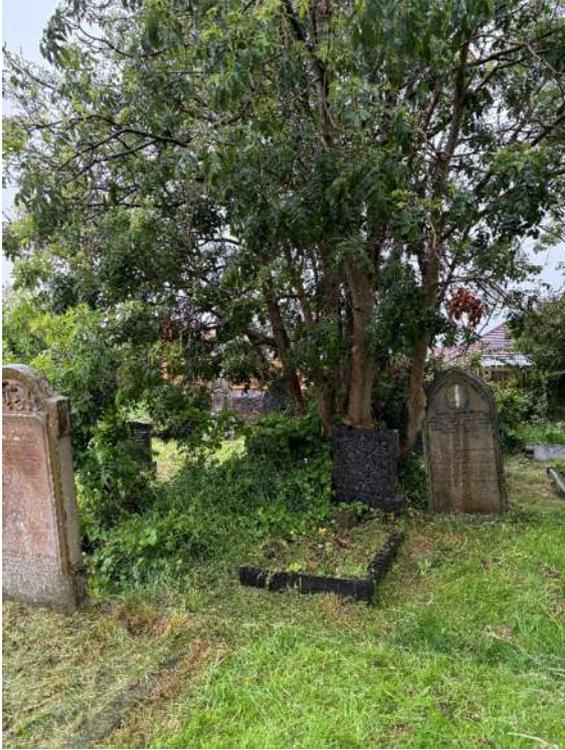
Example of how trees are impacting headstones. This is evident in several areas.

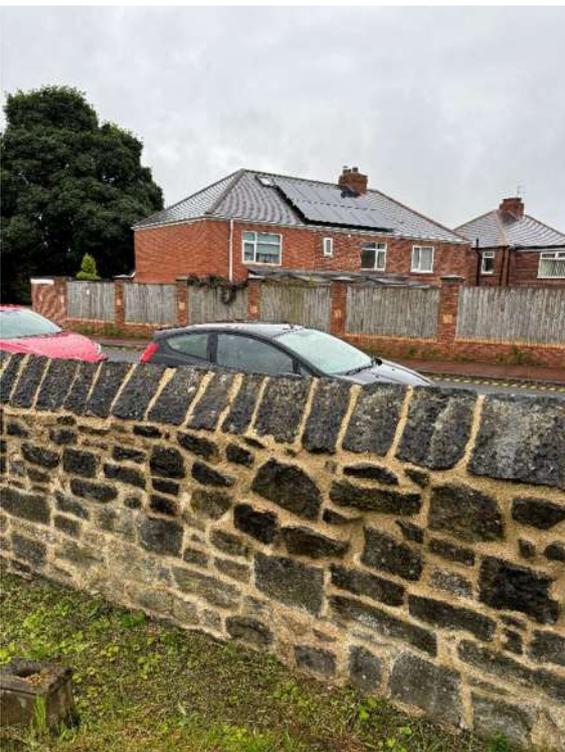
More recent repairs to South Wall – with public footpath next to it.

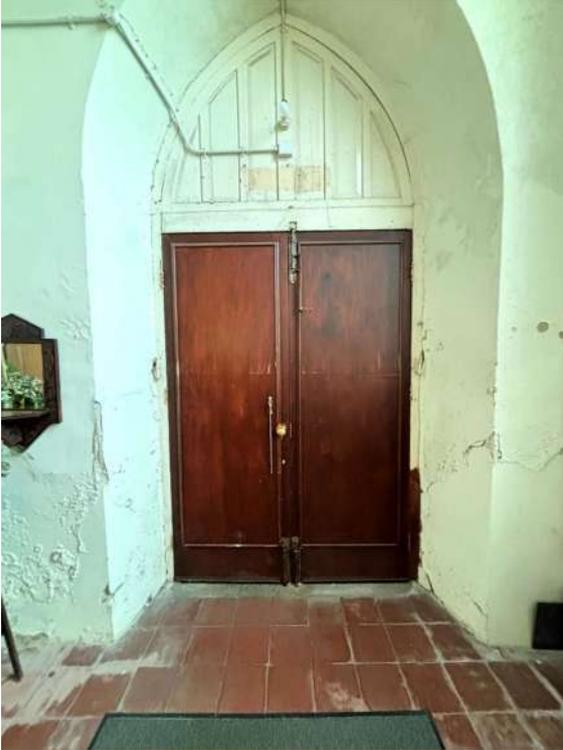
Blistering plasterwork surrounding ED.01.

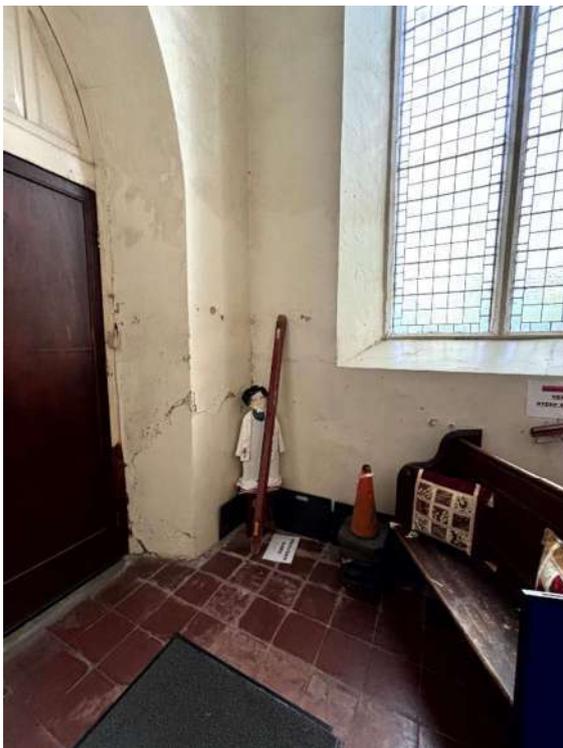
Glazing lost to tiles and cracks to plasterwork.

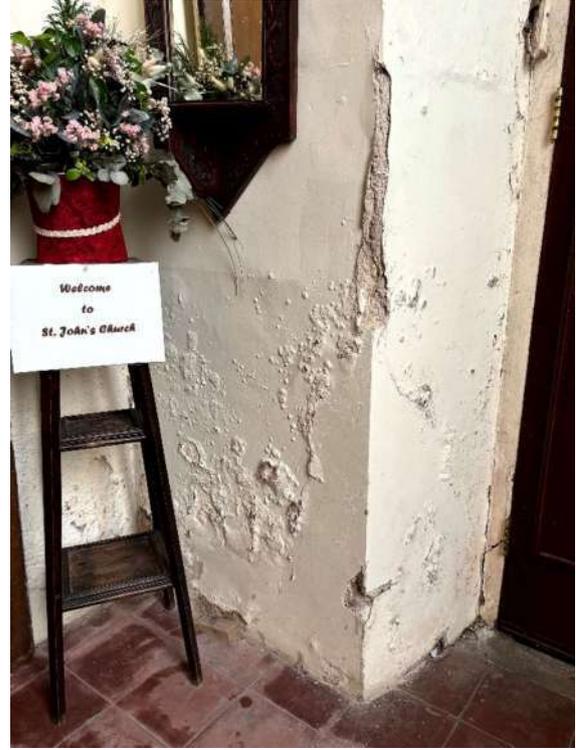
Blistering plasterwork to walls.

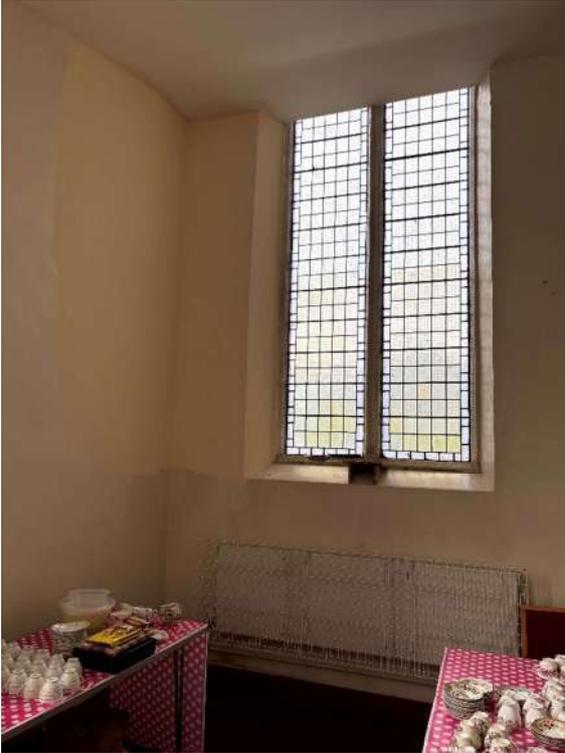
Area to wall which has been plastered and repainted with Beeck mineral paint.

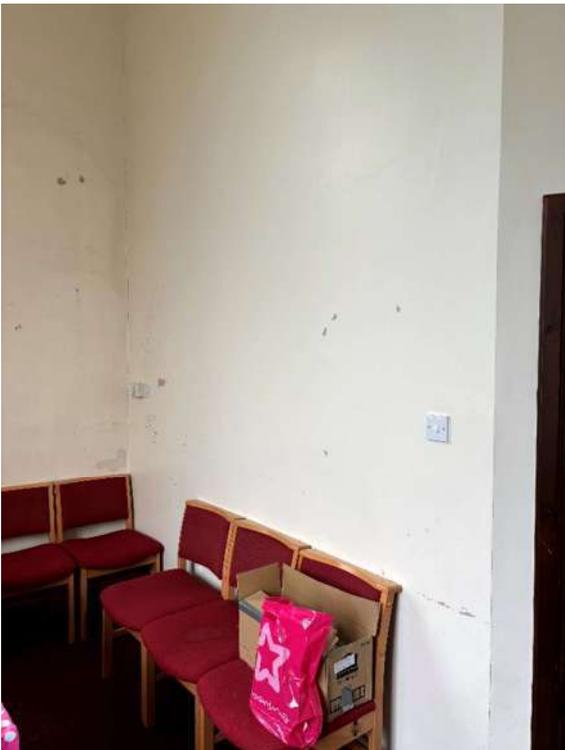
Some flaking of paint to walls.

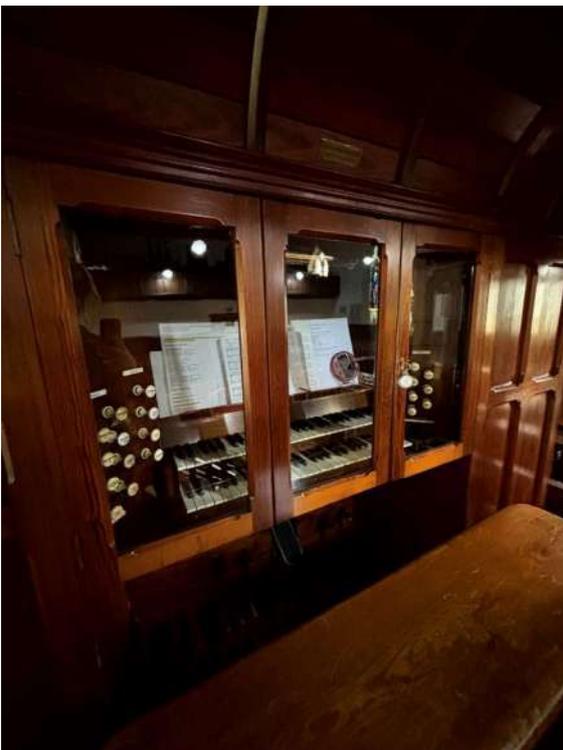
Some mould visible to wall behind organ.

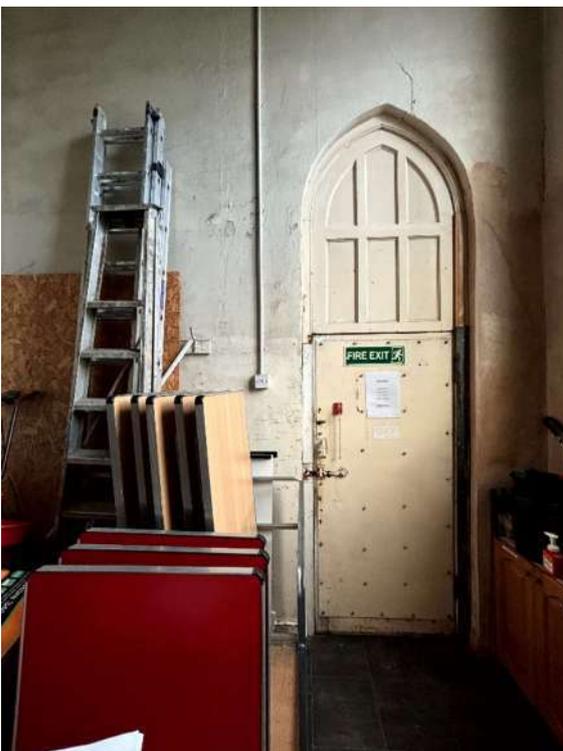
Mould visible to walls and cracking of paint.

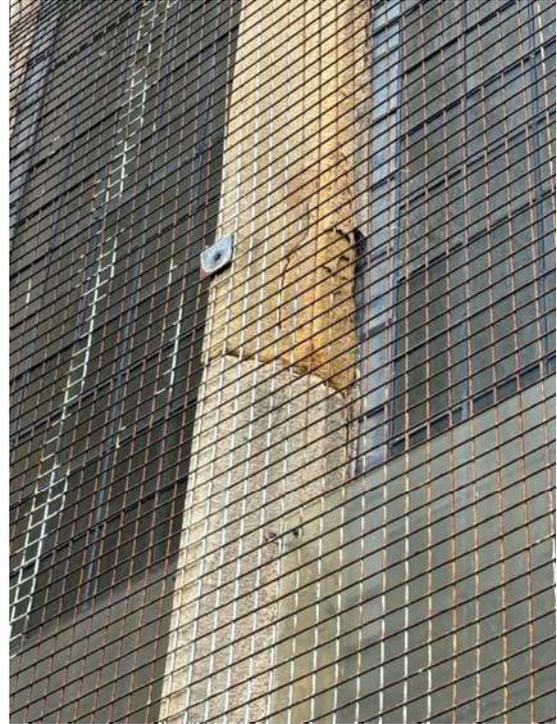
Crack to upper section of mullion, right hand side.

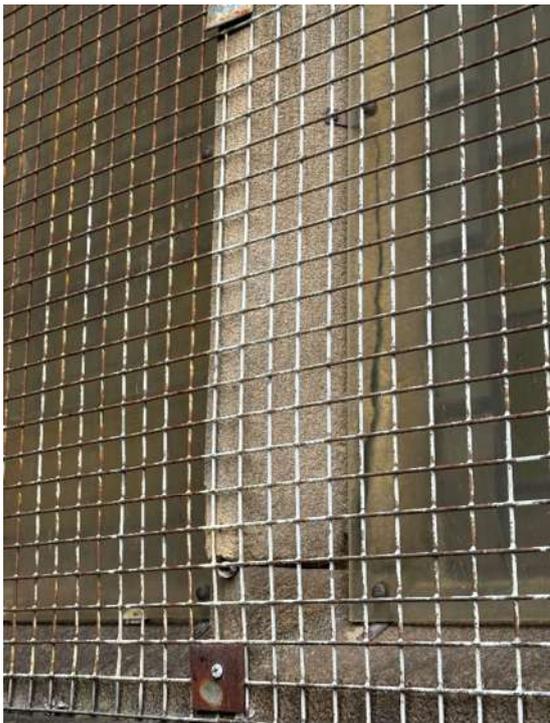
Crack to lower section of mullion, right hand side.
