## **QUINQUENNIAL REPORT**

*For the Parish Church of  
St John, Gateshead Fell*

***Report Date: July 2024***

Inspecting Architect:  
Becky Smith BA(Hons), MArch, ARB

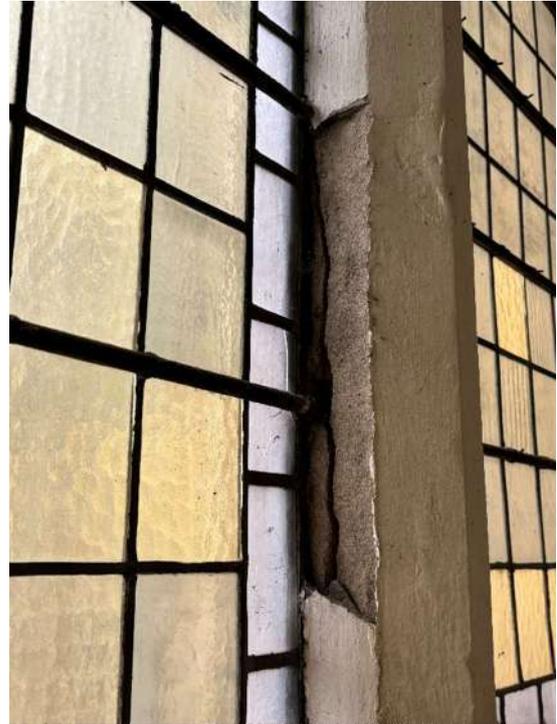
Paint and plaster have fallen from lower left side of mullion, crack to stone visible.

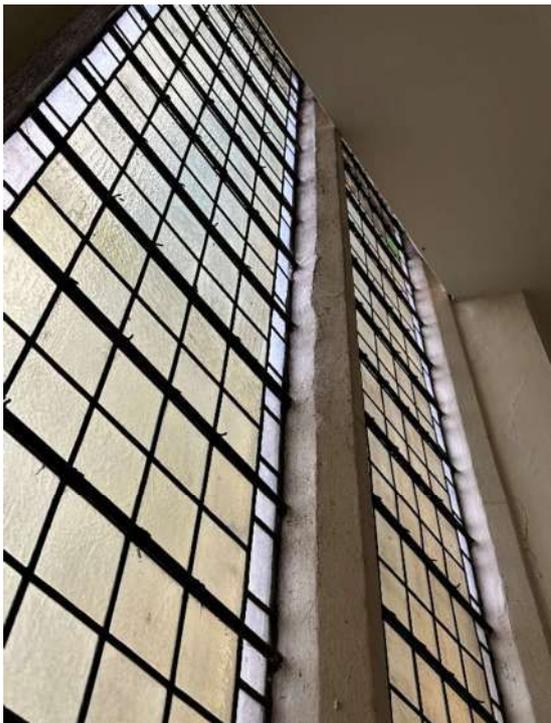
Cracking to paint visible to upper left side of mullion.

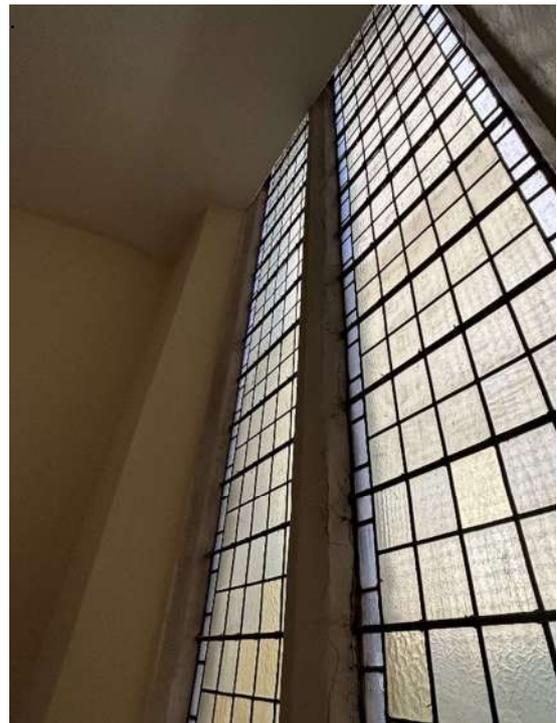
Cracking to paint visible to right side of mullion.

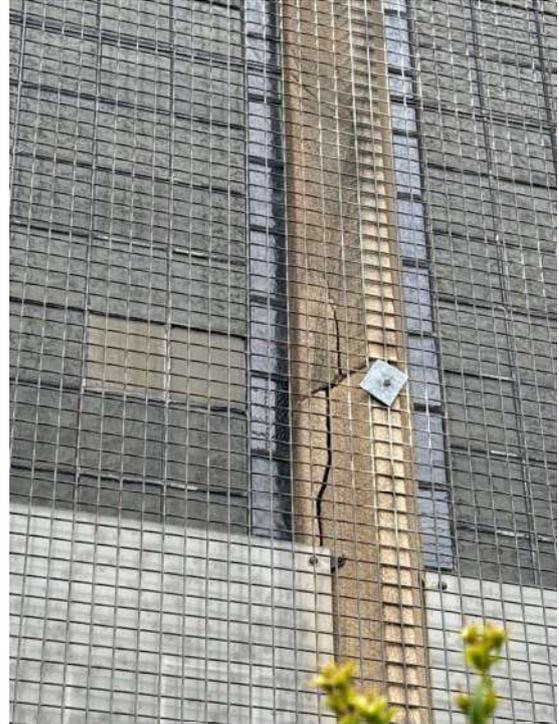
Cracks visible to central mullion left hand side.

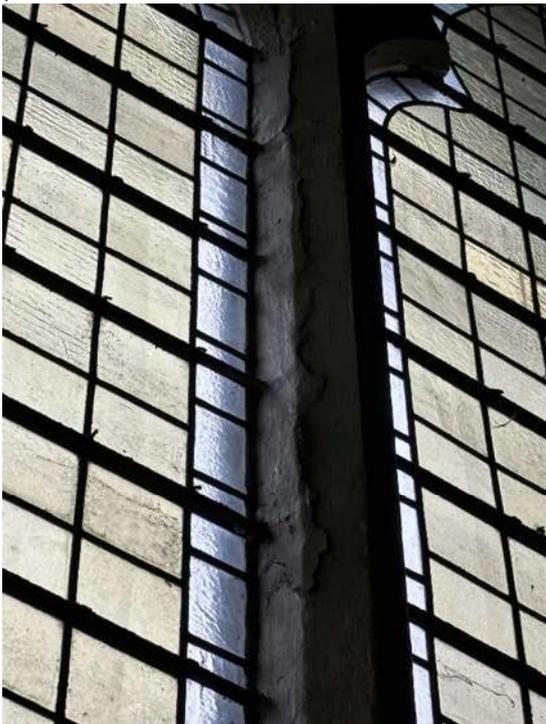
Internally: Cracking to upper left side of paint to mullion.

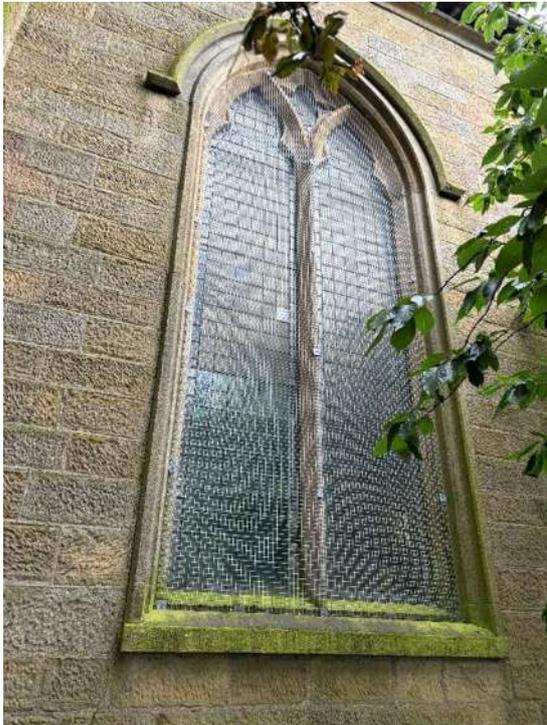
## W.10 – EXTERNALLY

Overview of Window Externally - slightly obscured by trees.

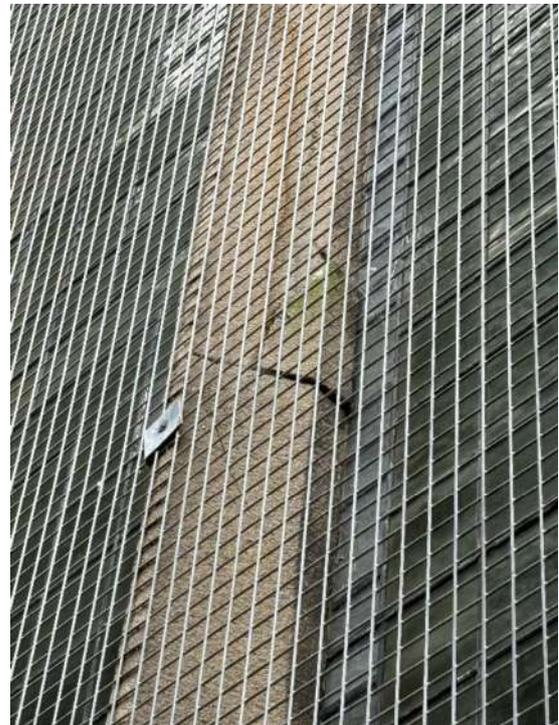
Crack to central right side of mullion.

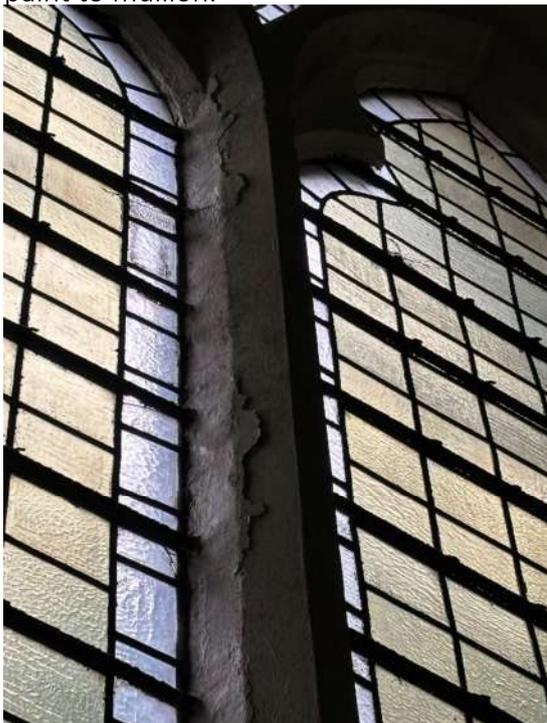
Internally: Cracking to upper left side of paint to mullion.

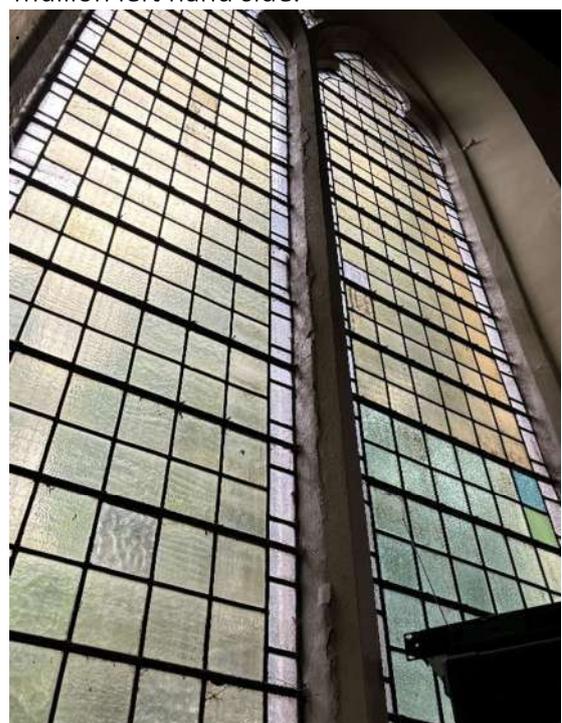
Internally: Cracking of paint to central mullion left hand side.
