Care of Churches and Ecclesiastical Jurisdiction Measure 1991 – Quinquennial Inspection  
**ST CHAD'S, ROSEWORTH – Non-Listed**

Diocese: Durham  
Archdeaconry: Aukland  
Church Code: 613 316

Date of Inspection: 07<sup>th</sup> Sept 2023  
Inspection undertaken by: Jamie Holden BA (Hons) RIBA RIAS  
Previously Inspection: May 2018 by Ian Ness

**Studio Tamacoco Architects**

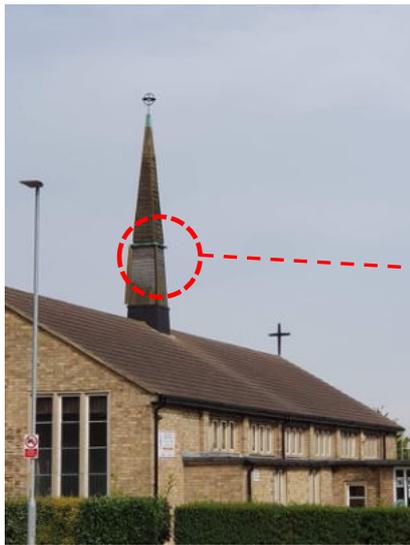
2.1.6

a) View from the SW.

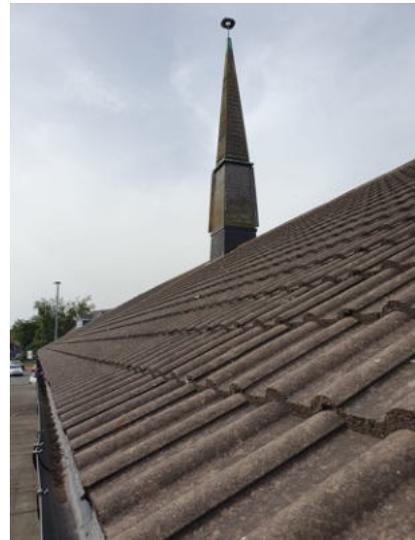
b) View looking west

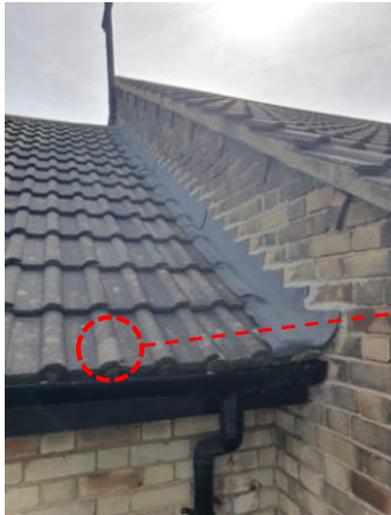
2.2.5

a) Flashing between the nave and sanctuary

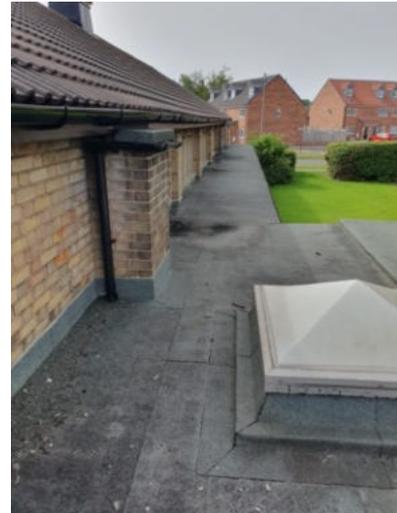
b) North aisle

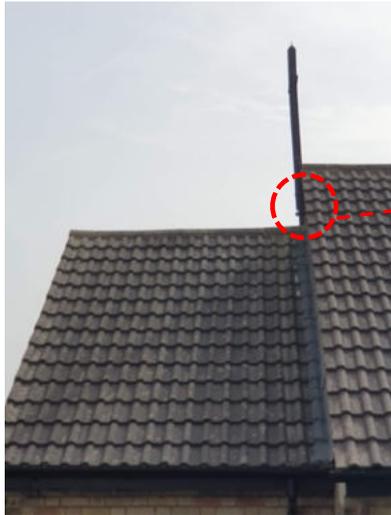
2.2.7

a) *Crucifix at east end gable*

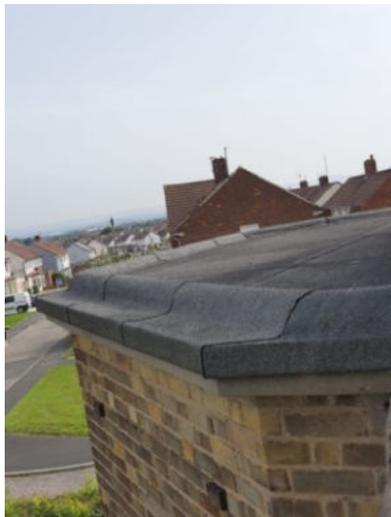
2.2.8

a) *Apse roof in good order*

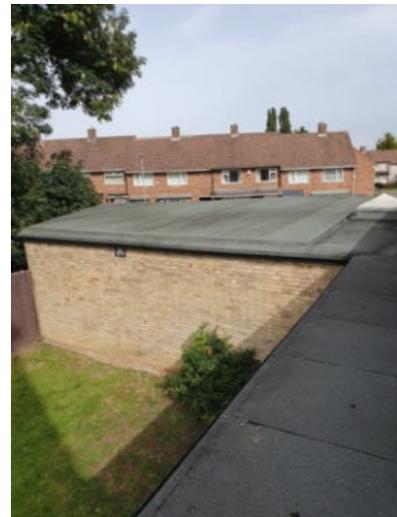
b) *Looking towards the east over the Parish Pantry roof*

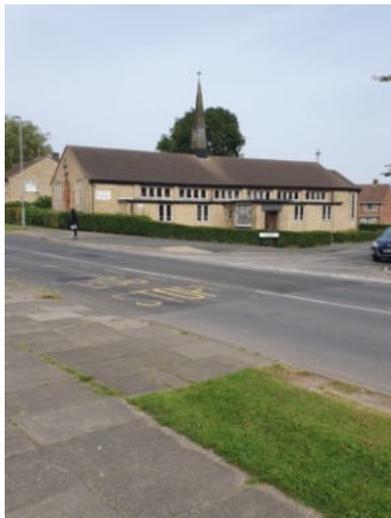
3.1.5

a) South elevation viewed from the SW

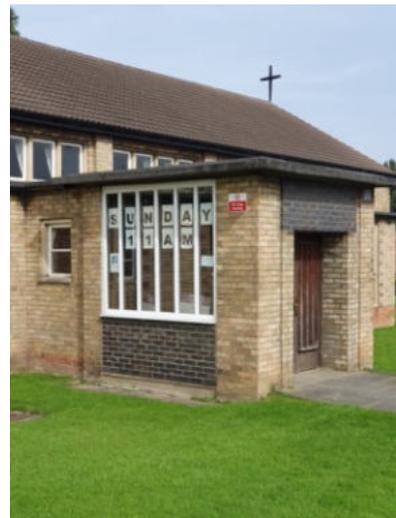
b) South porch

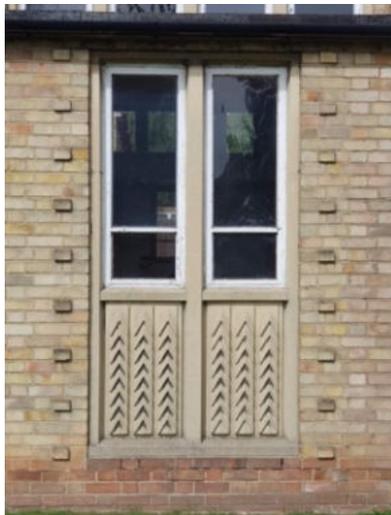
3.1.7

*a) Cast stone window surrounds and decorative panels*

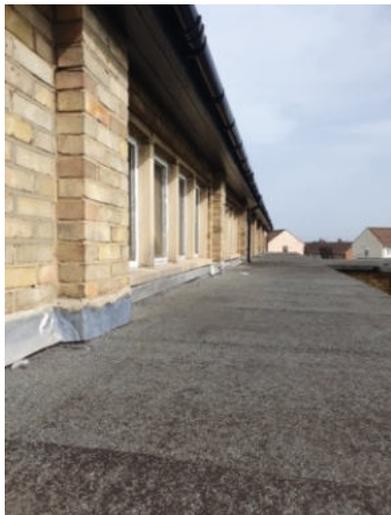
3.1.8

*a) Clerestory windows*

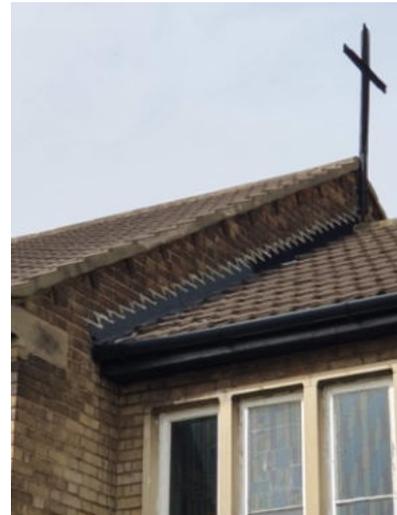
b) East gable to the nave and abutment flashing is all in good order.

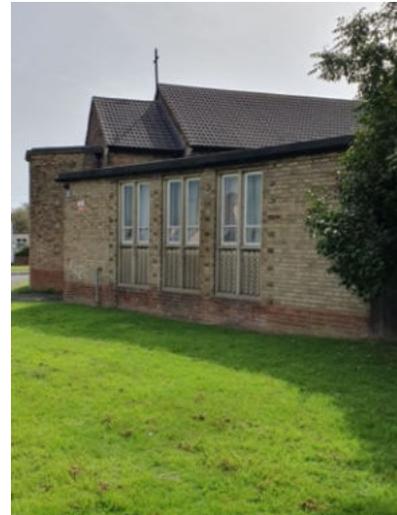
- 3.2.5 The main east elevation of the parish pantry has three windows positioned centrally. The windows are metal framed within cast stone surrounds as found elsewhere on the building. It is noted that a couple of the projecting headers surrounding the windows are damaged but apart from that the brickwork is in reasonable order.

b) East elevation of the Pantry

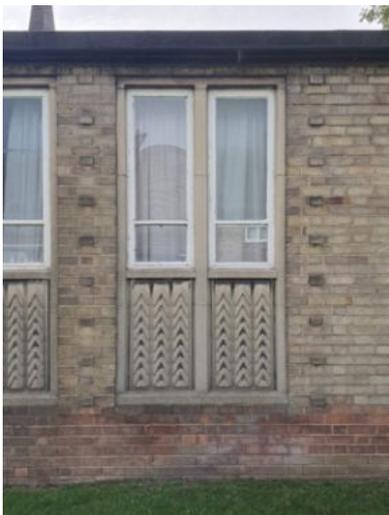
3.2.9

a) Typical window and surround

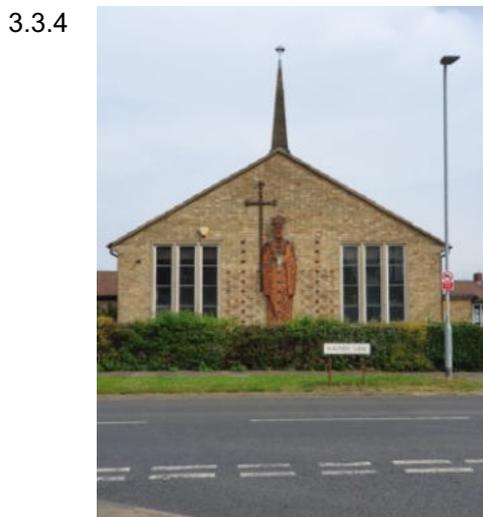
3.3.2 The masonry is all in good order, however, there appears to be a slight sag in the brickwork coursing directly above the lefthand window and some minor distortion in the cast-stone surround. This is likely to be a long-standing issue and is of no great concern currently, however, this item should be reviewed at the next QI.

a) West elevation

3.3.3 In the top left-hand corner of the window to the left of St Chad, the mortar has fallen out leaving an open joint between the brickwork and cast stone surround. This ought to be carefully repointed to prevent moisture ingress. **2**

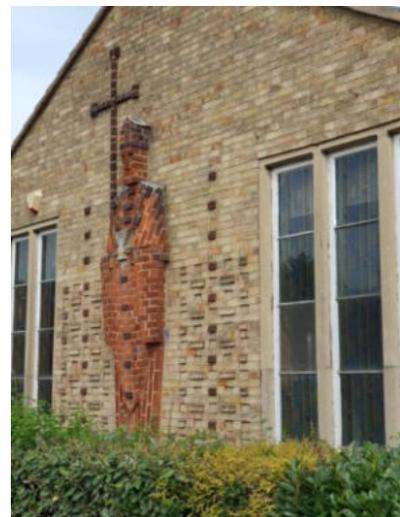
b) Brick relief of St Chad with panels of decorative brickwork on either side.

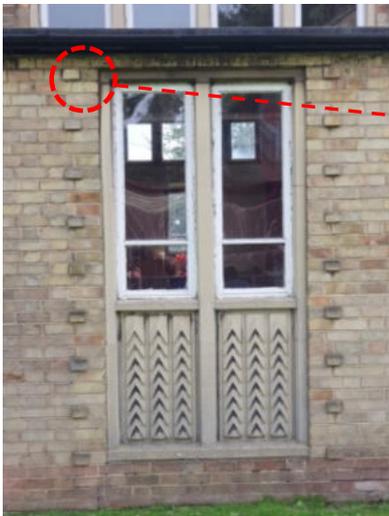
3.4.4

3.4.2 There are a couple of minor settlement cracks in the aisle window second from the west and around the abutment flashing at the far west-end of the aisle roof. These defects were alluded to in the 2018 QIR, they do not appear to have changed significantly but should remain under observation. ○

a) 2nd<sup>d</sup> window from the west

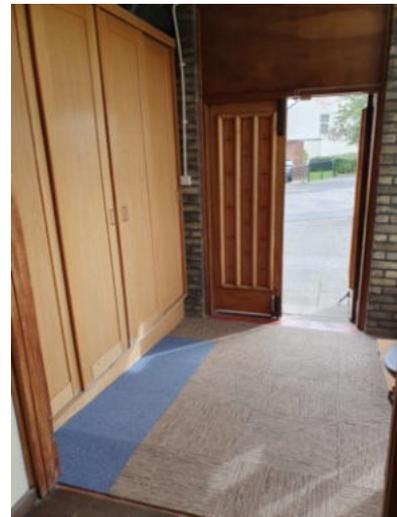
b) The gently ramped floor provides reasonable 'accessibility for mobility impair visitors.

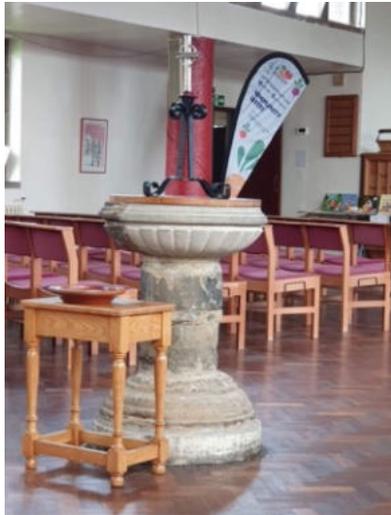
4.2.16

- 4.2.11 In the centre of the nave there is a stone font brought from St Mary's church, Norton. It is understood to be medieval in origin. The font has been fitted with a modern cover. Being positioned in the centre of the nave allows plenty of space for people to congregate for baptisms, however, its position may also limit the extent to which the church could accommodate 'alternative' activities.

a) Font

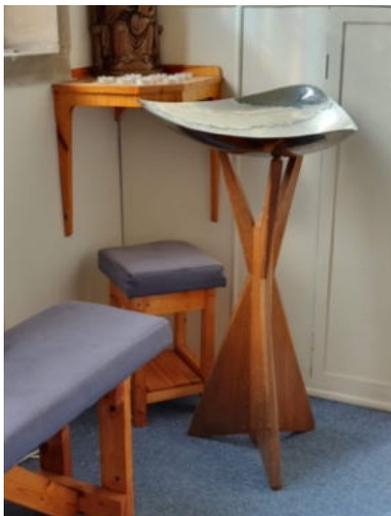
4.3.7

a) Modern font

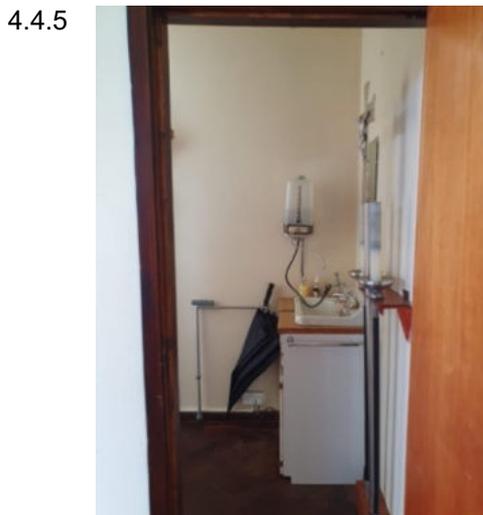
a) Sink unit at the entrance to the vestry

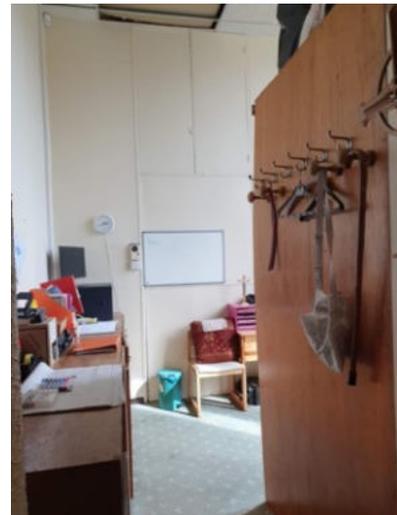
4.4.4 **Furniture:** There is an assortment of furniture in the vestry including built-in cupboards, a mirrored wardrobe and sink unit. There are two safes which are built into the cupboards. The furniture and joinery are well-worn and showing their age, however, they appear to serve the purpose. A full refurbishment of the vestry would be quite justifiable although this would have to be considered a desirable rather than a sensual undertaking.

b) Furniture, well-worn but serviceable.

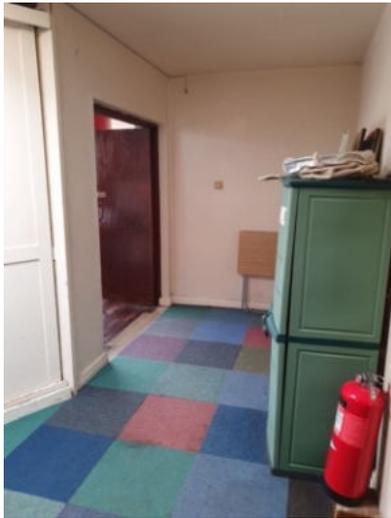
a) Lobby

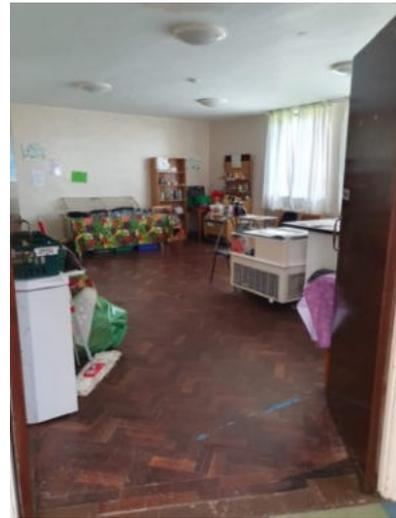
b) The parish room/ 'pantry'

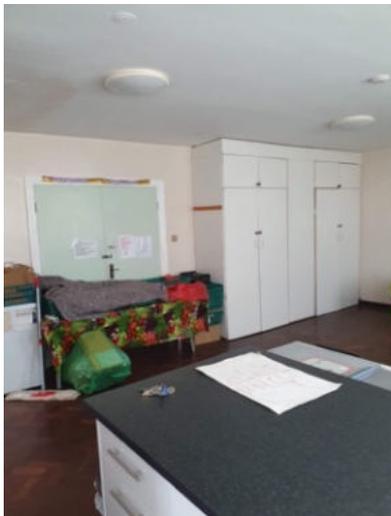
a) Built-in storage

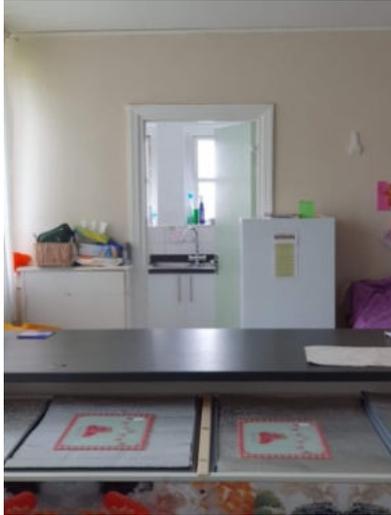
*a) Fridge freezer and worktop, servery beyond*

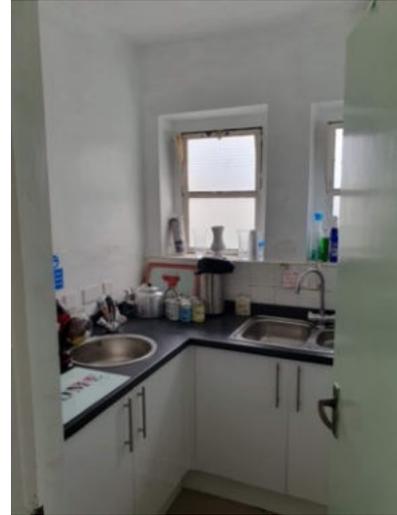
*b) Servery allows hot drinks and snack to be provided.*

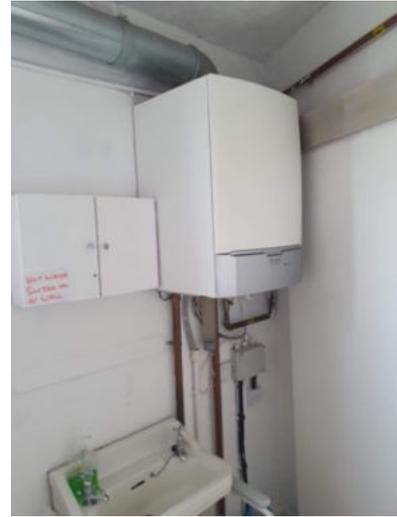
*b) Boiler*

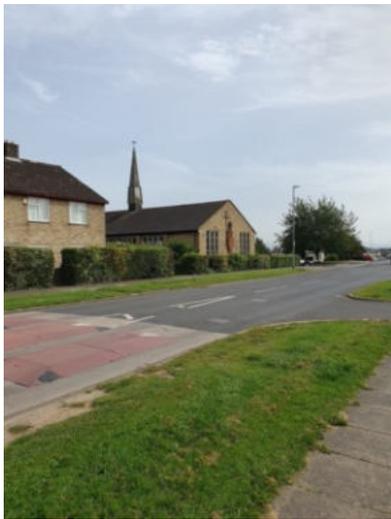
*a) View from the NW*

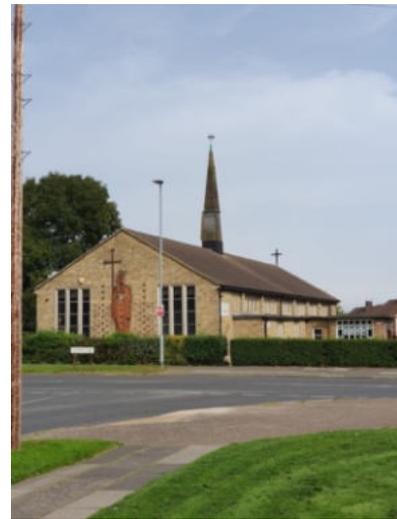
5.1.3 The churchyard is laid to grass throughout except at the main entrance where concrete flags provide access to the south porch and there is a short access way in rough concrete to the parish room/ pantry. The hard surfaces are in adequate condition and the grass area is well kept. The boundary is planted with a neat low-level hedge.

*b) Low hedge to all boundaries*

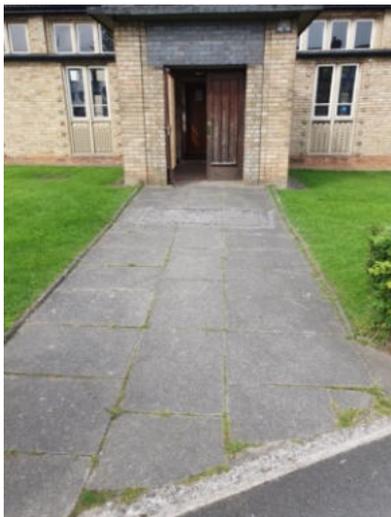
*a) Paved access to the main entrance*
